Collapse of the Grimburgwal, a historic quay in Amsterdam, the Netherlands

Proceedings of the Institution of Civil Engineers: Forensic Engineering

Research Article

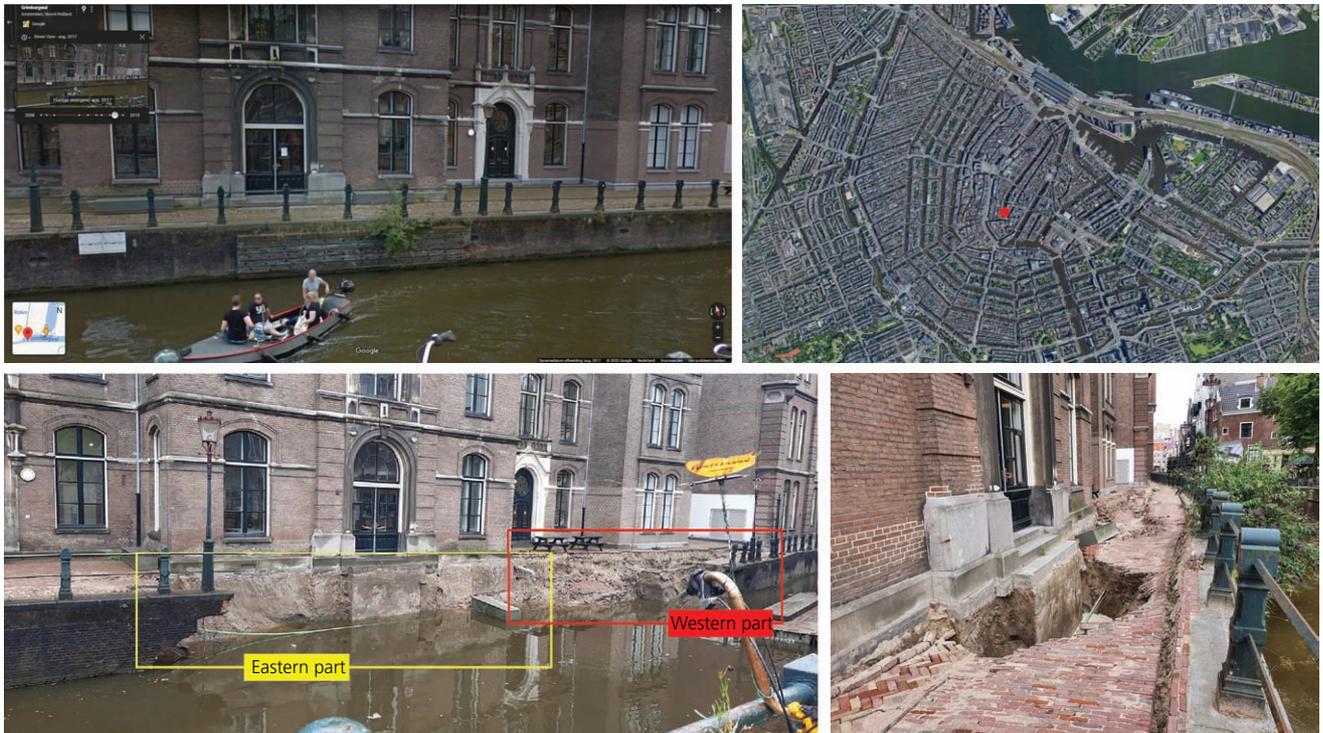
On 1 September 2020, part of the quay wall along the Grimburgwal (GBW) in Amsterdam, the Netherlands, collapsed. It concerns a quay right adjacent to an educational building, both dating from around 1870. A picture of the collapsed quay can be seen in Figure 1. During the collapse, video images were taken by a security camera, which show that the quay leans forward into the canal and a stretch of about 25 m disappears into the canal. As streets in Amsterdam are usually very busy, the collapse triggered the question of the safety of the remaining quay walls in the city. This paper describes the forensic investigation that was carried out to determine the failure mechanisms and factors that contributed to the collapse. The investigation aimed to learn from this failure and prevent similar failures in the future.

Figure 1. Collapsed quay and location in Amsterdam. Top left: initial condition of the quay in May 2019; picture from Google. © Google. Top right: location of GBW in Amsterdam at red dot. Bottom left: front view of quay just after collapse. Bottom right: surface view just before collapse

manoeuvre to turn and to steer into a narrow clearance under a historic bridge opposite of the failed quay. Signs of multiple ship collisions were found (see Figure 1). In old drawings, an older quay was found to cross the current quay near the site of the collapse. Also, the meteorological conditions just before the collapse were investigated. In 2014 the foundation of the building behind the quay was renewed. New piles were installed from the inside of the building. Interference with the foundation of the quay wall at the spot where the proximity of building and quay is closest could not be excluded.

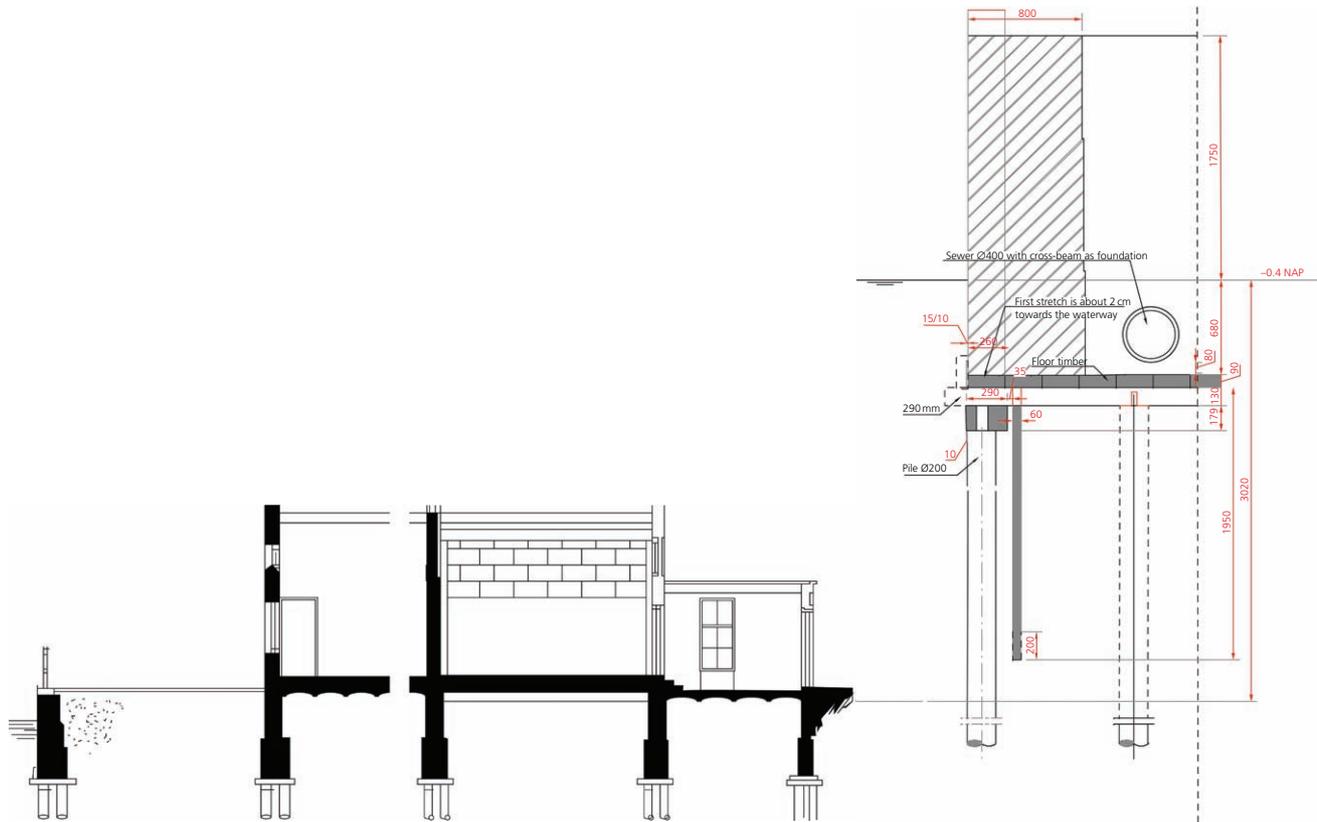
Figure 2. Cross-section of the quay wall according to historic evidence (the quay was built around 1875) on the left, and cross-section according to divers' inspection with dimensions on the right (dimensions are in mm). NAP, Amsterdam Ordnance Datum

The main failure mechanism was the horizontal bending of the piles as a result of a local deepening of the canal followed by breaking of the quay piles. This explanation assumes that only two rows of piles were present or functioned effectively over at least part of the quay. This is in accordance with the historic evidence and the underwater inspection and is also the most likely given the very short distance from the quay to the building behind it, where there is not enough space for a system with three piles. The long-existing cracks in the masonry wall reduced the possibility of redistribution of forces in the quay in the longitudinal direction, so that the loads could no longer be transferred to the stronger parts (with three rows of piles). The analyses were carried out with the assumption that the timber was not degraded, which to date needs to be confirmed. The presence

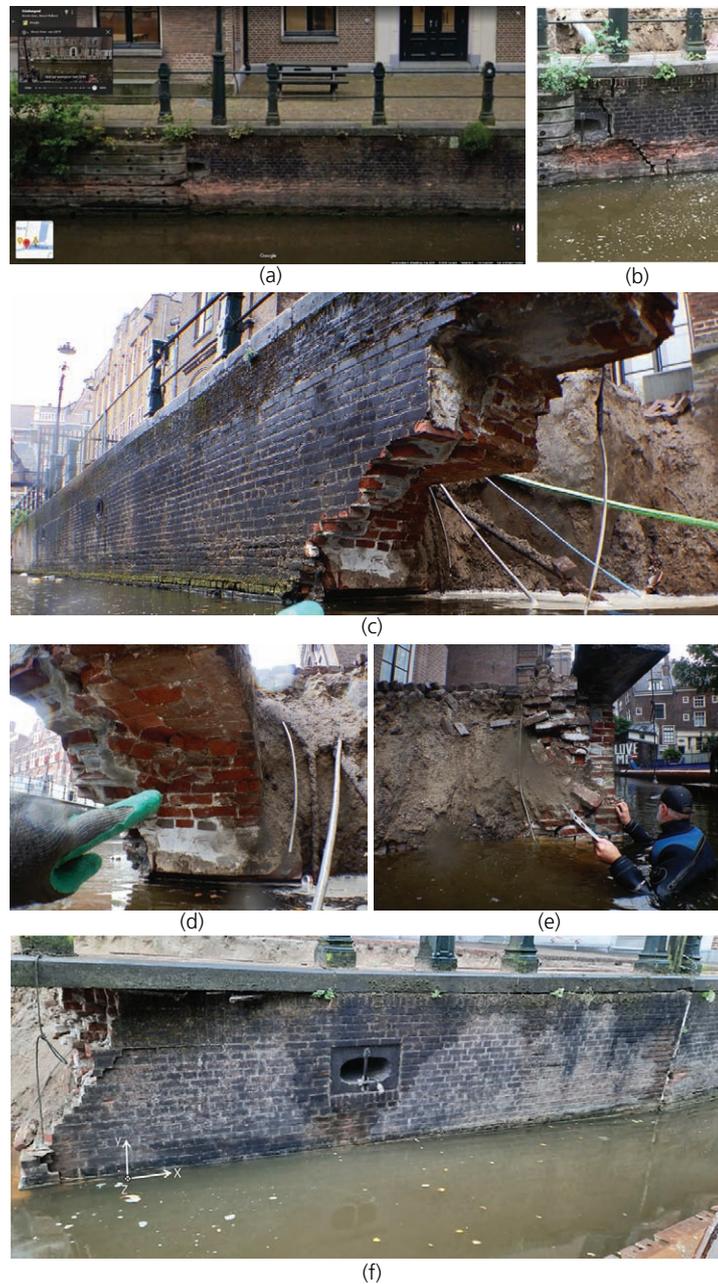
A detailed assessment of the cracks (see Figure 7 for the crack locations and identification) was made. The middle crack (crack ref. 2) was clearly visible a few minutes before the collapse of the structure (Figure 3(b)). The crack was located in an area subject to extensive damage due to mainly boat impacts, opened and deformed out of plane. The latter can be related to actions of the soil laterally pushing the quay wall. It is not clear if the crack already existed before the collapse of the quay wall started.

On the eastern side of the collapsed quay wall, a regular diagonal/vertical crack (crack ref. 3) was observed (Figure 3(c)). The surface shows an identical shape along the entire thickness of the quay wall. This indicates that out-of-plane torsional actions are to be excluded. The eastern crack is vertical on the top part of the quay wall. To obtain this pattern, a deformation along the quay wall was required. This deformation can be triggered by an in-plane rotation of the

failed part of the quay wall. The eastern crack shows a sequence of horizontal and diagonal sections just below the top part of the quay wall. To form such a pattern, a deformation along the vertical direction was required. This deformation can be triggered by an in-plane rotation of the failed part of the quay wall and/or an in-plane vertical collapse of the failed part of the quay wall.

Pictures available in Figures 3(c) and 3(d) indicate that the failure occurred in a restricted time span, as all cracks, excluding the previously described existing cracks, are fresh. However, damage due to environmental conditions at the waterline, which can also be seen in these pictures, can be a sign of earlier deterioration of the material.

On the western side of the collapsed quay wall, a diagonal/vertical crack was observed, indicated as ref. 1 in Figure 7 and in detail shown in Figure 3(e). The surface shows an irregular shape along the thickness of the quay wall, including the opening of vertical joints in the thickness. This indicates that out-of-plane torsional actions occurred in this section. Considering the out-of-plane deformation of the remaining part observed at the front side of the quay wall (Figure 3(e)), it is possible that the collapsed western part failed due to out-of-plane torsional actions and out-of-plane overturning action. From the overview, it is possible to observe that the remaining part of the quay wall shows a residual

Figure 3. Cracks in the quay. (a) Ship collision crack ref. 2 from Google 1 year before collapse. © Google. (b) Crack B visible minutes before the collapse. (c) Eastern crack ref. 3 after collapse. (d) Eastern crack ref. 3 detail with sharp surface in bricks. (e) Western crack C after collapse. (f) Front view of western crack ref. 1 left and dilation joint ref. 5 on the right

vertical deformation. This deformation can be triggered by an in-plane rotation of the failed part of the quay wall and/or an in-plane vertical collapse of the failed part of the quay wall.

Furthermore, Figure 3(f) on the right shows a dilatation joint (ref. 5) with an opening without the presence of out-of-plane deformations. This potential in-plane deformation is compatible with the vertical residual deformation recorded for the remaining part of the quay wall. Lastly, a tapered crack (crack ref. 4) cuts through the quay wall on the

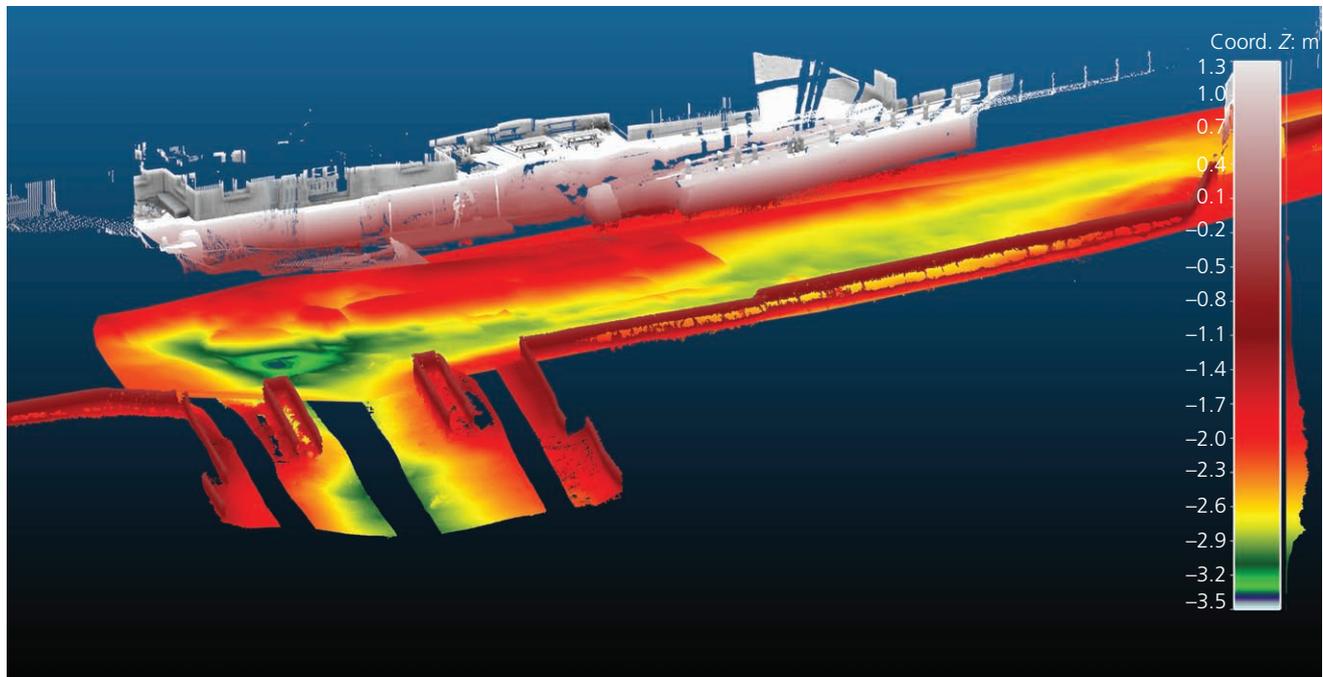
Figure 4. Visualisation of the multibeam and three-dimensional scan made after collapse of the quay by Van Gellecum (2021). The colour red refers to shallow bed levels, showing debris in canal and quays and bridge foundations opposite of collapsed stretch, and colours green to blue refer to the deepest canal bed level (NAP -3.25 m and locally to NAP -3.5 m)

The cause of the deeper canal bed is likely related to the fact that the canal is very narrow at this location and exactly at this spot the four boats turn sharply under a bridge. It has been

observed that the depth of the canal increases in the direction of the bridge and then decreases again. The repeated collisions of the tour boats have weakened the quay. Ship traffic was a cause of masonry damage, which caused a precondition with less ability to distribute loads along the quay. The trigger for the collapse was believed to be the renewal of the pavement in May and August 2020. This repaving was necessary as a result of the deformation of the quay that occurred before. The effects of this repavement were clearly recognisable in the satellite measurements that show an increased settlement rate over time during repaving. Groundwater flow and drought/rain may also have played a role in accelerating the failure in combination with the horizontal quay deformation that had already occurred and the leakage path from behind the quay towards the canal for the formation of holes in the pavement as shown in Figure 1.

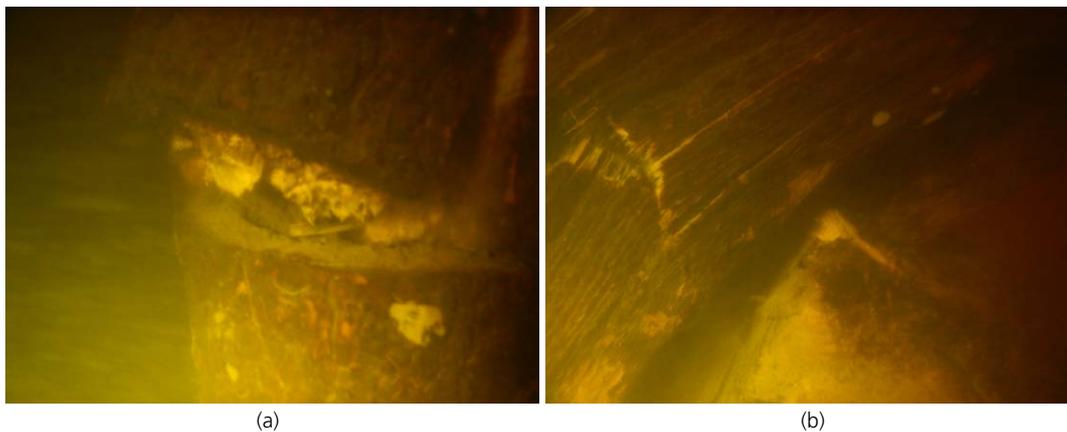
Figure 5. Pictures of the collapsed foundation under water by Van Gellecum (2021): (a) broken pile; (b) broken cross-beam

From Figure 11, it can be seen that for the two-row pile system, the bending stress in both pile rows exceeded the timber capacity (in green) for the smaller piles even for small increases in canal bed depths. For larger pile diameters, this was not the case nor for quays with three pile rows. Comparing the results of the bending of the piles with the initial horizontal movement of the quay as seen in Figure 1 and the deformations of the satellite measurements in Figure 6, as well as the broken foundation parts in Figure 5, leads to a consistent collapse mechanism.

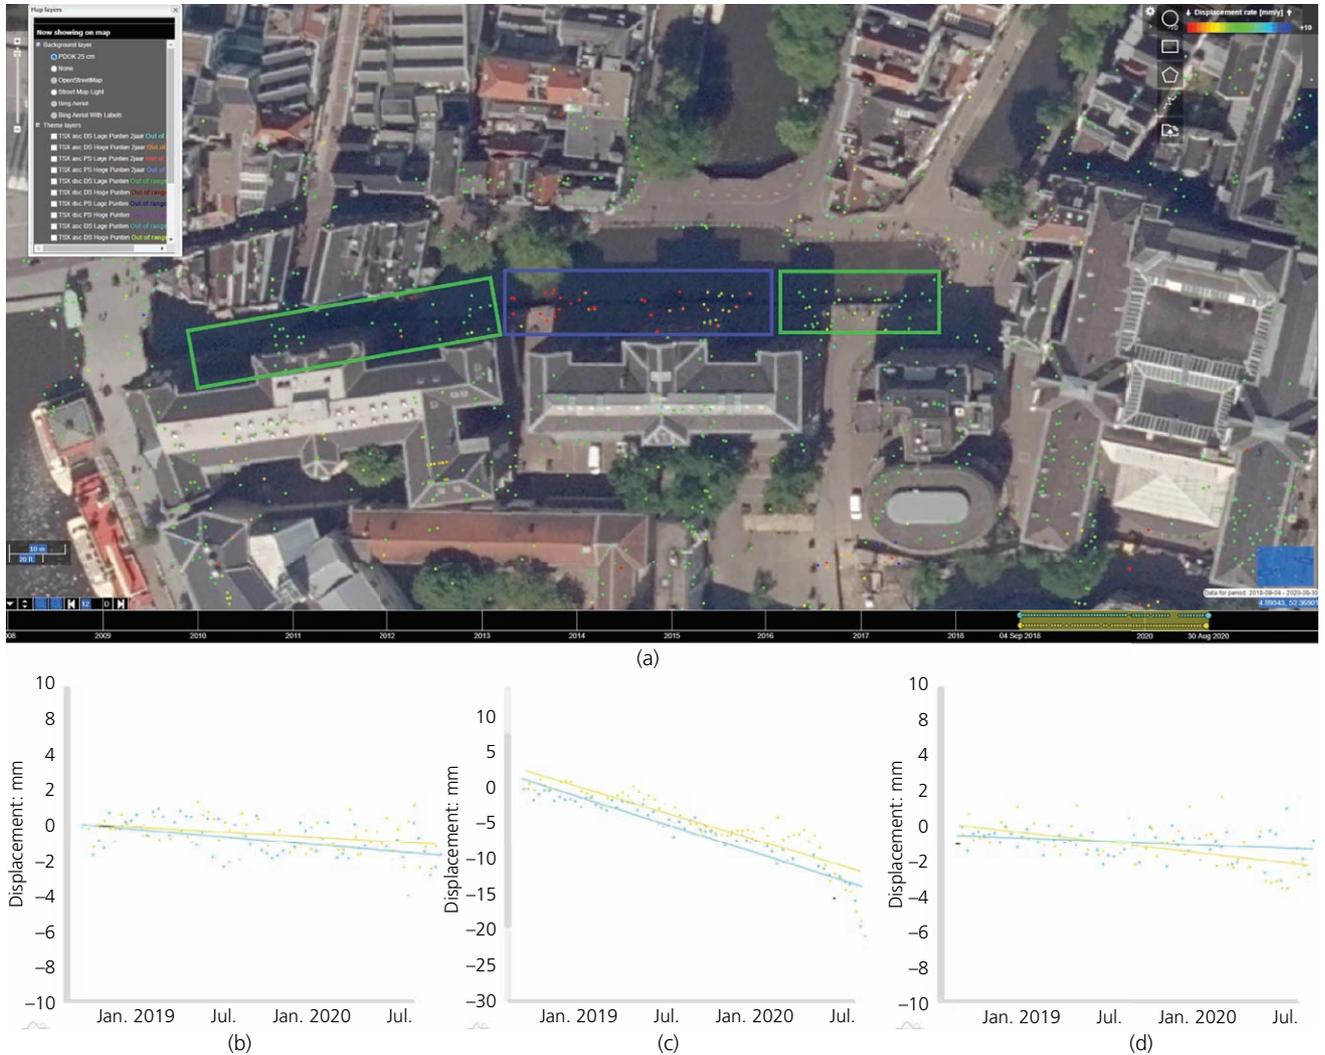
Figure 6. Satellite measurements with (a) overview of settlement reflection points over the 2 years before the collapse on a scale of -10 mm in red to $+10$ mm in blue. (b, d) Settlement point average of the zones on either side of the collapse in green rectangles in (a) and (c) settlement point average of the collapsed section in blue rectangle in (a); results from both ascending (yellow) and descending (blue) tracks are shown

Furthermore, it was found that interferometric synthetic aperture radar (InSar) measurements provided a good insight into the weakness of the quay wall section, as it was possible to identify deviating settlements of the street behind the quay already long before the collapse. The vertical settlements are a result of horizontal deformation of the quay, an indicator of possible collapse. It is thus possible to use InSar in the stress testing of quay walls and to reduce the risk of collapse by paying systematic attention to settlements behind the quays. Analysis of the subsidence of the quays with InSar measurements can help map other 'hotspots'. Additionally, a registration/notification system can be set up for the occurrence of subsidence on the quays or necessary street work. Also, it is advised to perform measurements of the quays (preferably not only horizontally on the quays but also vertically) and to investigate the relationship between the deformation and possible failure (numerical or experimental). Further analyses must be performed to determine which limit values indicate failure.

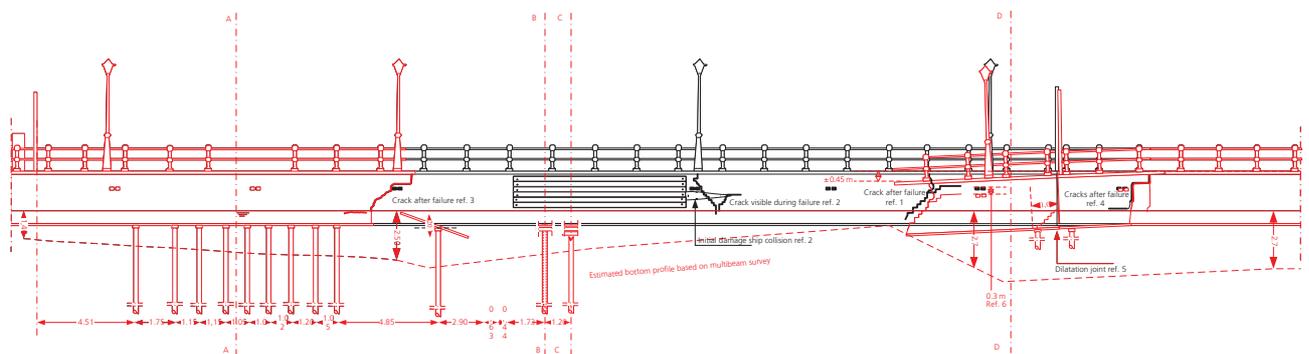
were found in the paving. The quay then became detached following a subsequent vertical deformation and fell out of plane towards the canal. A section of the wall of approximately 25 m long submerged completely. The collapse started in the eastern part. The western part was pulled along and tilted as a result; see Figure 8 for a visualisation of the collapse in progress and the relative movements of the masonry sections.

Figure 7. Front view of the wall. In black, the situation prior to collapse; in red, the situation found after collapse, including crack locations (dimensions are in m). East is on the left; west is on the right

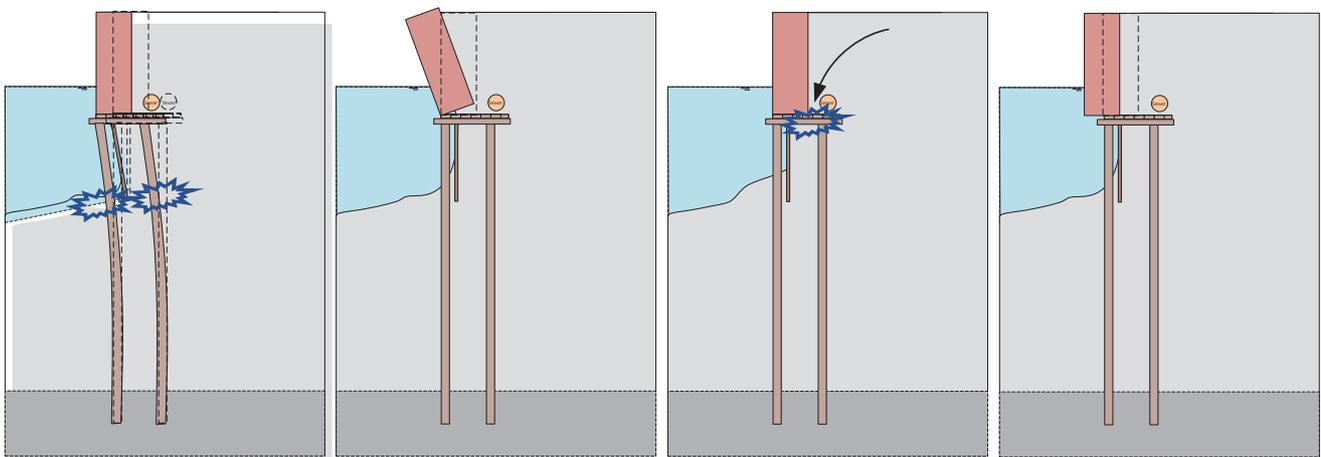
Some of the most important mechanisms are shown in Figure 9 and can be found in general sense in, for example, the handbook *Quay Walls* (De Gijt and Broeken, 2013) or the Dutch handbook of inner-city quay walls (Roubos and Grotegoed, 2014). From left to right, Figure 9 shows the horizontal bending of the piles and local geotechnical failure of soil around the piles, the overturning

of the masonry wall, cross-beam failure and horizontal sliding of the masonry from the deck. Other failure mechanisms investigated include the axial capacity of the foundation piles and the structural failure of the masonry wall.

Figure 9. Most relevant failure mechanisms for the quay wall from left to right: horizontal bending of the piles and local geotechnical failure of soil around the piles, overturning of the masonry wall, cross-beam failure and horizontal sliding of the masonry from the deck

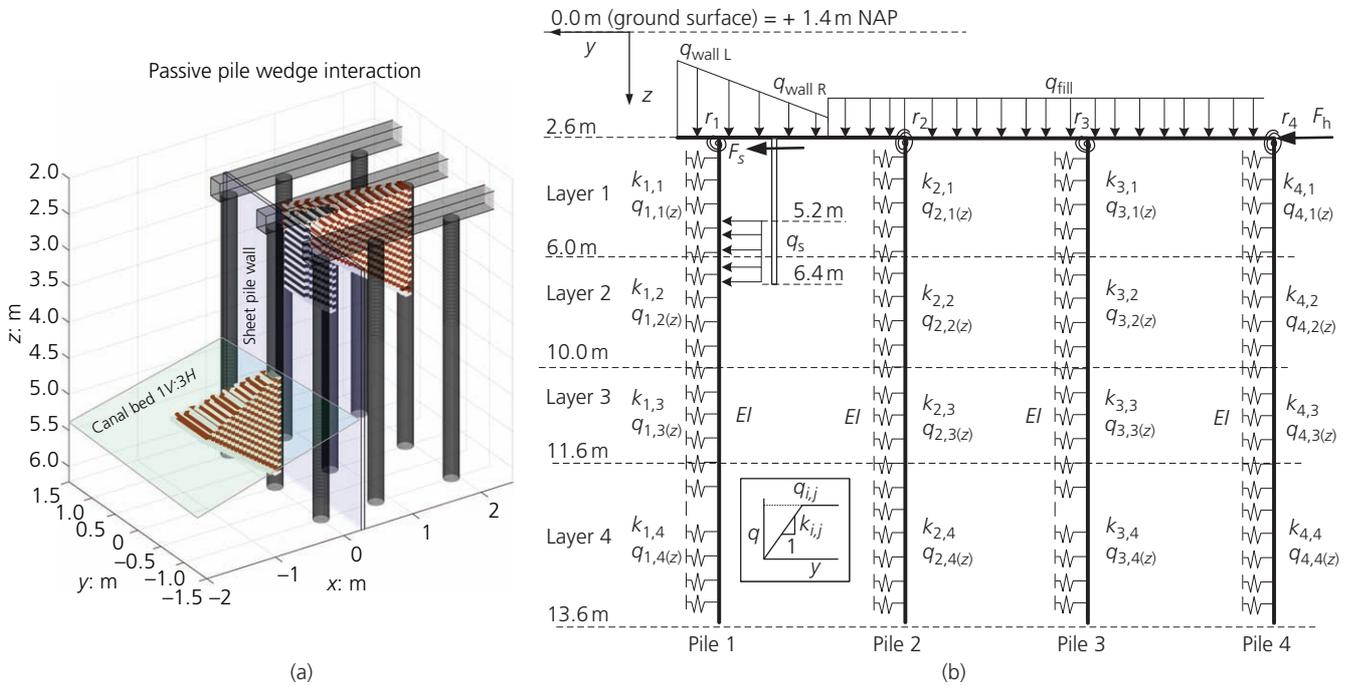
In step 4, modelling took place to determine the most likely (combination of) failure mechanisms based on the information collected in steps 1–3. The overturning mechanism turned out to be stable with a low factor of safety for most combinations of loads. This, therefore, was not considered as the initiating mechanism. The pile axial capacity was sufficient to resist the axial loads, even though according to the historic evidence, the piles were shorter than normal. This excluded a local axial failure of the piles being the initiating mechanism. Other important assessments were made with a model describing the geotechnical and structural behaviour of the foundation of the quay, with a masonry wall and soil fill of clay and sand on top of a timber deck supported by timber piles. These calculations were performed by using a model developed by one of the team members (Hemel *et al.*, 2022) using an elastic-perfect-plastic soil–pile behaviour. The main principle of the model is shown in Figure 10, and the results are in Figure 11. As it was clear from step 1 that the bottom of the canal was deepened up to 1.5 m by erosion (most likely by boats), the response of the foundation of the quay to the deepening of the canal was assessed for various situations. The variations included two and three pile row foundations, pile diameters of 0.2 and 0.25 m and canal bed depths between Amsterdam Ordnance Datum (NAP) -1.2 m and NAP

Figure 10. (a) Three-dimensional passive wedge model for computing the plastic limit of p - y springs with nine piles and three cross-beams shown as well as the sheet pile wall behind the front pile row and the canal bed; (b) structural model showing in cross-section the schematised springs resisting and loads acting on the piles and the cross-beam

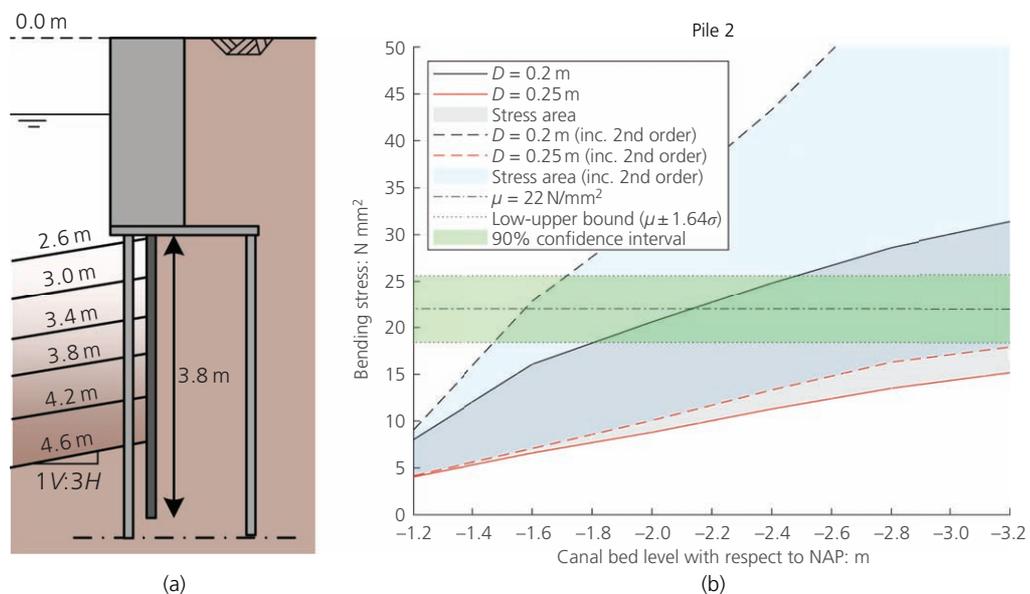
Figure 11. Results of the bending stress in the piles (a) depending on the depth of the canal and (b) for different pile diameters, first- and second-order calculations and strength of the timber

This assessment has shown that the geometry of the quay played an important role in the sensitivity of the quay to the deepening of the canal. This resulted in measures/follow-up actions being recommended related to stress testing the historic quays in Amsterdam. The main recommendations are to check other places with soil erosion of the canal bottom, quays that have only two rows of piles as foundation and/or quays with damage of the masonry in the form of cracks.
