## Failure Analysis of Two HP-Nb Heat-Resistant Tubes after 46,000 h Exposure to Reformer Service Conditions

# Failure Analysis of Two HP-Nb Heat-Resistant Tubes after 46,000 h Exposure to Reformer Service Conditions

**Abstract:** This study presents a failure analysis in two reformer tubes used for hydrogen production in a petrochemical industry. These tubes (Tube A and Tube B) were made by the centrifugal casting of HP-Nb alloy in such a way that one contained titanium as a micro-element, and the other was free from titanium in its chemical composition. Although the two tubes were subjected to similar creep conditions, Tube A failed after only 46,000 h of operation against the design life of 100,000 h. SEM images showed initiation and growth of creep pores next to chromium carbide particles, as well as the formation of microcracks in Cr<sub>23</sub>C<sub>6</sub> carbides. Pore initiation occurs as a result of grain boundary sliding and is strongly dependent on structural morphology. The tube containing titanium (Tube B) showed higher thermal stability and higher creep resistance than the tube without titanium (Tube A), which was due to the formation of finer and more discrete c

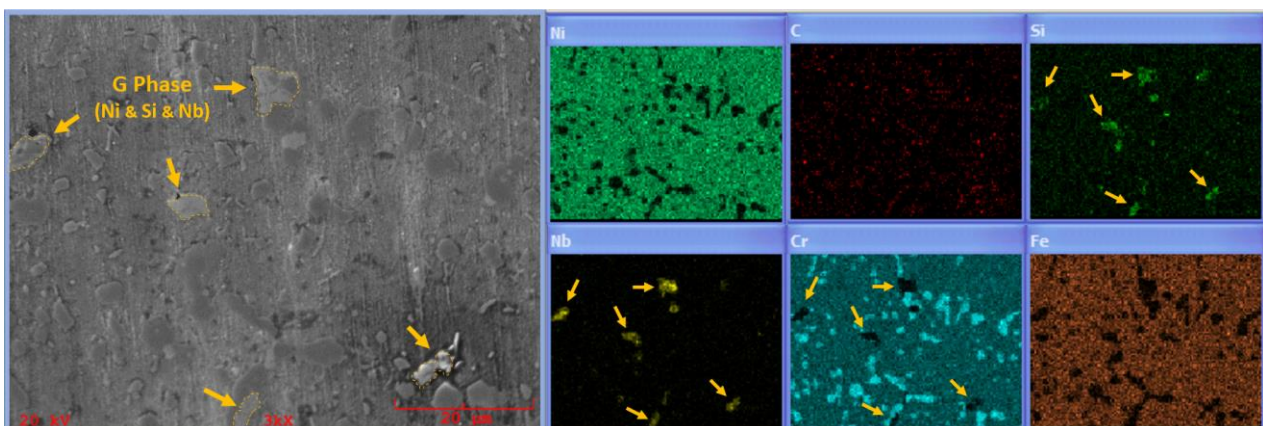
**Figure 4.** X-Ray Mapping images of tube A showing the distribution of various elements in SEM images.

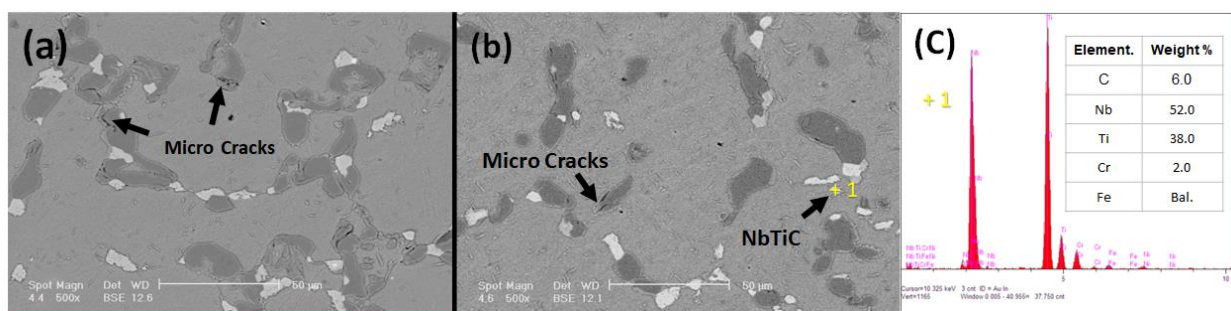
According to Figure 5, the coalescence of the carbide network in the titanium-free sample is higher compared to the sample containing titanium. Furthermore, the tube

containing titanium as an alloying element (Tube B) has a finer structure. Therefore, based on the effects of microstructural morphology on the initiation, growth, and coalescence of creep pores, it is expected for the Tube B to have higher ductility and creep resistance compared to the Tube A. This improvement in creep behaviour can be due to the presence of Ti carbonitrides and their effect on secondary carbide precipitates during ageing. The reason for the lack of failure in Tube B, despite tolerating similar service conditions to Tube A, is the positive effects of titanium on the creep behaviour of the alloy.

**Figure 5.** SEM images of tube microstructures after ageing: (a) Tube A without titanium and (b) Tube B containing 0.12 wt. % of titanium (c) point elemental analysis of NbTiC phase using EDS system.

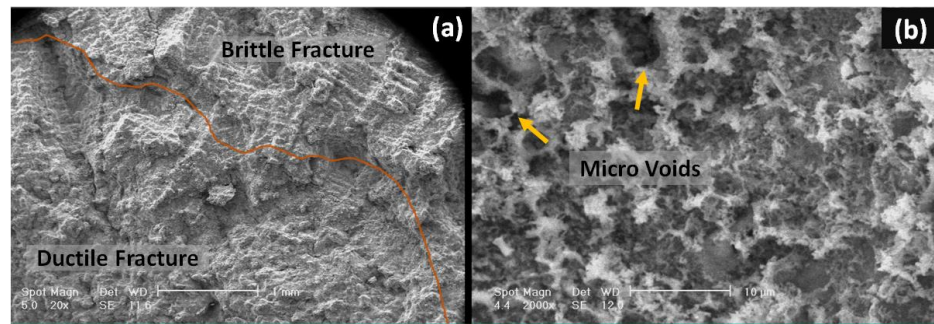
Based on the results of fractography studies, the fracture morphology of the failed tube (Tube A) is jagged, which indicates unsuitable mechanical properties. The furrow and ridges distributed on the fracture surface are seen in Figure 10a. The porosity has resulted in non-uniformity of distribution in tensile/compression stress. The imaginary line indicates the boundary between ductile and brittle fracture zones. As can be seen in Figure 10b, the fracture is ductile using the void coalescence mechanism in the areas with merged carbide particles (arrows). These microvoids are a suitable location for the coalescence of cracks due to the increase in local stress.

Figure 10. SEM images of fracture surface morphology of the failed tube, (a) final ductile and brittle fracture surfaces and (b) ductile fracture surface.

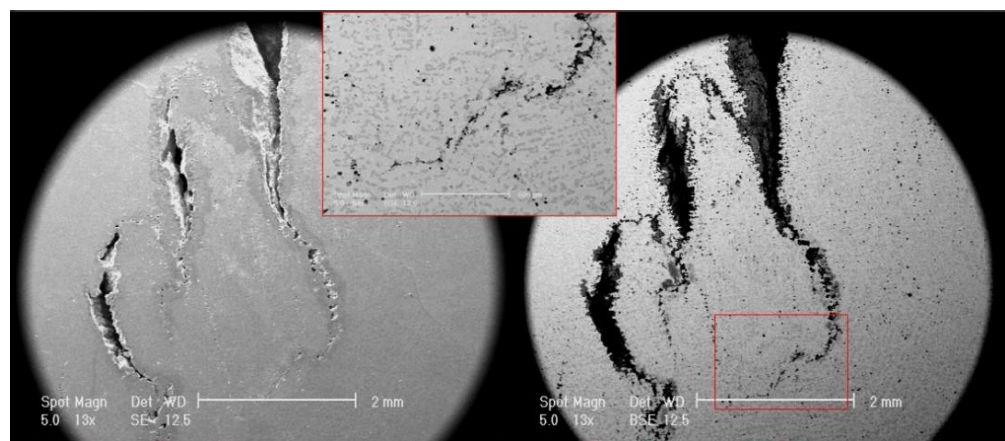
As a result of cyclic mechanical and thermal loadings caused by unexpected shut-downs, the thermal-mechanical fatigue process leads to microstructural damages such as carbide cracks and creep pores. According to Figure 12, the macrocracks are formed as a result of the coalescence of microcracks formed on the surface of chromium carbide particles as well as creep pores. The growth rate of these cracks is proportional to the applied strain and these cracks are grown perpendicular to the direction of applied stress. The creep behaviour of studied tubes in the current study is highly dependent on the difference in microstructural properties as a result of the addition of titanium to HP-Nb alloy.

Figure 12. SEM images of cracked regions; directional creep pores are seen along the length of main cracks. The singular creep pores have a uniform distribution in the matrix.
