Balconies in Maastricht

Karel C. Terwel

This chapter focuses on human and organisational factors that are usually behind the technical cause of failure. This is illustrated by a case of the collapse of five balconies in 2003 in Maastricht (The Netherlands) resulting in two fatalities.

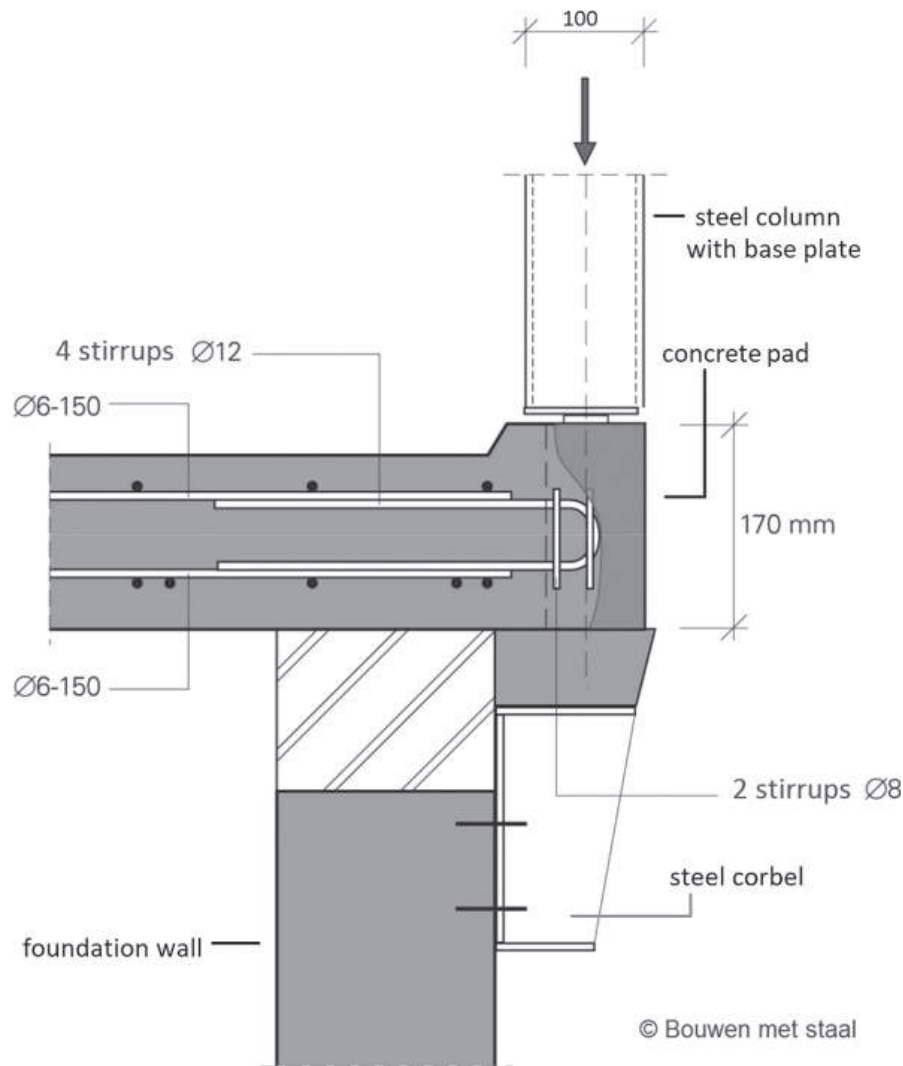
Various parts of the structure were subject to the forensic investigations. Experts agreed that detailing of the reinforcement of the pad at ground floor was inadequate and not according to the codes. Furthermore, the bolted connection of the steel corbel on the foundation wall was not properly constructed and the connection between the steel corbel and the concrete pad was suboptimal.

Finally, it was concluded by experts and court that the combination of a bending moment and a concentrated force on the small pad resulted in failure of the pad at ground

Figure 4.2 Detail of solution with steel corbel ground floor (adapted from [11, 13] with permission).

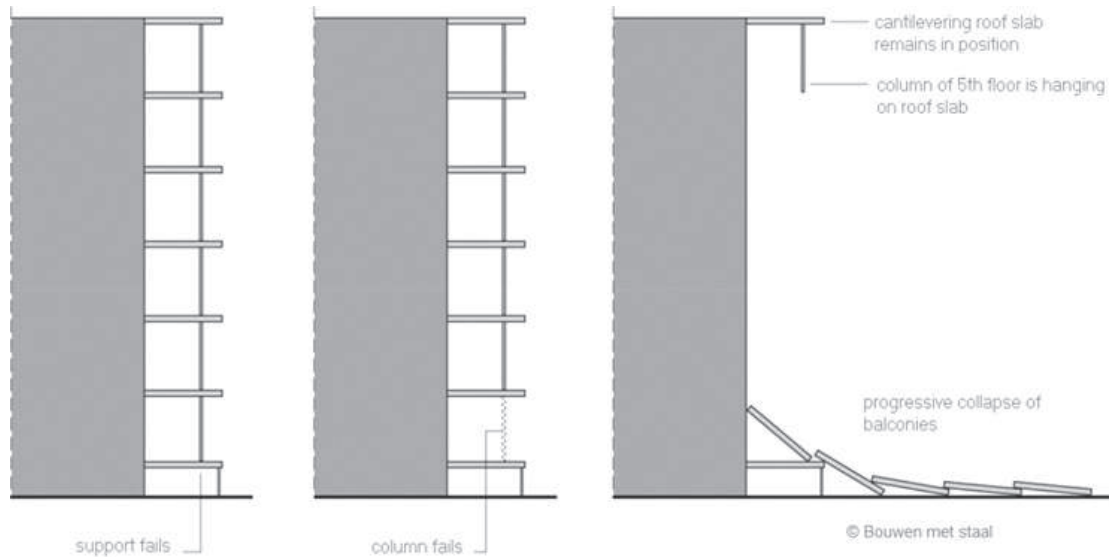
floor level. This resulted in a progressive collapse of the other balconies (see Figure 4.3) as the columns lacked support [3]. The triggering event was not evident; it was suggested that a relatively warm day resulted in lengthening of the steel columns, or that creep effects of the roof slab might have played a role [4].

Figure 4.3 Side view of building: initial failure leading to progressive collapse (adapted from [11], with permission).
