Performance of flood defences in the Netherlands during the 2021 Summer floods

André Koelewijn¹, Joost Pol² and Malou van Schaijk³

Abstract

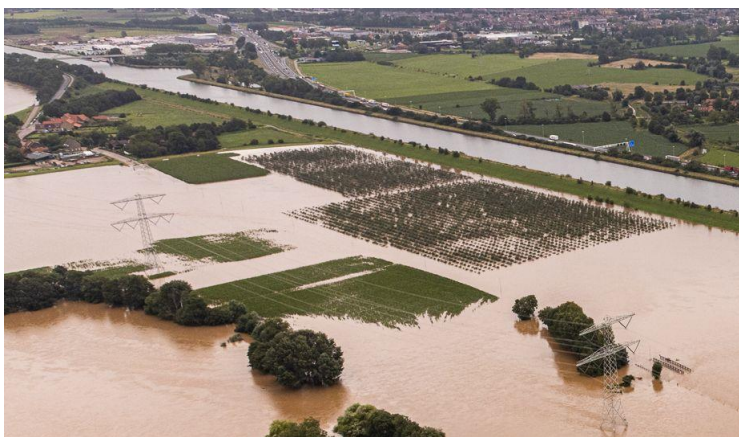
An example of this is the dike section 82, locally known as Aasterberg (Figure 3). During the peak of the floods along the Meuse, locally on Friday 16 July, the water level near to the northern side of this small dike section rose higher than the crest of the dike (contrary to what the previous figure suggests). Sandbags had been installed in time on the raised road behind the dike which prevented the area from flooding. The residents were evacuated (Limburg, 2021a). At the critical sections indicated in Figure 2, most notably dike section 83, sand bags were applied as an effective measure.

Figure 3: Aerial view of Aasterberg (upper left corner) on July 16, 2021, a few hours before peak flood level (photograph Dutch Coast Guard).

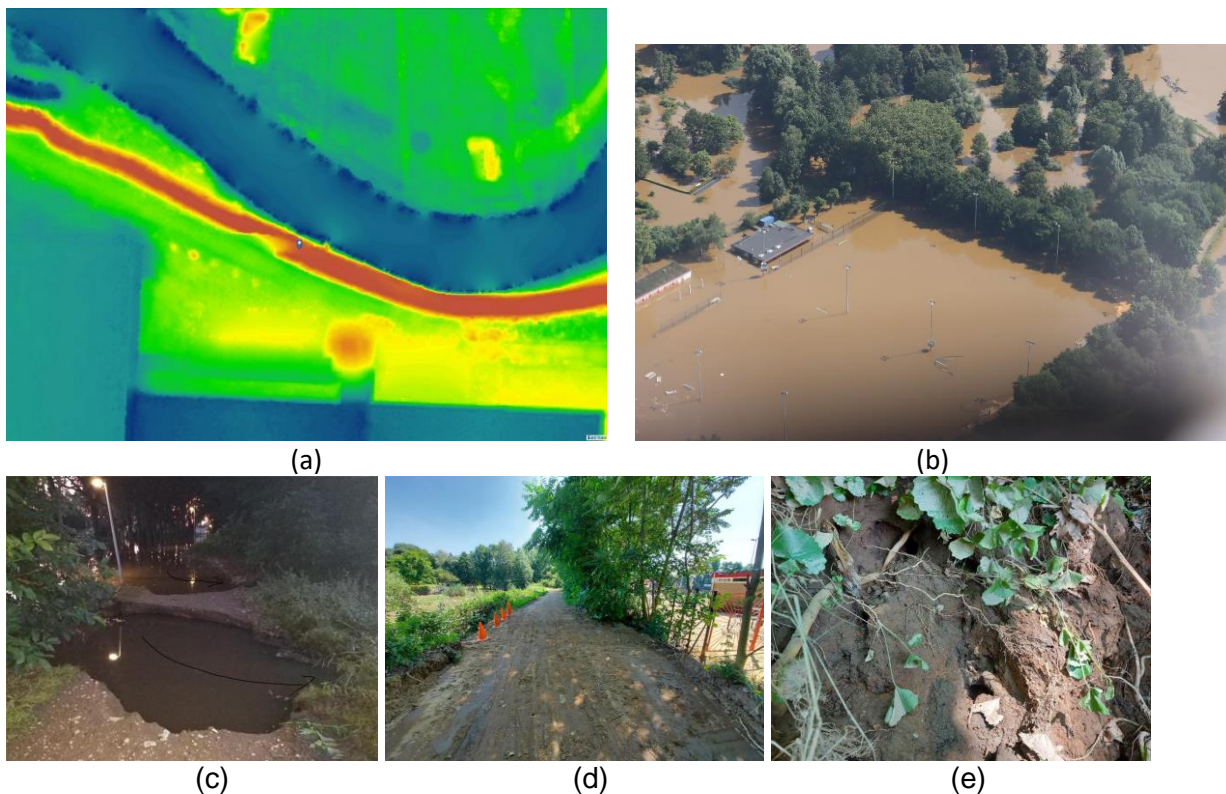
A breach approximately 2 m wide occurred in the dike after an overflow of a slightly lower part of the crest (Figure 4). At this location, the crest height is NAP + 21.10 to + 21.20 m while the maximum water level was NAP + 21.43 m, as indicated by measurements at station “Roermond Andersonweg bij stuw Hoge Bat” [<https://www.waterstandlimburg.nl/Home/Waterstanden/140>]. High-water marks on the nearby floodgate to the west of the Bisschop Lindanussingel indicate a similar level, which must have been the same at the breach location, because there was hardly any current in this branch of the Roer as the downstream floodgate was closed (see Section 2.6). Due to the flooding, the hockey fields were almost 2 metres underwater. Based on several sources of information, the following timeline of events can be reconstructed:

Figure 4: Concordia hockey fields: (a) digital terrain model showing locally lowered crest at the first breach location, situation before the floods (from the nationwide elevation model AHN3), (b) aerial photograph taken on Saturday 17 July at 11:15 AM – the dike with breach is located just behind the clubhouse and the blue container among the trees (photograph Dutch Coast Guard), (c) situation with backflows with the scoured location of the lower crest at the front and the breach location behind (photograph David Knops, HKV), (d) sealed breach, : holes in dike embankment approximately 100 m from the location of the breach.

It is not known when exactly the breach occurred, whether this was before the water entered the area or after. Therefore, the failure mechanism at this location cannot be inferred clearly from the observations. As the maximum water level in the Roer exceeded the local depression in crest level, external erosion by overflowing water is a likely candidate. Traces of external erosion at the inner slope have been observed on the same levee, about 100-200 m from the breach

location. It is also possible that burrowing by animals played a role in the weakening of the levee and the occurrence of the breach: holes several centimetres in diameter were found in a number of places in the dike embankment near the breach location, possibly made by voles (Figure 4e). These holes increase the vulnerability for saturation and slope instability and internal erosion from the embankment body. However, if the breach occurred after the area flooded due to overflow, a possible failure mechanism is that the breach was caused by the outflowing water, for instance external erosion or slope instability of the outward slope (by then, the river level was lower and the levee must have been saturated).

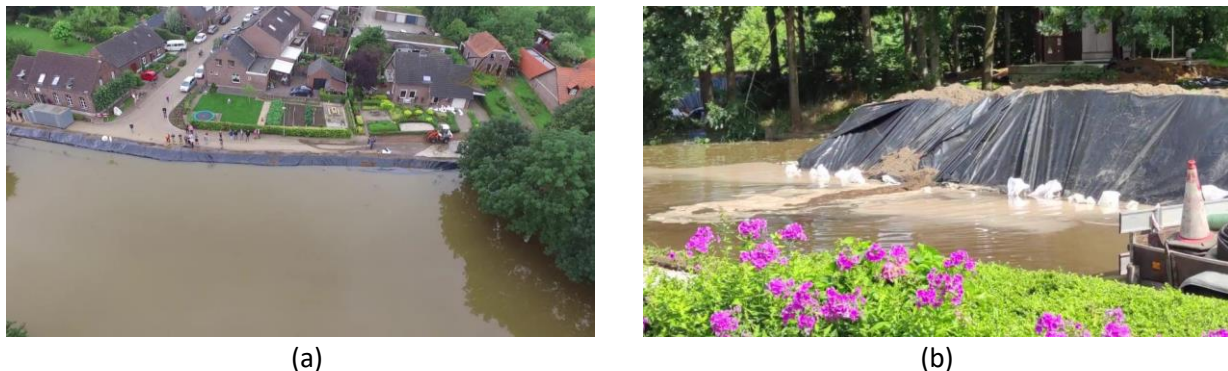
The village of Horn near Roermond is located on the boundary of a flood retention area called Lateraalkanaal-West. The lowest street in the village runs adjacent to the retention area. There is a flood defence here (without an official primary or regional status) consisting of a low retaining wall on which concrete blocks can be stacked if necessary. Those blocks were not used during the most recent floods. According to residents, the contractor who should do this in case of flooding was bankrupt. Therefore, residents built an emergency dike approximately 450 m long, shortly before the flood came. It consisted of a loose earthen embankment covered with an impermeable plastic sheet (Figure 5a). In the afternoon on Saturday 17 July at around 13:00, this dike breached (Figure 5b). At that moment, the water level was well below the crest. Two possible causes are: softening by seepage water inside the dike or erosion due to a leak in the geotextile. There was a lot of seepage water behind the dike, including flow from a manhole which was probably in contact with the water in the retention area. This could have caused softening of the newly applied soil.

Figure 5: (a) Emergency dike near Horn with the location of the subsequent breach to the right (YouTube, 2021a), (b) the start of the breach (YouTube, 2021b).

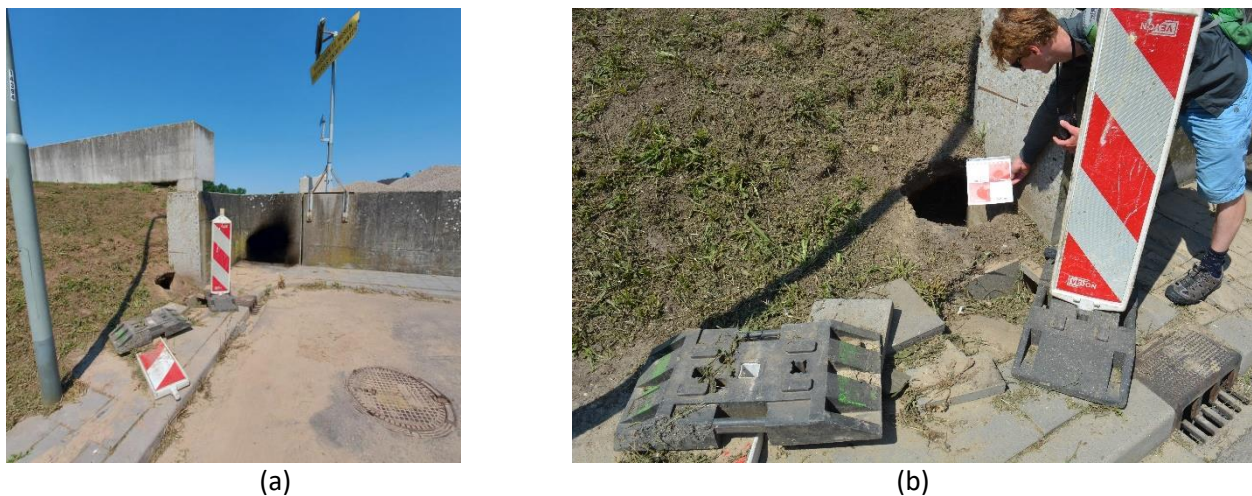
On Friday 16 July, an industrial zone in Roermond – where businesses including a large Designer Outlet are located – was evacuated. According to the water authority, the area was evacuated because of the risk that the retaining walls were not high enough. During an inspection by members of the Flood Defence Emergency Team (CTW) on Saturday 17 July, active internal erosion was found between two retaining walls in the dike section along Schippershaven, see Figure 7.

It was observed that the outflowing water was turbid and that there was sand around the boil. The CTW advised building a ring of sandbags around the boil in order to stop the flow of water. Implementation of the measures was stopped shortly after starting because the local situation was deemed too dangerous for the people carrying out the repairs. After the flood event, it was inferred that the newer retaining wall was not attached correctly to the older retaining wall and the water was able to get in through the small gap between these walls. No water marks were observed on buildings and walls in the surrounding area, suggesting that the area remained dry and the water drained away via the sewers.

Figure 7: Signs of internal erosion at the junction between two different retaining walls: (a) overview showing the lower and higher retaining walls, (b) detail showing the hole left behind (the red and white blocks on the card each measure 10 by 10 cm).

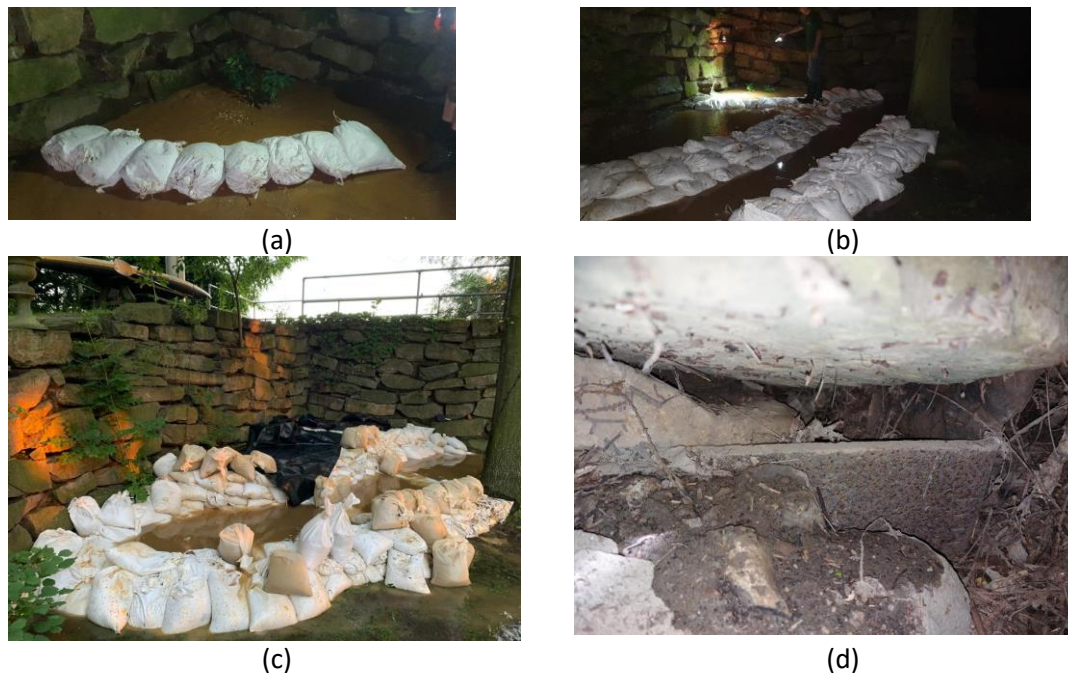
Another incident with internal erosion occurred at a floodgate in the city of Roermond (Figure 8). This floodgate in the Roer river, which is a tributary of the Meuse river, was closed in order to protect the city centre from flooding. At this location, excessive seepage and erosion in the corner of the L-shaped wall on the downstream side was reported on Saturday 17 July at 03:15 AM. The sand boil was bringing up coarse sand and gravel. Half an hour later, the first ring of sandbags was put down (see Figure 9ab) which was eventually built 3 to 4 layers high (Figure 9c). This stopped the erosion process. In the afternoon, again outflow of water and sand was reported, and the ring of sandbags was heightened to a height of 60 to 80 cm which turned out to be sufficient to stop the erosion for the maximum water level drop of more than 1.6 m that was present over the structure. To be sure to stop further erosion, the area near the corner was completely filled with sandbags [Figure 9c].

After the floods, a poor connection was found between the sheet pile and concrete cover on the high-water side (Figure 9d). This opening may have enabled the water to flow through the opening, and down behind the sheet pile, resulting in the formation of the sand boil.

Figure 9: Observations around the Roer floodgate: (a) sand and gravel deposited near the first sandbags (photograph Guido van Rinsum, Witteveen+Bos), (b) ring of sandbags on 17 July at 04:30 (photograph Guido van Rinsum, Witteveen+Bos), (c) sandbags on 17 July at around 20:00 (photograph Guido van Rinsum, Witteveen+Bos), (d) the poor connection of the gate structure between sheet pile and concrete cover on the high-water side, photo taken after the flood.

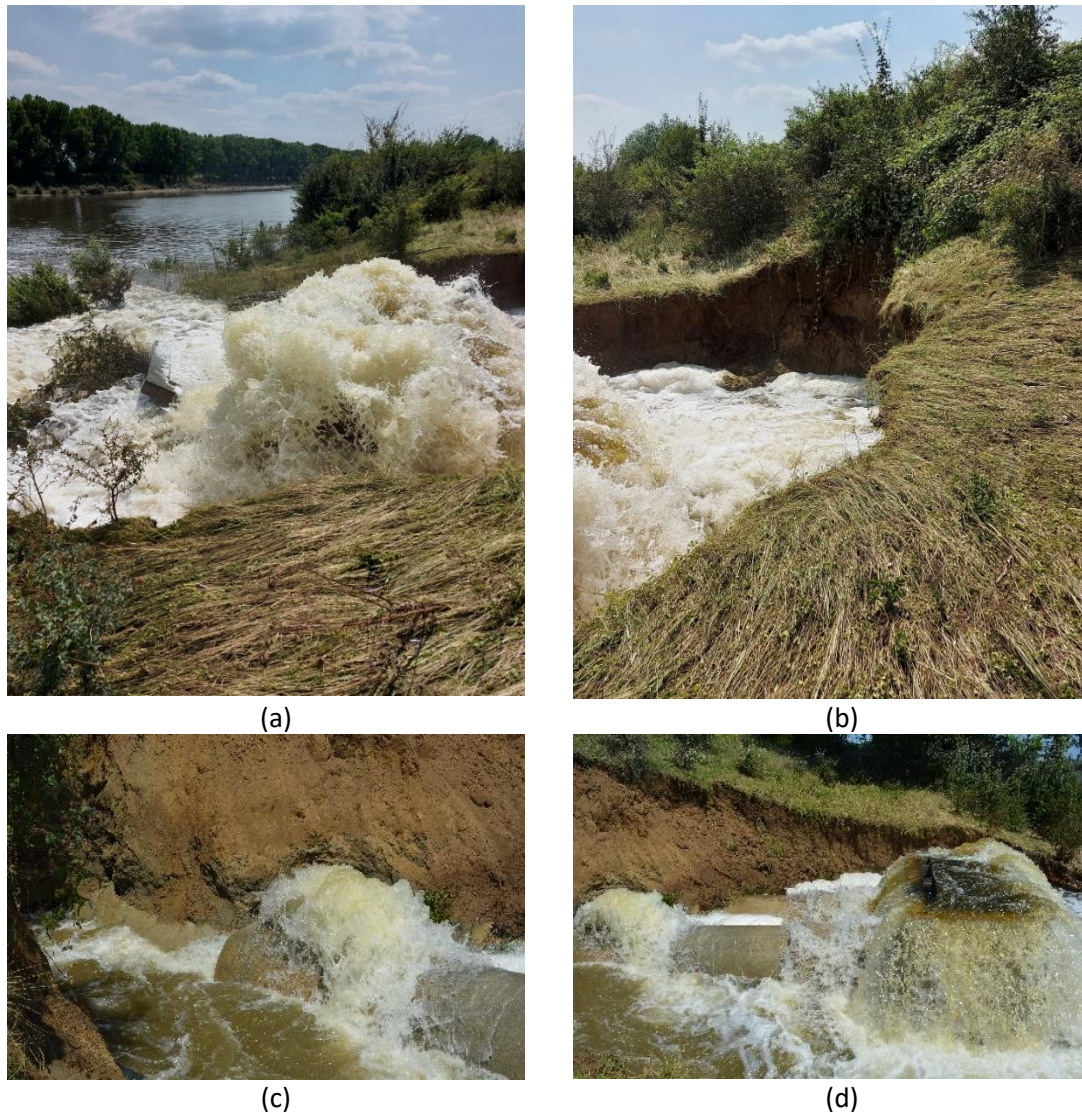
The Lateraalkanaal-West retention area near Horn (see also Section 2.3) includes an outlet structure for emptying the retention area after floods have passed. On the afternoon of Wednesday 21 July, damage to this outlet structure was reported. The site was also visited by the research team two days later, see Figure 11. The damage concerned erosion of the dike at the outlet structure. While the water should have flowed through the pipes directly into the river, a large part of the water came out through an inspection hole. The damage to the dike was caused by the flow of water from the broken southern pipe, as shown in Figure 11c. As the flood had receded, a dike breach was no longer possible, but the design of this outlet structure must be improved before it is repaired to prevent future similar damage.

Figure 11: Zeven Ellen Waterlaat near Horn: (a, b) situation on 21 July (photographs Erik Bijlsma, Directorate-General for Public Works and Water Management), (c, d): situation on 23 July with a level of approximately 1.95 m below the peak water level in the retention area.

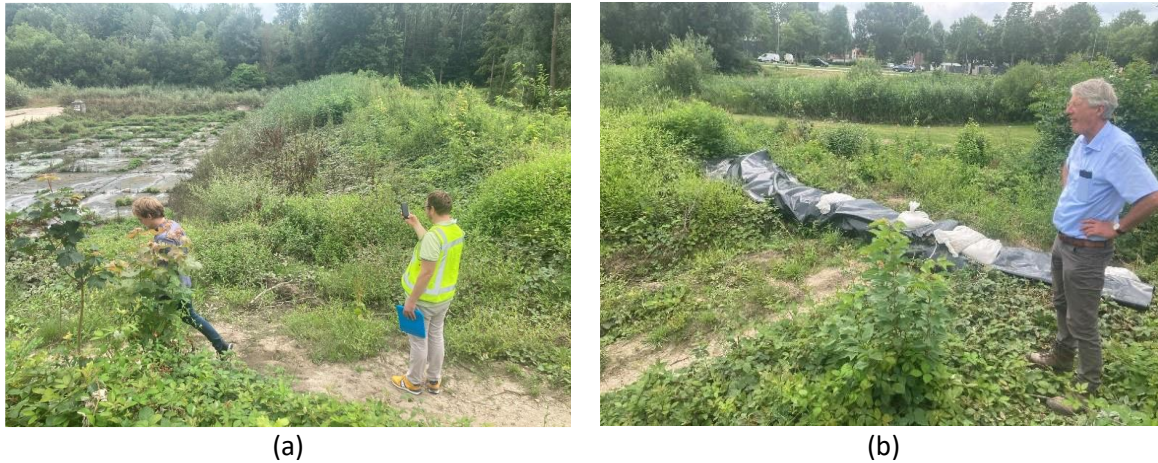
In various places in South Limburg, rainwater storage basins have been created in order to protect the built-up areas against flooding and mudflows. One example of a storage basin is 'De Dem' near the village of Hoensbroek. The main purpose of this buffer is to store sewer overflows from the urban district of Heerlen. The first warning regarding an embankment of this basin was issued on 14 July at 15:12. The reason was that the basin was full but rainwater was still flowing in. The overflowing water led to erosion of the embankment, see Figure 12, but the embankment did not fail. It is recommended for such rainwater storage embankments to be provided with an erosion-resistant overflow structure with sufficient capacity so that failure cannot occur.

Figure 12 De Dem water storage basin with (a) the outflow location in the bottom right-hand corner of the photograph and (b) traces of erosion in the same location (photographs provided by Bas Jonkman, TU Delft).

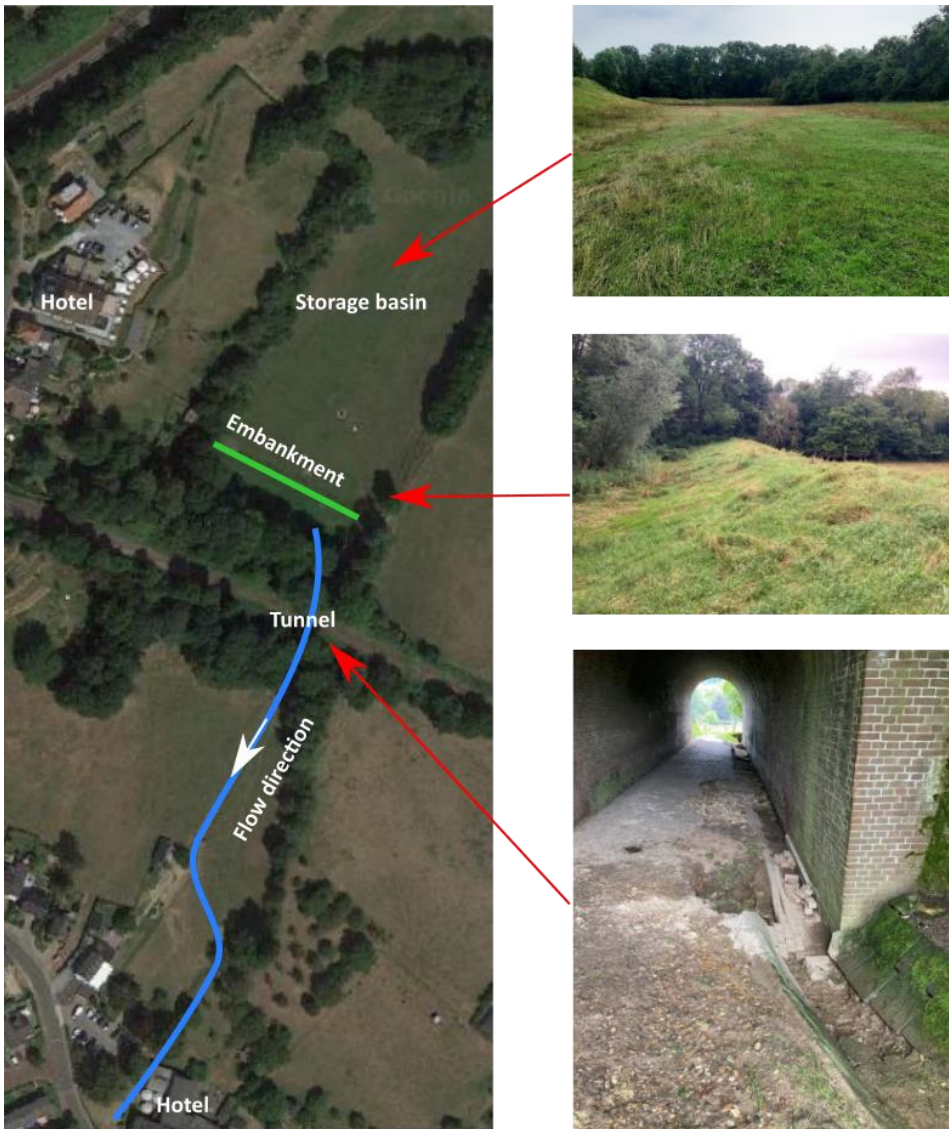
The ‘Ransdaal’ rainwater storage basin is located northeast of the village of Schin op Geul, see Figure 13. During the extreme rainfall event, floods occurred downstream of the area along the Scheumerbeek. For example, the nearby hotel downstream of the storage basin was flooded with several decimetres of water. During the field visit, it was found that water had overtopped the dike – in the middle and along the eastern side of the dam. The water flowed through a tunnel (where there were signs of significant erosion that point to high flow rates), and that led to the flooding downstream along the Scheumerbeek. This affected the hotel and a number of houses.

Figure 13: Location of Ransdaal storage basin near Schin op Geul (left) and images of the basin, the dike/embankment, and the erosion in the tunnel downstream (photographs provided by Bas Jonkman, TU Delft).

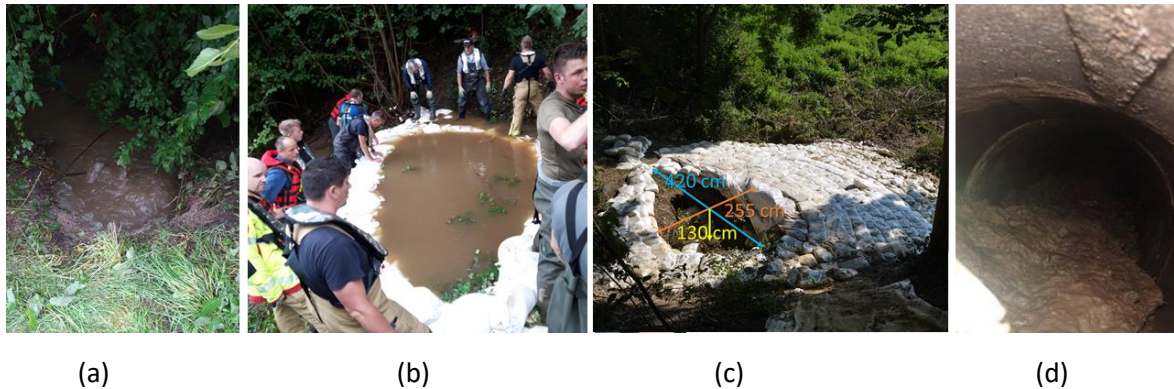
On the afternoon of Friday 16 July, various media reported that a dike had breached near the village of Meerssen or Bunde (1Limburg, 2021b) - (RTL News, 2021) - (De Telegraaf, 2021). On closer inspection, it was found to be a substantial sediment-carrying flow of water which also washed out gravel, just to the north of the approach road leading to the bridge over the Juliana Canal near Bunde, see Figure 14 and Figure 15. As a matter of urgency, this water flow – that was mistaken for a large sand boil– was handled by installing a coffer dam more than a metre high consisting of around 3000 sandbags which stabilised the situation. It was initially thought that the dike along the Juliana Canal which is elevated here was on the verge of failing due to a leak from the canal or from the Meuse. However, it was water from the Geul that was the problem, see Figure 15. Because not all of it could flow through the culvert under the Juliana Canal, it flowed along the eastern side of the Juliana Canal to the north. At the approach roads leading to the bridges near Bunde and Geulle, water then flowed around the road and through the originally constructed culverts. However, near Bunde the culvert had become covered and was not included in asset databases so that the flow of water from this culvert was initially misinterpreted as coming from the subsoil (“sand boiling”). It was discovered that there was a culvert here a week later when further investigation of this location was carried out. This last example clearly shows how the capacity of emergency services can be absorbed to a significant extent by issues that appear to be irrelevant at hindsight – or with sufficiently

Figure 14: Situation near Bunde: (a) prior to effective measures (photograph Bertram de Rooij, WUR/Fire Service Gelderland Midden), (b) stabilised boiling (photograph Hoite Detmar, the Directorate-General for Public Works and Water Management), (c) boiling area with dimensions after drying out, (d) the concrete culvert where the water came out (photograph Anton van der Meer, Deltares).
