## Performance of flood defences in the Netherlands during the 2021 summer floods

Koelewijn, André; Pol, Joost; van Schaijk, Malou

Journal of Coastal and Riverine Flood Risk

## Abstract

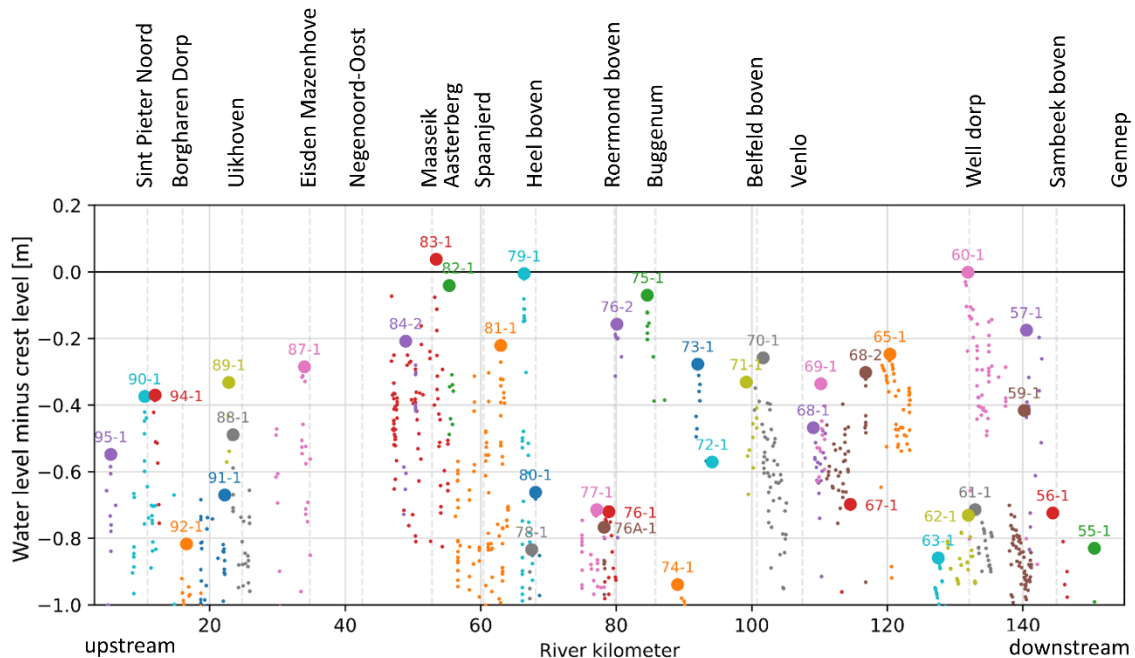
crest level and the water level are compared for the dike sections along the Meuse between the Belgian-Dutch border (kilometre 0) and the village of Gennepe (kilometre 155). Each point represents a dike section and the most critical point of each dike ring area is shown with a bigger marker and its code number. It should also be noted that there may be small differences between this figure and the situation in the field during the flood, because of both changes that occurred since the survey for AHN3 (the third version of the nationwide digital elevation model of the Netherlands), and local differences between the hydrological model and reality, resulting from e.g. the model grid size and local backwater effects.

Figure 2: Differences between crest level derived from elevation model AHN3 and modelled water levels for all dike sections along the Meuse between the Belgian-Dutch border and Gennepe (figure courtesy of Jurjen de Jong, Deltares).

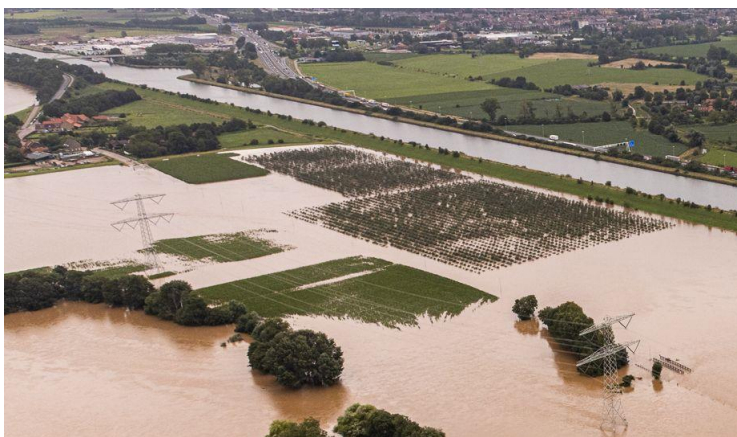
An example of this is the dike section 82, locally known as Aasterberg (Figure 3). During the peak of the floods along the Meuse, locally on Friday 16 July, the water level near to the northern side of this small dike section rose higher than the crest of the dike (contrary to what the previous figure suggests). Sandbags had been installed in time on the raised road behind the dike which prevented the area from flooding. The residents were evacuated (Limburg, 2021a). At the critical sections indicated in Figure 2, most notably dike section 83, sand bags were applied as an effective measure.

Figure 3: Aerial view of Aasterberg (upper left corner) on July 16, 2021, a few hours before peak flood level (photograph Dutch Coast Guard).

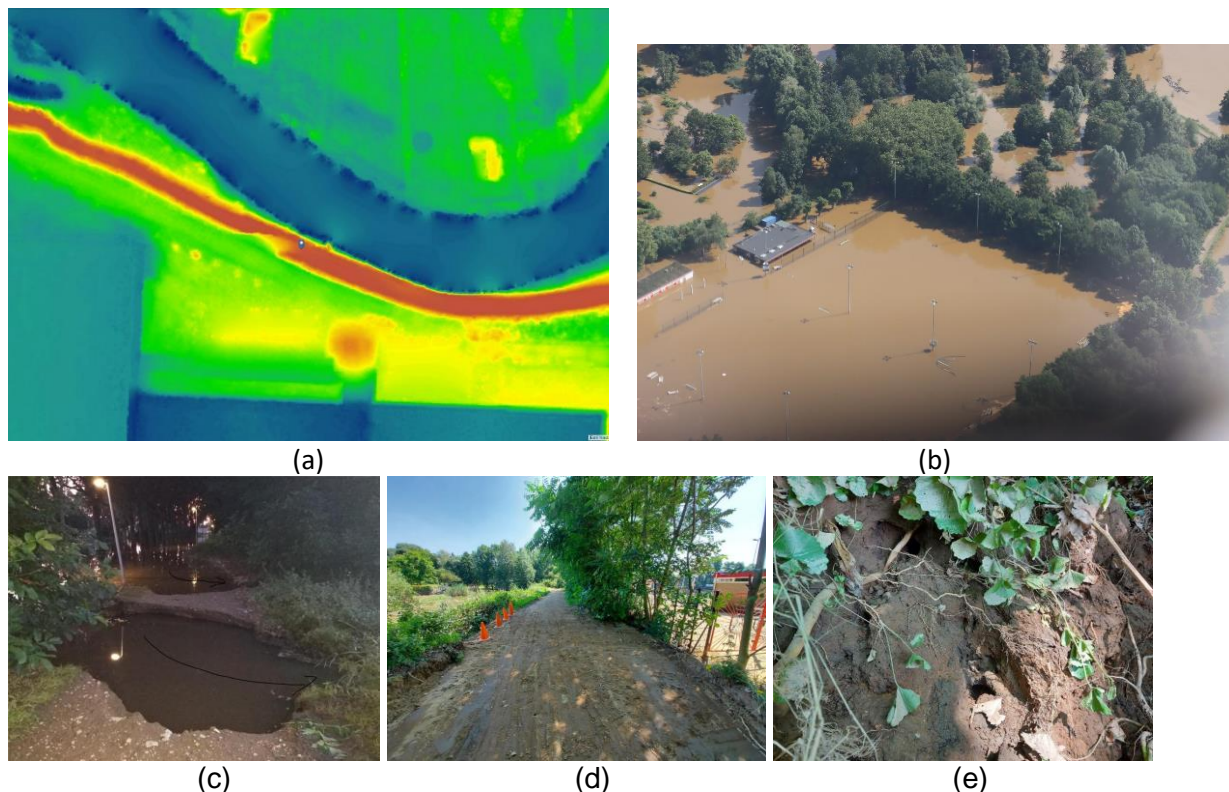
A breach approximately 2 m wide occurred in the dike after an overflow of a slightly lower part of the crest (Figure 4). At this location, the crest height is NAP + 21.10 to + 21.20 m while the maximum water level was NAP + 21.43 m, as indicated by measurements at station “Roermond Andersonweg bij stuw Hoge Bat” [<https://www.waterstandlimburg.nl/Home/Waterstanden/140>]. High-water marks on the nearby floodgate to the west of the Bisschop Lindanussingel indicate a similar level, which must have been the same at the breach location, because there was hardly any current in this branch of the Roer as the downstream floodgate was closed (see Section 2.6). Due to the flooding, the hockey fields were almost 2 metres underwater. Based on several sources of information, the following timeline of events can be reconstructed:

Figure 4: Concordia hockey fields: (a) digital terrain model showing locally lowered crest at the first breach location, situation before the floods (from the nationwide elevation model AHN3), (b) aerial photograph taken on Saturday 17 July at 11:15 AM – the dike with breach is located just behind the clubhouse and the blue container among the trees (photograph Dutch Coast Guard), (c) situation with backflows with the scoured location of the lower crest at the front and the breach location behind (photograph David Knops, HKV), (d) sealed breach, : holes in dike embankment approximately 100 m from the location of the breach.

It is not known when exactly the breach occurred, whether this was before the water entered the area or after. Therefore, the failure mechanism at this location cannot be inferred clearly from the observations. As the maximum water level in the Roer exceeded the local depression in crest level, external erosion by overflowing water is a likely candidate. Traces of external erosion at the inner slope have been observed on the same levee, about 100-200 m from the breach

location. It is also possible that burrowing by animals played a role in the weakening of the levee and the occurrence of the breach: holes several centimetres in diameter were found in a number of places in the dike embankment near the breach location, possibly made by voles (Figure 4e). These holes increase the vulnerability for saturation and slope instability and internal erosion from the embankment body. However, if the breach occurred after the area flooded due to overflow, a possible failure mechanism is that the breach was caused by the outflowing water, for instance external erosion or slope instability of the outward slope (by then, the river level was lower and the levee must have been saturated).

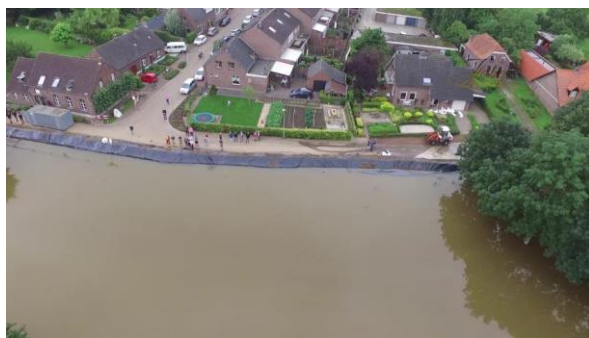
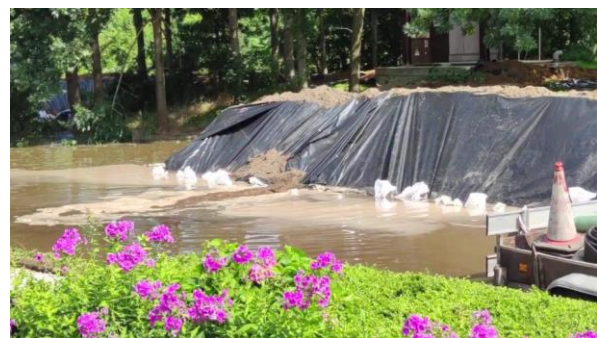
The village of Horn near Roermond is located on the boundary of a flood retention area called Lateraalkanaal-West. The lowest street in the village runs adjacent to the retention area. There is a flood defence here (without an official primary or regional status) consisting of a low retaining wall on which concrete blocks can be stacked if necessary. Those blocks were not used during the most recent floods. According to residents, the contractor who should do this in case of flooding was bankrupt. Therefore, residents built an emergency dike approximately 450 m long, shortly before the flood came. It consisted of a loose earthen embankment covered with an impermeable plastic sheet (Figure 5a). In the afternoon on Saturday 17 July at around 13:00, this dike breached (Figure 5b). At that moment, the water level was well below the crest. Two possible causes are: softening by seepage water inside the dike or erosion due to a leak in the geotextile. There was a lot of seepage water behind the dike, including flow from a manhole which was probably in contact with the water in the retention area. This could have caused softening of the newly applied soil.

Figure 5: (a) Emergency dike near Horn with the location of the subsequent breach to the right (YouTube, 2021a), (b) the start of the breach (YouTube, 2021b).

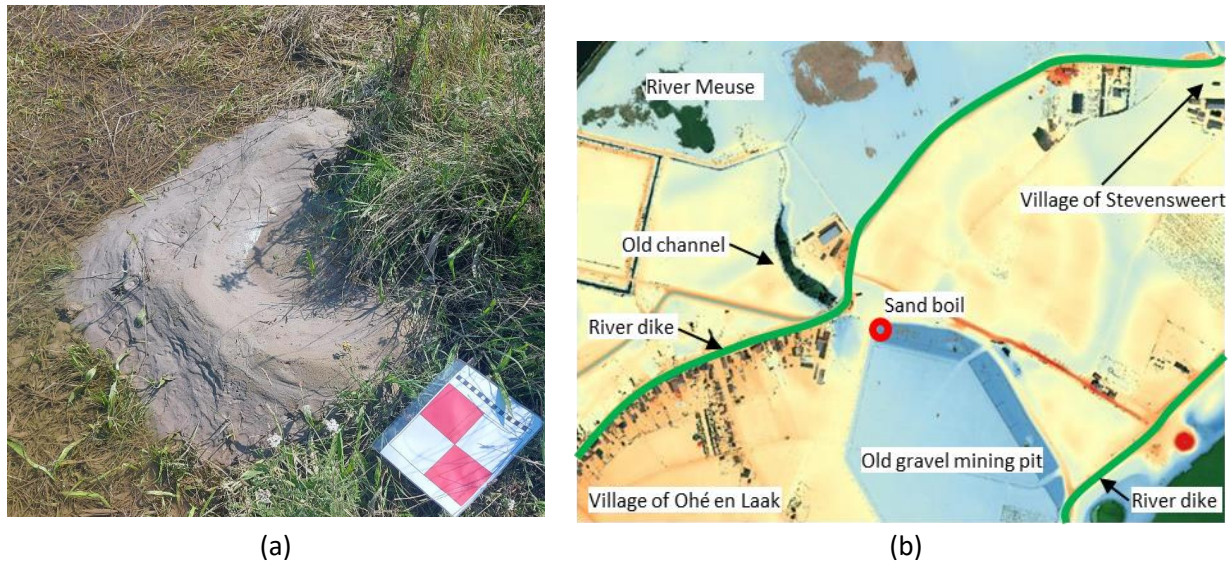
A sand boil at St. Annakapel near the village of Ohé en Laak, was not discovered until the water had subsided (Figure 6a). This sand crater measuring 120 cm in diameter was located approximately 100 m from the landside dike toe, in an area that had become low-lying on account of gravel extraction carried out in the past, see Figure 6b. The maximum water level difference across the dike here was approximately 4 m. The combination of a low-lying, highly permeable subsoil, and the presence of an old channel belt under the dike makes this location particularly vulnerable to the development of seepage and possibly backward erosion piping. Further investigation of the local subsoil is required to reveal where the sand came from and whether additional reinforcement measures to protect against piping are required.

Figure 6: (a) Remnants of a sand boil near St. Annakapel observed after the floods. The sand deposited is relatively fine. (b) ground level in the area of the sand boil (based on the nationwide elevation model AHN3), the dikes are indicated by means of a green line.

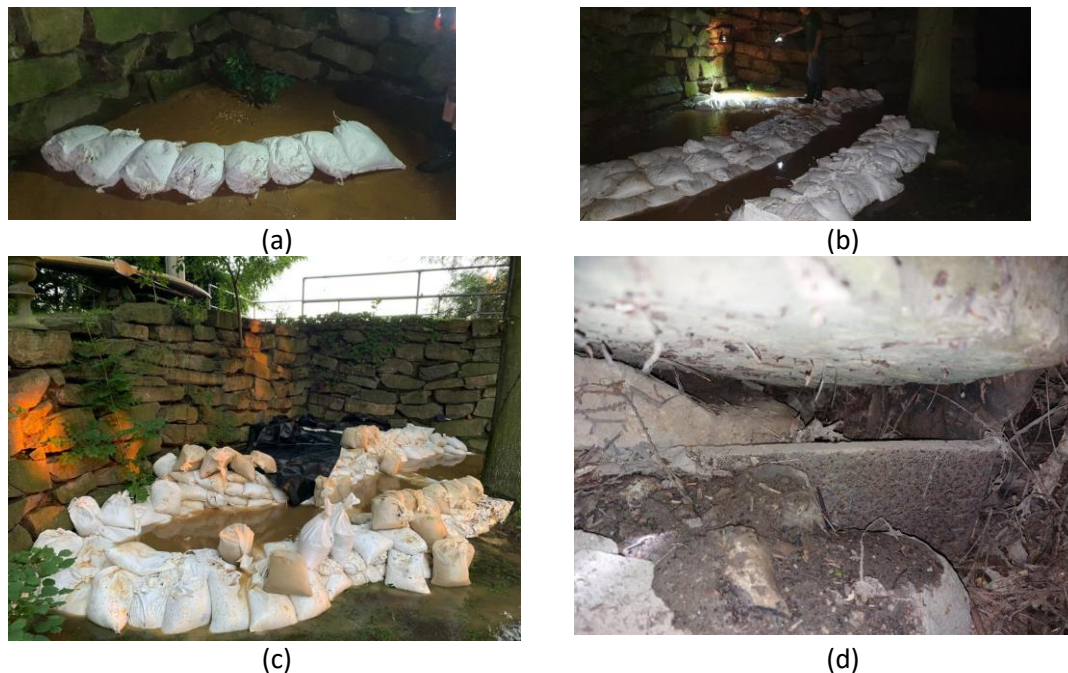
Another incident with internal erosion occurred at a floodgate in the city of Roermond (Figure 8). This floodgate in the Roer river, which is a tributary of the Meuse river, was closed in order to protect the city centre from flooding. At this location, excessive seepage and erosion in the corner of the L-shaped wall on the downstream side was reported on Saturday 17 July at 03:15 AM. The sand boil was bringing up coarse sand and gravel. Half an hour later, the first ring of sandbags was put down (see Figure 9ab) which was eventually built 3 to 4 layers high (Figure 9c). This stopped the erosion process. In the afternoon, again outflow of water and sand was reported, and the ring of sandbags was heightened to a height of 60 to 80 cm which turned out to be sufficient to stop the erosion for the maximum water level drop of more than 1.6 m that was present over the structure. To be sure to stop further erosion, the area near the corner was completely filled with sandbags [Figure 9c].

After the floods, a poor connection was found between the sheet pile and concrete cover on the high-water side (Figure 9d). This opening may have enabled the water to flow through the opening, and down behind the sheet pile, resulting in the formation of the sand boil.

Figure 9: Observations around the Roer floodgate: (a) sand and gravel deposited near the first sandbags (photograph Guido van Rinsum, Witteveen+Bos), (b) ring of sandbags on 17 July at 04:30 (photograph Guido van Rinsum, Witteveen+Bos), (c) sandbags on 17 July at around 20:00 (photograph Guido van Rinsum, Witteveen+Bos), (d) the poor connection of the gate structure between sheet pile and concrete cover on the high-water side, photo taken after the flood.

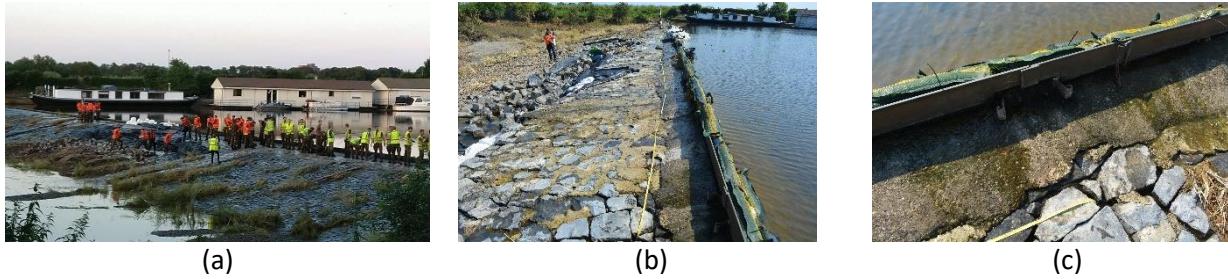
The Borgharen barrage is located directly downstream of the Julian Canal's entrance in the Meuse floodplain, between Maastricht and Borgharen. The Bosscherveld bypass which incorporates a fixed barrage runs parallel to this. That barrage consists of an earth dam with stone revetment on the downstream side. On top of the dam, there is a steel edge approximately 15 cm high, consisting of anchored elements which are each 4 m long. When the water level dropped, it was found that one of these steel elements that was located roughly in the middle of the dam had disappeared. Behind was an erosion hole approximately 15 m wide and up to around 1.5 m deep. This became visible during the afternoon of Saturday 17 July, when the discharge via the barrage was already significantly reduced. It was decided to carry out an acute emergency repair for which the army was also deployed (Limburg, 2021c) on account of the poor accessibility of the location with equipment, see Figure 10.

Incidentally, the abovementioned damage was at the same location as previous damage which occurred about ten years ago. The repairs probably created a weak spot. In addition, the detailing of the anchoring of the steel edge, with an easily removable locking pin, seems susceptible to vandalism.

Figure 10: Barrage near Bosscherveld: (a) emergency repairs with the assistance of the army (photograph Wilbur van Beijnen, Directorate-General for Public Works and Water Management), (b) overview of defence after repair (high-water marks still visible from the vegetation in the background), (c) detail of anchoring of steel edge.

Despite not being a critical situation, partly because a dam-break flow would remain within the Meuse river, it was decided to carry out the immediate repairs on account of further damage in case of a possible second flood event. For instance, a further widening of the erosion hole could cause the crest to collapse and further erode the earth dam in a lateral direction. The accessibility for repairs would get much more problematic in that case. At the same time, the water level at Borgharen would no longer be controllable by the barrage, which is important for the stability of structures in the Juliana Canal.

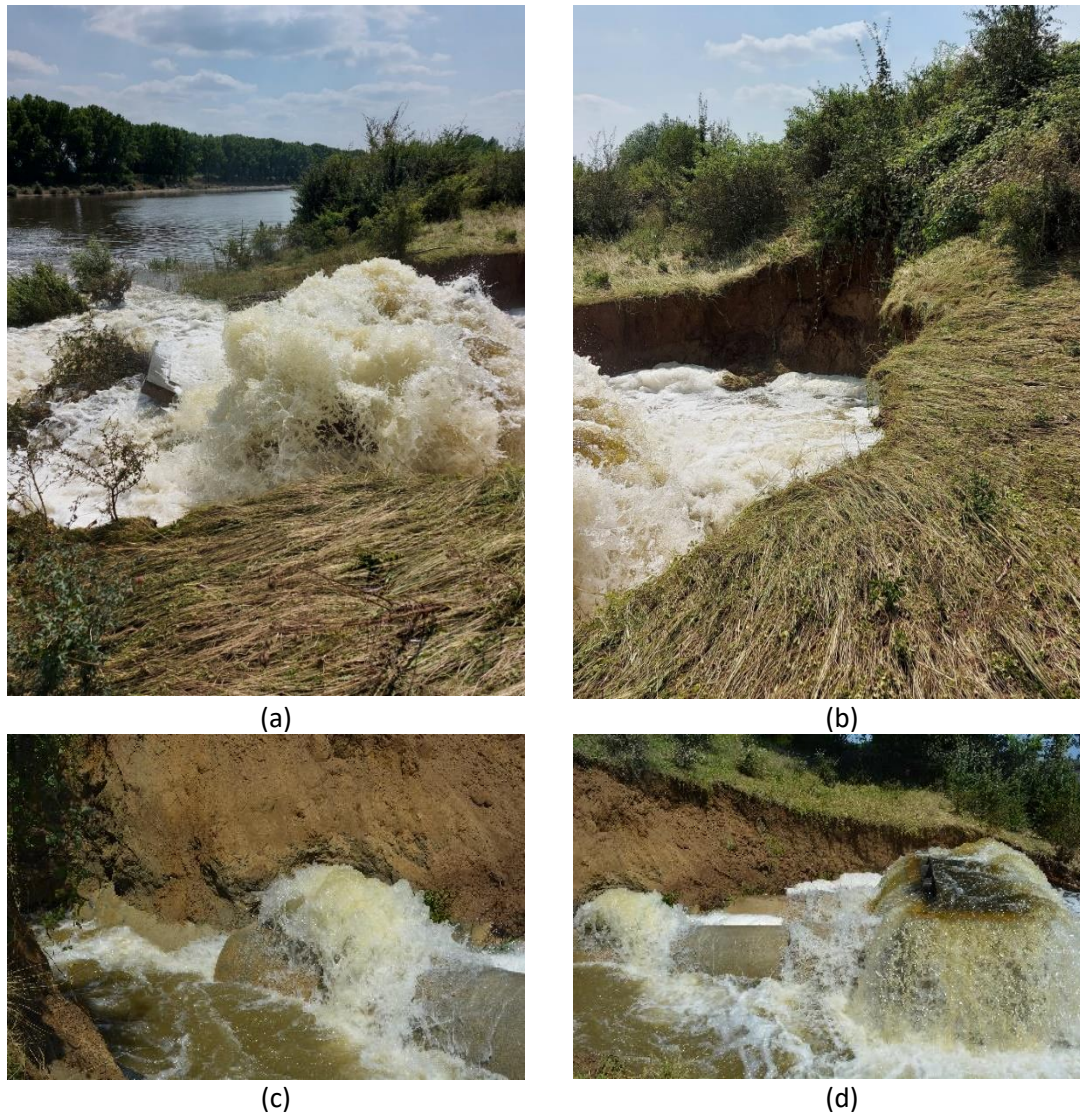
The Lateraalkanaal-West retention area near Horn (see also Section 2.3) includes an outlet structure for emptying the retention area after floods have passed. On the afternoon of Wednesday 21 July, damage to this outlet structure was reported. The site was also visited by the research team two days later, see Figure 11. The damage concerned erosion of the dike at the outlet structure. While the water should have flowed through the pipes directly into the river, a large part of the water came out through an inspection hole. The damage to the dike was caused by the flow of water from the broken southern pipe, as shown in Figure 11c. As the flood had receded, a dike breach was no longer possible, but the design of this outlet structure must be improved before it is repaired to prevent future similar damage.

Figure 11: Zeven Ellen Waterlaat near Horn: (a, b) situation on 21 July (photographs Erik Bijlsma, Directorate-General for Public Works and Water Management), (c, d): situation on 23 July with a level of approximately 1.95 m below the peak water level in the retention area.

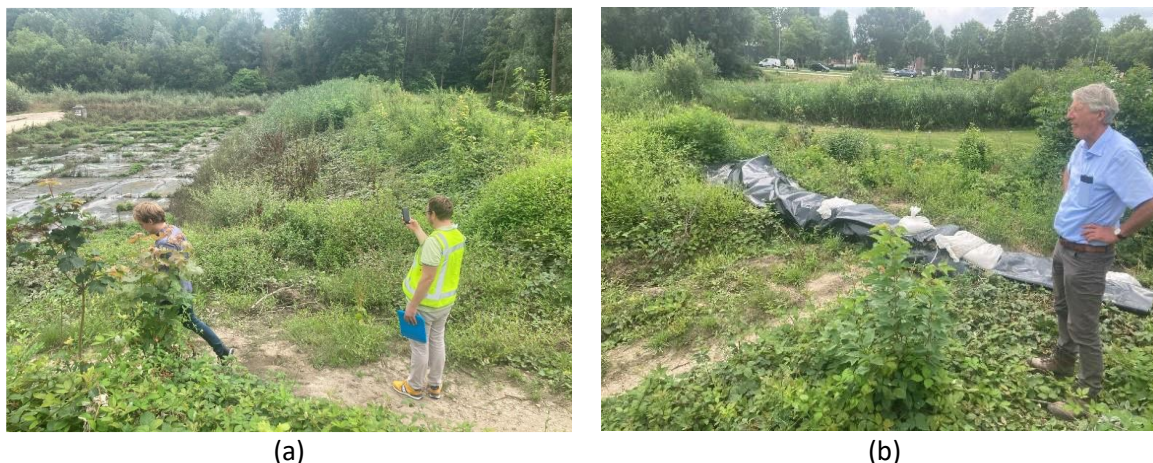
In various places in South Limburg, rainwater storage basins have been created in order to protect the built-up areas against flooding and mudflows. One example of a storage basin is 'De Dem' near the village of Hoensbroek. The main purpose of this buffer is to store sewer overflows from the urban district of Heerlen. The first warning regarding an embankment of this basin was issued on 14 July at 15:12. The reason was that the basin was full but rainwater was still flowing in. The overflowing water led to erosion of the embankment, see Figure 12, but the embankment did not fail. It is recommended for such rainwater storage embankments to be provided with an erosion-resistant overflow structure with sufficient capacity so that failure cannot occur.

Figure 12 De Dem water storage basin with (a) the outflow location in the bottom right-hand corner of the photograph and (b) traces of erosion in the same location (photographs provided by Bas Jonkman, TU Delft).

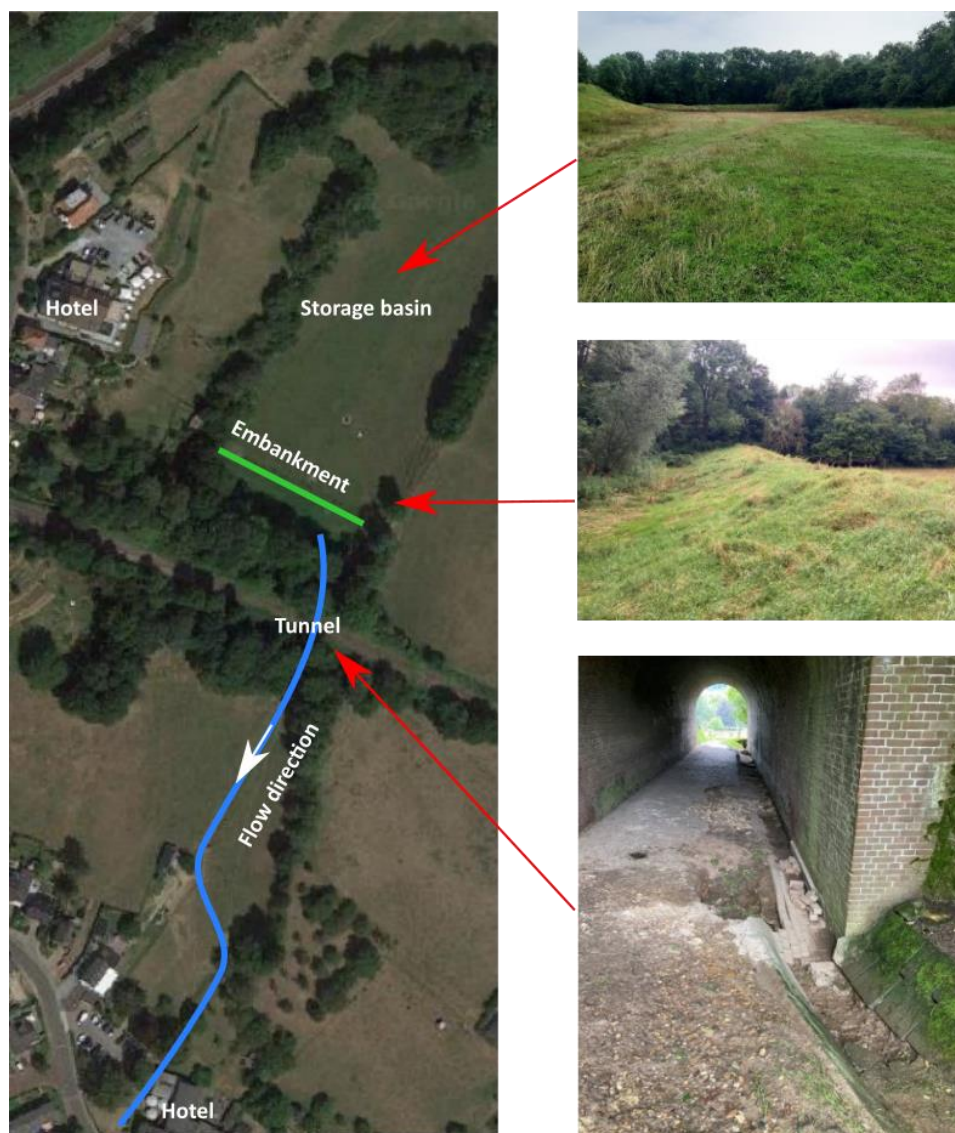
The ‘Ransdaal’ rainwater storage basin is located northeast of the village of Schin op Geul, see Figure 13. During the extreme rainfall event, floods occurred downstream of the area along the Scheumerbeek. For example, the nearby hotel downstream of the storage basin was flooded with several decimetres of water. During the field visit, it was found that water had overtopped the dike – in the middle and along the eastern side of the dam. The water flowed through a tunnel (where there were signs of significant erosion that point to high flow rates), and that led to the flooding downstream along the Scheumerbeek. This affected the hotel and a number of houses.

Figure 13: Location of Ransdaal storage basin near Schin op Geul (left) and images of the basin, the dike/embankment, and the erosion in the tunnel downstream (photographs provided by Bas Jonkman, TU Delft).

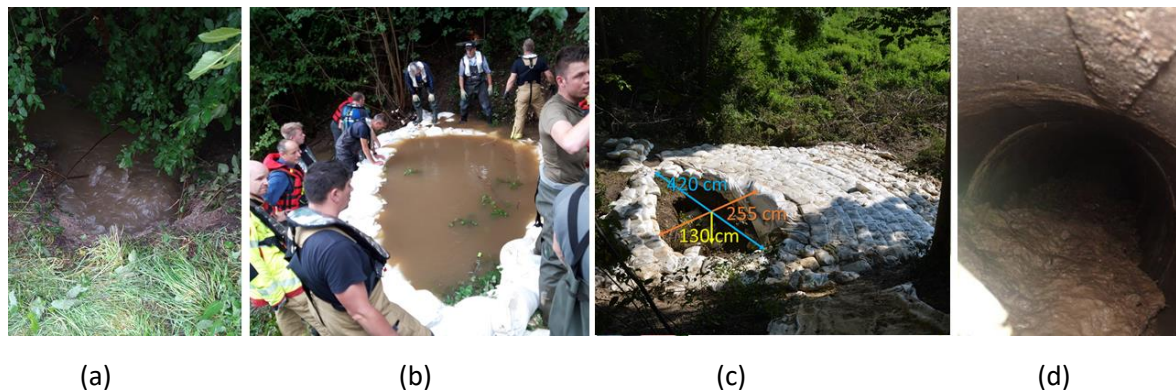
On the afternoon of Friday 16 July, various media reported that a dike had breached near the village of Meerssen or Bunde (1Limburg, 2021b) - (RTL News, 2021) - (De Telegraaf, 2021). On closer inspection, it was found to be a substantial sediment-carrying flow of water which also washed out gravel, just to the north of the approach road leading to the bridge over the Juliana Canal near Bunde, see Figure 14 and Figure 15. As a matter of urgency, this water flow – that was mistaken for a large sand boil– was handled by installing a coffer dam more than a metre high consisting of around 3000 sandbags which stabilised the situation. It was initially thought that the dike along the Juliana Canal which is elevated here was on the verge of failing due to a leak from the canal or from the Meuse. However, it was water from the Geul that was the problem, see Figure 15. Because not all of it could flow through the culvert under the Juliana Canal, it flowed along the eastern side of the Juliana Canal to the north. At the approach roads leading to the bridges near Bunde and Geulle, water then flowed around the road and through the originally constructed culverts. However, near Bunde the culvert had become covered and was not included in asset databases so that the flow of water from this culvert was initially misinterpreted as coming from the subsoil (“sand boiling”). It was discovered that there was a culvert here a week later when further investigation of this location was carried out. This last example clearly shows how the capacity of emergency services can be absorbed to a significant extent by issues that appear to be irrelevant at hindsight – or with sufficiently

Figure 14: Situation near Bunde: (a) prior to effective measures (photograph Bertram de Rooij, WUR/Fire Service Gelderland Midden), (b) stabilised boiling (photograph Hoite Detmar, the Directorate-General for Public Works and Water Management), (c) boiling area with dimensions after drying out, (d) the concrete culvert where the water came out (photograph Anton van der Meer, Deltares).
