A case study of apparently spontaneous fracture

Glass Structures and Engineering

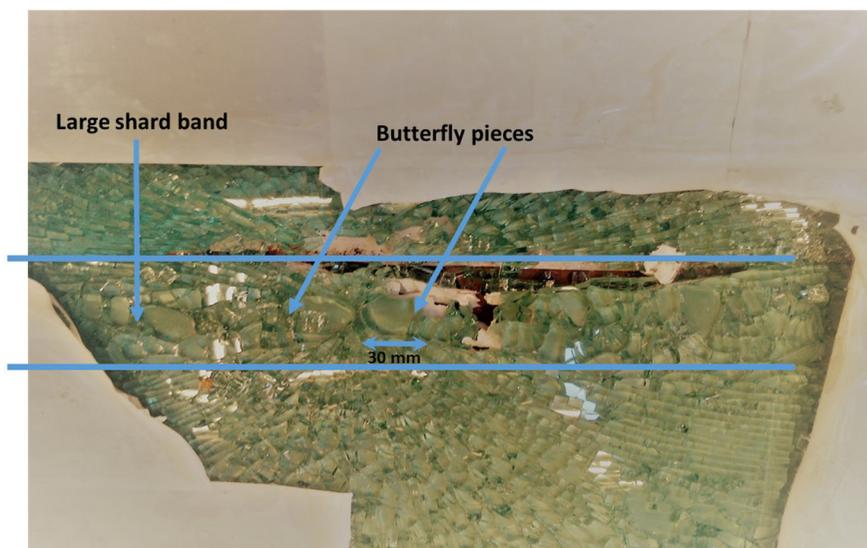
Fig. 1 Band of large shards and butterfly in spontaneously failed vehicle roof window supplied to authors after in service failure. Length of butterfly fragment around 30 mm, width of small shards about 4 mm

The spontaneously broken windows showed two clear characteristic features. Firstly, there were alternating bands of large and small shards, illustrated in Fig. 1, indicating uneven tempering. Secondly there were pairs of shards that looked like a butterfly pattern at what looked like the initial point of failure from the radiating fragmentation pattern centred on the butterfly, as is shown in Fig. 2. It should be noted that as the glass was monolithic and only held together by the foil, the butterfly shards were slightly displaced, showing a gap between them. The butterfly shards were carefully removed and fractographically examined.

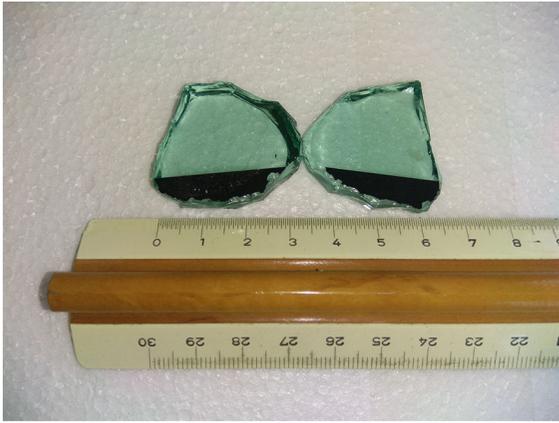
Fig. 2 Butterfly fragments removed from “spontaneously” failed window

On one set no clear fractographic information was visible with a microscope. However, if the two pieces were put together it was clear that a small piece was missing. Presumably the piece of glass where the fracture originated was separated from the butterfly pieces and not recovered.

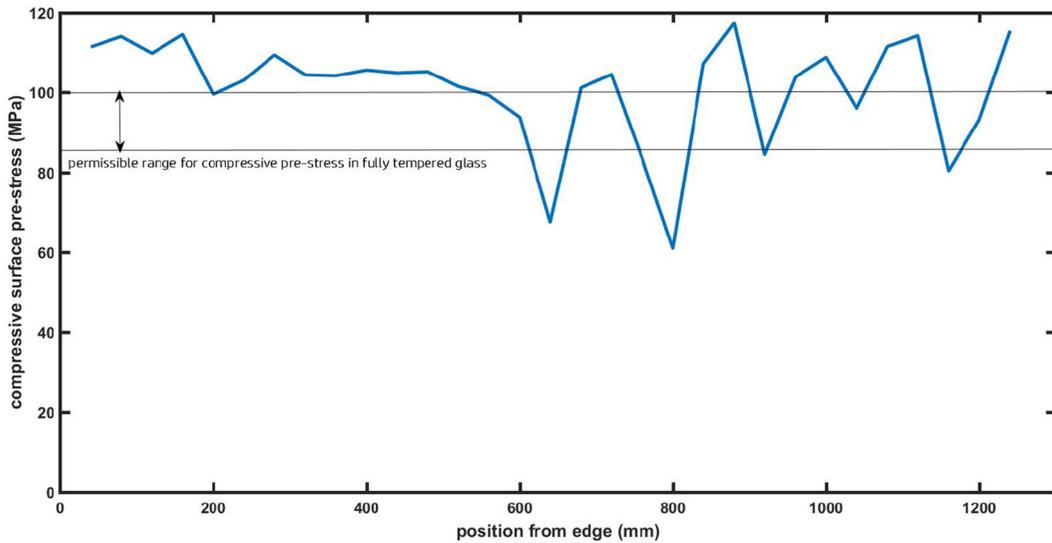
Fig. 3 Measured compressive surface pre-stress at the centre of the length of the window, measured across the width of the window from left edge to right edge for specimen 1

The compressive surface pre-stress was found to vary considerably across the width of the window forming bands similar to the bands of shards visible in the spontaneously failed specimens. As the variation is far greater than the 5% measuring error, the differences must be assumed to represent physical differences in the compressive surface pre-stress.

Figure 3 shows a typical variation in compressive pre-stress as measured with the SCALP 5 device. It should be noted that at the centre of the specimen, where the highest bending stresses occur, the compressive surface pre-stress is significantly lower. Depending

on the specimen, local values for the compressive surface pre-stress as low as 20 MPa were measured. This is in sharp contrast with the values of 100 MPa measured in the properly thermally toughened zones.

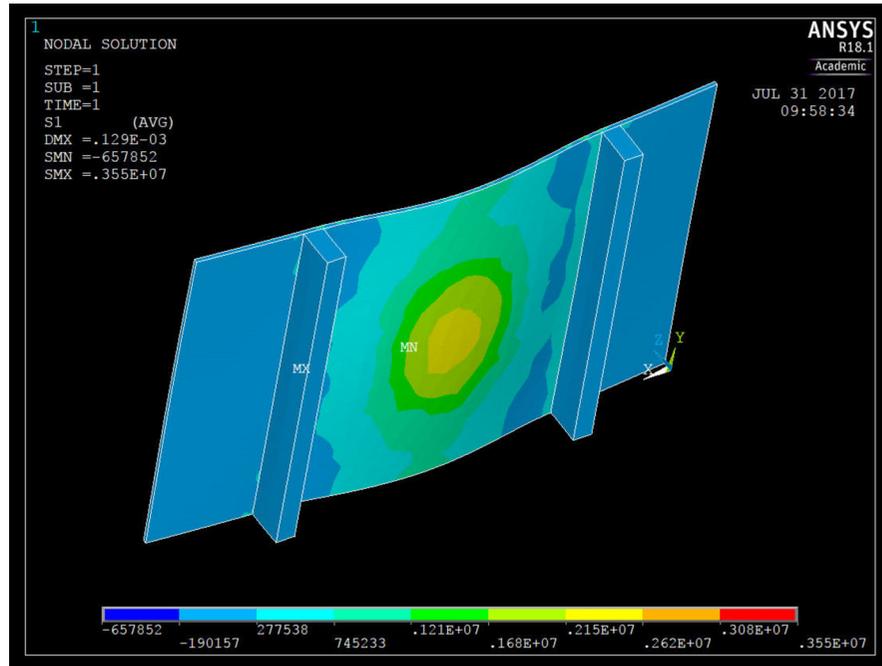
Fig. 6 Stress distribution according to ANSYS model

and illustrated in Fig. 7. All failures originated in the area with the highest applied stress shown in Fig. 6. The bands of large and small shards visible in Fig. 7 corresponded to the bands of lower and higher compressive surface pre-stress measured with the SCALP 5 device.

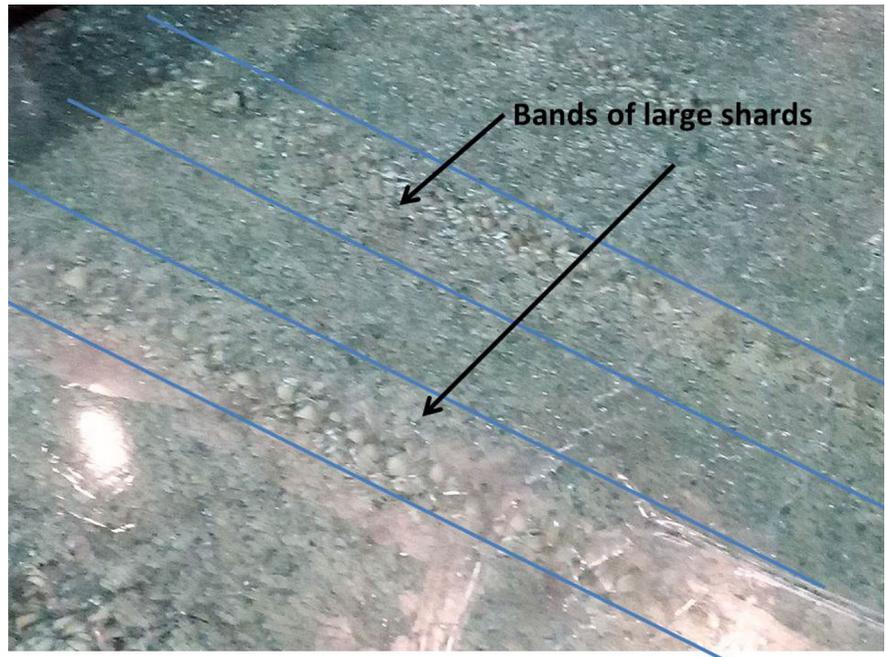
The loading rate was 250 N/min. Table 3 gives the calculated failure stresses. After failure, all specimens showed the same pattern of bands of small and large shards as observed in the spontaneously failed windows

Fig. 7 Specimen after failure, drawn bands are approximately 40 mm wide

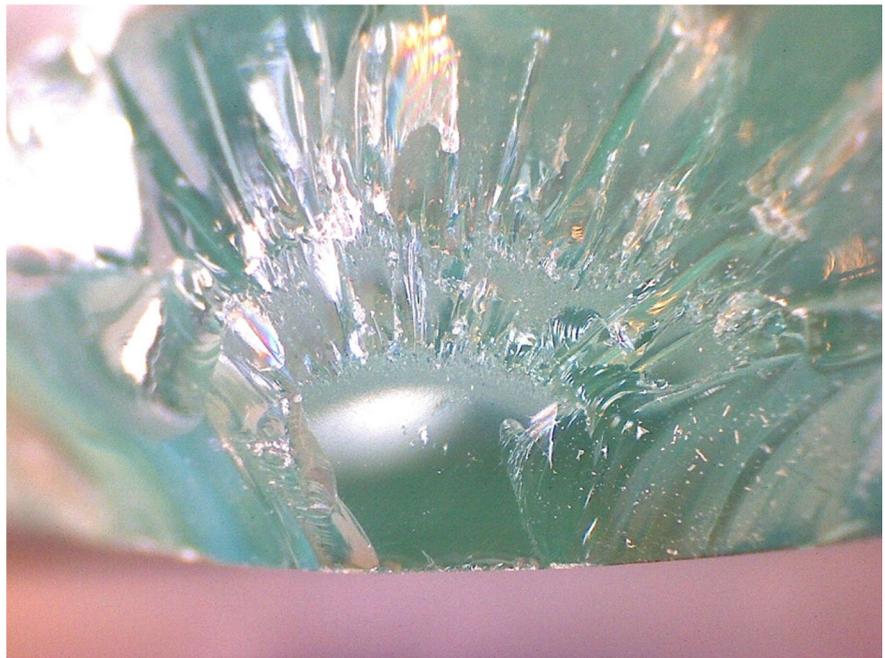
Fig. 8 Fractography of butterfly piece, typical mist, mirror, hackle zones

The second set of butterfly pieces showed a clear fractographic pattern under a microscope. This is shown in Fig. 8. The source of failure is clearly at the surface of the specimen and not in the interior, where a NiS failure would originate. The failure pattern is simi-

lar to that for an overload as given by Ono (2004), showing the typical mist, mirror and hackle pattern. This pattern alone makes it clear that no inclusion caused the original "spontaneous" failure.
