Contributing human and organizational factors for damage of Bos & Lommer plaza in Amsterdam

Karel Terwel

Abstract

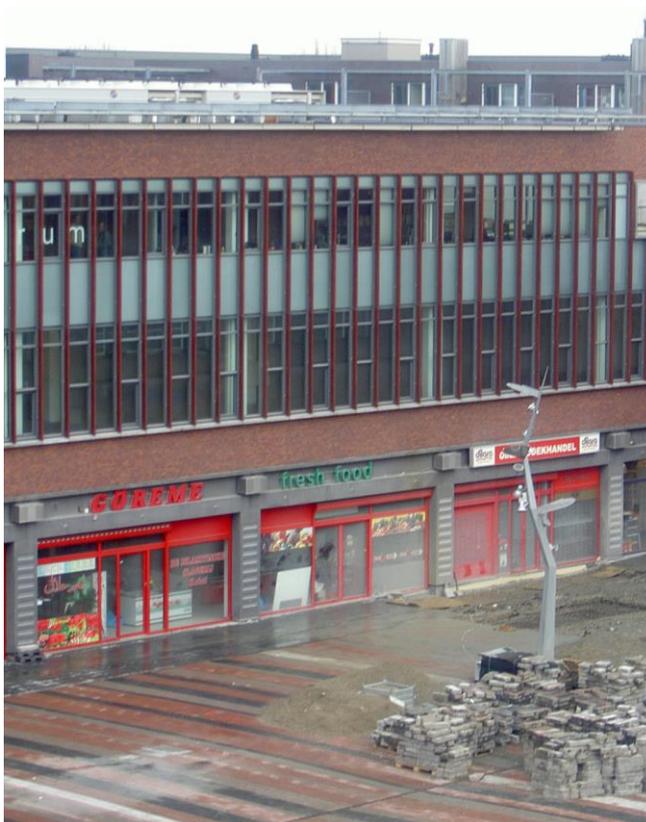
The Bos & Lommer plaza complex in Amsterdam was completed in 2004. This complex consisted of apartments, shops and a parking for over 500 cars. In 2006, an 11 ton truck was positioned on the plaza deck and caused structural damage. Part of the load bearing structure had failed and the apartments were evacuated, until the deck was strutted.

Figure 7.1 Recovery activities at Bos & Lommer Plaza (photo: Dick Hordijk)

The failure of the half-joint, which triggered investigation of Bos & Lommer plaza project, was caused by application of insufficient reinforcement compared to the drawings [1, p. 148]. It appeared that on many positions reinforcement was deviating from drawings, although in the majority of situations safety was assured [2, p.161-163].
