Health Condition Monitoring of Insulated Joints based on Axle Box Acceleration Measurements

Maria Molodova, Maider Oregui, Alfredo Núñez, Zili Li*, and Rolf Dollevoet

Section of Railway Engineering, Faculty of Civil Engineering and Geosciences, Delft University of Technology, Stevinweg 1, 2628 CN Delft, The Netherlands

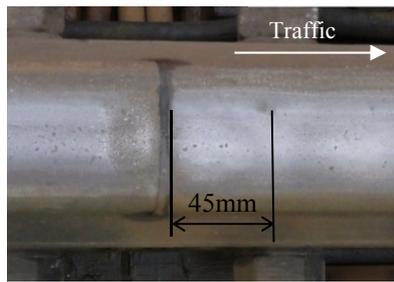
(a) IRJ number 1 with light surface deformation.

In this section, four IRJs from the track Eindhoven – Weert (E-W) were investigated, IRJ number 1 and 2 with light plastic deformation (Figure 5a-b) and the IRJ number 3 and 4 with severe plastic deformation of the rail surface (Figure 5c-d). The plastic deformation is caused by the impact occurring after the gap and has a typical wavelength of about 35-50 mm (Oregui et al, 2015b). Since IRJ number 2 with light surface deformation did not have any other visible damage at the fastener and insulation layer, it will also be used for comparison in the next sections as a reference IRJ in normal condition.

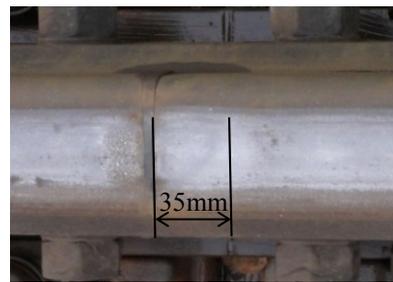
(b) IRJ number 2 with light surface deformation.

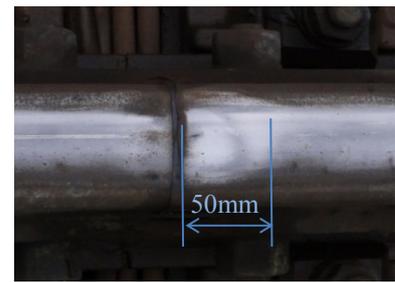
To study the relationships between the state of IRJs and ABA values we compared two IRJ with high ABA magnitude (IRJs number 3 and number 9 indicated with red circles in Figure 4a) and two IRJs with comparatively low ABA magnitude (IRJs number 1 and number 16 indicated with green circles in Figure 4a). As it appeared from the visual inspection of the IRJs, the two IRJs with high ABA magnitudes (above 200 m/s^2) were indeed in a deteriorated condition: the IRJ number 3 had plastic deformation D_1 on the rail surface caused by the impact at the endpost (Figure 5c) and the IRJ number 9 had a crack in the fastener D_2 (Figure 5g-h). As for the IRJs with comparatively low ABA magnitude (below 150 m/s^2), the IRJ number 1 may be considered as in a good condition (Figure 5a), since only light deformation of the rail surface is visible. While the IRJ number 16 had a significant gap between the two pieces of the rail, as a result of the loss of insulation material D_3 (Figure 5j). Thus, the ABA magnitude at IRJs cannot be an indication of D_3 . Therefore, further investigation of the frequency content of ABA is presented in the next section.

(c) IRJ number 3 with severe plastic deformation.

The ABA measured at these four IRJs are shown in Figure 6a. The ABA signals for each IRJ in this section and the next sections are the average signals out of four repetitive ABA signals, filtered with the low-pass Butterworth filter with a cut-off frequency of 2 kHz. The averaging and the filtering were done in order to reduce the noise in the measured signals. The ABA signals at these IRJs had a wavelength of about 50 mm. The local maximum ABA was the highest for IRJ number 3 ($a_{D_I}^{max} = 220 \text{ m/s}^2$) and about 2.4 times higher than ABA at the IRJ number 2 in normal condition ($a_N^{max} = 91 \text{ m/s}^2$). The plastic deformation at IRJ number 3 has the longest wavelength among these four IRJ's, 50 mm (Figure 5c).

IRJ number 3 has the longest wavelength of plastic deformation (50 mm) and the highest local maximum ABA compared to the other three IRJs in Figure 6a. However, the PSD at 500-550 Hz for IRJ number 3 was not the highest among these IRJs, because the energy was distributed over a range of frequencies (270 Hz, 730 Hz, 830 Hz, 1150 Hz, see Figure 6b). This can indicate that there is damage in other components of IRJ number 3 besides plastic deformation of the rail surface (sleeper, fastener, etc.) Thus, there is no direct correlation between degree of plastic deformation of the rail surface and PSD at 500-550 Hz. However, the combination of high ABA magnitudes and high values of PSD at 500-550 Hz can

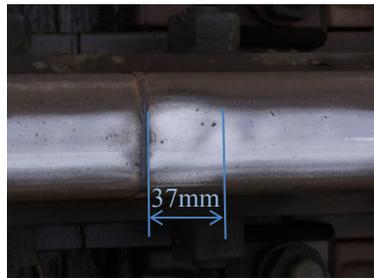
(d) IRJ number 4 with severe plastic deformation.

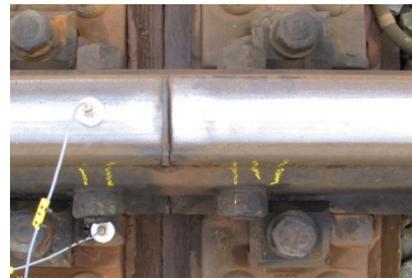
(e) IRJ number 7 with rusty fastening.

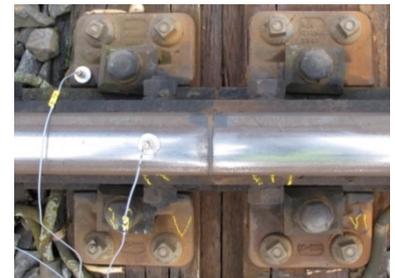
(f) IRJ number 8 with rusty fastening.

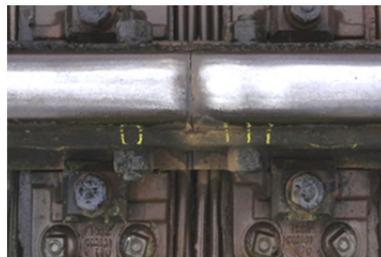
(g) IRJ number 9 with a crack in the fastener.

In this section the IRJ with a crack in the fastener was investigated (D_2). That is IRJ number 9 in Figure 5g-h. The dynamic responses at this IRJ were compared to the reference IRJ without visible damage in the fastener (Figure 5b).

The ABA at the IRJ with a crack in the fastener is shown in Figure 6e (solid line) together with the reference IRJ (dashed line). The ABA signal at this IRJ has a high peak of about $a_{D_2}^{max}=220 \text{ m/s}^2$. This peak is also related to high contact force, which caused the deformation of the rail surface, visible in Figure 5g as a broadened shiny wavy running band after the gap. It can also be observed in Figure 6e that the ABA magnitude of the IRJ number 9 is elevated compared to the reference one.

The PSD at the IRJ with a crack in the fastener is presented in Figure 6f. The major peak for an IRJ with a crack in the fastener is at 70 Hz, and the other two peaks at 340 Hz and 520 Hz are similar to the peaks of the reference IRJ. The frequency at 70 Hz is probably related to the change in the stiffness of the fastening caused by the crack. This frequency might be responsible for the higher level of vibration after the gap.

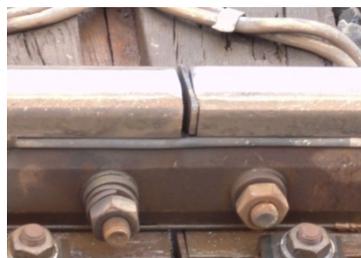
(j) IRJ number 16 with damaged insulation layer and a crack in the fastener.

In this section, an IRJ number 16 with two types of damage was investigated: with damaged insulation layer (Figure 5j) and the crack in the fastener (Figure 5k). The damage of the fastener for this IRJ was similar to the one of IRJ number 9 in Figure 5h.

The ABA at this IRJ is shown in Figure 7a with a solid line. The ABA magnitude at this IRJ is comparable to the reference IRJ ($a_{D_3}^{max}=86 \text{ m/s}^2$), but the wavelength is shorter than that of the reference signal. The PSD at the IRJ with the damaged insulation layer is shown in Figure 7b. The major two frequencies for this IRJ are 100 Hz and 645 Hz.

From these data it is impossible to extract the information about the health state of the IRJ due to low ABA magnitude and PSD. Thus, the retrospective analysis of the ABA measurements was performed to obtain more information. Figure 7c presents the ABA signals measured in October 2009 – July 2010. The ABA magnitude at this IRJ in October 2009 was $a_{D_3}^{max}=134 \text{ m/s}^2$, in March 2010 was $a_{D_3}^{max}=129 \text{ m/s}^2$, and in July 2010 was $a_{D_3}^{max}=257 \text{ m/s}^2$.

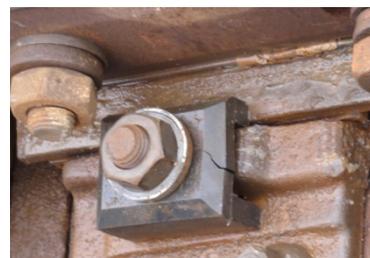
(k) IRJ number 16 with damaged insulation layer and a crack in the fastener.

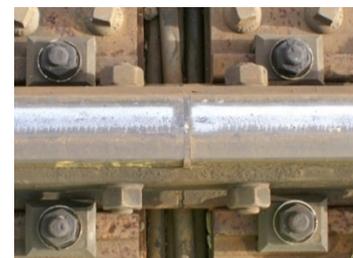
(l) IRJ number 3 on the track Groningen – Assen.

In Figure 4b the ABA on the track Groningen – Assen has less variation in values, than on the track Eindhoven – Weert, with the average local maxima ranging between 50 to 100 m/s². The IRJ with the highest ABA value is number 3, which has moderate degradation of the rail surface D_I (Figure 5l).

Figure 6c presents the ABA measured at IRJs 3 from the track Groningen – Assen (G-A), see photo in Figure 5l. The ABA signal at this IRJs had a wavelength of about 50 mm. The local maximum ABA was $a_{D1}^{max} = 100 \text{ m/s}^2$, which is quite close to the normal condition ($a_N^{max} = 91 \text{ m/s}^2$). The PSD at these IRJs is shown in Figure 6d. There major peaks for this IRJ are 90 Hz, 350 Hz and 570 Hz, which is consistent with the frequencies in Figure 6b.
