**Investigation of Olympus TJF-Q180V Scopes at UMC Utrecht regarding contamination found after cleaning and disinfection
Reporting, Conclusions and Suggestions**

Reporting, Conclusions and Suggestions

April 19th 2017

Dr. Arjo J. Loeve

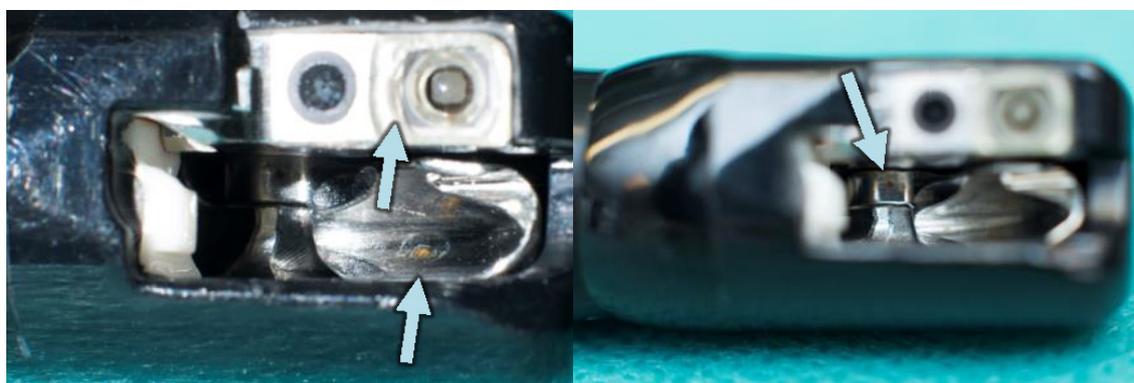
- Brown and white deposits in the forceps elevator region.
- Brown deposit behind the light cover glass
- Various scratches in the suction/biopsy channel, and one noticeable area of damage (~ 1 mm) in the distal section of the suction/biopsy channel.
- The Olympus representatives state that the channel does not appear to be from Olympus originally. The material is blue instead of white or clear (see appendix H) and appears to have a ribbed structure.
- When the borescope is inserted completely, the end of the suction/biopsy channel is not reached.

Figure 32: (from left to right) Close-up of the tip, with brown deposit in the forceps elevator and behind the light source cover glass; Brown deposit on several parts on and around the forceps elevator;

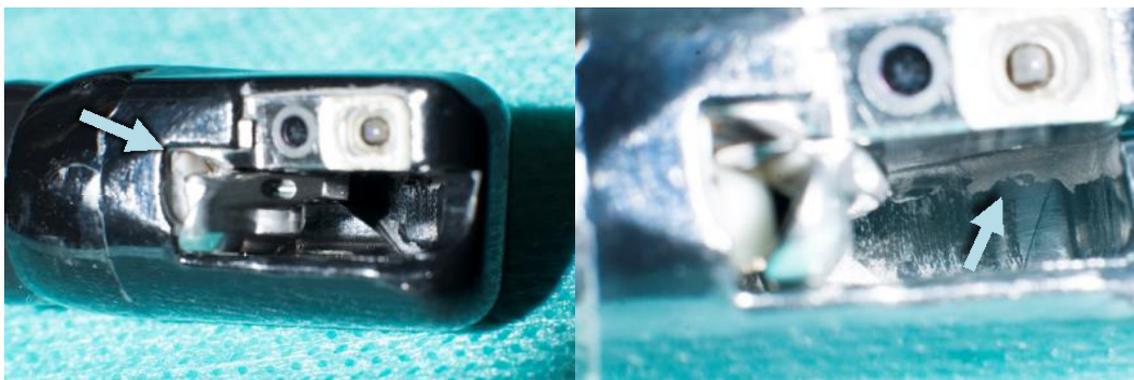
Figure 33: (from left to right) Red-brown deposits between the Z-block (the white part) and the tip housing; White, visually porous deposit in the forceps elevator area on the tip cover.

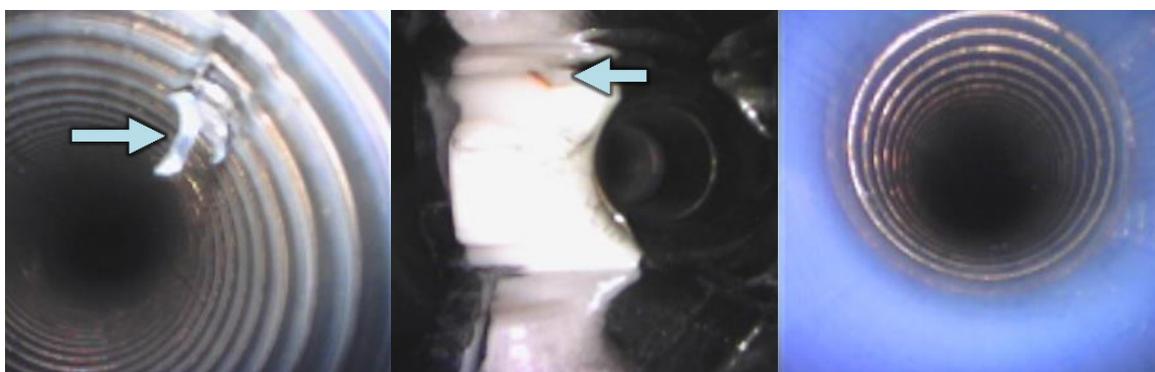
Figure 35: Borescope images. (from left to right) Damage in the suction/biopsy channel a few centimeters from the tip; Red-brown deposits on white Z-block; Part of the suction-biopsy channel viewed from the distal (tip) side toward the control section, where the smooth tube becomes the ribbed tube.

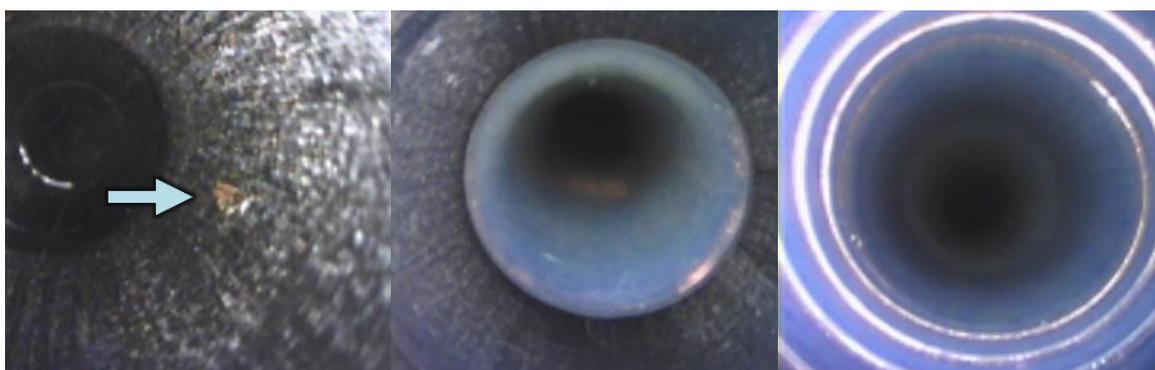
Figure 36: Borescope images. (from left to right) Brown deposit at input of suction/biopsy channel; Merging of entrance suction/biopsy channel to smooth tube of suction/biopsy channel; Merging of ribbed tube for suction/biopsy channel to smooth tube for suction/biopsy channel, shown from the control section towards the tip.

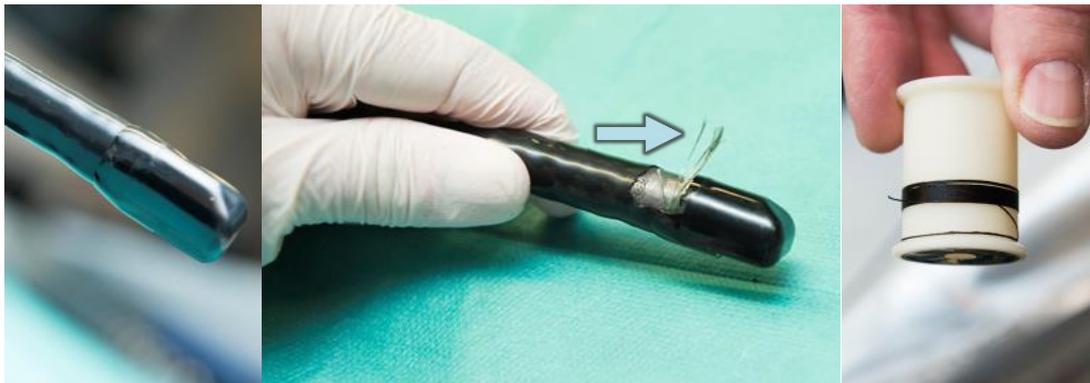
- In the anterior bonding joint of the cardan rubber, a green thread was found, while Olympus uses black thread (see appendix H).
- The glue did not adhere well to the thread, and is lying on the thread and not between and below.
- The glue appears to be more brittle than the glue Olympus uses, according to P8.
- Under the glue, everything is fine.
- No Molykote powder is found under the cardan rubber, while there should be 0.3 g of Molykote powder present (see appendix H).

Figure 37: (from left to right) Dent in the tip cover; Green thread under the front bonding joint of the cardan rubber; Original black thread used by Olympus for bonding.

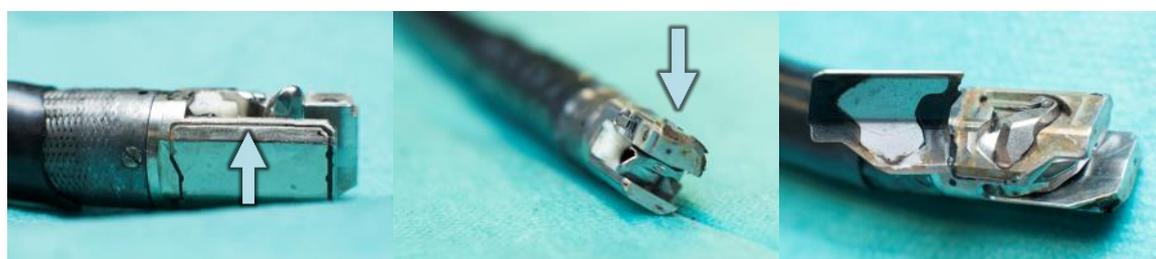
- Insufficient (see appendix H) amount of black glue in the edge around the arm cover, through which there are openings in the seal.
- Brown deposit under the tip cover.
- P8 expresses doubts about the origins of the arm cover: a normal lip around the arm cover to make the arm cover easy to remove is missing according to P8.
- Arm cover is soldered to the tip, which is not consistent with Olympus standards (see appendix H).
- The glue is not everywhere on the arm cover, so the seal is not complete.
- Brown deposit under the arm cover.

Figure 40: (from left to right) Side view of arm cover that shows part of the locking groove is without glue; Front view of tip with brown deposit; Opened arm cover, still attached to the tip due to soldering, with brown deposit underneath the arm cover.

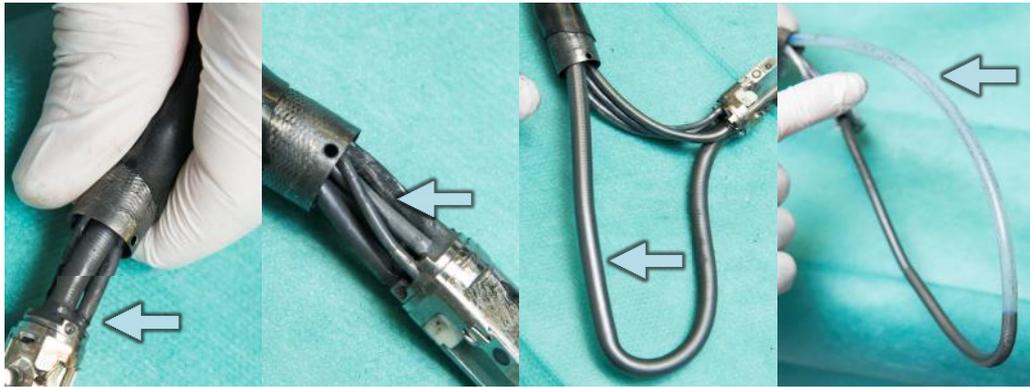
Figure 48: (from left to right) Black glued channels at the tip; Crossed channels at the tip; Non-original suction/biopsy channel (see appendix H); Smooth transparent part of the non-original suction/biopsy channel.

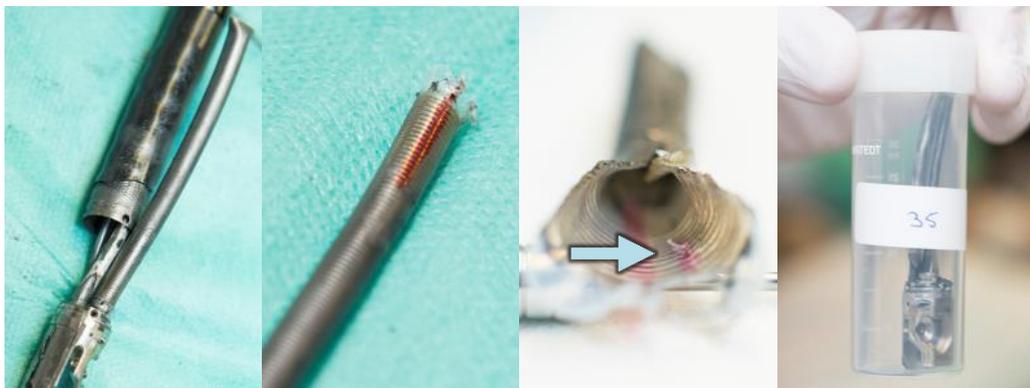
Figure 49: (from left to right) Removed suction/biopsy channel; Loose, distal piece of suction/biopsy channel with externally marked location of the internal damage; Detail of the internal damage in the suction/biopsy channel; removed tip.

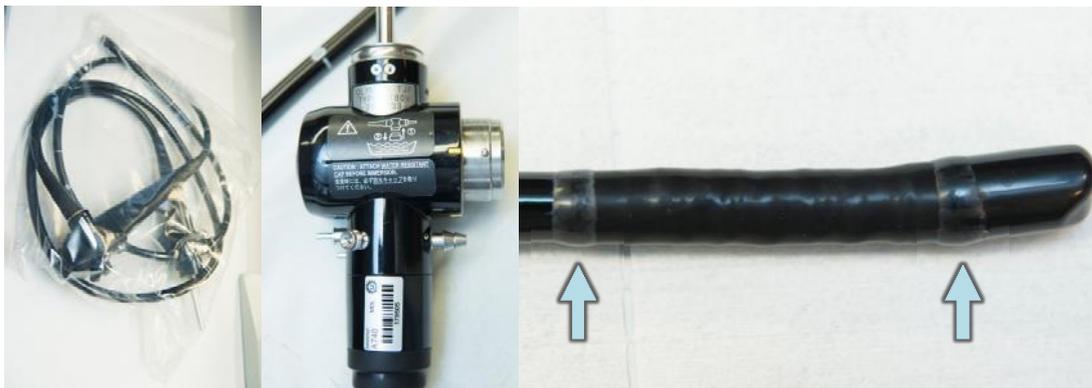
- The distal and proximal bonding joints of the cardan rubber are irregular, thicker than usual (see appendix H) and show a great deal of loosening.

Figure 50: (from left to right) Scope B in undamaged sterile bag; Connector of Scope B; Distal part of Scope B with irregular bonding joints of the cardan rubber showing traces of releasing.

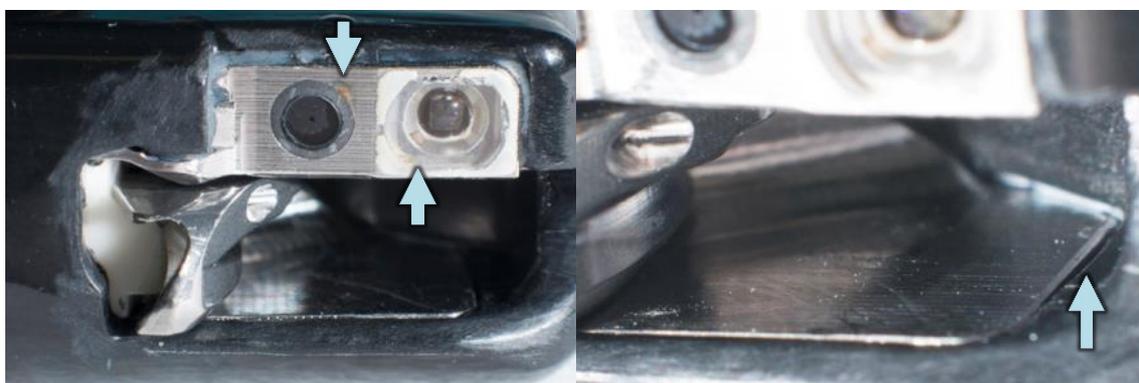
Figure 52: (from left to right) Close-up of the tip with brown deposit behind the cover glass; Space between the frame of the tip and the tip cover, the tip cover does not line up properly.

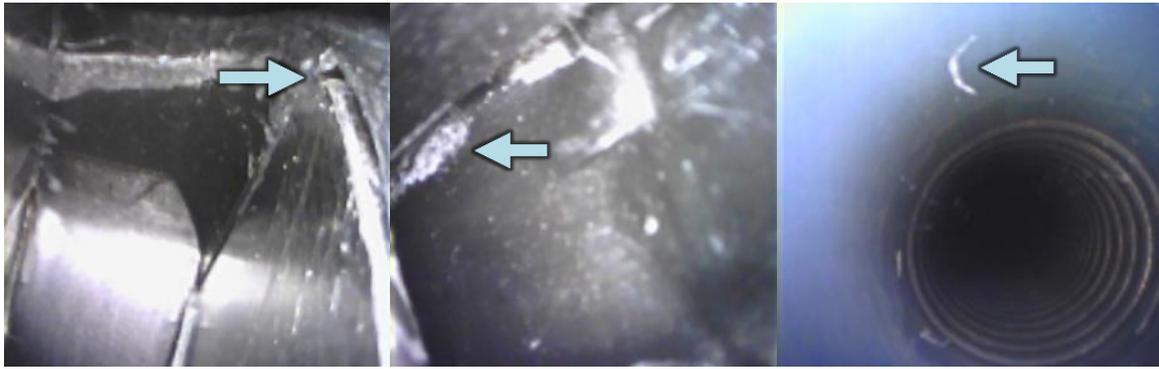
Figure 54: Borescope images (from left to right) Clearly visible space between the frame of the tip and the tip cover; Some white deposits in the rim of the forceps elevator recess; Fiber in the suction/biopsy channel, just before the merge from smooth tube (distal) to ribbed tube (proximal).

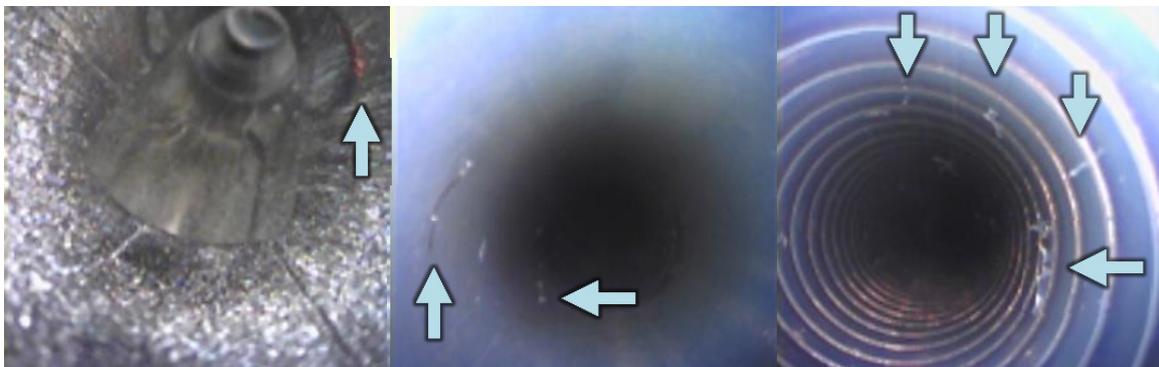
Figure 55: Borescope images (from left to right) Red-brown deposit in the input of the suction/biopsy channel in the control section; Fibers in the smooth tube of the suction/biopsy channel; Fibers in the ribbed tube of the suction/biopsy channel.

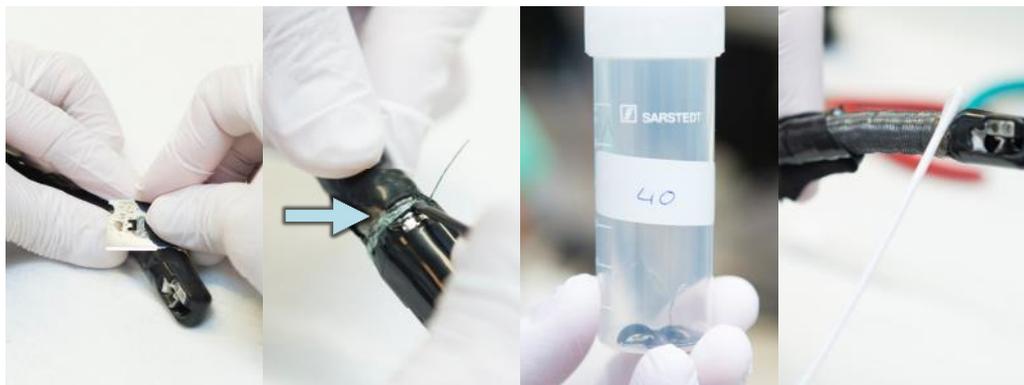
- 14:58 hrs The anterior bonding joint of the cardan rubber is cut away by P8, which reveals a number of things, very consistent with the other scope:
- In the anterior bonding joint of the cardan rubber, a green thread was found, while Olympus uses black thread (see appendix H).

- Under the glue, everything is fine.
 - There is hardly any Molykote powder found under the cardan rubber, while there should be 0.3 g of Molykote powder present (see appendix H).

Figure 56: (from left to right) Cutting loose the front bonding joint on the cardan rubber. Green thread underneath the first bonding joint of the cardan rubber; Stored pieces of bonding {40}; Sampling under the front bonding joint of the cardan rubber and underneath the cardan rubber.

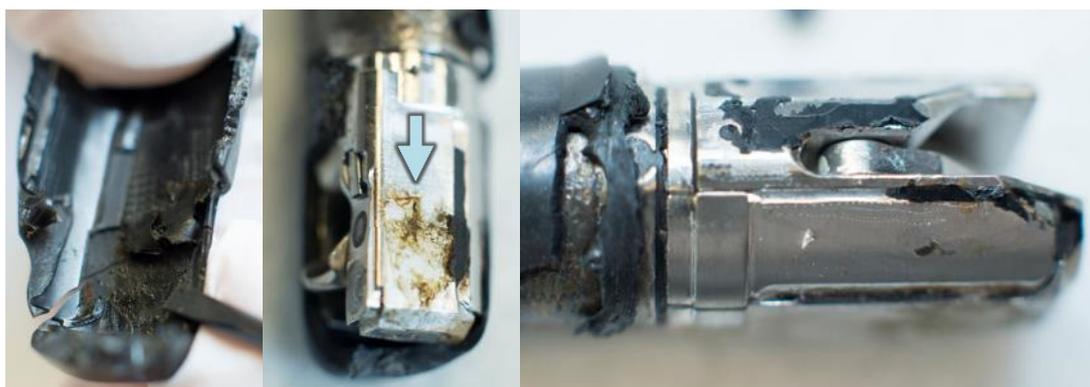
Figure 57: (from left to right) Brittle structure of the tip cover; Brown deposit under the tip cover; Black glue underneath the tip cover.

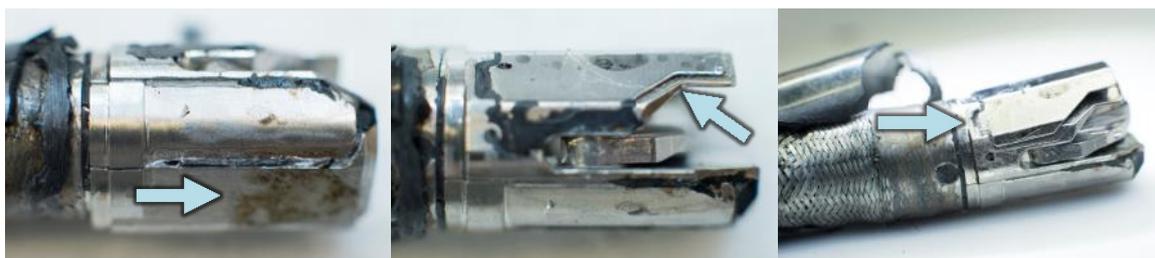
- Insufficient amount of black glue in the edge around the arm cover, through which there are openings in the bonding joint.
- P8 expresses doubts about the origins of the arm cover: a normal lip around the arm cover to make the arm cover easy to remove is missing according to P8.
- Arm cover is soldered to the tip, which is not consistent with Olympus standards (see appendix H).
- The glue is not everywhere on the arm cover (see appendix H), so the bonding joint is not complete.
- The "extra" cavity in the tip (see figure 60) appears to P8 not to be original. When reviewing the photos of the other scope, this cavity also appears to be present there.
- A piece of black glue that fits into the "extra" cavity is found to be stuck to the arm cover and is stored separately {49}.

Figure 59: (from left to right) Brown deposit under the tip cover; Opening in the bonding joint on the arm cover;

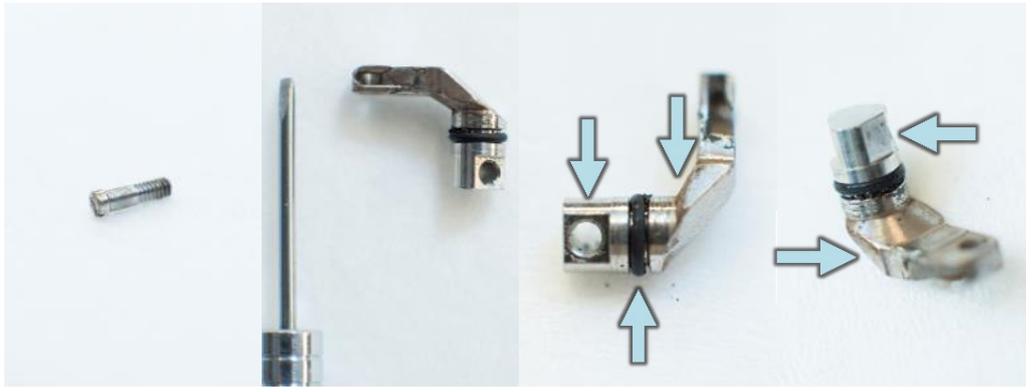
Figure 62: (from left to right) The screw that affixed the forceps elevator to the lever shaft; Lever with lever shaft and O-ring next to a 1mm diameter screw driver; Brown deposit on the lever, lever shaft and O-ring; Brown deposits on both drive section side (lower arrow) and patient side (upper arrow).

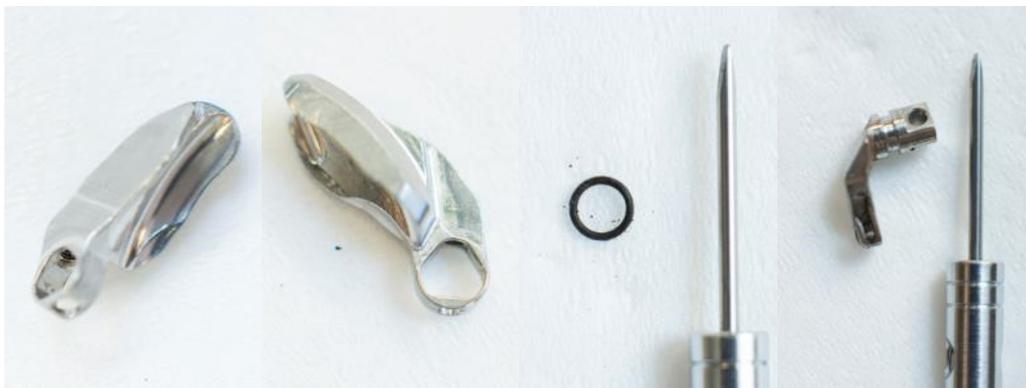
Figure 63: (from left to right) Forceps elevator with brown deposit in the shaft opening; Forceps elevator; O-ring met brown deposit next to a 1 mm diameter screwdriver; Lever with lever shaft next to a 1 mm diameter screwdriver, brown deposit in O-ring groove both on drive unit side and patient side.

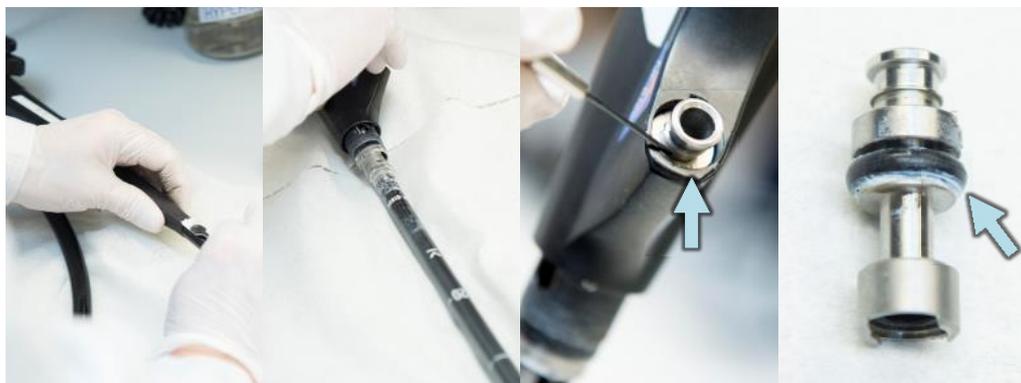
Figure 64: (from left to right) Soapstone powder is applied to be able to slide the distal cuff of the control section over the insertion tube; Under the distal cuff there is no Olympus brand name, insertion tube is not original; Water droplets under the rubber ring of the entrance to the suction/biopsy channel in the control section; Input valve with O-ring has material which looks like silicone gel.

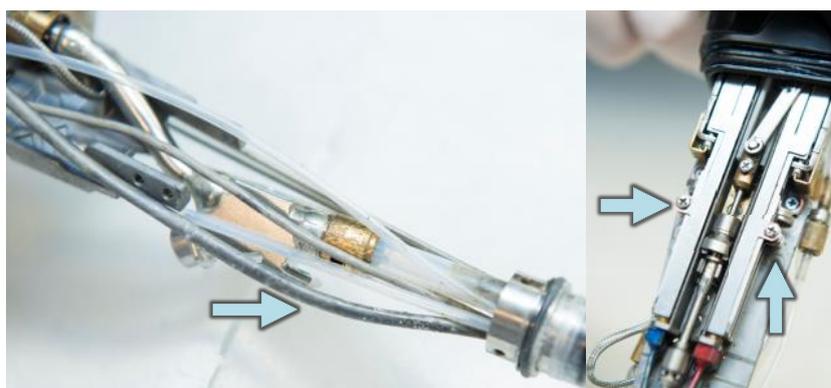
Figure 65: (from left to right) Channels in the control section, moisture damage traces on the exterior of various channels; Control section interior and screws with missing green locking adhesive.

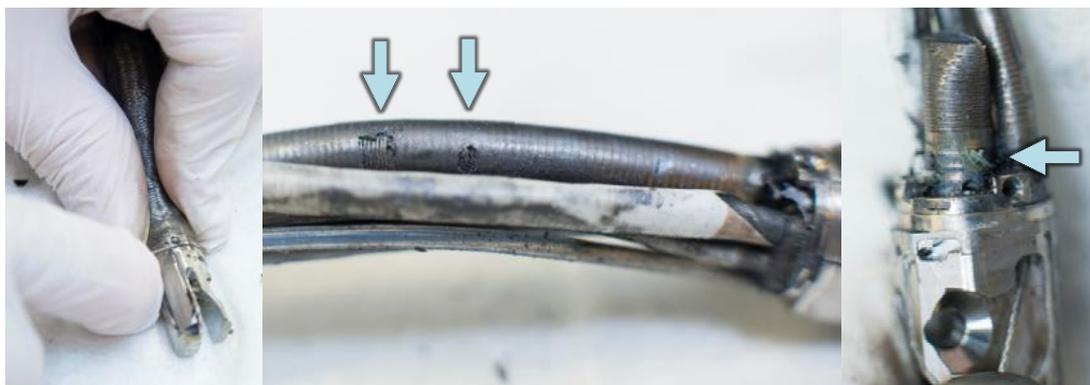
Figure 66: (from left to right) Screws from the tip attachment are hard to remove because they are covered with glue; Seriously damaged exterior sleeve of suction/biopsy channel; Green wire visible in black fixation glue of the suction/biopsy channel.

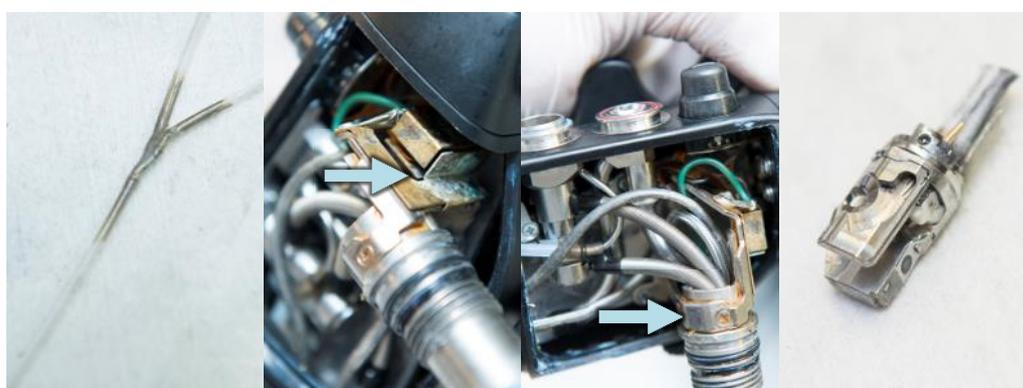
Figure 67: (from left to right) Y-connector water air channel; Strong oxidization around electrical circuit in control section; Strong oxidization on coupling parts of the signal tube; removed tip of Scope B.

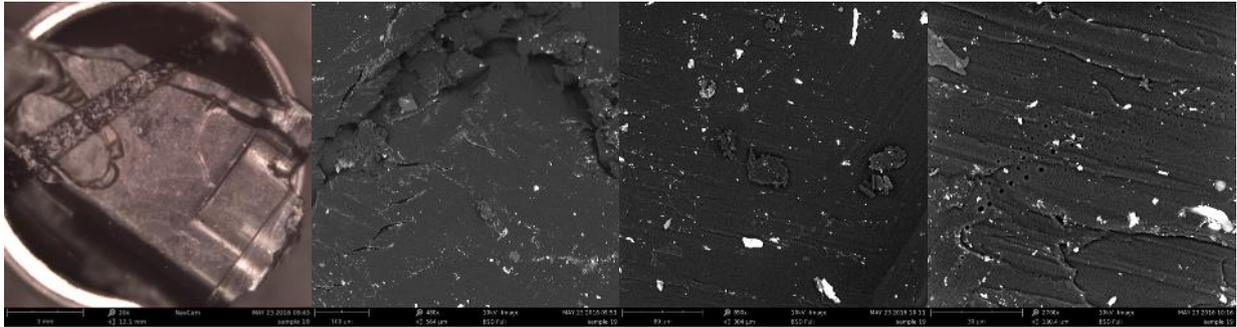
Figure G01: (from left to right) Interior piece tip cover Scope A; Detail scan (480x). Structure of the plastic; Detail scan (890x). Surface structure with particles; Detail scan (2700x). Visible air bubbles.
