Investigation of the formation of corrugation-induced rail squats based on extensive field monitoring

Deng, Xiangyun; Qian, Zhiwei; Li, Zili; Dollevoet, Rolf

International Journal of Fatigue

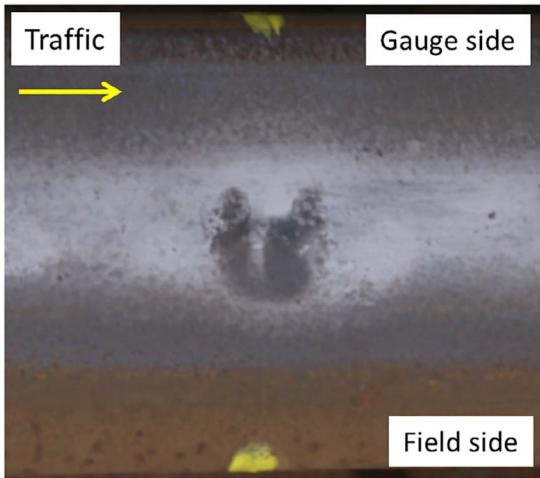
Fig. 1. A typical squat in a two-lung shape with cracks at the monitored site.

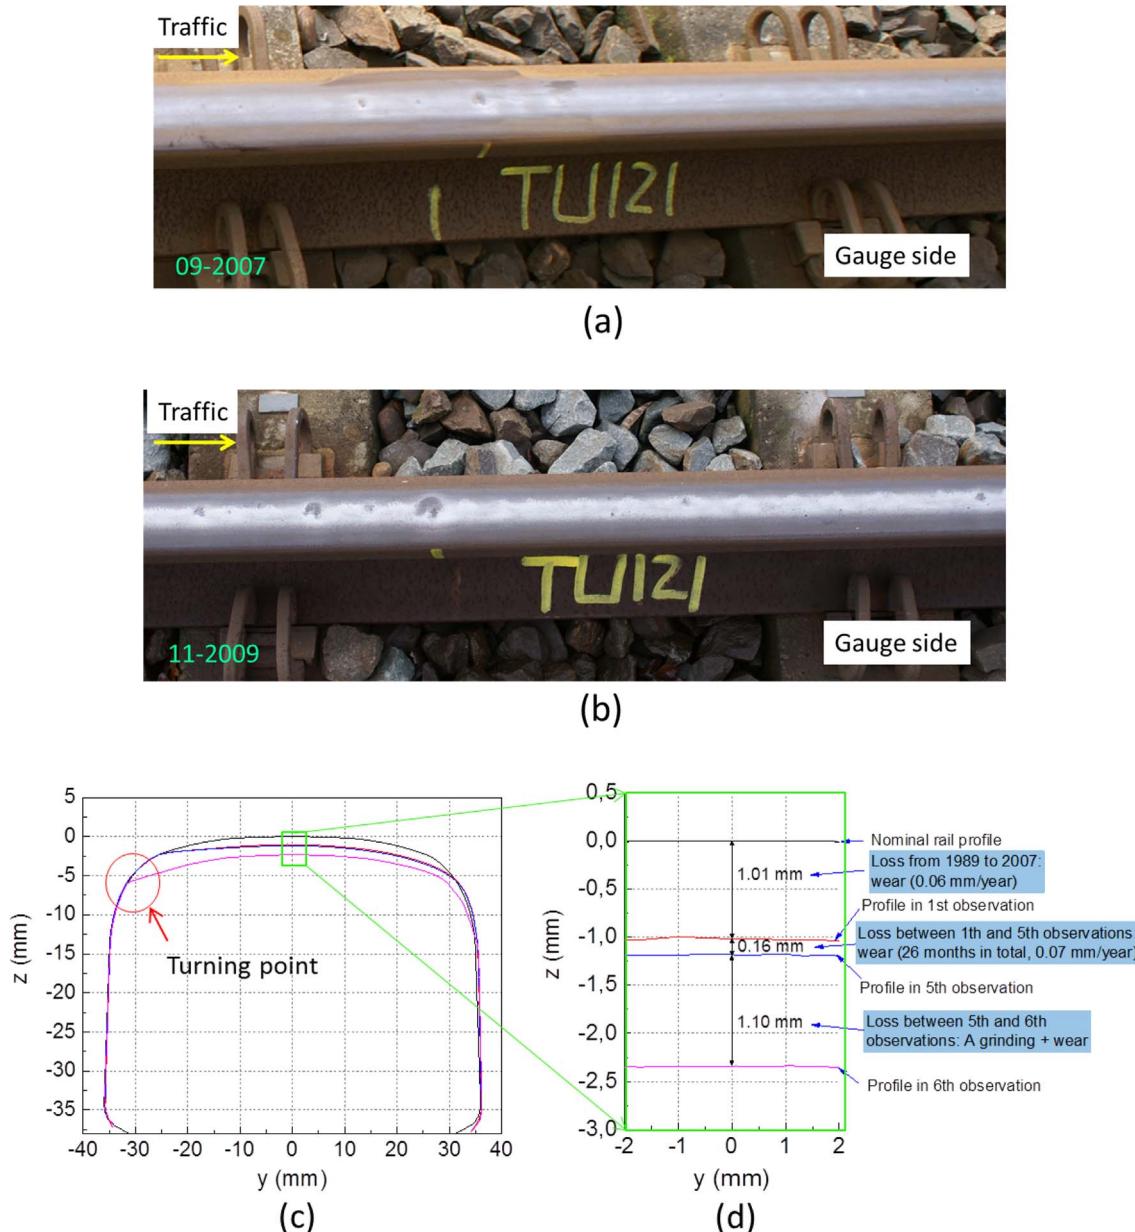
The section of track was selected for monitoring because of the following reasons. First, some corrugation and resulting squats of various severities were observed at the beginning of the monitoring, as shown in Fig. 3(a). In view of the active nature of corrugation-induced squats, it was predictable where new squats would initiate and grow from the developing corrugation. This makes a fruitful selection of monitoring locations possible. The second reason is that there were no visible defects or residual cracks in the rail surface other than the intended corrugation and squats. The third reason is that the rails had not been ground. To prove that any grinding was not performed before the start of the monitoring, the rail profiles measured during the monitoring at a number of defect-free locations were analyzed. It was found that the average rail head loss due to the natural wear was 0.07 mm/year between the first and fifth observations, and the average rail head height loss was 0.06 mm/year between 1989 and 2007. The height loss of 0.06 mm/year would have not been possible if any corrective grinding had taken place. This was further confirmed by looking at the measured profiles, as shown in Fig. 3(c) and (d), where the measured profiles are aligned with the nominal profile (in black) on the field side (the left side). The measurements show good repeatability. The profile (in magenta) measured immediately after a corrective grinding at the sixth observation is as smooth as the other profiles on the gauge side. In contrast, the ground profile has a larger rail head height loss (see Fig. 3(d)) and a sharp turning point at the field side (indicated in Fig. 3(c)), apparently it is different from other profiles. If there was any

Fig. 3. Typical corrugation with several squats of various severities adjacent to a monitored squat and measured rail profiles for analysis of grinding: (a) in the first observation, corrugation and some squats already existed adjacent to a monitored squat; (b) in the fifth observation, the corrugation and squats in (a) had become severe and new squats of different severity appeared; (c) measured rail profiles by MiniProf in the vicinity of one squat: from top to down they were the nominal (black) and those measured in the first (red), fifth (blue) and sixth (magenta) observations, respectively; (d) zoom-in of (c) in the middle of the profiles. (For interpretation of the references to color in this figure legend, the reader is referred to the web version of this article.)

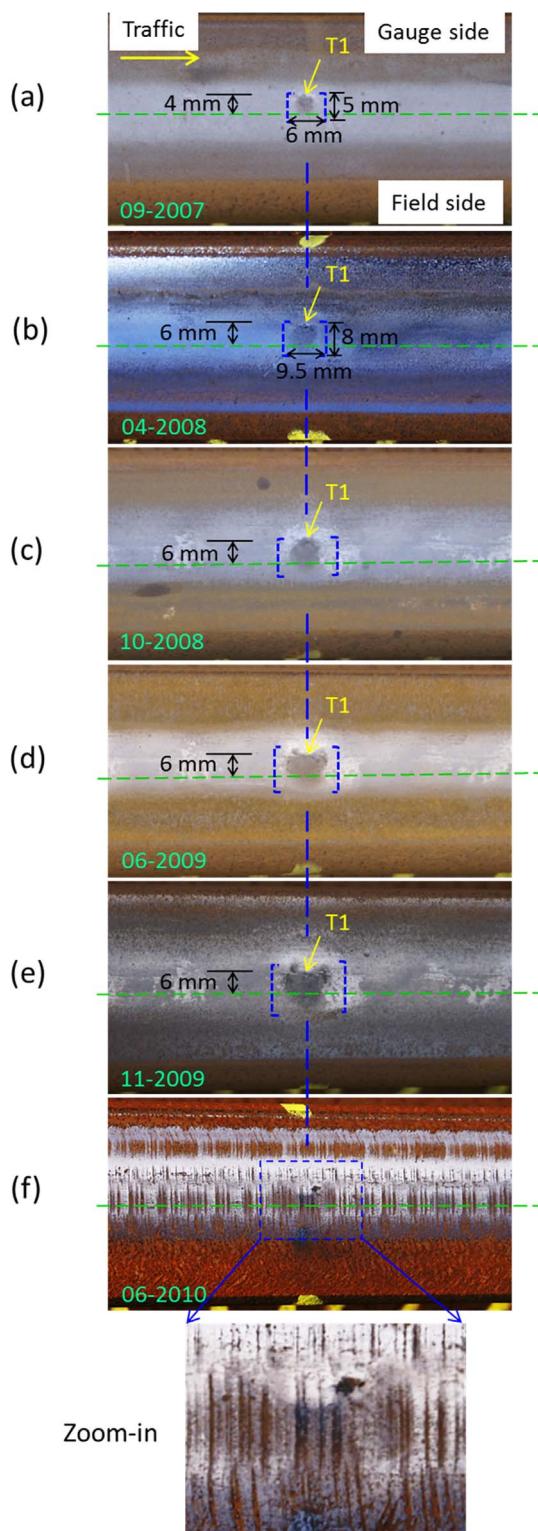
The series of photographs in Fig. 4, which were obtained during the first six field observations, show the evolution of a squat. The changes in size and in the bright running band near the squat can be seen. At the time of the first observation, the squat was a small black depression in an approximately elliptical shape with a size of approximately 5 mm in the lateral direction and 6 mm in the traffic direction. The position of T1 is approximately 4 mm from the rail centerline. This black depression did not have visible surface cracks. It was growing in size until the fifth observation, shortly before the rail grinding. The squat eventually evolved into a kidney-like shape with its concave part resembling a shallow U, as seen in Fig. 4(d) and (e). As will be shown later, this shallow U developed into a full U that was the primary surface crack of the squats. Thus, this concave part is referred to hereafter as U-shaped. At the time of the fifth observation, the running band at the squat was widened on the gauge side, as indicated by the shining part above point T1, indicating that the depression broadened the running band.

Although it was hard to confirm the presence of surface macrocracks by visual inspection during the first five observations, eddy current tests showed that a crack began to appear as of the second observation. At this time, T1 of the depression was approximately 6 mm from the rail centerline, and the dimension of the depression was approximately 8 mm in the lateral direction and 9.5 mm in the traffic direction. These results indicate that cracks initiated when the black depression grew to a certain size. This finding was confirmed by the observations of another 5 squats of the 30 selected squats, which did not have macrocracks in the beginning, but cracks were observed at the sixth observation. This finding is in line with the critical size of squat initiation that was numerically derived in [13] by comparing the maximal von Mises stress with tensile strength, and the material was also R260Mn.

After the crack had appeared, the shape of the depression began to change into a kidney-like shape, and the location of T1 remained approximately 6 mm from the rail centerline. Eddy current tests and ultrasonic tests showed that the crack continued to grow after their initiation. The phenomenon of crack growth with the fixed location of T1 relative to the rail center was observed with all the other monitored squats.

After the rail grinding to a depth of 1.1 mm, the black depression was removed, and a shallow U-shaped crack was exposed, as shown in Fig. 4(f). This observation shows that the crack had propagated into the rail deeper than 1.1 mm and that the depth of the black depression was less than 1.1 mm. This finding confirmed the presence of the cracks measured by the eddy current tests and ultrasonic tests. The removal of the black depression and the exposure of the residual cracks were also observed at the other monitored squats with cracks deeper than

Fig. 4. Evolution of a squat with the critical size of 8 mm for crack initiation and subsequent cracking (the dashed straight green line represents the rail centerline): (a)–(e) Before rail grinding to a depth of 1.1 mm; (f) after the rail grinding, revealing a shallow U-shaped crack, as seen in the zoom-in. (For interpretation of the references to color in this figure legend, the reader is referred to the web version of this article.)

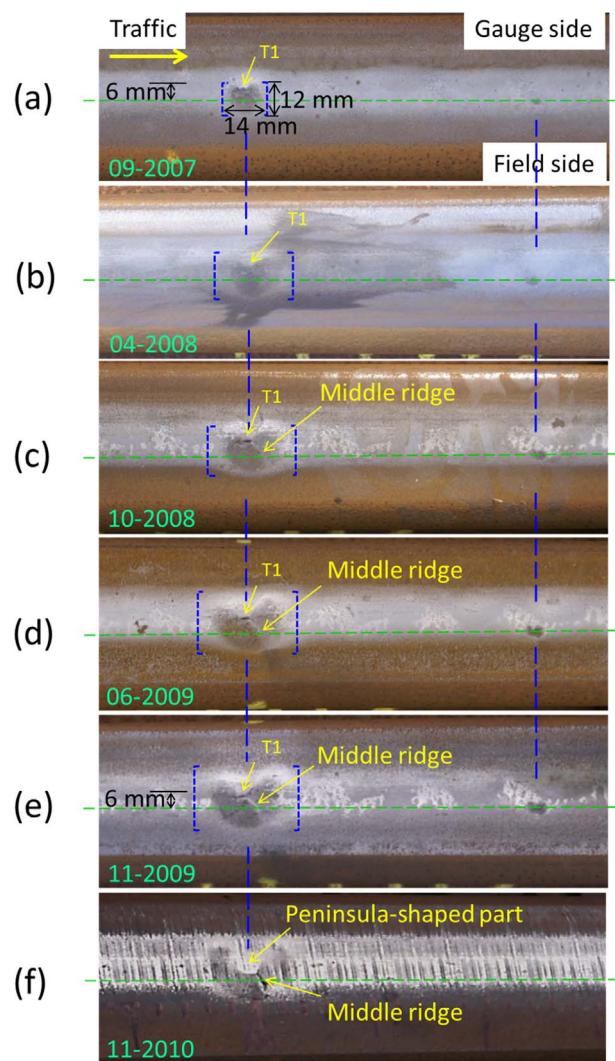
Fig. 5 illustrates the development process with another squat. The figure consists of six photographs from the first five consecutive observations before the rail grinding and from the seventh observation after the grinding; the photo from the sixth observation was not sufficiently clear. These photographs show that T1 was the bottom point of the U shape and that its position stayed fixed not only in the lateral direction, as demonstrated with Fig. 4, but also in the traffic direction. The latter concluded as follows: the rail head has a constant width of 72.2 mm. With this value, the sizes of the depressions and cracks were derived from the photos for this paper. In Fig. 5, there is, beside the squat, another small black spot. With the known rail head width, the

distance between the small black spot and point T1 is determined, and it can be seen in Fig. 5 that T1 remained at a constant distance from the small black spot.

With T1 aligned according to the blue dashed lines, Fig. 5 shows that the squat grew longitudinally in both the traffic and opposite-

Fig. 5. Confirmation of the crack initiation point according to the relative positions of the black spot and point T1 (the green line represents the rail centerline): (a)–(e) Before rail grinding; (f) after rail grinding to a depth of 1.1 mm. (For interpretation of the references to color in this figure legend, the reader is referred to the web version of this article.)

traffic directions as well as laterally toward the gauge side and field side simultaneously. This growth pattern was observed at all 21 of the moderate and severe squats. The squat in Fig. 5 first grew into a kidney-like shape with the concave part of the kidney bounded by a U-shaped crack, and then it gradually evolved into a two-lung shape with a middle ridge (Fig. 5(c)–(f)). After the grinding, the part bounded by the full U-shaped crack took on a peninsula-like shape, as seen in Fig. 5(f). A more detailed discussion about the formation of the middle ridge and the peninsula-shaped part is in Sections 3.4.1 and 3.4.2. Notably, the typical two-lung shape and the peninsula-like shape were not clearly observable at the squat in Fig. 4 because the squat was still in a relatively early stage; the crack and geometry had not yet grown into the typical shape.

The very small black spot in Fig. 5(a), barely visible to the naked eye, was growing before the grinding. At the fifth observation, it turned into an obvious surface depression; its size was already comparable to that of Fig. 4(a), and it should have been able to develop into a squat if not removed. The initiation and growth of black spots are, in the very beginning, driven by the corrugation. At the same time, the black spots are rail surface irregularities that excite (additional) dynamic contact force; the larger the black spot, the larger the dynamic force, creating a positive feedback loop that promotes the continuous and accelerates

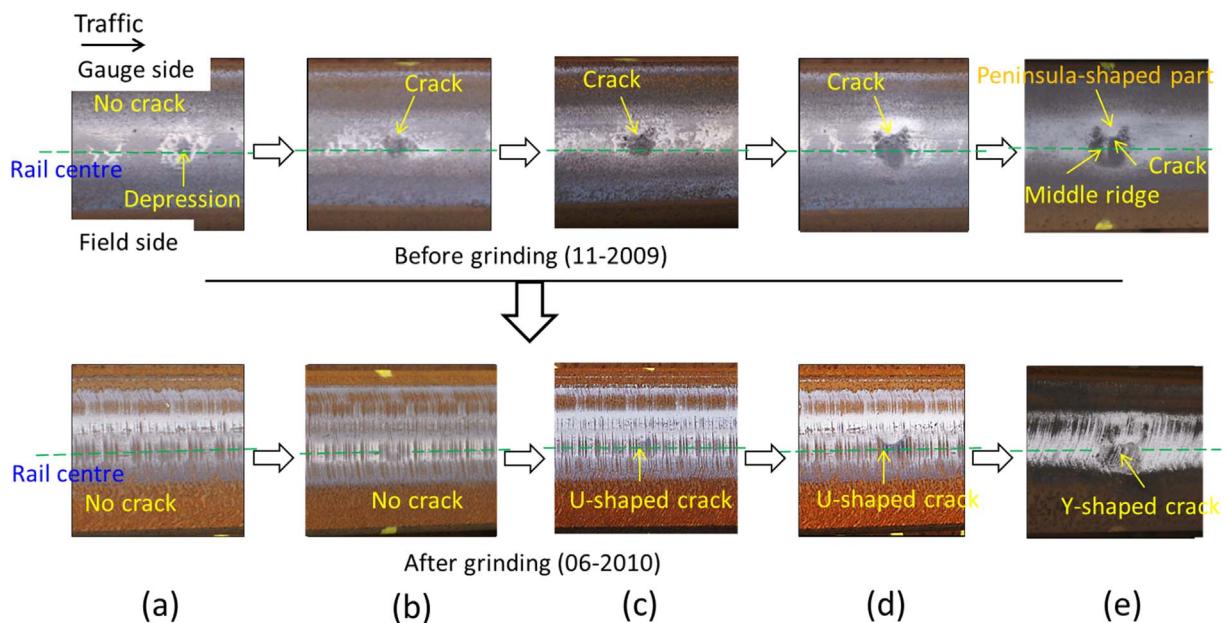
Fig. 6. Different squats at various severities: earlier stages to later stages.

In (a), the black depression was still significantly smaller than the critical size of 8 mm; no crack was observed in the rail surface either before or after the rail grinding, as seen in Fig. 6(a). It is reasonable to assume that the macrocrack had not yet initiated at this time. In (b), the size of the depression (10 mm (in the lateral direction) \times 14 mm (in the traffic direction)) was larger than the critical size of crack initiation; a small surface primary crack became visible at this stage prior to the rail

grinding (see the arrow in Fig. 6(b)). After the grinding, the crack was removed. This observation suggested that the crack was shallower than 1.1 mm. In (c) and (d), the squats were in a kidney-like shape before the grinding, and a U-shaped crack became visible after the grinding. The length of the U-shaped crack continued to grow from the bottom along the U in both directions, i.e., in the traffic and the opposite-traffic directions, with the evolution of the squat. These observations confirm that the bottom of the U-shaped cracks was the initiation point of the cracks in or near the rail surface on the gauge side of the depression. The point of the crack initiation corresponded to position T1 in Figs. 4 and 5. After initiation, the crack propagated along the U shape, as well as into the rail toward the field side, as discussed in Sections 3.3 and 3.4. Moreover, the crack grew more rapidly in the traffic direction than in the opposite-traffic direction; see the discussion in Section 4.3. In (e), the squats reached a more severe stage: they evolved into the two-lung shape with a middle ridge, and an I-shaped crack appeared at this ridge after the grinding. More details about the I-shaped crack are provided in Section 3.4.

was not very clearly visible, as shown in Fig. 6(a), the convex part of the kidney-shaped depression was elliptical, as seen in Fig. 6(b)–(d), and this elliptical shape most likely originated from the elliptical contact area between the wheel tread and the rail crown. The elliptical shape is more clearly visible in Fig. 4, especially in Fig. 4(a) and (b). Therefore, the small black depression in (a) should have been approximately elliptical in shape.

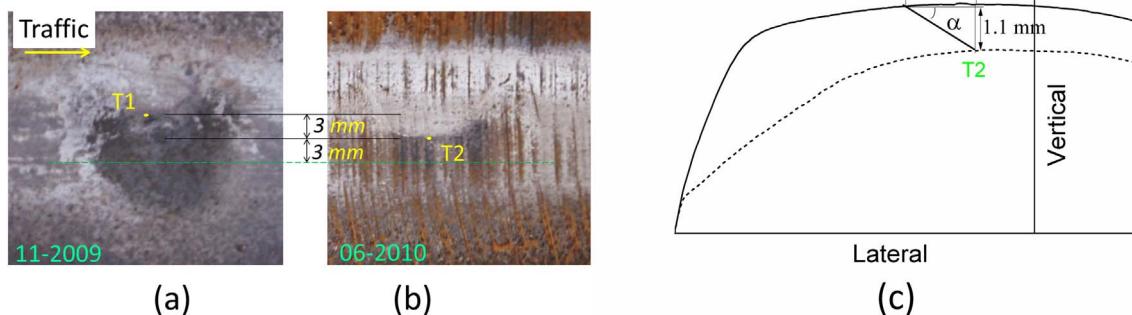
Fig. 7. Determination of the cracking angle relative to the rail surface in the vertical-lateral cross-section (the green line represents the rail centerline; T1 and T2 denote the bottom of the U-shaped crack): (a) Before rail grinding; (b) after rail grinding to a depth of 1.1 mm; (c) cross-sectional profiles of the rail. (For interpretation of the references to color in this figure legend, the reader is referred to the web version of this article.)

A moderate squat with a U-shaped surface crack was examined to determine its cracking angle in the vertical-lateral cross-section, which passes through the bottom of the U shape, as shown in Fig. 7. In Fig. 7(a), bottom point T1 of the crack was the crack initiation point, and it was located on the gauge side at a distance of 6 mm from the rail centerline. After the rail grinding to a depth of 1.1 mm, the bottom of U-shaped crack T2 shifted 3 mm toward the field side, as shown in Fig. 7(b). The cracking angle α was then approximately 20° , as illustrated in Fig. 7(c), indicating that the surface crack propagated into the rail at an angle of approximately 20° toward the field side. This finding agrees with the findings in the computed tomography investigation in [20].

For verification purposes, another 18 moderate and severe squats with cracks on the gauge side were also examined. All the crack initiation locations were approximately 6 mm from the rail centerline on the gauge side. These locations were also the bottom points of the U-shaped cracks of the squats, and they corresponded to point T1. After the rail grinding to a depth of 1.1 mm, the bottom points moved 3 mm toward the field side. Thus, the cracking angles were again approximately 20° for all the examined squats, 7 of which are shown in Figs. 1, 4–7 and 15. All the results were in good agreement with the cracking angle shown in Fig. 7.

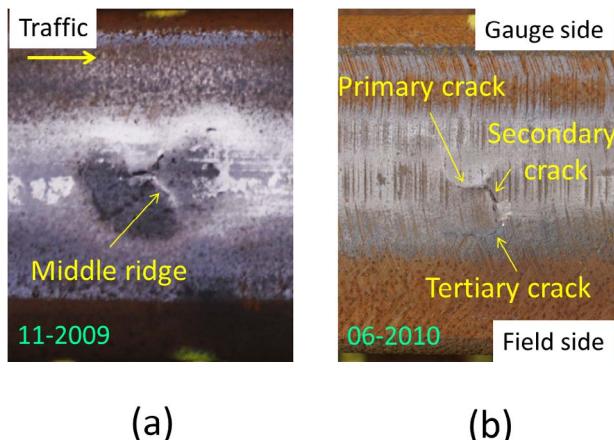
Fig. 9. A typical two-lung-shaped squat with a Y-shaped crack and a semi-circular tertiary crack (the same squat as in Fig. 5): (a) Before rail grinding; (b) after rail grinding to a depth of 1.1 mm.

The two impacts at the peninsula-shaped part punched and pushed the depressed rail material so that a “ridge” was formed in the middle of the black depression, as indicated in Fig. 9(a). This ridge is clearly shown on the surface in Figs. 1, 5(c)–(f), 6(e), 9, 10 and 15. Cracks can develop at the middle ridge, as seen in Figs. 5(f), 6(e) and 8–10, especially in severe squats. This crack is the secondary I-shaped crack. The I-shaped crack is also shown in the 3D geometry of the crack in Fig. 8(b).

When the U-shaped crack and I-shaped crack occur simultaneously, they together become a Y-shaped crack, as shown in Figs. 9 and 10. The Y divides the elliptical shape into the shape of two lungs, which occurs with the typical shape of severe squats.

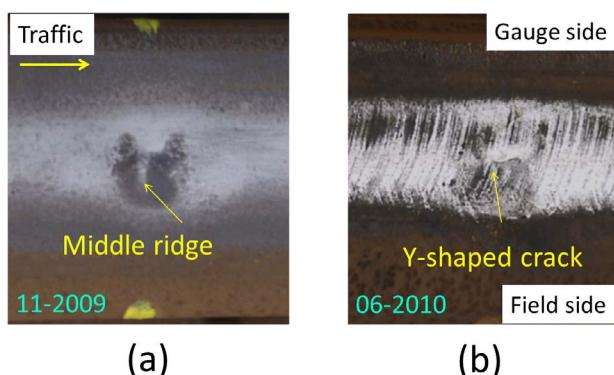
Fig. 10. Another typical two-lung-shaped squat with a Y-shaped crack (the same squat as in Fig. 6(e)): (a) Before rail grinding; (b) after rail grinding to a depth of 1.1 mm.

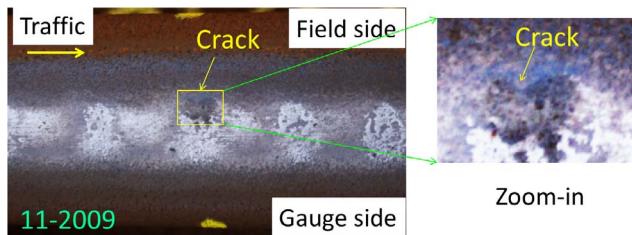
Fig. 14. A squat with a primary crack on the field side edge of the black depression.

When the rail inclination is at the nominal value of 1/40, as shown in Fig. 13(a), the presence of the black depression shifts the main contact area to the gauge side. This shift is determined by the contact geometry, namely the profiles of the wheel and the rail, as illustrated in Fig. 12(b) and, especially, Fig. 12(e): the wheel-rail profiles are more conforming to each other on the gauge side than on the field side so that, when there is a depression, the main contact area is usually on the gauge side. As a result, the crack tends to initiate and propagate into a U shape on the gauge side edge of the black depression. This scenario in which the location of the primary crack is on the gauge side (schematically shown in Fig. 12) occurs at most of the monitored squats, such as those squats shown in Figs. 1, 3–10, 15 and 17, the only exception is the case shown in Fig. 14 corresponding to the situation in Fig. 13(c).

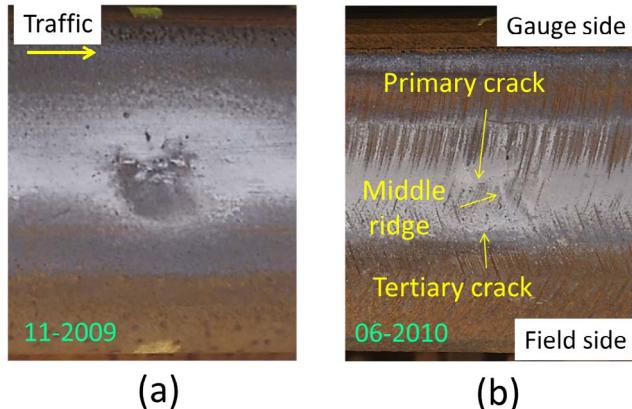
Fig. 15. A squat with two cracks, i.e., a primary crack and a tertiary crack: (a) Before rail grinding; (b) after rail grinding to a depth of 1.1 mm.

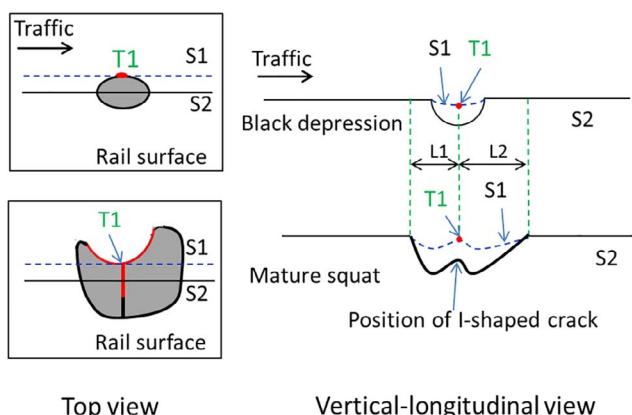
Fig. 16. Evolution of the squat geometry. S1 and S2 indicate the two vertical-longitudinal sections.

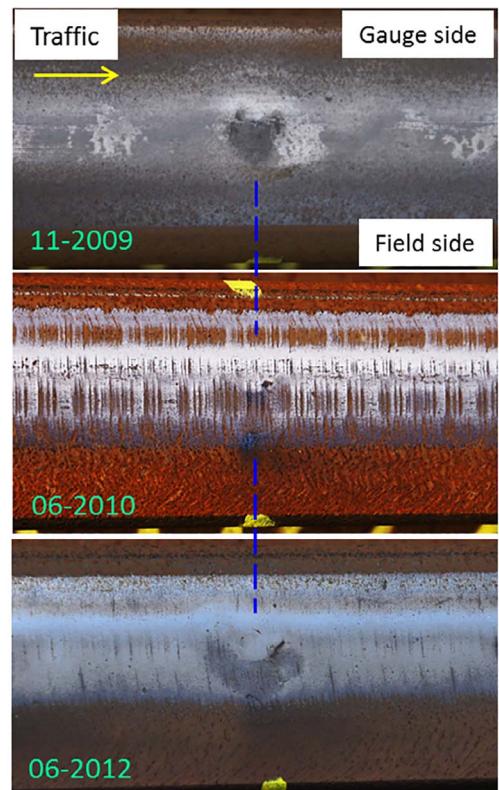
Fig. 17. Squat (the same as in Fig. 4) development after rail grinding: (a) Fifth observation before rail grinding; (b) sixth observation after grinding to a depth of 1.1 mm; (c) tenth observation after another grinding of approximately 0.3 mm between the seventh and eighth observations.

During the ten continual observations, rail grinding to a depth of 1.1 mm was performed after the fifth observation. Some of the squat cracks had already propagated more than 1.1 mm into the rails; therefore, the rail grinding did not remove the cracks completely. The remaining cracks grew further and developed into a new squat, as shown in Fig. 17.
