Creep Failure of Reformer Tubes in a Petrochemical Plant

Abstract: This paper investigates a failure in HP-Mod radiant tubes in a petrochemical plant. Tubes fail after 90,000 h of working at 950 °C. Observed failure is in the form of excessive bulging and longitudinal cracking in reformer tubes. Cracks are also largely branched. The microstructure of service-exposed tubes was evaluated using optical and scanning electron microscopes (SEM). Energy-dispersive X-ray spectroscopy (EDS) was used to analyze and characterize different phases in the microstructure. The results of this study showed that carbides are coarsened at both the inner and the outer surface due to the long exposure to a carburizing environment. Metallography examinations also revealed that there are many creep voids that are nucleated on carbide phases and scattered in between dendrites. Cracks appeared to form as a result of creep void coalescence. Failure is therefore attributed to creep due to a long exposure to a high temperature.

1. Introduction and Case Background

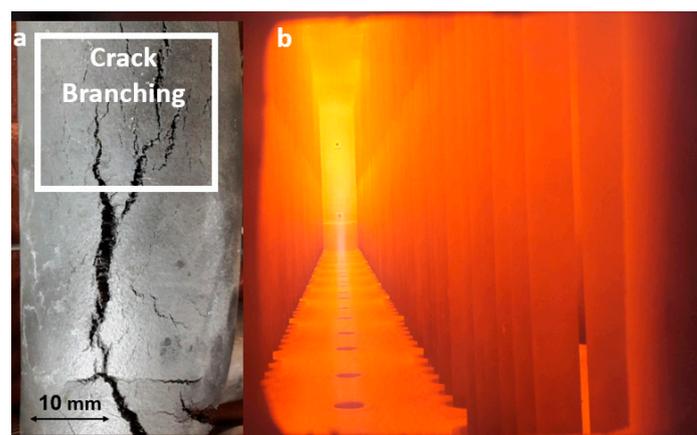
Figure 1 shows an example of failed reformer tubes together with an image, showing how tubes are installed in a reforming unit. As can be seen, cracks have propagated longitudinally. Extensive branching is also observed overall on the outer surface. It is also noticeable that in some parts tubes are largely deformed in such a way that a clear bulging is observed. Cracks are often seen in areas of localized deformation/bulging.

Figure 1. (a) Example of failed tubes and (b) an image of tubes in service.

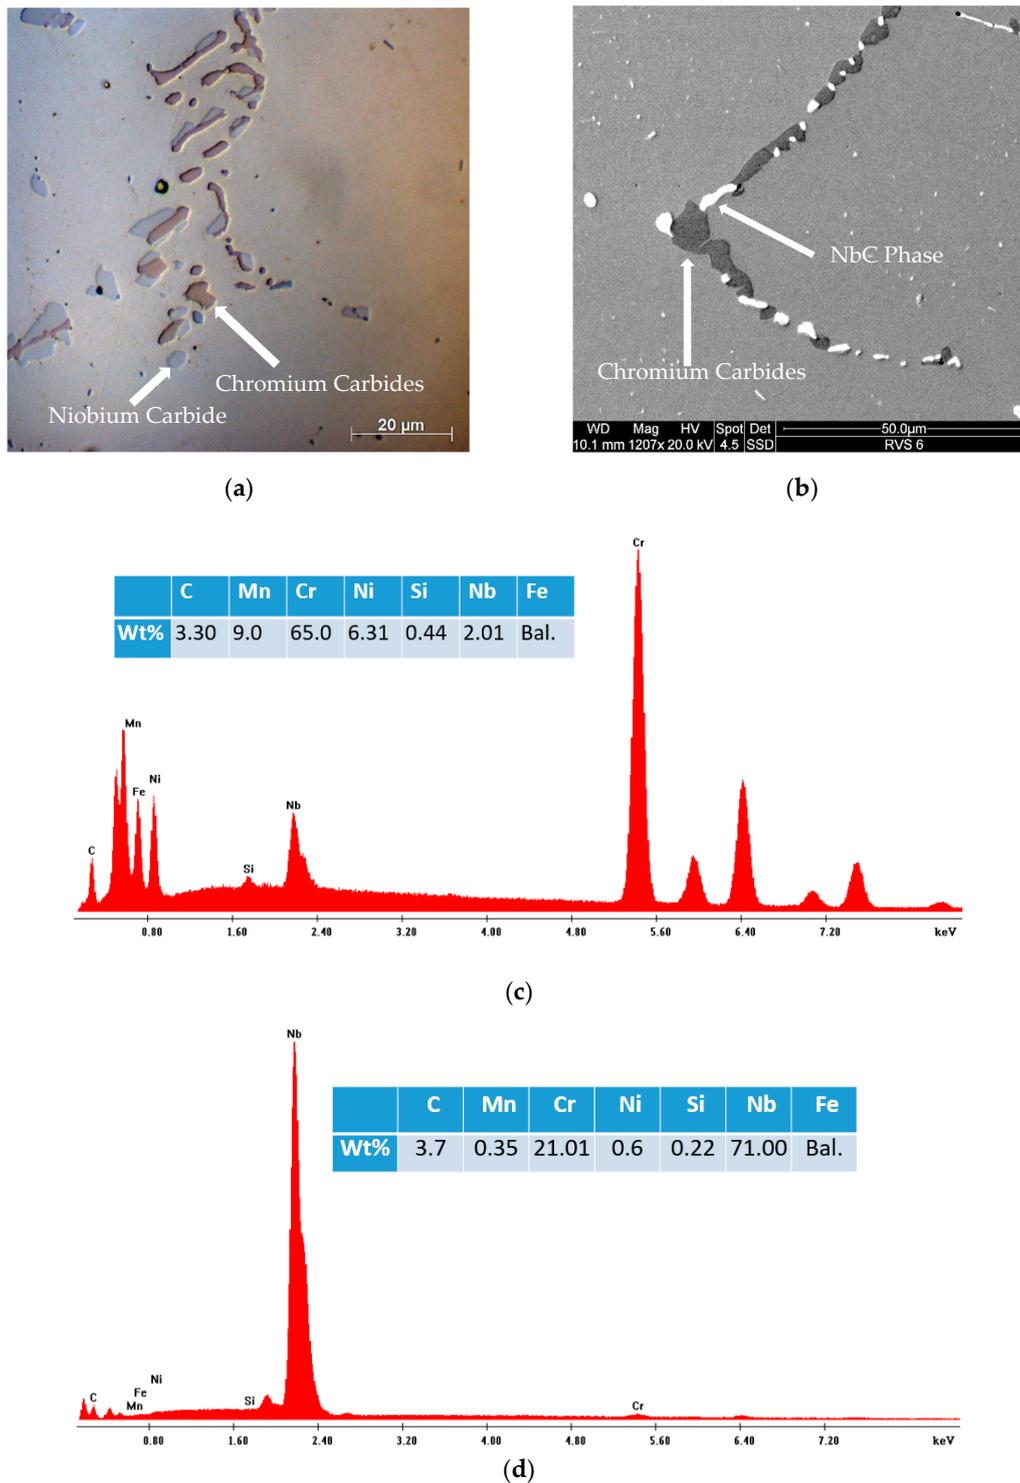
Optical and SEM micrographs of service-exposed tubes are shown in Figure 2. As can be seen, there are two types of morphologies for primary eutectic phases in the matrix. Primary eutectic phases can be categorized into “Chinese script” morphology (see Figure 2a) and a rather continuous grain boundary phase morphology (see Figure 2b). EDS analyses show that the eutectic phase is a mixture of dark and white phases, with the former ones being chromium carbides (Figure 2c), and more

specifically $M_{23}C_6$ and M_7C_3 carbides ($M = Fe, Cr$) ($M_{23}C_6$ carbides reportedly gradually transform to M_7C_3 carbides during the service due to carbon diffusion/carburization [6,7]), with the latter being niobium carbide (Figure 2d).

Figure 2. (a) Optical and (b) SEM images of the microstructure in failed tubes, together with EDS analyses of the (c) black phase (chromium carbide) and (d) white phase (NbC).

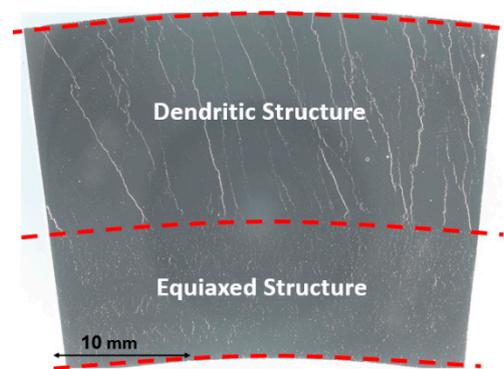
Figure 3. Stereomicroscope image of the cross section of the failed tube.

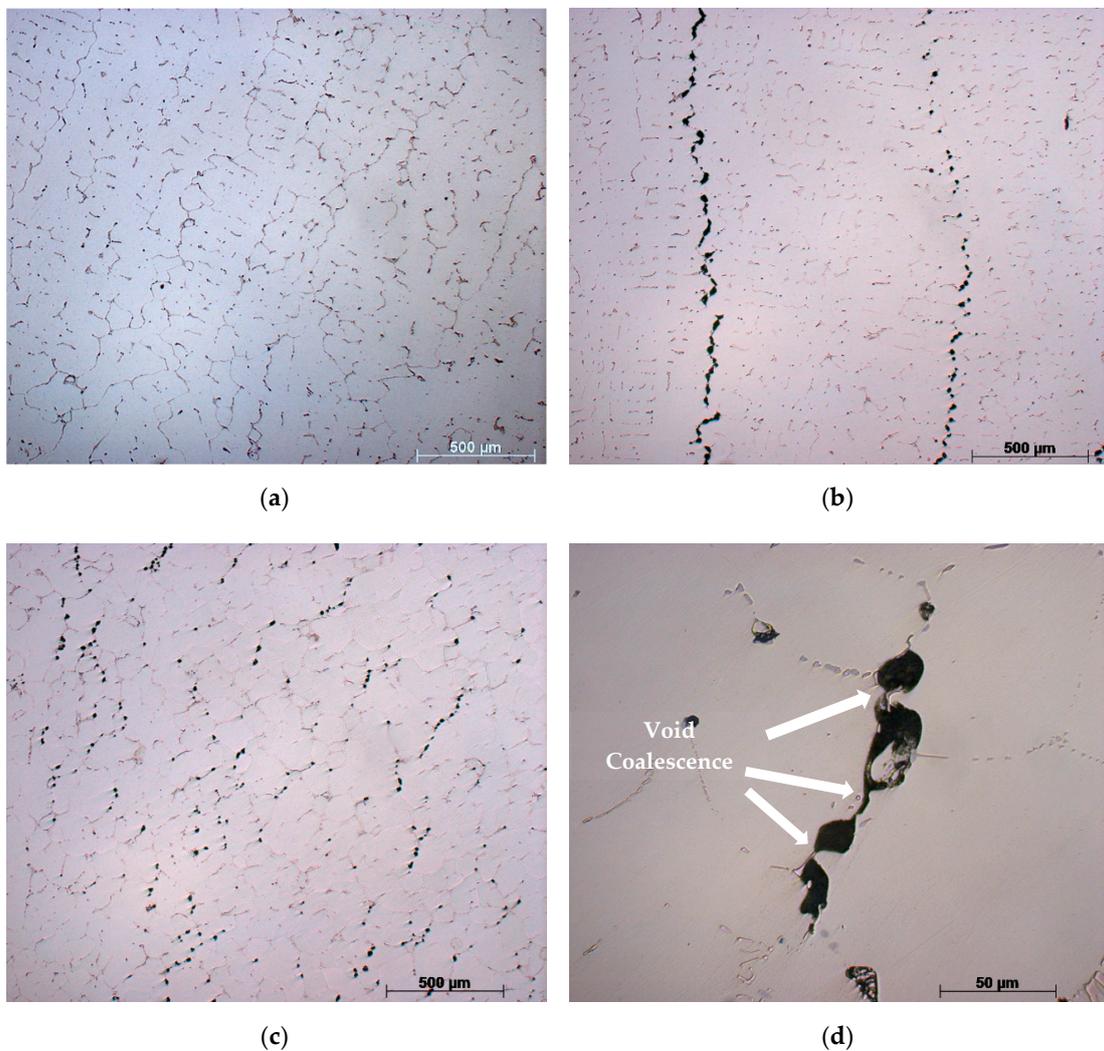
Figure 4. (a) The as-cast microstructure and voids in failed samples in (b) the dendritic structure region and (c,d) the equiaxed grain region.

- Creep voids were observed through the thickness of failed tubes. Voids in the dendritic structure region were oriented more alongside dendrites and were seen more often in the inter-dendritic regions. On the contrary, voids in the equiaxed grain structure were more randomly distributed without any directionality.

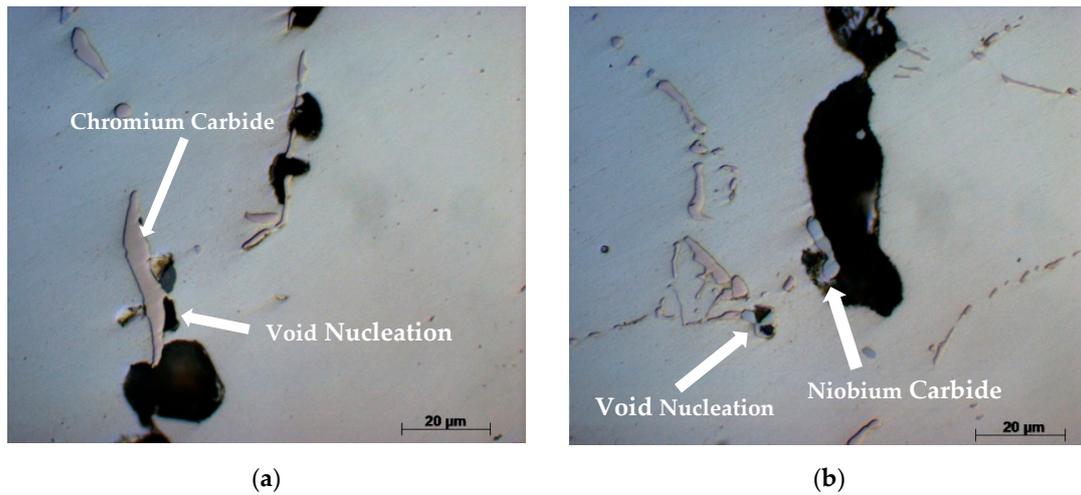
Figure 5. Void nucleation on (a) chromium carbide and (b) niobium carbide particles.

- Creep voids were nucleated on both chromium and niobium carbides. Cracks were formed due to the growth and coalescence of voids.
- The root cause analysis of the concerned failure showed that tubes failed due to creep failure.

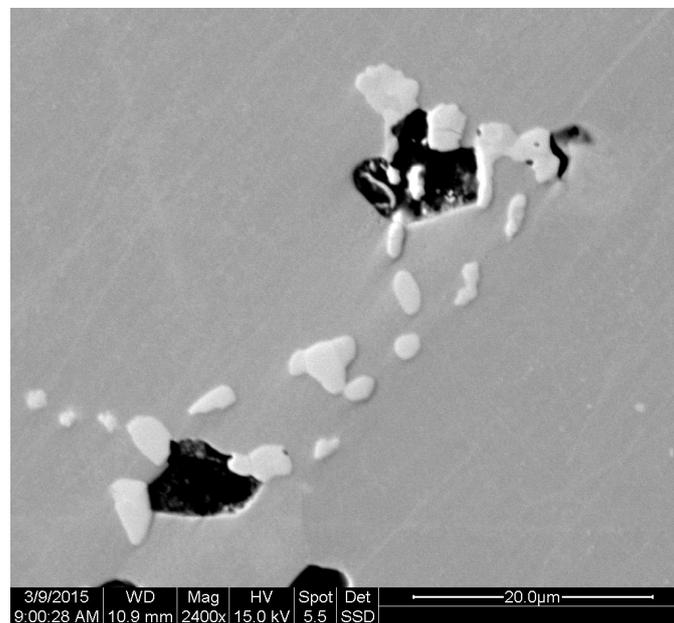
Figure 6. Creep voids are often nucleated in-between particles.

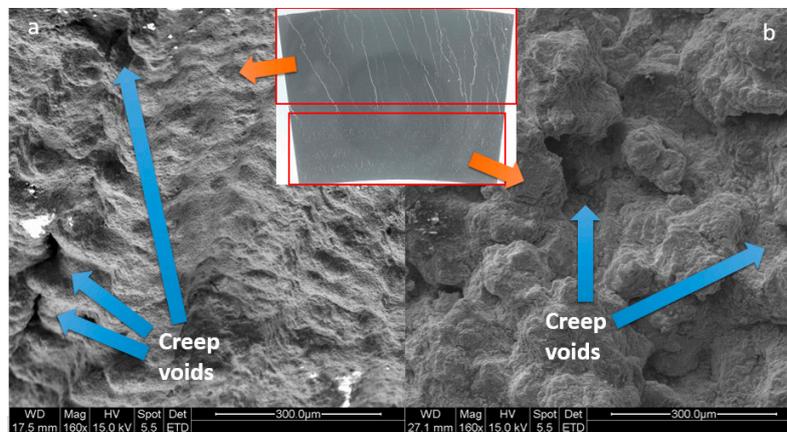
argument of creep-induced embrittlement in failed tubes [17]. However, the pictures do not show ordinary intergranular or interdendritic fractures. It is likely that the fracture surface was altered by the interaction with the steam/hydrocarbon/hydrogen atmosphere.

Figure 7. Fracture surface in (a) dendritic and (b) equiaxed grain regions.
