Failure Analysis of Two HP-Nb Heat-Resistant Tubes after 46,000 h Exposure to **Reformer Service Conditions**

Harandi, Ali Nazemi; Eslami, Abdoulmajid; Bahrami, Abbas; Bakhtafrouz, Asghar; Yazdan Mehr, Maryam

DOI 10.3390/met13020228

Article Failure Analysis of Two HP-Nb Heat-Resistant Tubes after 46,000 h Exposure to Reformer Service Conditions

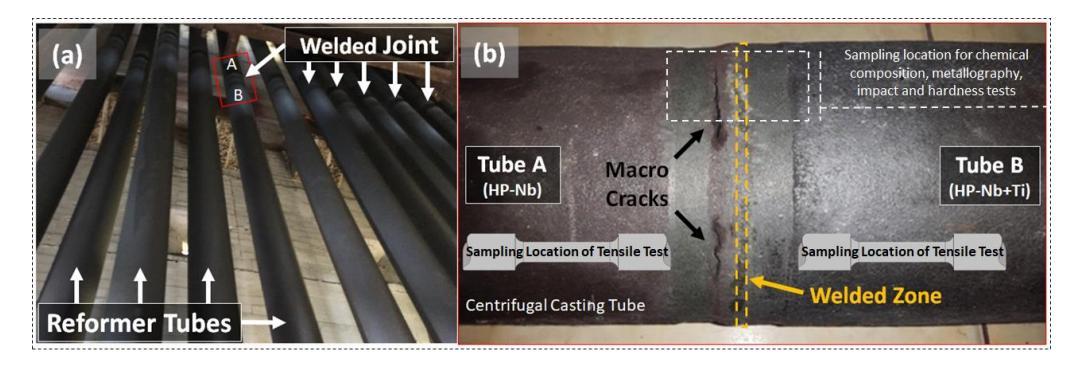
Figure 1a shows the location of these tube sections (Tube A and Tube B) in the reformer furnace. Although both tubes were under similar temperature and stress conditions, Tube A showed premature cracking and failure (Figure 1b). According to visual inspection, latitudinal cracks were observed at a distance of 6 mm from the welded joint in Tube A while no macroscopic cracks were observed in Tube B. The premature failure of the HP-Nb reformer tube without Ti (Tube A) after 46,000 h of service at the approximate temperature of 1000 °C as compared to Tube B (with 0.12% Ti) was studied. The observed damages included latitudinal cracks adjacent to the welding area, resulting in the need to replace the tubes after 46,000 h of service which is significantly lower than the expected life of the tubes.

Figure 1. (**a**) Centrifugal cast tubes in the reformer furnace and (**b**) latitudinal cracks formed perpendicular to the stress direction on Tube A.

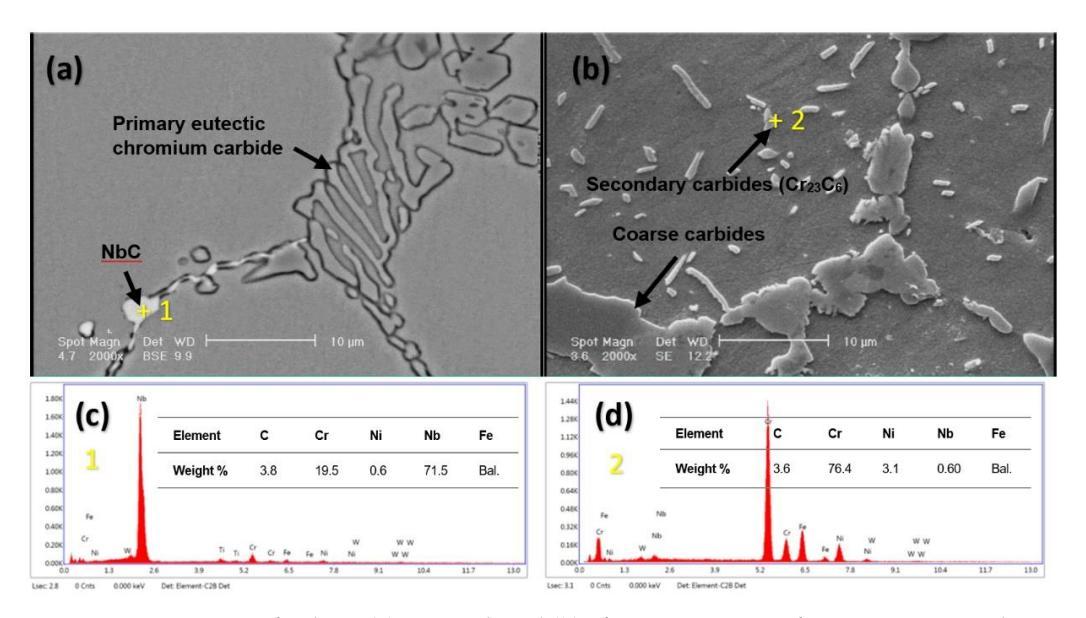
The failed tube (tube A) showed several microstructural features. As can be seen in Figure 2a, the as-casted microstructure before exposure to service conditions consists of a primary carbide network (mostly including chromium and niobium carbides) in the interdendritic grain boundaries. Due to the low solubility of niobium in the austenite matrix, the niobium carbides precipitated at the grain boundaries or cell boundaries. This resulted in higher activation energy for slip and formation of creep pores, which can be supplied through stress or temperature [20]. Exposure of the tubes to high temperatures results in the conversion of the primary eutectic carbides to coarse $Cr_{32}C_6$ particles and the coalescence and precipitation of dispersed $Cr_{23}C_6$ carbides in the matrix (Figure 2b).

Figure 2. SEM images of Tube A (**a**) as-cased, and (**b**) after exposure to reformer service conditions for 46,000 h, (**c**,**d**) point elemental analysis of present phases using EDS system.

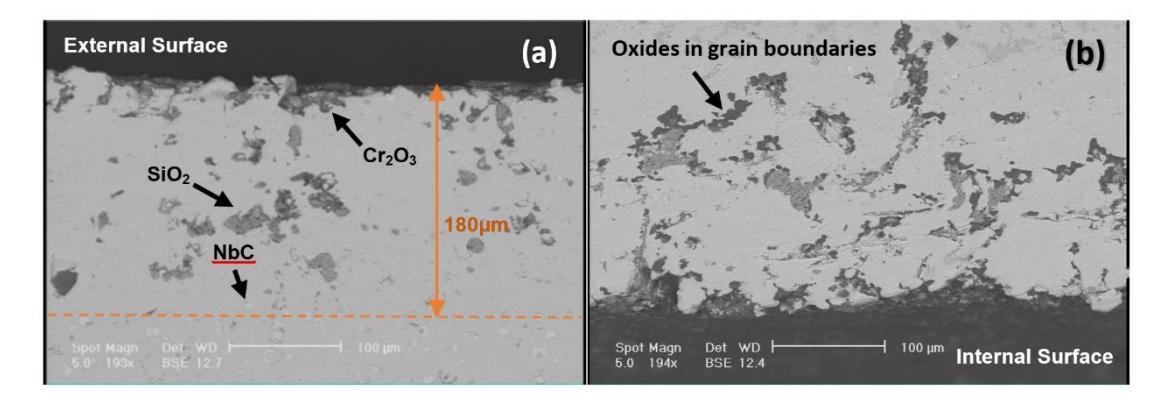
Near the outer shell of Tube A, a thin chromium-rich oxide layer and then a band of silicon oxides with an approximate thickness of 180 micrometres were observed (Figure 3a). In this region, despite the presence of niobium carbides as fine, dispersed particles (white precipitates), no chromium-rich precipitates were observed. The presence of the Cr_2O_3 layer has resulted in the depletion of chromium from adjacent areas in this layer, creating a region with no chromium-rich precipitates. Similarly, on the internal surface of the tube, oxide particles were observed at the boundary of austenite grains with an approximate thickness of 200 micrometres after the oxide layer (Figure 3b). These precipitates resulted in extreme brittleness of the tube and can be the initiation point for creep cracks. Carburation of the internal surface can automatically decrease the alloy's ductility at high temperatures. During this process, the formation of grain boundaries as microcrack sources results in decreased ductility. Furthermore, a decrease in chromium content in the matrix can result in the loss of oxide films on the internal surface of the tube, thus resulting in decreased corrosion resistance [21]. Although carburation and oxidation processes are known as the failure processes for reformer tubes, no sources for creep pores or cracks were observed next to the external or internal surface of the failed Tube A. In other words, the main reason for failure in Tube A is not the carburation of the internal surface or oxidation of the external surface of the tube.

Figure 3. BSE micrograph of Tube A from (**a**) oxides and chrome-depleted zones near the external surface and (**b**) oxides and chrome-depleted zones near the internal surface of the tube.

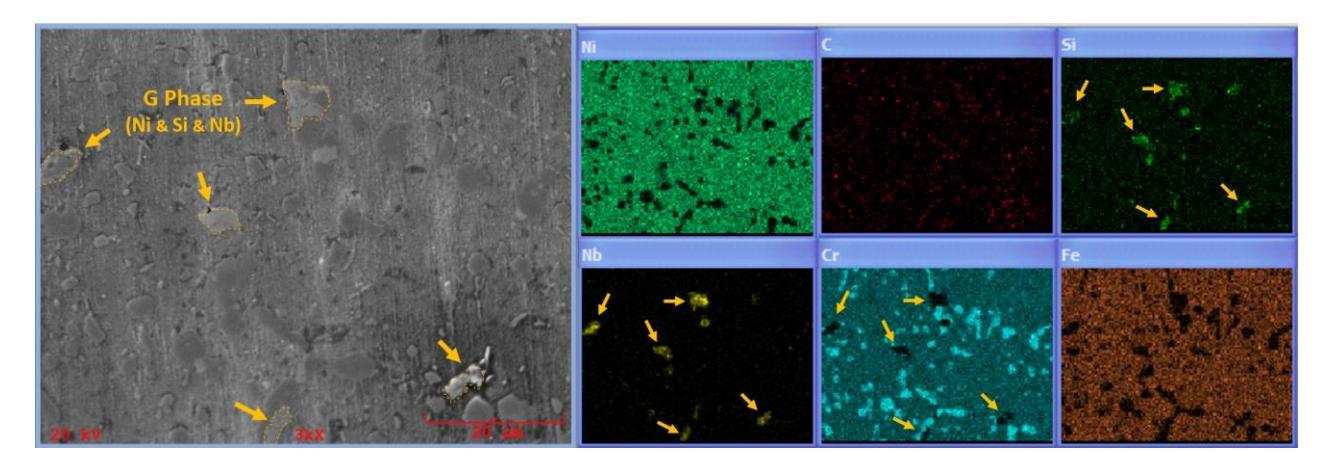
Our investigation showed that there is no evidence of the G phase in tubes containing titanium (Tube B). A low titanium concentration can result in the formation of niobium–titanium carbide complexes. Since titanium is insoluble in the G phase, it can increase the stability at higher temperatures and delay the transformation of (NbTi)C to the G phase. Therefore, the volume fraction of the G phase is lower in HP steel modified with Ti [22,24]. According to the X-Ray Mapping images presented in Figure 4, there are nickel, silicon, and niobium-rich areas identified in Tube A which is due to the presence of the G phase in tubes without titanium. These areas, indicated with arrows, have low chromium content, which, due to the lower strength and ductility of this phase compared to niobium carbides, are suitable areas for the initiation of creep pores. The volume expansion as a result of niobium carbide to G phase transformation can result in stress and therefore the formation of creep pores [12]. On the other hand, the transformation of niobium carbide into the G phase removes the hard phase (NbC) that can prevent the movement of dislocations and thus this phase transformation reduces the creep resistance [17].

Figure 4. X-Ray Mapping images of tube A showing the distribution of various elements in SEM images.

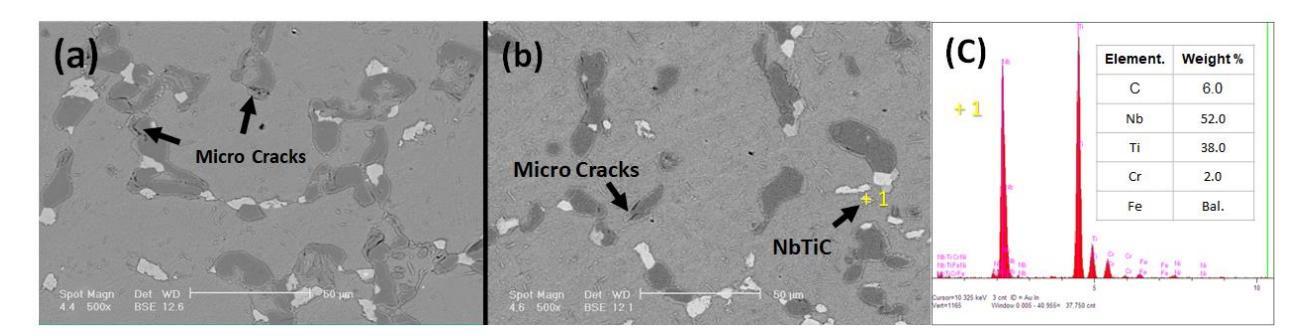
According to Figure 5, the coalescence of the carbide network in the titanium-free sample is higher compared to the sample containing titanium. Furthermore, the tube

containing titanium as an alloying element (Tube B) has a finer structure. Therefore, based on the effects of microstructural morphology on the initiation, growth, and coalescence of creep pores, it is expected for the Tube B to have higher ductility and creep resistance compared to the Tube A. This improvement in creep behaviour can be due to the presence of Ti carbonitrides and their effect on secondary carbide precipitates during ageing. The reason for the lack of failure in Tube B, despite tolerating similar service conditions to Tube A, is the positive effects of titanium on the creep behaviour of the alloy.

Figure 5. SEM images of tube microstructures after ageing: (**a**) Tube A without titanium and (**b**) Tube B containing 0.12 wt. % of titanium (**c**) point elemental analysis of NbTiC phase using EDS system.

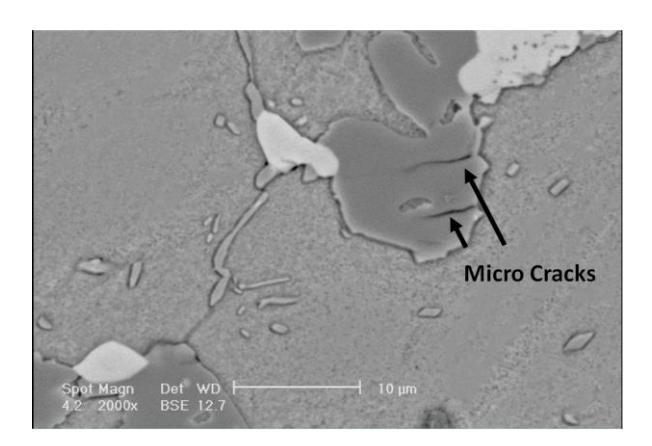
According to the SEM images obtained from the microstructure of failed tube (Tube A) close to the main crack, the creep pores have initiated on grain boundaries perpendicular to the direction of the applied stress and their number and size has increased over time. The continuous initiation of creep pores in this case is dependent on the strain and is generally facilitated by the cracks formed on the $Cr_{23}C_6$ carbide particles. As shown in Figure 7a,b, intergranular fracture occurred along the continuous carbides, and creep voids grew more on coarser carbides, especially in the triple grain boundary regions. According to spot analysis (Figure 7c) and the weight ratio of carbon and chromium, the stoichiometry of these carbides is mainly $Cr_{23}C_6$.

Figure 6. SEM images of microstructure of failed tube (Tube A). Micro cracks formed within chromium carbide particles are indicated with the arrows.

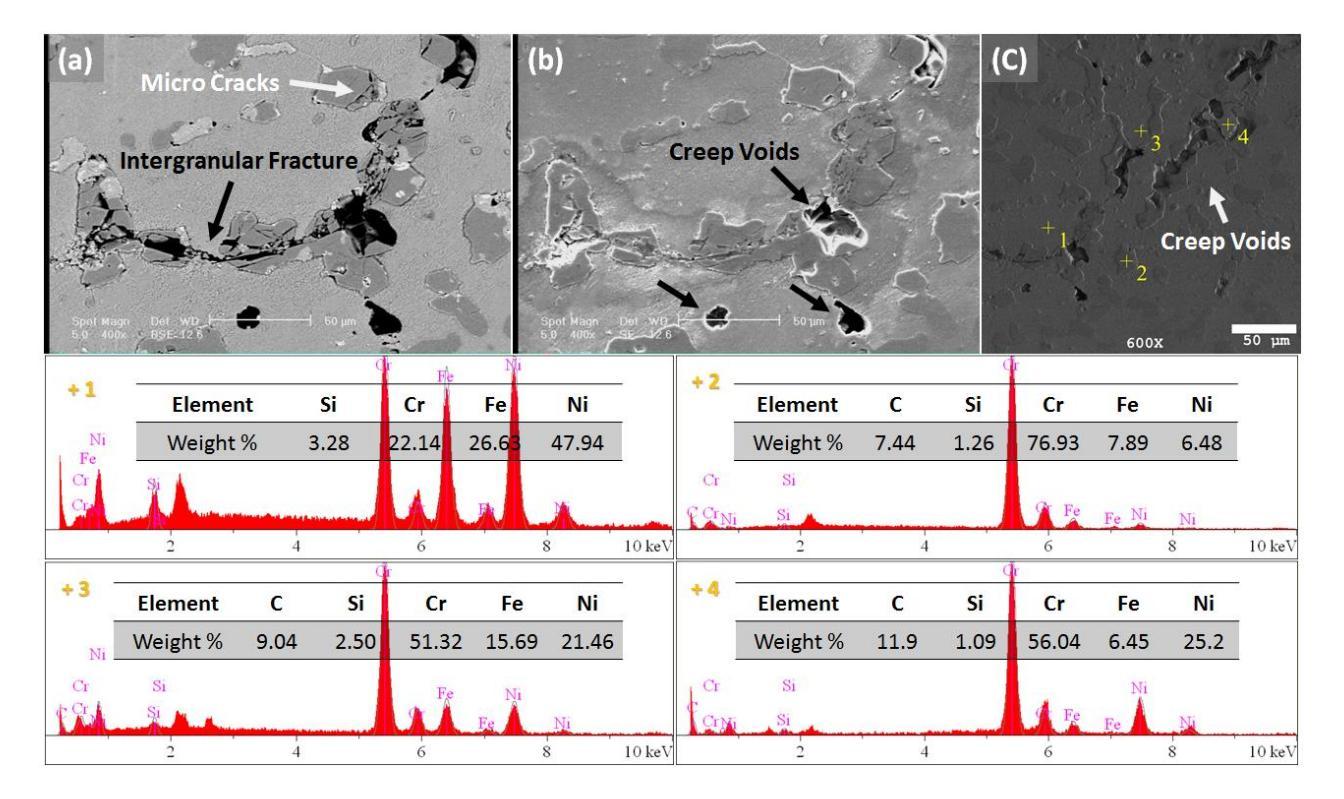
Figure 7. (**a**,**b**) SEM images of Microstructure degradation of Tube A, (**c**) point analysis of phases in the degraded area using SEM equipped with an EDS. The growth of creep voids and propagation of microcracks at grain boundaries and chromium carbides are shown.

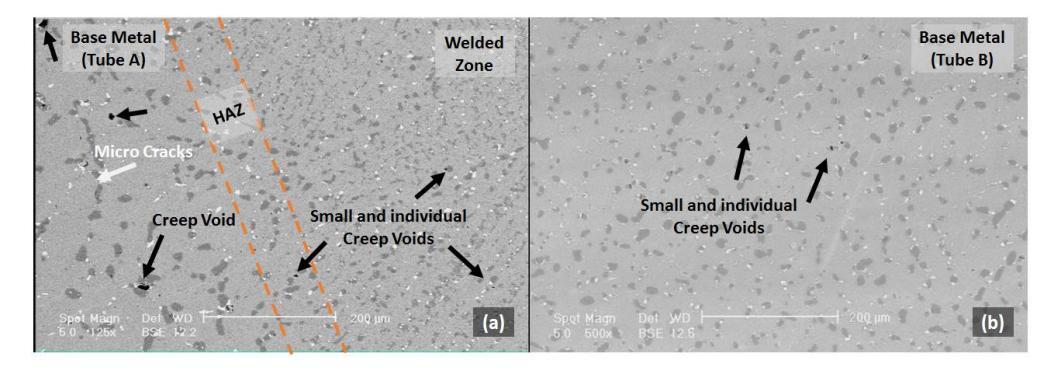
The SEM studies of the interface between the welded area and base metal in Tube A show no evidence of creep pores or microcracks in the welded zone. However, creep pores and microcracks are apparent at approximately 200 microns from the welded line in the base metal of Tube A (Figure 8a). This can be due to the presence of larger carbide particles in the base metal compared to the welded zone. As shown in Figure 8b, small and individual creep voids have nucleated in a base metal of the Tube B, but they have not been able to grow. This issue can be caused by the difference in microstructural morphology between Tube A and Tube B in terms of the distribution and size of chromium carbides.

Figure 8. SEM images of (**a**) the interface between welded zone and base metal in tube A, (**b**) base metal in tube B.

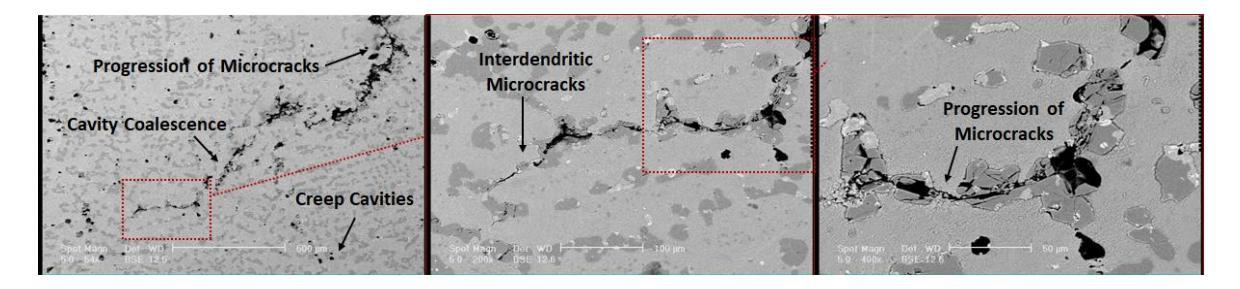
The decrease in the life cycle of reformer tubes is determined under the influence of creep damage which is indicated by progressive changes in the microstructure. The transfer of carbides, initiation of microcracks, and formation of creep pores often occur in the final stage of the creep damage and immediately before the failure. The growth of these creep pores mostly occurs perpendicular to the direction of the applied stress, and their growth rate is controlled by localized creep strain. The final fracture occurs due to pile-up of the pores, formation of grain boundary cracks, and an increase in the number and size of cracks. According to Figure 9, creep cavities are mostly observed in the triple or wedge-shaped areas and on chromium carbide particles. Coarsened chromium carbide particles merge under the influence of reformer temperature, and create suitable areas for initiation of creep pores. The pile-up of grain boundary cracks also occurs along the length of chromium carbide particles, indicating merged carbide particles as preferred crack initiation zones.

Figure 9. SEM images showing the pile-up of creep pores along the length of grain boundaries or inside grain boundary carbide particles and coalescence for the formation of cracks in the failed tube.

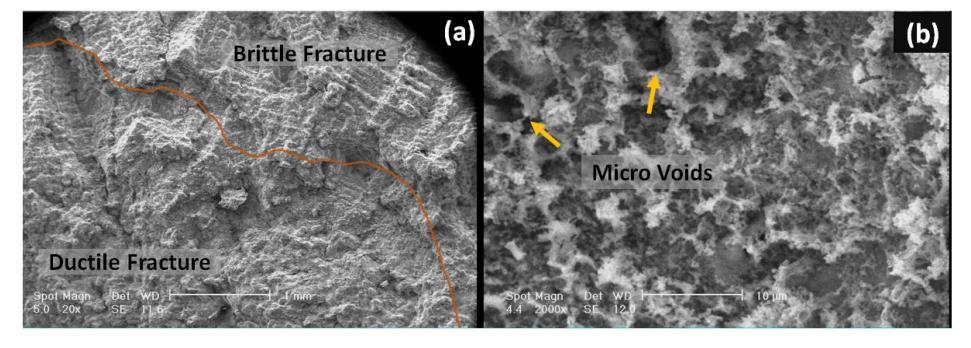
Based on the results of fractography studies, the fracture morphology of the failed tube (Tube A) is jagged, which indicates unsuitable mechanical properties. The furrow and ridges distributed on the fracture surface are seen in Figure 10a. The porosity has resulted in non-uniformity of distribution in tensile/compression stress. The imaginary line indicates the boundary between ductile and brittle fracture zones. As can be seen in Figure 10b, the fracture is ductile using the void coalescence mechanism in the areas with merged carbide particles (arrows). These microvoids are a suitable location for the coalescence of cracks due to the increase in local stress.

Figure 10. SEM images of fracture surface morphology of the failed tube, (**a**) final ductile and brittle fracture surfaces and (**b**) ductile fracture surface.

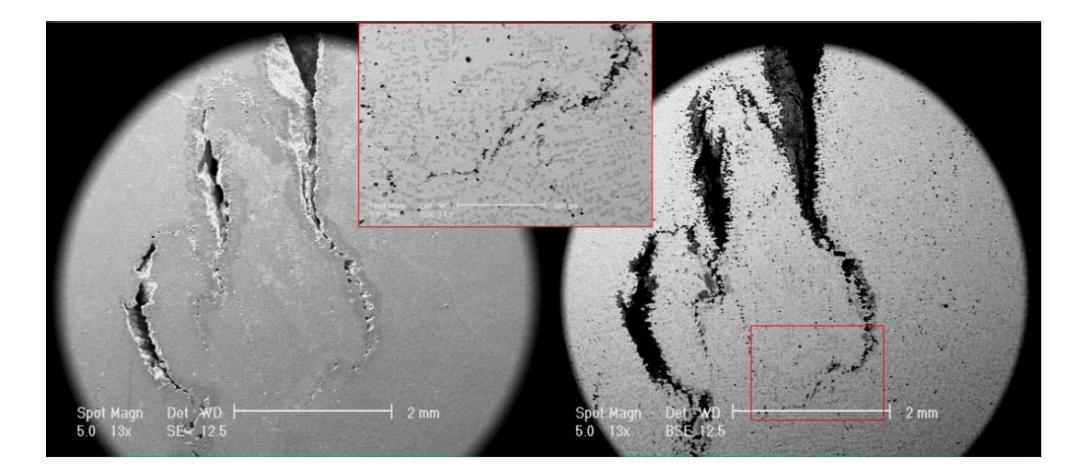
As a result of cyclic mechanical and thermal loadings caused by unexpected shutdowns, the thermal-mechanical fatigue process leads to microstructural damages such as carbide cracks and creep pores. According to Figure 12, the macrocracks are formed as a result of the coalescence of microcracks formed on the surface of chromium carbide particles as well as creep pores. The growth rate of these cracks is proportional to the applied strain and these cracks are grown perpendicular to the direction of applied stress. The creep behaviour of studied tubes in the current study is highly dependent on the difference in microstructural properties as a result of the addition of titanium to HP-Nb alloy.

Figure 12. SEM images of cracked regions; directional creep pores are seen along the length of main cracks. The singular creep pores have a uniform distribution in the matrix.
