## Accuracy of visual inspection of flood defences

Klerk, W. J.; Kanning, W.; Kok, M.; Bronsveld, J.; Wolfert, A. R.M.

Structure and Infrastructure Engineering

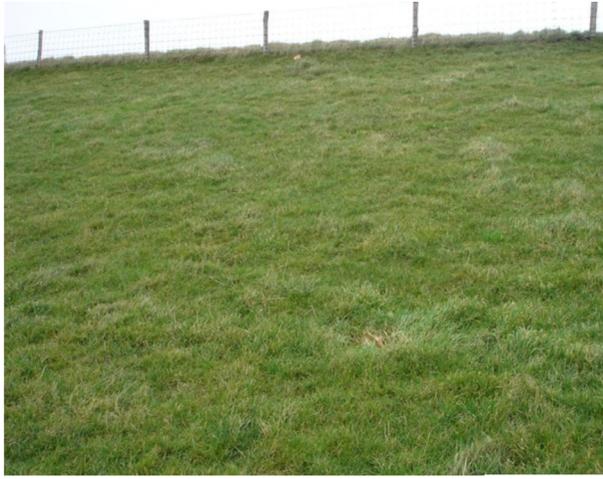
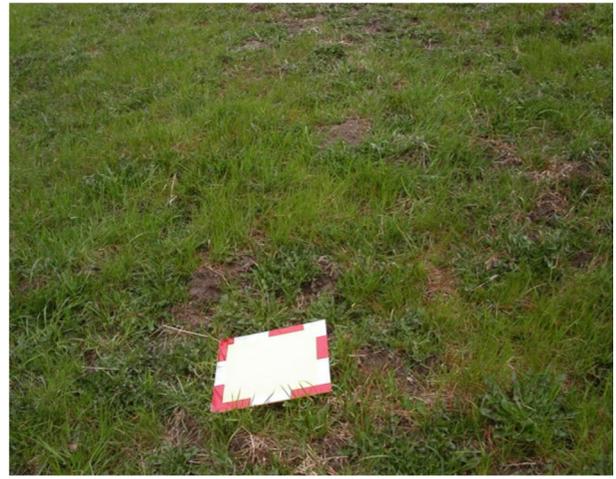
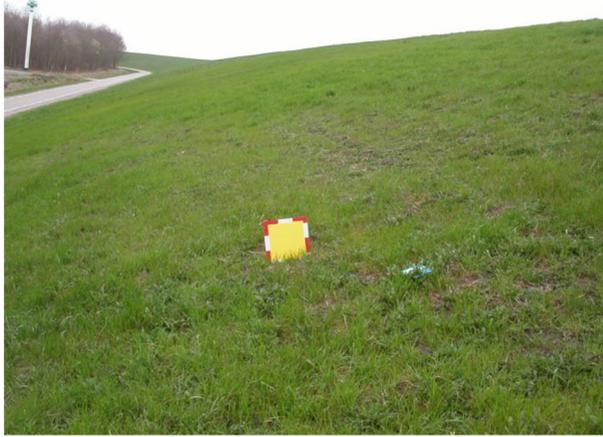
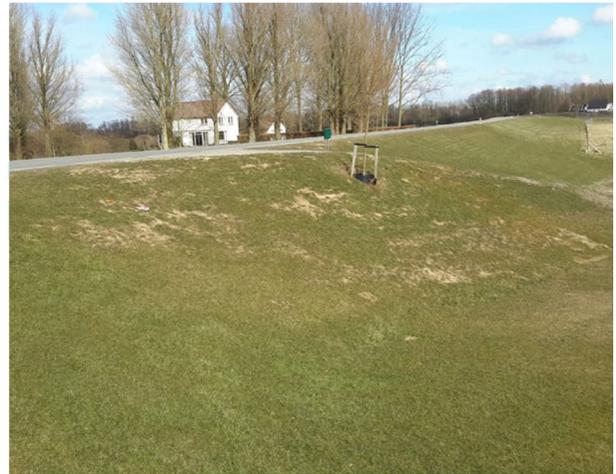
(a)  
Good: no bare spots.

(b) Reasonable: at most 5 spots with a diameter  $< 0.2$  m where vegetation is gone.

(c) Mediocre: at most 5 spots with  $0.2 \text{ m} < \text{diameter} < 0.3 \text{ m}$  where vegetation is gone.

(d) Bad:  $> 6$  spots with diameter  $> 0.2$  m, or 1 spot with diameter  $> 0.3$  m where vegetation is gone.

**Figure 1.** Example of Digigids classification for bare spots. panes a-d show increasing severity (good, reasonable, mediocre, bad). Captions for subfigures give description of category. All descriptions apply to an area of 25 square metres. All figures originate from Het Waterschapshuis (2016). (a) Good: no bare spots. (b) Reasonable: at most 5 spots with a diameter  $< 0.2$  m where vegetation is gone. (c) Mediocre: at most 5 spots with  $0.2 \text{ m} < \text{diameter} < 0.3 \text{ m}$  where vegetation is gone. (d) Bad:  $> 6$  spots with diameter  $> 0.2$  m, or 1 spot with diameter  $> 0.3$  m where vegetation is gone.

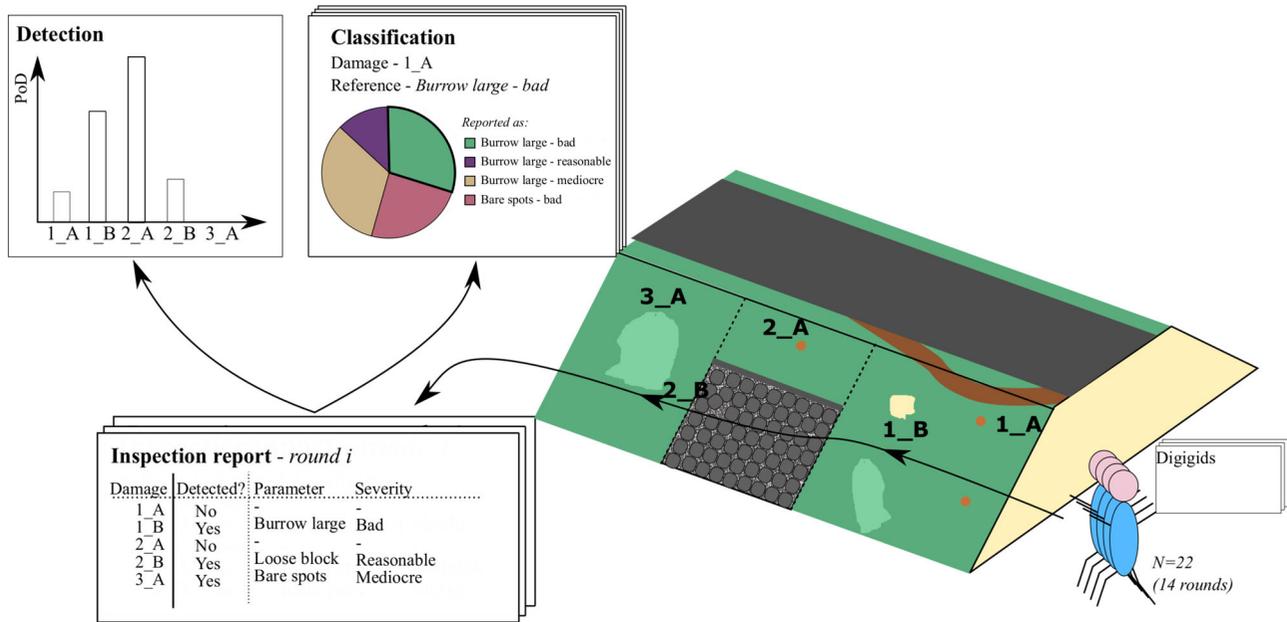
**Figure 2.** General approach to the field test. Inspectors inspect several dike sections as by their normal practice. This results in an inspection report for each inspection round where for each damage present it is indicated whether it was detected and how it was classified. This enables analysis of the detection accuracy and classification consistency based on the predefined reference situation.

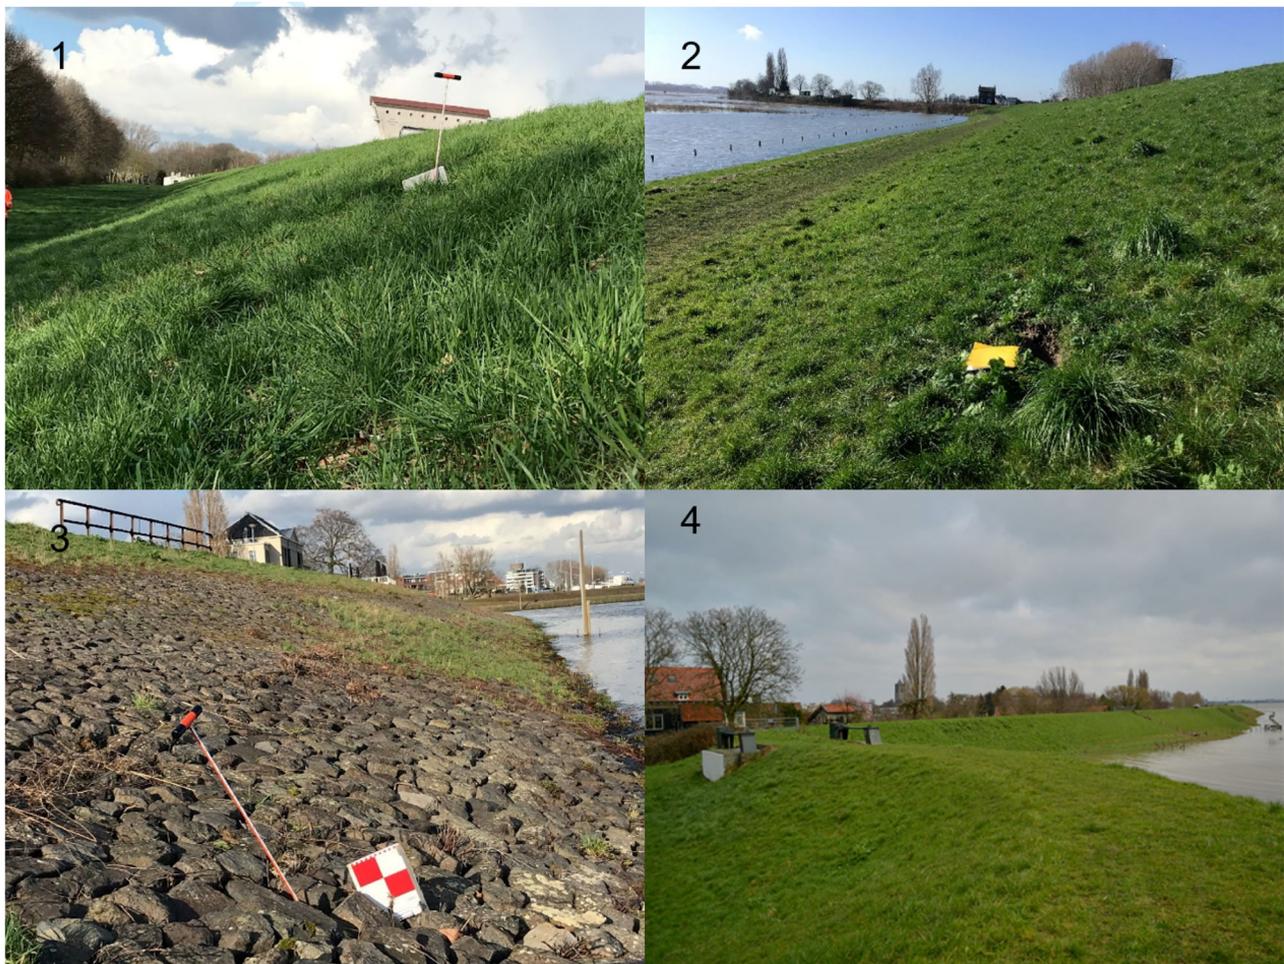
Figure 3. Impression of the 4 sections. Photos for sections 1, 2 and 3 were taken by inspectors during the test. Photo 4 was taken by one of the supervisors.

The field test was conducted at 4 dike sections near the city of Tiel, along the Waal river in the Netherlands. Pictures of the 4 sections are shown in Figure 3. The sections were

Section 1 is approximately 185 metres long. Here the inner slope, which consists of a grass revetment, was inspected. Several small damages are present to the grass cover, both burrows and other types of damage. Additionally the slope is deformed locally. Both the presence of burrowing at a section level, and the slope deformation are essential damages in an inspection of this section.

Section 2 is 200 metres long, and here the outer slope was inspected. The general shape of the grass revetment is good except for a few spots with weeds. However, there is a significant number of animal burrows, mostly caused by dogs who enlarged smaller pre-existing mice or rabbit burrows. It has to be noted that damage point 2\_6 developed during the field test and could therefore only be observed in 5 of 14 rounds. This is the only damage that developed in the period the field test was executed. Although there was high water during the test, the water level did not influence the inspectability at this dike section.

is in a relatively bad shape: there are several loose and missing blocks, the joint fill material has washed out and there are tree trunks that penetrated the revetment and displaced the blocks. Many of the damage points at this section are therefore classified as essential. The grass at the higher part of the slope is also not in good shape. It has to be noted that at section 3 the influence of the high water level conditions influenced the outcome of the test, as it was impossible to walk on the maintenance path at the lower part of the revetment. During some test sessions the inspectability was lowered as the revetment was wet due to rainfall and therefore difficult to access.

Section 4 is approximately 80 metres long, but here both inner and outer slope as well as the crest and the inlet structure had to be inspected. In general there is a significant amount of rough vegetation at this section, and the transition between revetment and structure is an important point of attention. Some parts of the outer slope contain a concrete lawn grid which is deformed in 1 location. The high water conditions had no influence on inspectability. [Figure 4](#) provides an example of the results from the Survey123 database for dike section 4. Here both registrations from the pre-assessment and the field test are shown for each damage point. All registrations have been manually coupled to the registrations, based on the attached photographs, description and location.

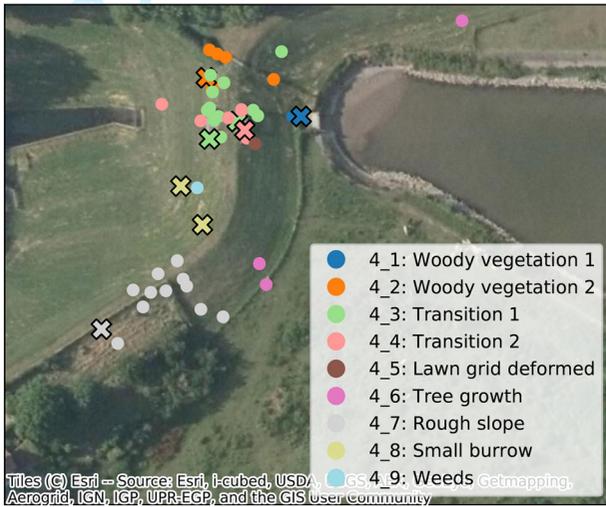
Figure 4. Results for dike section 4 obtained from the Survey123 database. Dots are registrations during the test, crosses indicate registrations during the pre-assessment.

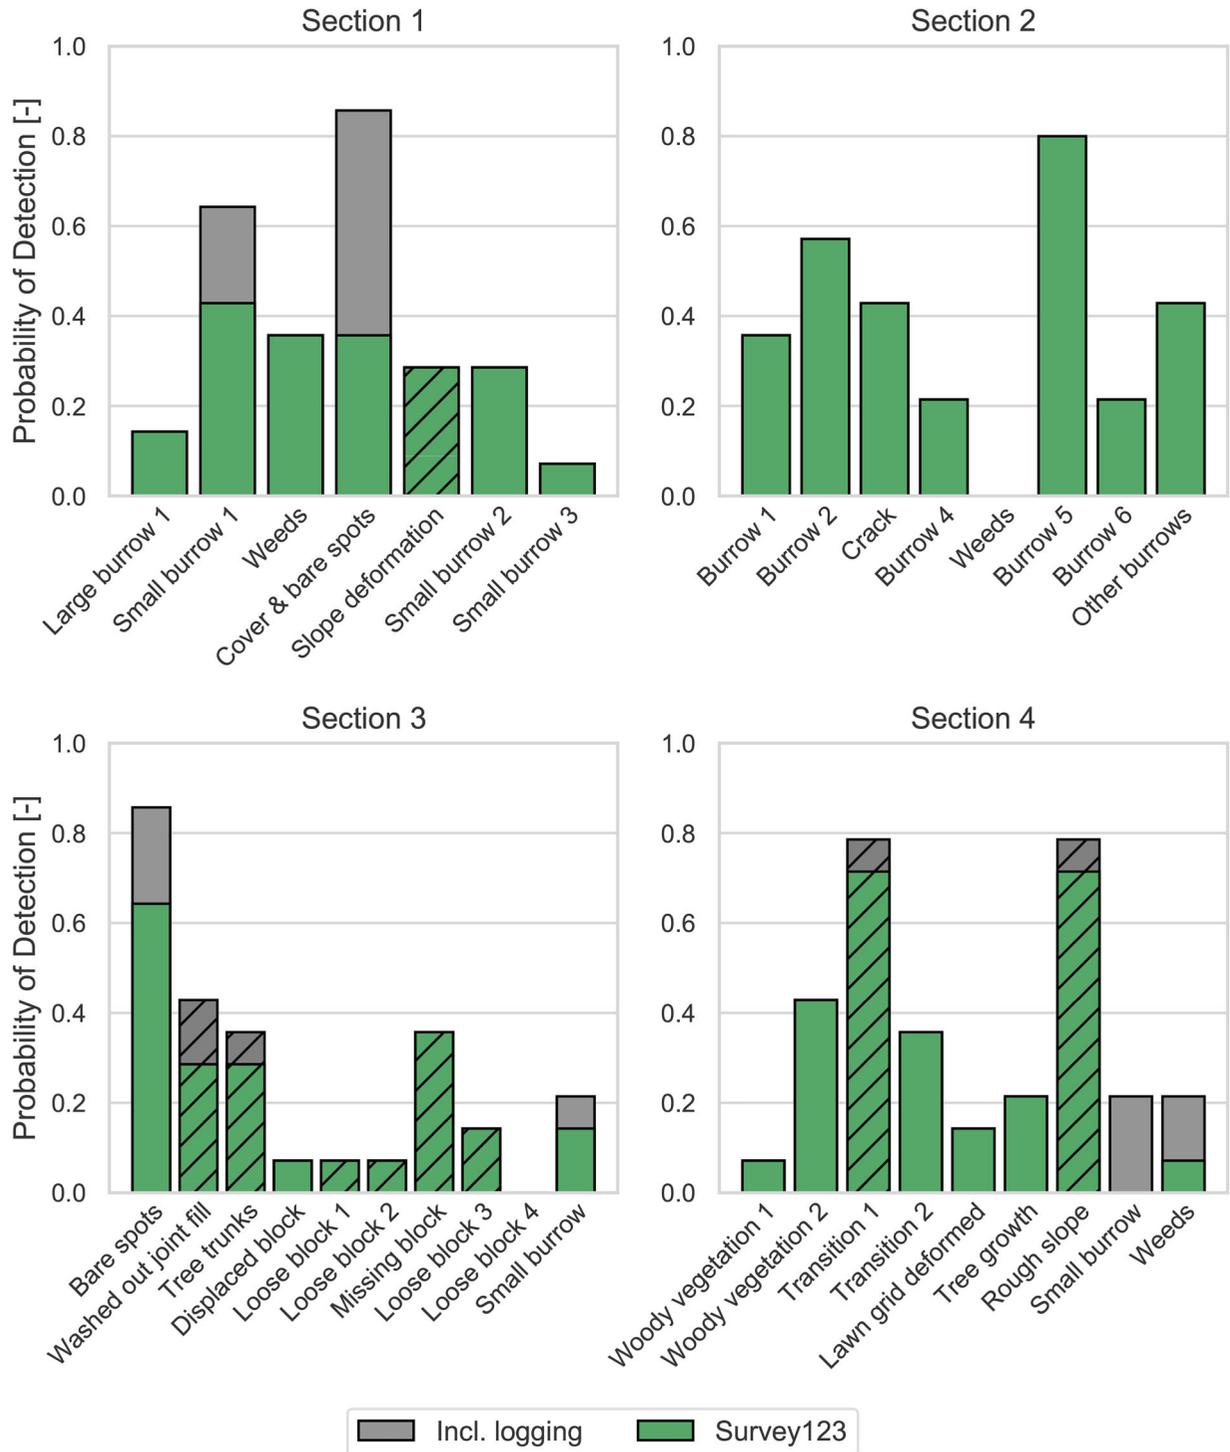
Figure 5. Probability of Detection for all damage points per section. Hatched bars denote damage points that were categorised as essential damages. Green indicates registrations in Survey123, whereas grey includes registrations added based on the supervisor logging. Note that Burrow 5 at section 2 was only present in the last field test session and was therefore only observable during 5 inspection rounds.

First the overall Probability of Detection (PoD) for damage points and section damages is analysed. Figure 5 shows the PoD for all damage points per section. Grey bars indicate registrations based on the supervisor logging, and hatched bars denote damage points that were marked as essential in

the reference. Overall, the PoD varies significantly, ranging from 0 to almost 0.9 per damage point. Most of the registrations added based on the logging concern smaller issues, such as small burrowing and the quality of the grass cover. Also note that there is no clear difference in the PoD for essential and non-essential damages, except for section 4 where the two essential damage points were registered by the majority of the inspectors.

The PoD is lowest for issues with the block revetment at section 3. Here the loose and missing blocks have been sparsely or not detected during the test. There are several explanations for this: first of all, the high water conditions hampered inspectors (which was also indicated in the questionnaires). Secondly, it should be noted that only damage point 3\_9 (Loose block 4) was detected during the pre-assessment, when conditions were much more favourable. A second explanation is therefore that inspecting block revetments is generally more difficult as it is harder to see and process all the details. This especially holds for blocks that are loose, but still in their place. This could also explain why the missing block was detected more often, even though its proximity to some of the loose blocks.

At sections 1 and 2, there were multiple burrows for which the PoD varies significantly. The question is whether the main reason is failure to detect, as inspectors indicated that in many cases they do not register all the burrows at a section. This reduces the work load during inspection, and common maintenance works to deal with it will be done at a section level anyway, so all burrows will be repaired together.

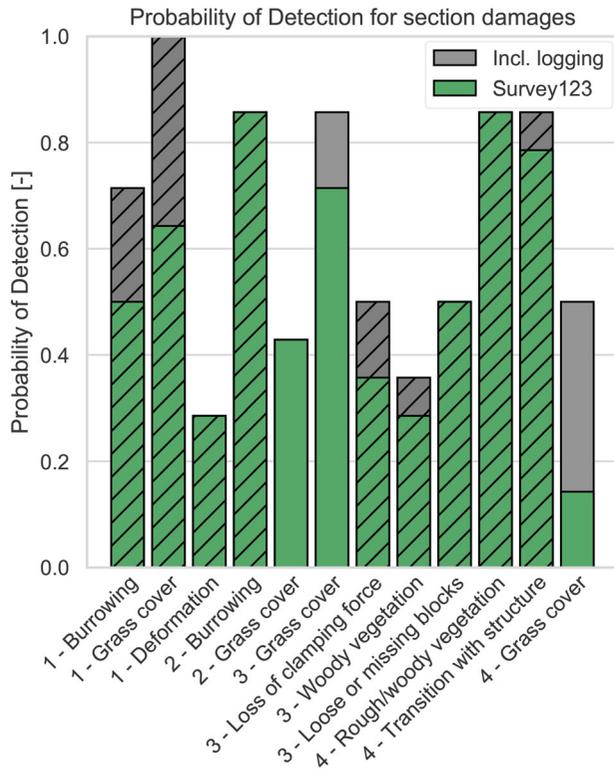
Figure 6. Probability of Detection for all section damages (numbers at horizontal axis denote the section). Hatched bars denote section damages that were categorised as essential. Green indicates registrations by inspectors in Survey123, whereas grey includes registrations added based on the supervisor logging.

From that perspective, it is more relevant to look at burrowing as a section damage. Figure 6 shows the PoD for all section damages. By definition these are higher than for individual points (see Equation (3)). It can be seen that at section 2 most inspectors (PoD = 0.86) registered at least 1 burrow.

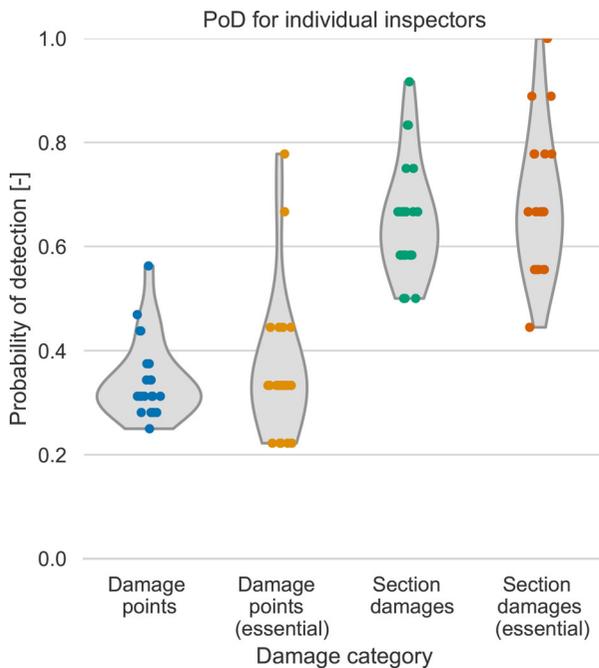
Figure 7. Probability of Detection (PoD) for individual inspectors. Grey shaded areas provide a density estimate capped at the highest and lowest PoD encountered in the test. Coloured dots provide results for individual inspectors for (essential) section damages and damage points.

An important aspect in the context of risk-based inspection is not only the average PoD, but also the variation among different inspectors. Figure 7 shows the variation among inspectors for both damage points and section damages, and subsets of the essential damages. For damage points, the PoD ranges between approximately 0.25 and 0.55, with a bit more variation for the essential damages. Note that this is strongly influenced by the low detection percentages of the various loose blocks at section 3. The PoD for section damages ranges between 0.5 and 0.9. The variation is similar to that of damage points, but the average is significantly higher.

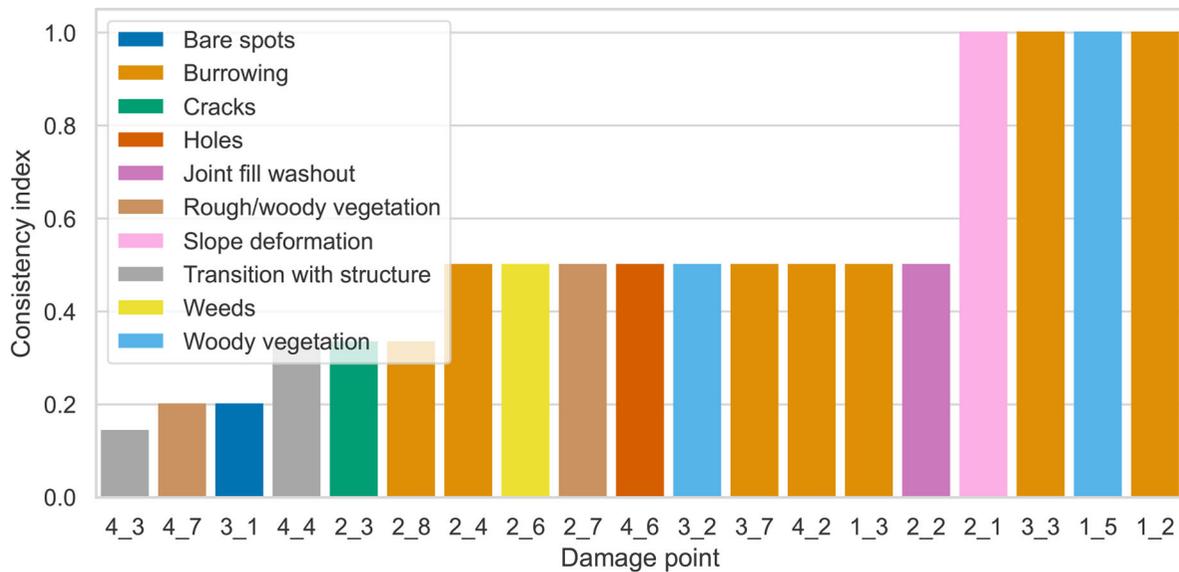
**Figure 8.** Consistency index of different damage points with more than 3 registrations in the database. Colours indicate the reference classification parameter (see Table 1) except for 'Transition' where no reference parameter could be determined, and burrowing where small and large burrows are combined.

Figure 8 shows the consistency index for all damage points with  $N > 3$ . Damage point 1\_4 was not included as this encompasses 2 damage parameters (bare spots and cover). It is found that especially for the damage to the transition (4\_3 and 4\_4) the registrations are very inconsistent: 4\_3 was registered 11 times with 7 different parameters, 4\_4 5 times with 3 different parameters. This indicates that there is no clear parameter to define damage to a transition. Note that in this case many of the parameters used by the inspectors are actually visible, as is shown in Figure 9. Here it can be clearly seen that there is rough vegetation, weeds, a bare

For burrowing the consistency is 0.5 in many cases, as inspectors used both small and large burrowing as parameters. This indicates that distinguishing these in practice is difficult. Other cases with low consistency (e.g. 2\_3, 3\_1 and

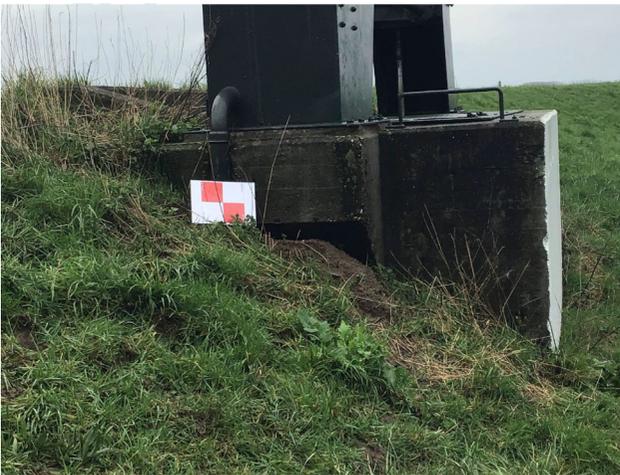
**Figure 9.** Example of the presence of multiple damage parameters at a single damage point (4\_3). At least bare spots, weeds and rough vegetation could be applicable here, while the cause of the bare spot (just right of the reference marker) could be burrowing.

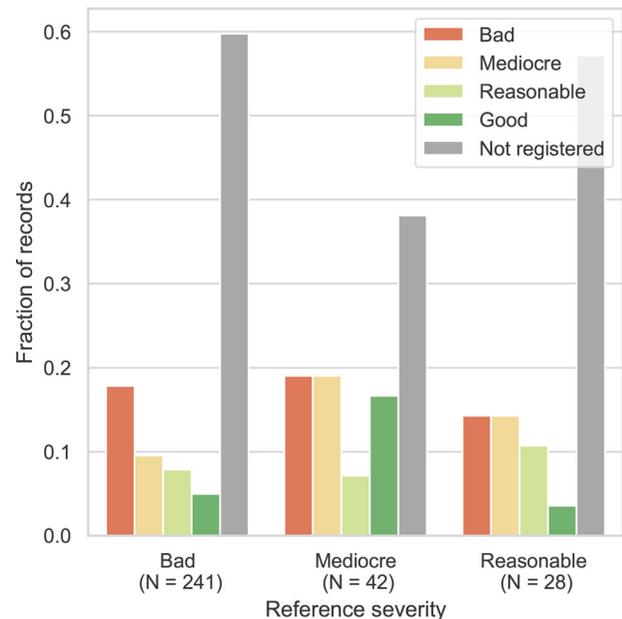
**Figure 10.** Fraction of records in the Survey123 database for different severity classifications compared to the reference.  $N$  denotes the number of possible registrations for each category.

reviewing with severity 'bad'. Figure 10 shows the fraction of records that was categorised in the different severity categories, including the fraction of inspections where a damage was not registered. The latter consists of damage points where inspectors failed to detect a damage, or where they found it not severe enough to register. For damage points with severity 'bad', more than half of the inspectors that registered such a damage classified it as less severe. For damage points with reference mediocre or reasonable, there is also a large variation in reported severity. It should be noted that this figure is based on the entire database, including points added based on the supervisor logging. If the same figure is made just for the points registered in Survey123, the fraction classified as 'good' is 0 in most cases, which emphasises that the grey bars contain many detected damage points classified as good.

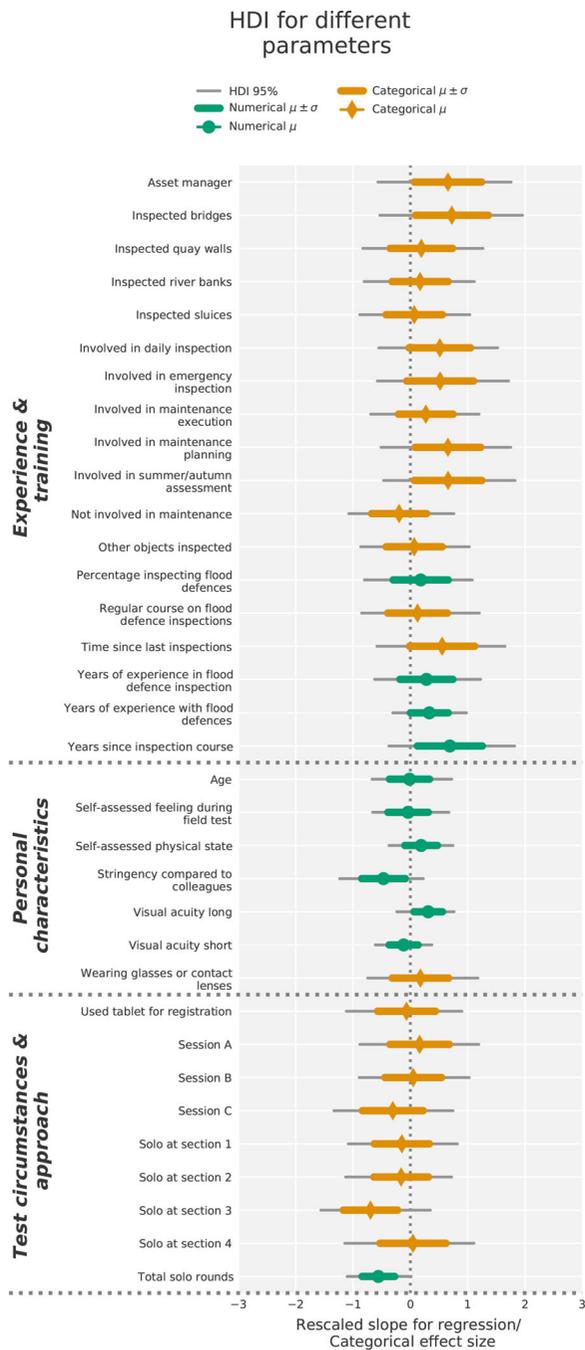
**Figure 11.** Results of Bayesian Parameter Estimation for categorical (orange) and numerical (green) variables. For categorical variables the effect size is given, for numerical variables the estimated slope of the linear regression. Diamonds and circles indicate mean values, coloured lines indicate the interval  $\mu \pm \sigma$ . Grey lines indicate the 95% Highest Density Interval. Note that the slope has been rescaled to the interval 1–5 to make numerical variables with different ranges comparable.

Figure 11 displays the Highest Density Intervals (HDI) for all numerical variables (green), and all categorical variables (orange) where each group consists of 5 or more participants. The HDI indicates that 95% of the probability density of the posterior distribution falls within this range (grey bar). For numerical variables the HDI for the slope of the regression line is shown. A negative slope means that higher values for the numerical variable relate to less detected damage points. To compare variables with different ranges all values have been rescaled to a 1 to 5 scale based on the minimal and maximal values in the dataset. For categorical variables the HDI for the effect size is given. If the value is positive it means that the listed category performs better. E.g. inspectors who are also asset manager perform slightly better than those who are not. If the HDI is (almost) entirely negative or positive, this indicates that a variable has effect on inspection performance (number of damage points detected). Additionally the coloured lines (orange for categorical, green for numerical variables) indicate the mean and interval  $\mu \pm \sigma$ .

and both daily and emergency inspection. All these variables are found to relate to a somewhat better inspection performance, although in none of the cases the HDI is entirely positive or negative. Logically, more experience in years also relates to better performance. For personal characteristics no clear relations are found. For the test circumstances and approach, it is found that the (negative) effect of inspecting solo at section 3 is relatively large.
