Mechanisms of short pitch rail corrugation

Shaoguang LI

Dissertation
for the purpose of obtaining the degree of doctor
at Delft University of Technology
by the authority of the Rector Magnificus Prof.dr.ir. T.H.J.J. van der Hagen;
Chair of the Board for Doctorates
to be defended publicly on
Wednesday 12 January 2022 at 15:00 o'clock

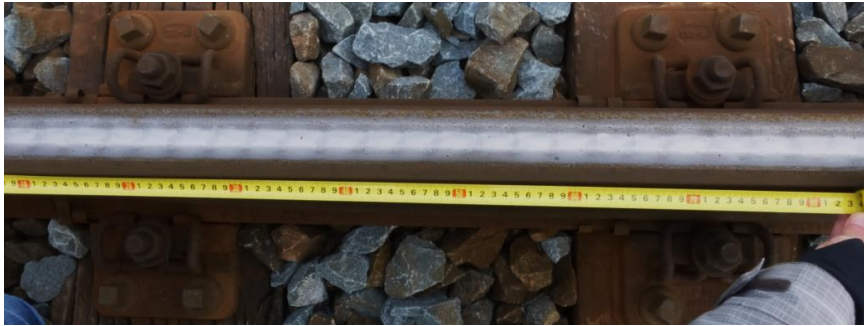
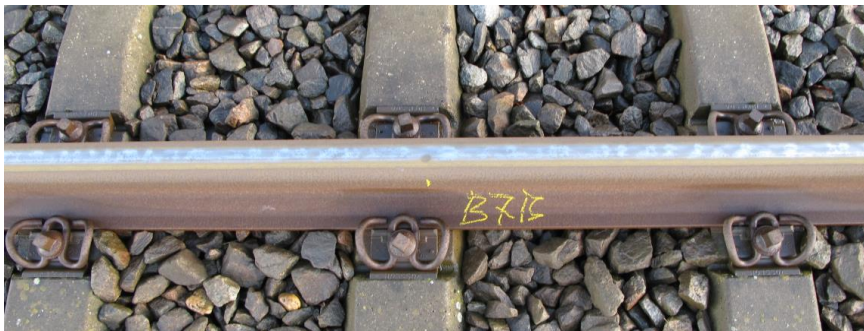
Fig. 1.1. Short pitch corrugation on the Dutch railway network.

Fig. 1.1 shows an example of the short pitch corrugation (subsequently called corrugation for short) observed from the Dutch railway network. It can be seen from the three subfigures that the corrugation can be uniform in wavelength and distributes evenly along a sleeper span, or its wavelength or amplitude can vary to some extent.

(a) Uniform corrugation.

(b) A non-uniform corrugation of varying amplitudes.

(c) A non-uniform corrugation of varying wavelengths.

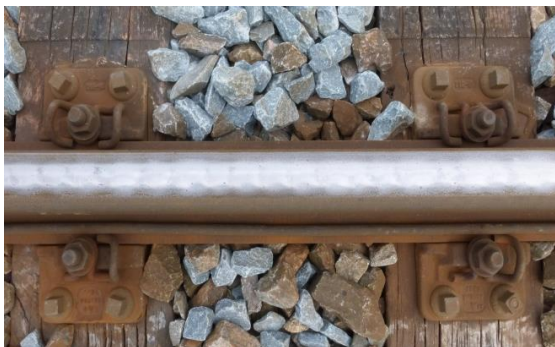
Fig. 1.2. Fracture of fastening clips

components. Fig 1.2 shows the fracture of fastening clips due to the presence of the corrugation. In worst scenarios, particularly critical in high-speed operations, the continuous loose and fracture of the fastening clips will oblige major maintenance activities as an increase in the risk of derailment will be experienced. In [3], it is reported that the corrugation is closely correlated to rolling contact fatigue (RCF), e.g., rail squats, which is accompanied by cracks (see Fig 1.3). The transverse propagation of cracks can finally result in rail fracture if maintenance is not conducted regularly.

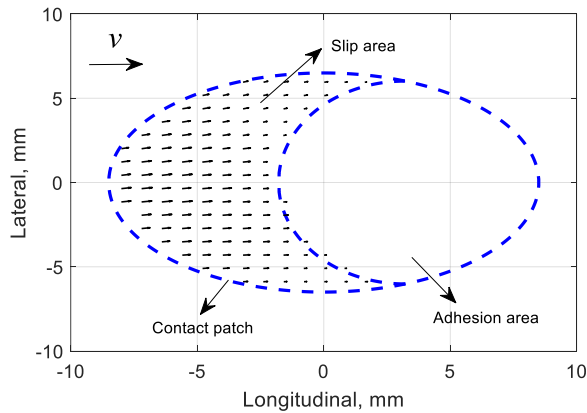
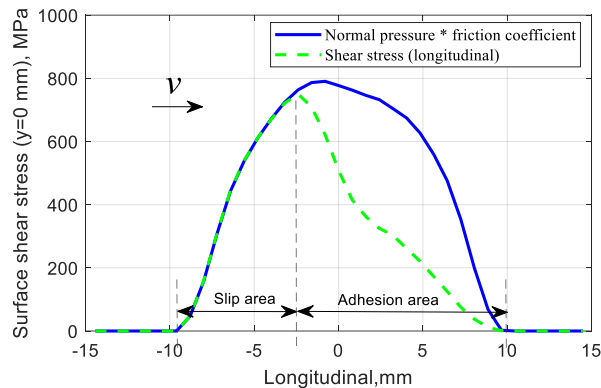
(a) Contact patch and vector of micro-slip within the slip area

(b) Distributions of surface shear stress and adhesion-slip areas.

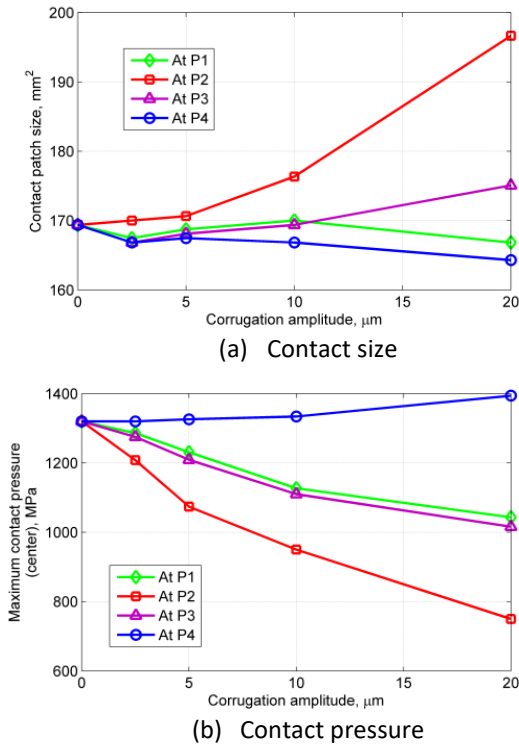
Fig. 2.4. Influence of corrugation amplitude on the size of the contact patch and the maximum contact pressure along the longitudinal axis $y = 0$ mm.

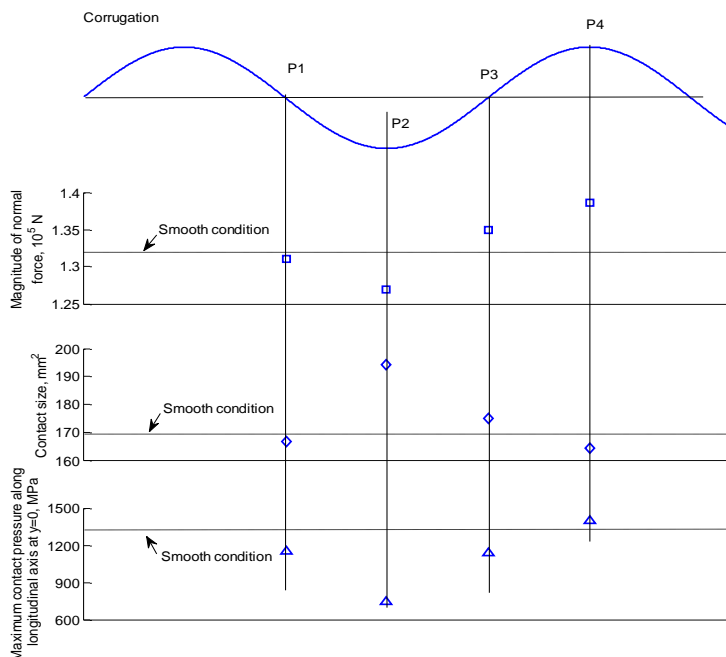
Fig. 2.5. Magnitude of the normal force, contact size, and maximum pressure along the longitudinal axis at ($y = 0$ mm) at the four analyzed positions P1, P2, P3 and P4 ($A = 20 \mu\text{m}$).

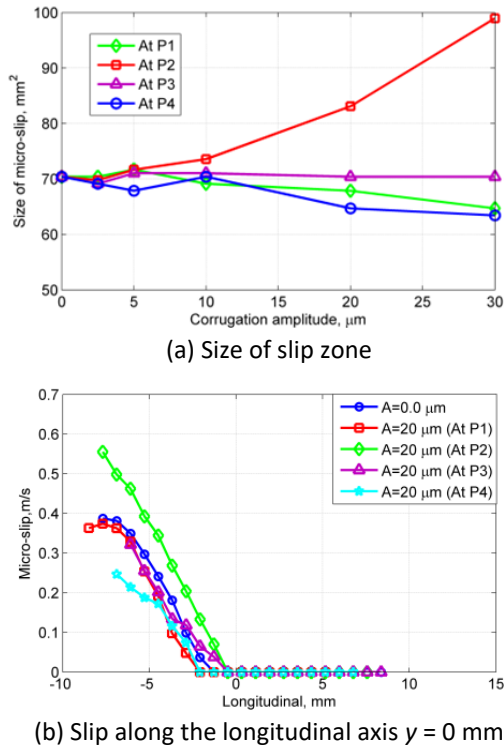
Fig. 2.7. Size of the slip zone as a function of the corrugation amplitude and slip distribution along the longitudinal axis $y = 0$ mm at the 4 positions.

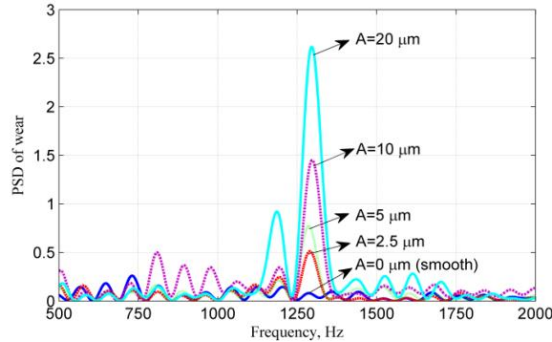
Fig. 2.9. Power spectral density (PSD) of wear $\lambda = 30$ mm, with a major peak at 1296 Hz and a secondary peak at 1185 Hz, when $A = 20$ μm .

that for the initiation of corrugation, the longitudinal mode, which is very close to the frequency of the observed corrugation, should have played a major role compared with the vertical mode.

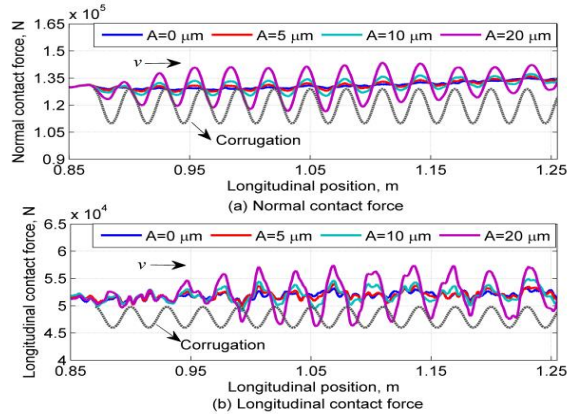
Fig. 2.11. Dynamic wheel-rail contact forces obtained for the corrugation in Fig. 2.3 with $\theta = 0$ and P4 at 1.2 m (1.2 m is in the middle of a sleeper and 0.9 m is at the midpoint between two sleepers.).

force, the normal contact force and the vertical natural mode are the same as the corrugation passing frequency; however, the longitudinal mode has not been previously considered.

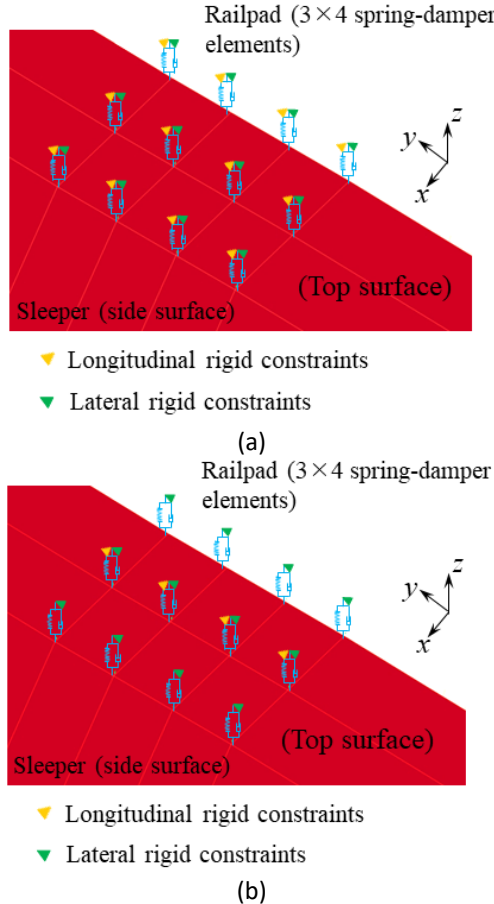
Fig. 3.4. Variation of railpad models: (a) RPM1 does not give rise to corrugation in [19] and (b) RPM3 gives rise to corrugation in this paper. RPM1 – 5 have the same lateral constraint.

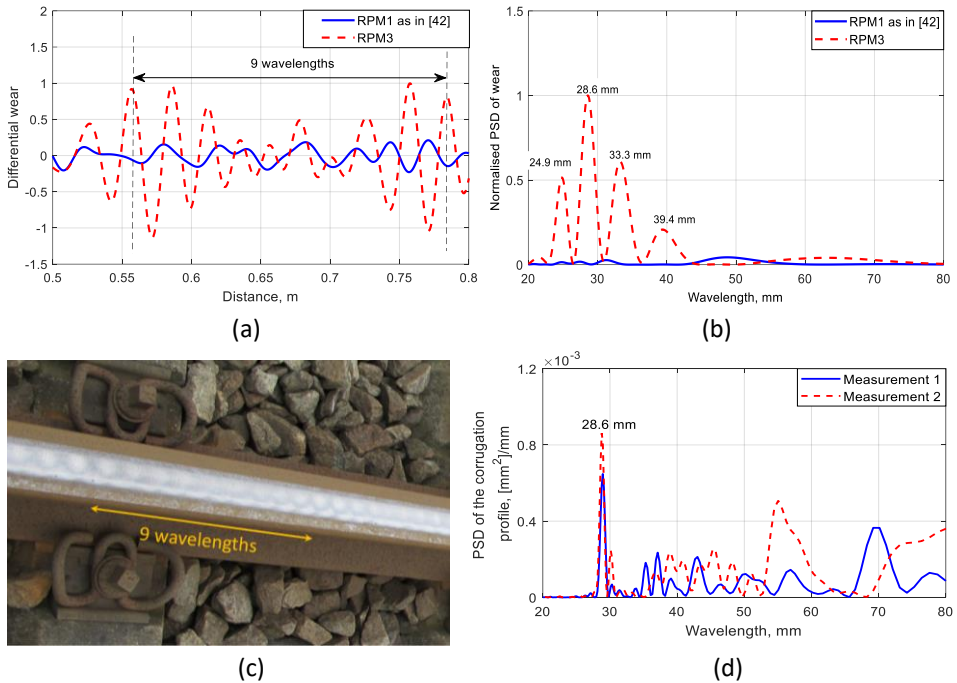
Fig. 3.5. Initial differential wear calculated with RPM1 and RPM3, 20–80 mm band-pass filtered, (a) in spatial domain (the differential wear is normalised with the maximum amplitude of the differential wear of RPM3); (b) in wavelength domain (the PSD is normalised with the magnitude of the dominant wavelength component of RPM3); (c) corrugation on a ballasted track with mono-block sleepers and fastenings with a W-shaped tension clamp. It was on a straight track near Assen, the Netherlands. The corrugation amplitude was non-uniform; (d) PSD of the field corrugation. The corrugation was measured with RAILPROF over 1 meter with a 5 mm sampling interval in the middle of the rail top surface.

Hz) and 24.9 mm (1562 Hz). The wavelength of 28.6 mm has the highest PSD magnitude and is thus dominant. The differential wear of RPM1 has much lower power intensity magnitudes in this wavelength range.

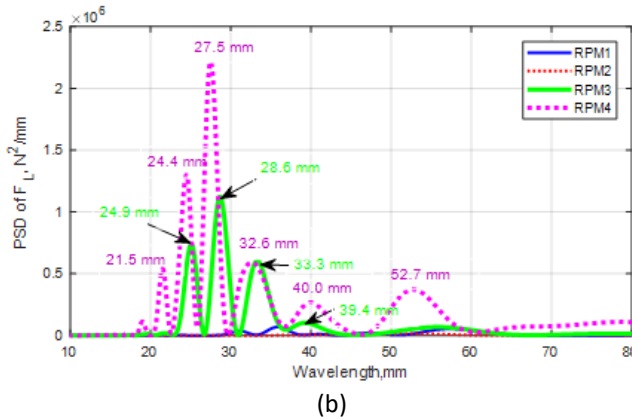
Fig. 3.9. Longitudinal contact forces F_L under RPM1 – 4. (a) F_L in the spatial domain; (b) F_L in the wavelength domain. The results were obtained with $2A_{max} = 0$ (smooth rail).

whereas RPM1 and RPM2 are more rigidly constrained in the longitudinal direction. This indicates that the longitudinal vibrational modes are much more important for the fluctuation of F_L . (3) Comparing the F_L of RPM1 and RPM2 in Fig. 3.9a tells that RPM2 has almost no fluctuation, whereas RPM1 still has some. This is because that RPM2 is rigidly constrained in the longitudinal direction at all the nodes of the rail foot bottom, in contrast to the longitudinal rigid constraint for RPM1 that is only applied at $m = 1, 2$ and 3 .

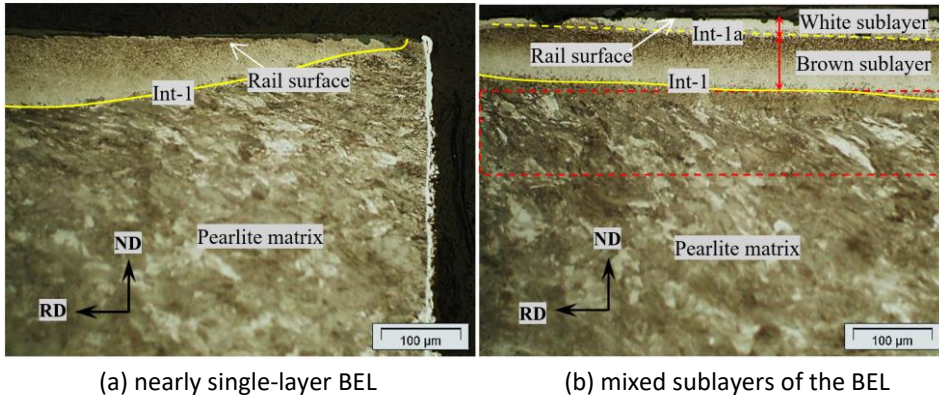
Fig. 4.3. Microstructural features of the BEL made visible via optical microscopy, etched by 3 vol% Nital (ND: rail normal direction; Int-1: BEL and pearlite matrix interface, Int-1a: white and brown sublayers interface)
