Proceedings of the 16th World Conference on Earthquake Engineering 2017

Cyclic pushover test on an unreinforced masonry structure resembling a typical Dutch terraced house

R. Esposito⁽¹⁾, K.C. Terwel⁽²⁾, G.J.P. Ravenshorst⁽³⁾, H.R. Schipper⁽⁴⁾, F. Messali⁽⁵⁾ and J.G Rots⁽⁶⁾

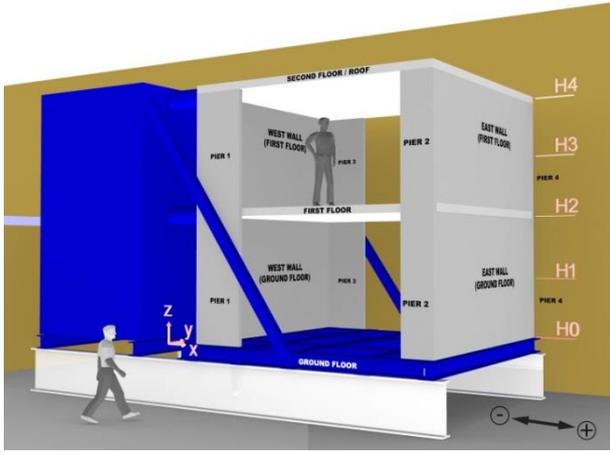
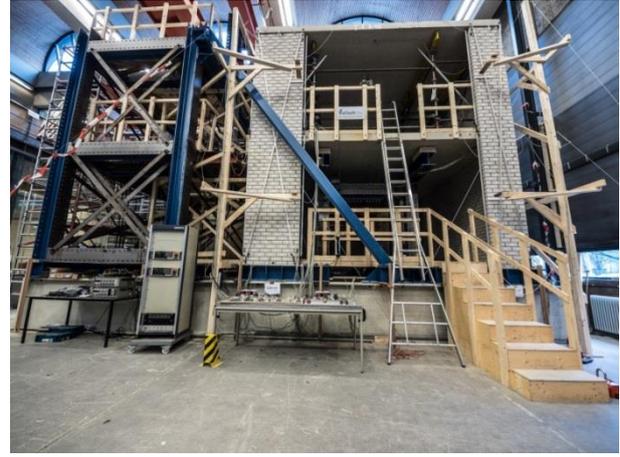
(a) (b)
Figure 1 – Set-up and test specimen: (a) 3D representation, (b) Picture.

To provide a benchmark for the validation of analysis methods, the selected case study represents only the loadbearing parts of a typical terraced house. Figure 1 shows a 3D representation of the specimen and the test set-up. The facades of the specimens have a length of 5.4 m. Due to limitation of the set-up, the depth of the specimen was restricted to 5 m. The total height of the specimen is 5.4 m (Figure 2). The south and north facades, which are identically, are represented only by the slender piers connected to the transversal walls. Two sizes of the piers have been selected: on the western side the wide piers P1 and P3 have a width of 1.1 m, while on the eastern side the narrow piers P2 and P4 have a width of 0.6 m. The walls represent only the inner leaf of the cavity wall system and are made of calcium silicate brick masonry. The masonry was made in stretcher bond allowing for the interlocking of the bricks at the corners of the transversal walls and the piers (Figure 2b). Each floor consisted of two separated prefabricated concrete slabs spanning between the loadbearing transversal walls. The floors were laid up on the loadbearing walls in a mortar bed joint (Detail C in Figure 2d). The two separated concrete slabs per floor were then connected by cast-in-place reinforced concrete dowels, aiming to approach the behaviour of a monolithic floor. At the first floor level, the floor was connected horizontally to the piers by anchors of 6 mm diameter, cast in the floor and masoned in the piers (Detail A in Figure 2d). The narrow piers were connected by three anchors, while the wide piers by five anchors. These steel anchors are commonly used as horizontal buckling or wind load support of the pier, and they are not designed to withstand any vertical load. At the second floor level, the floor was laid on both the loadbearing walls and the piers. However, during construction the floor was first laid on the loadbearing transversal walls (Detail D in Figure 2d). Only after hardening of the mortar joint between the floor and the transversal walls, the joints between the floor and the piers were filled by mortar (Detail B in Figure 2d). Consequently, the weight of the floor is not directly carried by the piers in the facades, but only by the transversal walls.

In order to apply the loading on the specimen, a braced steel tower was built (the blue steel structure in Figure 1, Figure 2). The tower, similarly to the specimen, was connected to the foundation beams. Because masonry shows very limited deformations in the elastic phase, it was aimed to limit the deformation of the test frame too. Stiffness requirements were governing over strength requirements. To increase the stiffness of the tower, two steel diagonal square tubes were connected from the top of the steel tower to the foundation beams. During the test, the vertical translation between the foundation beams and the laboratory floor were measured with linear potentiometers on several positions over the length of the beam, to evaluate the rotation of the specimen and of the tower. Measurements showed that these translations in Z direction and the accompanying rotations were negligible.

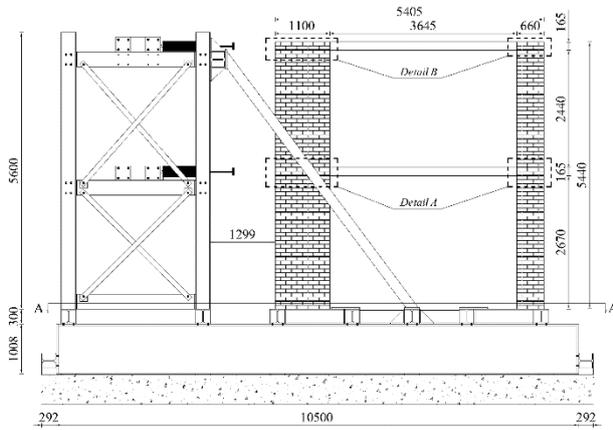
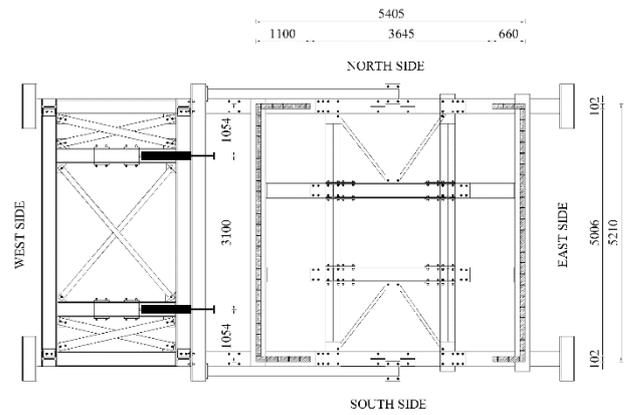
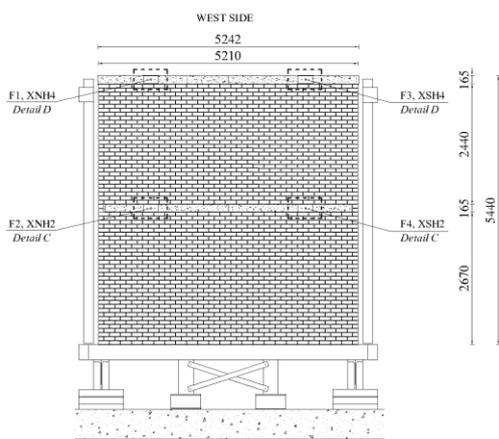
Detail A - First floor, facades

Detail B - Second floor, facades

Detail C - First floor, west side

Detail D - Second floor, west side

Figure 2 – Set-up and test specimen: (a) Front view (southern side); (b) Top view of ground floor in section A-A; (c) Side view (western side); (d) Construction details.

Since the focus of the test is on the structural response, the specimen has been built on a rigid base foundation. The rigid base is mainly composed by two steel HEM 1000 beams positioned on the southern and northern side supported by the laboratory reinforced concrete floor (with thickness of 600 mm). These beams have been used as a base for a rectangular structure composed of HEB300 beams, which formed the foundation beams of the specimen. The first layer of the masonry walls was glued to the steel beams to avoid sliding at the base.

The masonry structure was loaded by four actuators, two per each floor. The actuators were positioned at approximately 1.1 meter inwards from the facades (Figure 2b). At the second floor level, the actuators No. 1 and 3 introduced a quasi-static cyclic horizontal deformation (Figure 2c). To impose a constant ratio between the forces at the two floor levels, the forces in the actuators No. 1 and 3 at the second floor level were mechanically coupled to the forces at the first floor level, by coupling the hydraulic system over the two floors, imposing that:

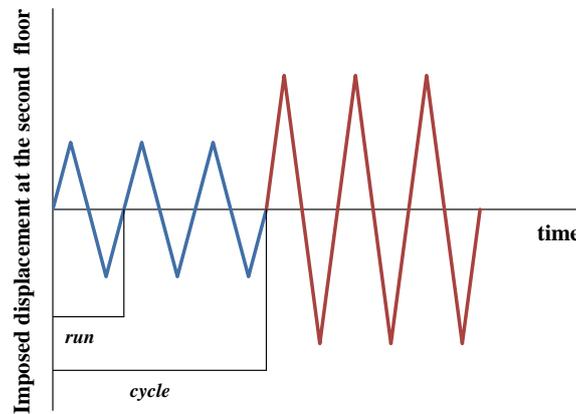
Figure 3 – Loading scheme.

The displacements at the second floor level were imposed in 21 cycles; each of them composed by 3 runs (Figure 3). A run is defined as the time needed to apply the maximum positive and negative target displacement starting and ending at zero. The speed of the imposed horizontal deformations was chosen for every cycle such that the cycle lasted 15 minutes. As a result of the increasing amplitude, the constant cycle time resulted in a deformation velocity increasing per cycle. Table 2 lists the maximum and minimum average displacement imposed at the second floor level d_2 for every cycle.

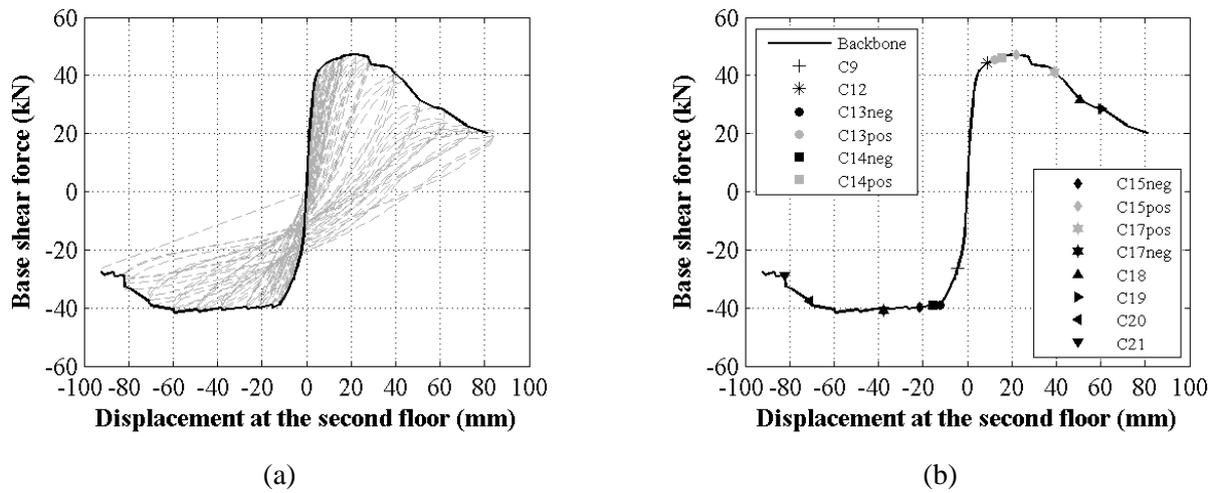
Figure 4 – Response of the assembled structure: (a) Capacity curve and corresponding backbone curve; (b) Cycle in correspondence of cracking observations (see also Figure 6)

Figure 4 shows the capacity curve of the assembled structure together with the corresponding backbone curve. Due to the different pier lengths, the behaviour in capacity and ductility results are asymmetric. This asymmetric behaviour results directly correlated to the crack pattern evolution (Figure 6).

The initial phase consisted of the first 8 cycles, in which a maximum displacement of $d_2 = \pm 3.0$ mm is reached. In this phase, the structure primarily shows a linear elastic behaviour. By analysing the capacity curve, the initial stiffness of the building could be estimated up to 15.6 kN/mm. In this phase, horizontal cracks with a maximum opening of approximately 1 mm were measured by the sensors (Figure 5), but they could not be recorded by the visual inspection (Figure 6). Figure 5 shows the development of these cracks for the corner between the western wall and the pier P1; a similar behaviour was observed in the other corners. The horizontal cracks were located at the interface between the floor and the transversal walls and at the bottom of the piers (Figure 5). For both the western and eastern transversal walls (Figure 5a, b), the cracks were wider at the corner rather than at the centre of the wall. The wider cracks were measured at the second floor level, while at the first floor level an opening of maximum 0.1 mm was recorded. At the ground floor level, the opening was negligible both at the centre and on the south corner of the transversal walls. For both the western (P1 and P3) and the eastern (P2 and P4) piers the maximum crack opening was measured at the bottom free side of the pier (Figure 5c, d). Due to the different size of the piers, a larger opening was recorded for the western piers (P1 and P3). Due to these horizontal cracks, a reduction of the stiffness in the negative direction (from eastern to western side) was observed in the capacity curve in correspondence of cycle 7 ($d_2 = \pm 2.7$ mm).

In the pre-peak phase, cycle 9 to 14 were executed to reach a maximum displacement of $d_2 = \pm 15.5$ mm. In this phase, all the piers visibly showed the horizontal cracks at both bottom and top side, which were previously measured in the initial phase. The cracks in correspondence of the ground floor level developed within the first mortar joint, being the masonry glued on the foundation beams. Extensive horizontal cracks developed also in the transversal walls: for the western wall, they were mainly concentrated at the ground floor level, while for the eastern wall they were located at the second floor level. In this phase, the first diagonal cracks occurred on the transversal walls. They were mainly located at the ground floor on the western side.

In the post-peak phase, cycle 15 to 21 were executed to reach a maximum displacement of $d_2 = \pm 82.0$ mm. The structure presented an asymmetrical behaviour for loading in the positive (from west to east side) and negative (from east to west side) direction. The maximum capacity was first reached for positive displacements. During cycle 15 ($d_2 = \pm 21.8$ mm), the maximum base shear force of 47.3 kN was reached for positive displacement, while for negative displacement approximately 97% of the maximum capacity was reached. During this cycle, the previously observed horizontal and diagonal crack on the transversal walls further extended. After the peak, the capacity and stiffness substantially reduced for positive displacements. This phenomenon was mainly governed by the diagonal/vertical cracks occurring first in pier P3 and subsequently in pier P1. Due to the extensive cracking of these piers, part of pier P3 was removed for safety reasons after cycle 19. For negative displacements, the maximum base shear force of 41.6 kN was reached in correspondence of a displacement of -60 mm (cycle 19). This event corresponded to the formation of a secondary diagonal/vertical crack in pier P3. During the post-peak phase, the out-of-plane crack on the transversal walls further developed, by forming the typical yield line envelope. In the last two cycles, where a maximum displacement of ± 82 mm was reached, the out-of-plane cracks became dominant on the eastern wall.

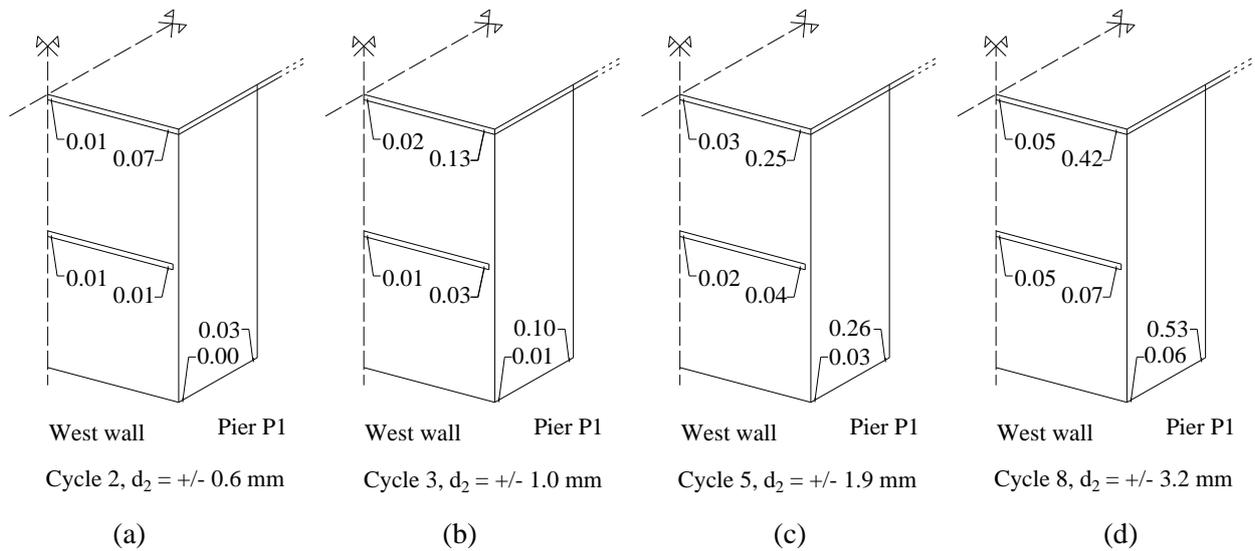
Figure 5 – Maximum opening of horizontal cracks at the floor-to-wall connection (western wall) and at the bottom of the pier P1, measured on the outside of the specimen during the initial phase (unit: mm).

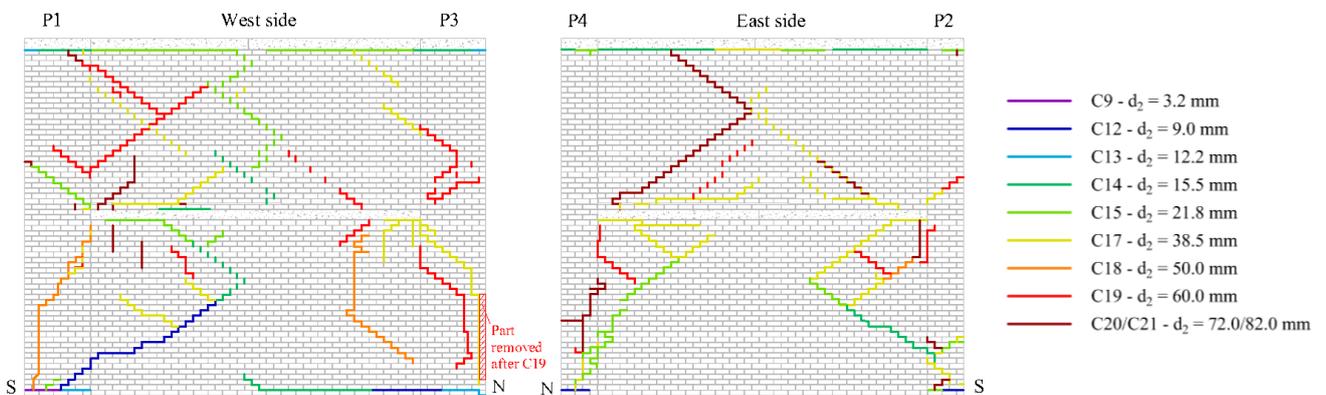
Figure 6 – Crack pattern defined on the base of visual inspection (see also Figure 4).

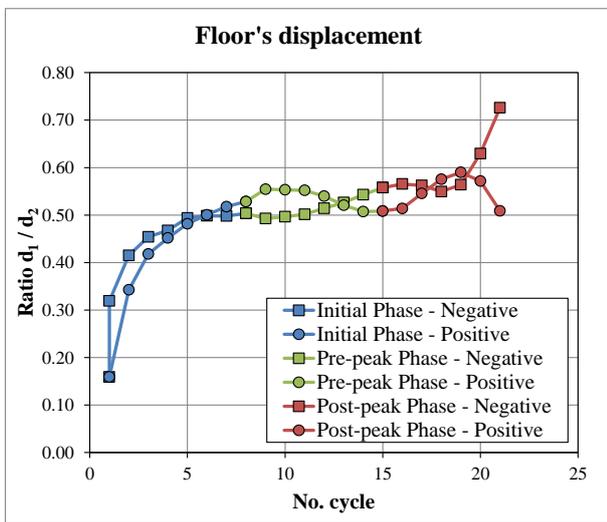
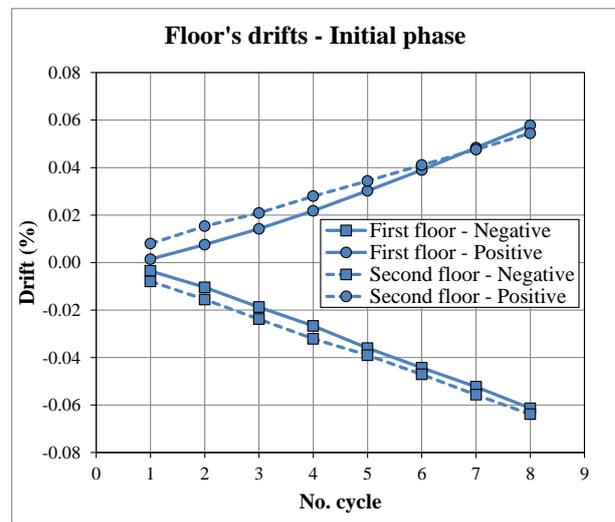
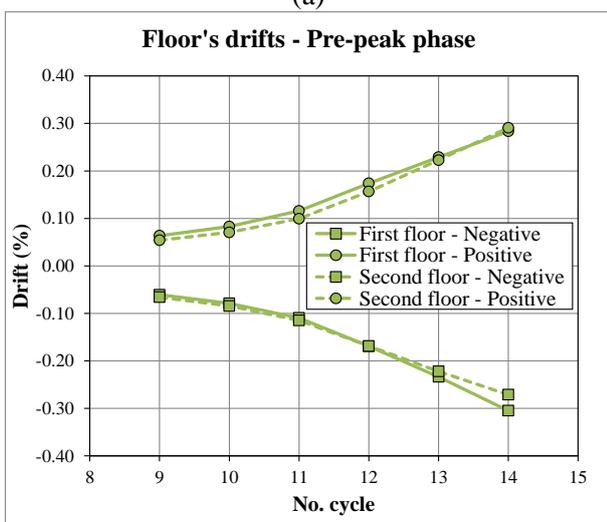
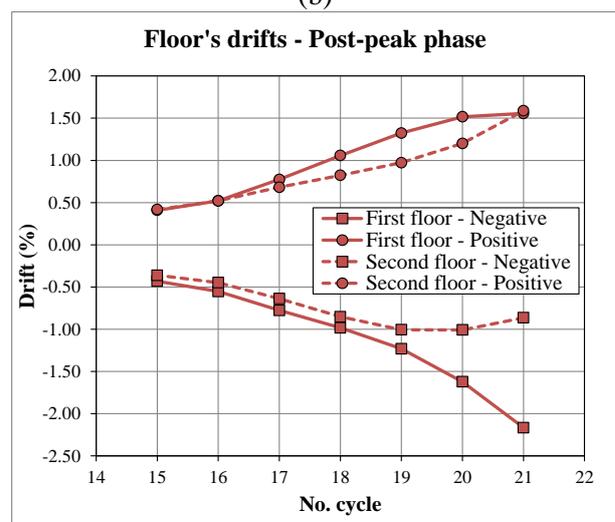
Figure 7 – (a) Ratio between first and second floor displacement; (b)-(d) Drifts of first and second floor (calculated with $H_{1st\ floor} = 2753\ mm$, $H_{2nd\ floor} = 2605\ mm$)

Figure 7a reports the behaviour of the structure in terms of floor displacements. The ratio of the floors' displacement was ranging between 0.2 and 0.5 in the initial phase; afterwards a constant trend was observed in the pre- and post-peak phases. Similar values of the ratio between the floor's displacements were observed for the loading in the positive and negative direction, with the exception of the last two cycles. In these cycles, the first floor level showed larger displacement for negative loading than for positive loading. This can be correlated to the opening/closing mechanism interesting the cracks in the western piers. These cracks are only located at the ground floor level and they interest also the connection of the piers with the transversal walls. If the specimen is subjected to negative displacements, these cracks are open and allow for large displacement of the transversal walls, thus of the first floor level. On the contrary, if positive displacement is applied to the specimen, these cracks are closed limiting the displacement of the floor.

Figure 7b-d reports the behaviour of the structure in terms of drifts. They are calculated as the ratio between the relative floor displacement and the interstorey height, which is 2.7 and 2.6 m for the first and second floor level, respectively. In the initial and pre-peak phase, both the first and second floor show similar drift values. At the end of the post-peak phase, a difference is observed, for both floor levels, between the drifts values obtained for negative and positive loading. This difference can be correlated to the extensive damage within the western piers. A maximum drift of +1.6/-2.4 % was reached at the first floor level, while the second floor showed a drift of +1.6/-1.0 %.

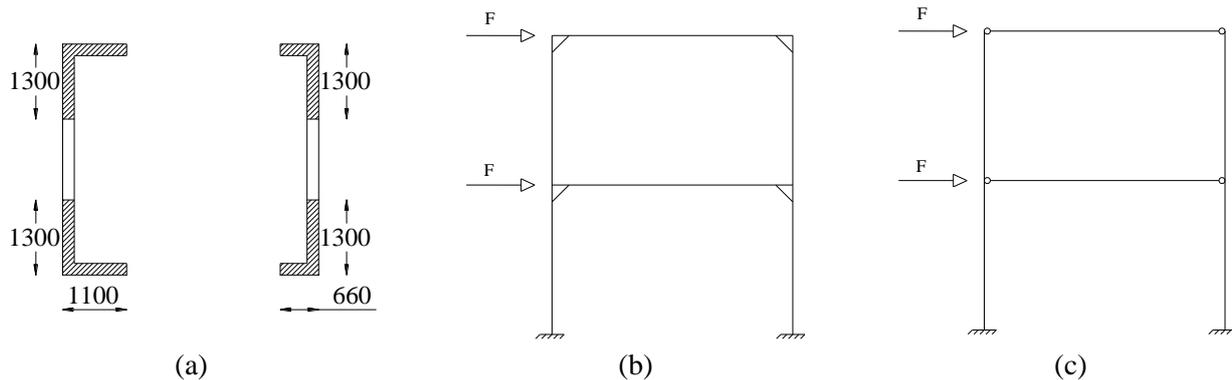
Figure 8 – Portal schematization to represent the: (a) Effective cross section; (b) Scheme with moment resisting connections to represent the elastic phase; (c) Scheme with hinged connections to calculate the reduced stiffness in the pre- and post-peak phase.

To represent the elastic phase of the test, a portal schematization is considered (Figure 8b). In this phase, the wall-to-floor connection is considered as a moment resisting connection. The masonry walls are represented as C-shaped elements to account for the flange effect. Accordingly to Ref. [2], the western (P1, P3) and eastern (P2, P4) piers can activate, through the flange effect, a contributing length of the transversal walls equal to 1300 mm (Figure 8a). The analytical calculation estimates an elastic capacity of approximately 10 kN and an initial stiffness of 21.7 kN/mm. Experimentally a similar elastic capacity and an initial stiffness of 15.1 kN/mm were measured.

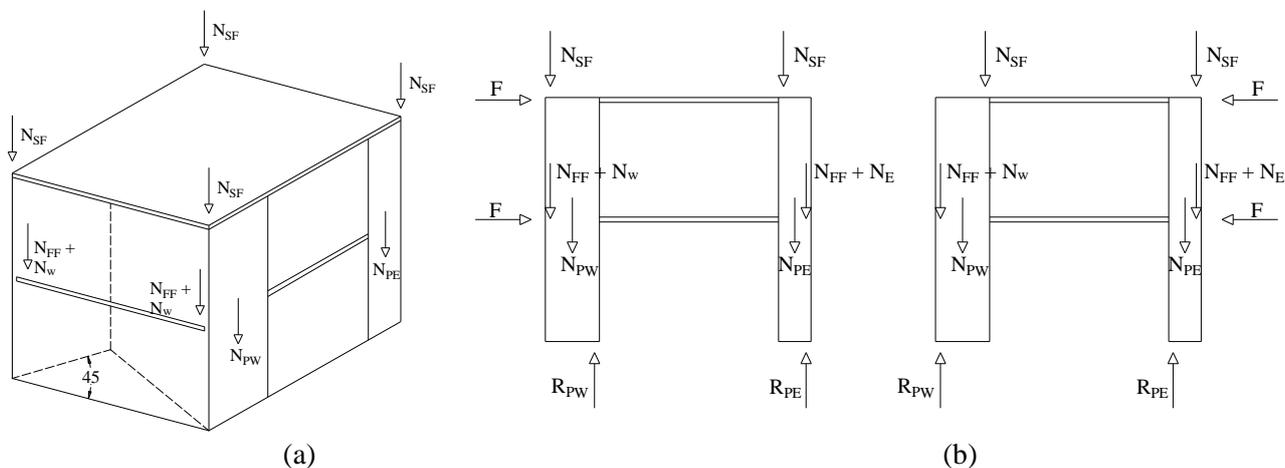
Figure 9 – Schematization adopted in the analytical estimate of the capacity: (a) Volume partition of the floors and of the transversal walls loading the piers; (b) Forces loading the piers for positive and negative loading.

In order to qualitatively explain the pre-peak behaviour of the assembled structure, an analytical estimate is presented in this section based on the observed damage evolution. The formation of the horizontal cracks at the floor-to-wall connections and at the piers edges is considered. In these calculations, the material properties of the masonry presented in Section 4 are adopted; the density of the masonry and of the concrete are respectively assumed equal to 2000 and 2400 kg/m³.

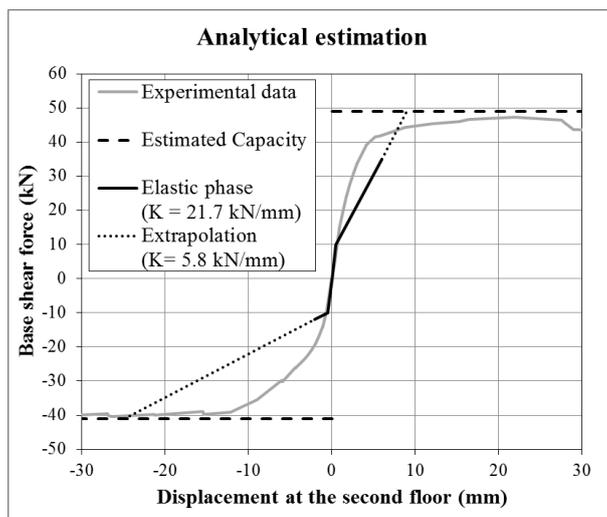
Figure 10 – Comparison between experimental results and analytical calculation.

To represent the pre-peak phase of the test, two assumptions are made: 1) it is conservatively assumed that the horizontal cracks at the floor-to-wall connection are developed for the entire length of the wall; 2) it is considered that the capacity of the structure is governed by the behaviour of the piers. The second hypothesis is also supported by the large-scale experimental tests on walls subjected to two-way out-of-plane bending. These tests showed that the walls could withstand displacements up to 90% of their thickness (more details can be found in Refs. [13]-[14]). Considering the first assumption, the degraded stiffness is evaluated with the previously adopted portal schematization, which is modified considering hinged connections between the transversal walls and the floors (Figure 8c). The analytical calculation provides a degraded stiffness of 5.8 kN/mm. Considering the second assumption, the capacity of the structure is calculated from the force equilibrium in the piers assuming that only horizontal forces can be transferred between them, as shown in Figure 9. The piers are subject to vertical forces due to the weight of the floors, of transversal walls and their own weight. It is assumed that the entire weight of the floor is transferred to the piers in an equal manner. Due to the horizontal cracking at the floor-to-wall interface, the normal force due to the second floor changes its position on the base of the applied horizontal loading direction, thus of the vertical movement of the piers. Considering the effect of the wall-to-pier interlocked connection and the initial crack pattern, a trapezoidal part of the transversal wall is assumed cooperating with the piers [2] (Figure 9a). Considering the piers equilibrium, the estimated capacity results approximately equal to 49 and -42 kN for the positive and negative direction, respectively. Considering the estimates of the degraded stiffness and capacity, an extrapolation of the analytical calculation can be made in the pre-peak phase (Figure 10).

The analytical calculation is able to qualitatively capture the pre-peak behaviour of the structure and estimate its capacity (Figure 10). Even if this estimation is adopted only for a qualitative comparison, some relevant conclusions can be drawn: 1) the connection between floor and wall is of importance with respect to the elastic behaviour of the specimen in terms of both stiffness and capacity; 2) the entire weight of the floor is activated during the test; 3) the maximum base shear force of the structure directly depends on the maximum in-plane capacity of the piers.
