Numerical investigation into the effects of corrosion on the shear performance of pretensioned bridge girders with cast-in-place slabs

Jadwiga Osmolska, Magdalena; Kanstad, Terje; Hendriks, Max A.N.; Markeset, Gro

Structures

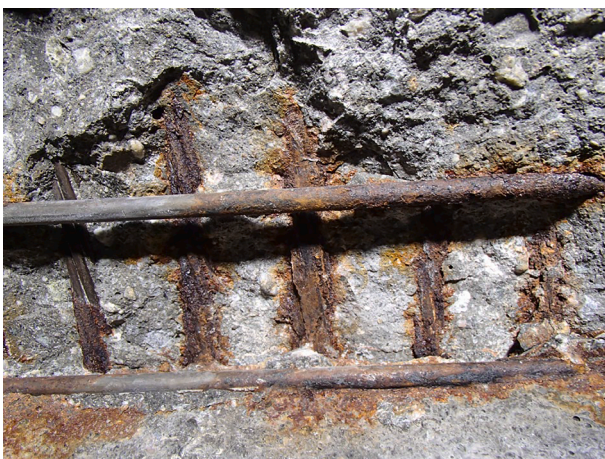
Fig. 7. Corrosion in the bottom layer of strands found near the middle support in an NIB girder in Hafrsfjord Bridge near Stavanger.

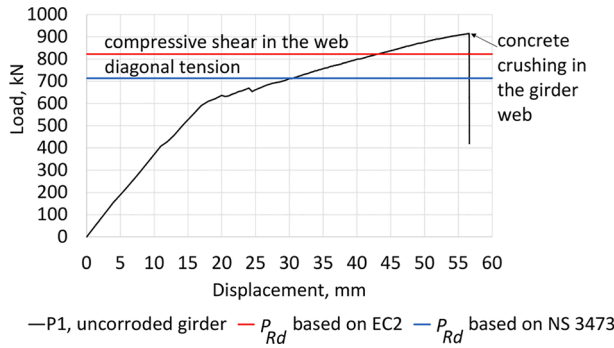
Fig. 17. Comparison of the maximum failure load obtained in NLFEA and load P_{Rd} resulting from shear resistance according to codes and load configuration shown in Fig. 4.

strut θ was assumed to be 23° , equal to the angle of main shear crack shown in Fig. 16c. This angle is between the limiting values of 21.8° and 45° recommended by the standard [48]. To calculate the V_R according to NS 3473 [45], the recommended θ of 45° was used. The shear resistance V_R values obtained are listed in Table 7. Next, the minimum values of V_R were used to express the shear resistance in terms of applied loads P_{Rd} as explained in Section 4, and P_{Rd} values were compared in Fig. 17 to the maximum failure load obtained in NLFEA.

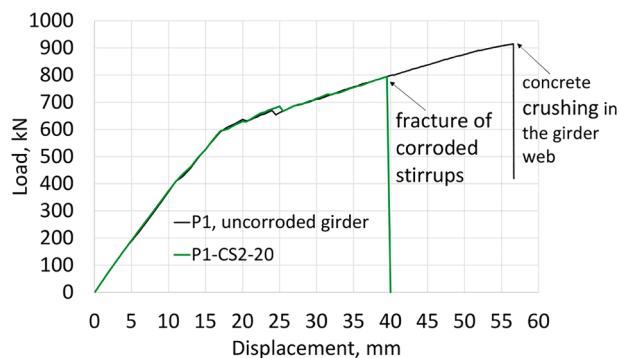
Fig. 22. The load–displacement curves obtained for the uncorroded girder (P1) and the girder with corroded stirrups (P1-CS2-20).

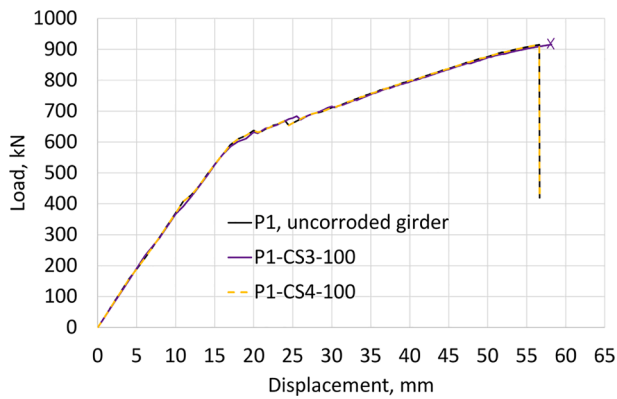
Fig. 24. Load-displacement curves obtained for the uncorroded girder (P1), the girders with corroded top strands (P1-CS3-100), and the girders with corrosion in the extended stirrups (P1-CS4-100).

Considerable corrosion in the top strands (P1-CS3-100) or in the extended stirrups near the support (P1-CS4-100) affects neither the capacity of the NIB girder nor its failure mode, see Fig. 24. The partial loss

of top strands caused only minor change in the tensile stresses of the bottom strands and a redistribution of stresses in concrete within the shear span, which did not affect the girder behaviour for higher loads. The loss of extended stirrups had almost no impact on the stresses in the remaining part of the stirrups or the RC slab, which implies their lack of contribution to girder performance.

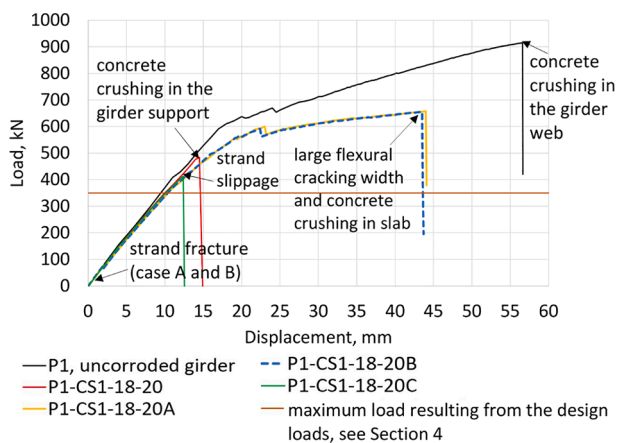
Fig. 25. Load-displacement curves obtained for the uncorroded girder (P1) and the girders with 20% corrosion in the bottom layer of strands assuming varying concrete or bond parameters as described in Table 6.

The structural behaviour of girders P1-CS1-18-20A and B are similar. Detailed results are therefore shown only for the girder with slightly lower capacity (Girder 20B). Fig. 26a shows that the bottom layer of the strands fractured at the assumed location (1.8 m from girder end) immediately after applying 20 % corrosion. Consequently, the girder stiffness was reduced as shown previously in Fig. 25. Despite the fracture

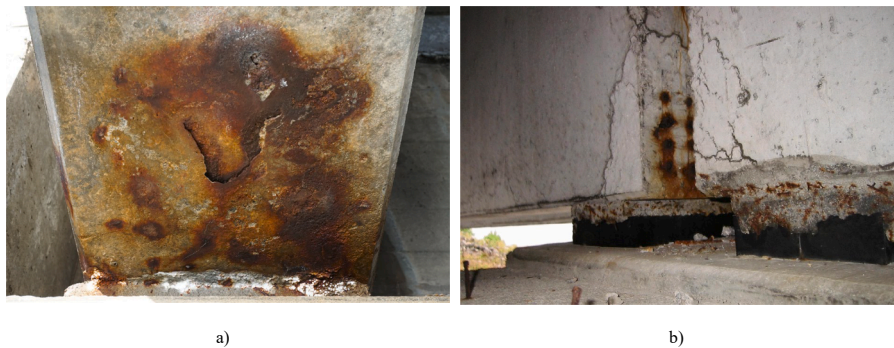
Fig. 30. Corrosion cracking in bottom of pretensioned girders: a) significant corrosion cracking in the NIB girder bottom flange near support, bridge close to Kristiansund; and b) corrosion cracking and spalling in the NIB girder-ends, photo by NPRA [7].
