## Fatigue behavior evaluation of full-scale OSD-UHPC composite bridge deck system

Engineering Structures

To investigate the fatigue performance and fatigue damage process of the Orthotropic Steel Deck (OSD) - Ultra-High Performance Concrete (UHPC) composite bridge deck, a two-span continuous full-scale specimen was designed and tested under cyclic loading. Test results showed that the fatigue cracks firstly initiated near the lower part of the weld toe of the rib-to-cross beam welded joint, and then cracks along the weld length of the U-rib butt-welded joint developed. These observations followed by the OSD-UHPC interface debonding. The U-rib bolted joint exhibited better fatigue resistance than the U-rib butt-welded joint. The *S-N* curves of the rib-to-cross beam welded joint, the U-rib butt-welded joint and the U-rib bolted joint were established based on existing fatigue test data, and were compared with provisions in design codes. The *S-N* curves from the beam test for the short-headed stud connectors were compared with that from the push-out test. And the established *S-N* curves with 95% survival probability from the push-out test could be used to assess the global fatig

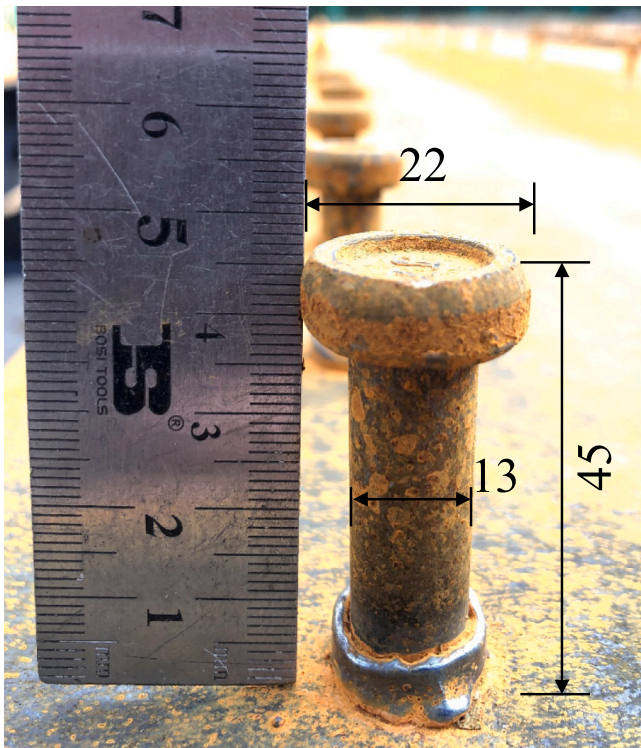
Fig. 2. Details of the short-headed stud connector (unit: mm).

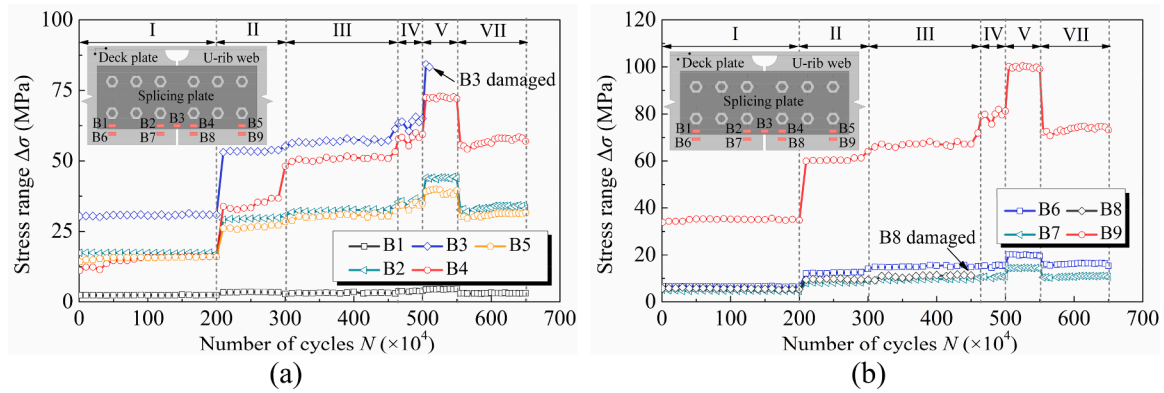
Fig. 15. Stress range evolution of measuring points at the U-rib bolted joint: (a) splicing plate; (b) U-rib.

No fatigue cracks were observed at the U-rib bolted joint. The stress range evolution of measuring points at the bolted joint are plotted in Fig. 15. As shown, the stress ranges of measuring points were kept almost equal at each cyclic loading phase, indicating that no severe fatigue damage occurred at the bolted joint. The U-rib bolted joint exhibited much better fatigue resistance than the U-rib butt-welded joint under the identical loading conditions. Therefore, the bolted joint is recommended as the connecting method for U-ribs when installed on site considering the excellent fatigue resistance of the bolted joint and the common welding defects of the butt-welded joint.
