An Overview

Overflow Tests on Grass-Covered Embankments at the Living Lab Hedwige-Prosperpolder: An Overview

Keywords: overtopping; grass; erosion; field test

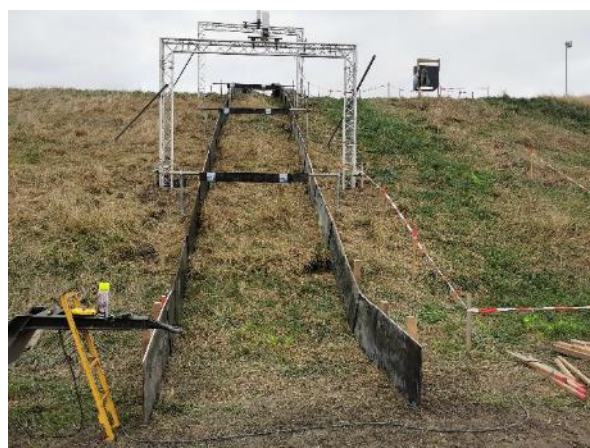
Figure 2. Standard setup of an overflow experiment, view from the landside dike toe. Camera and sensor frames are placed across the 2 m wide test section, prior to execution.

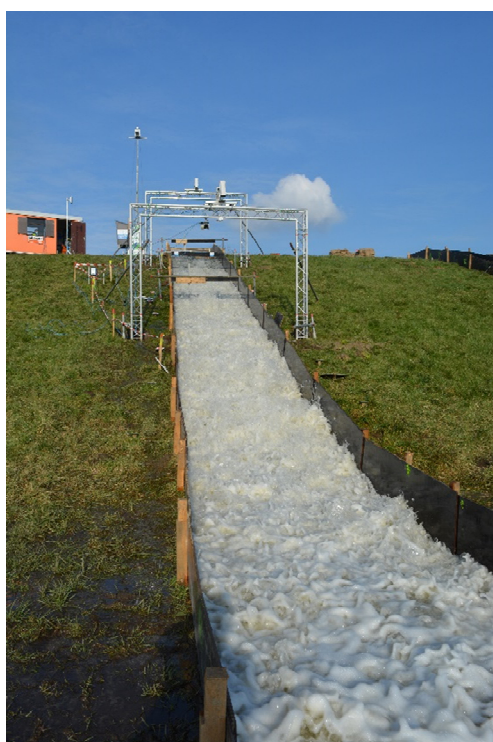
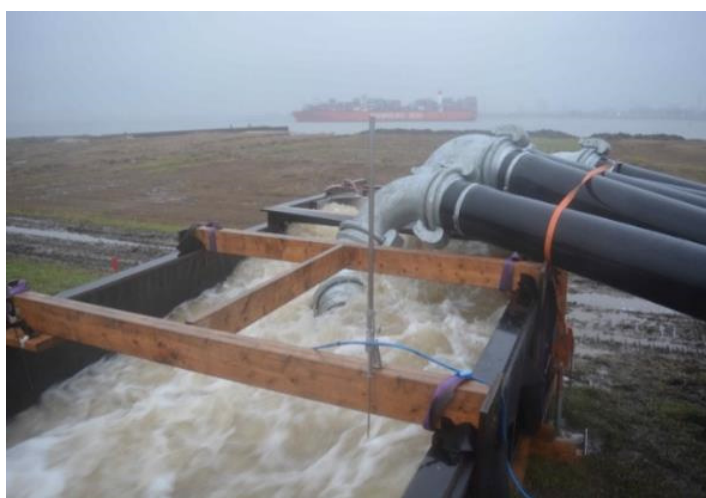
Figure 3. (a) Overflow in progress; (b) Overflow generator at maximum discharge of 1100 L/s.

The flow canal used for directing the water flow over the grass cover of the dike was 2 m wide. At the crest of the dike it was connected to the overflow generator. Both sides of the flow canal were made of coated hardboard plates of $2 \times 0.7 \times 0.01$ m. The plates were hammered and sliced into the ground to a depth varying between 7 and 15 cm deep. The plates were screwed to wooden poles of a size of approximately 0.1–0.1–1.0 m with one pointed end. The poles were hammered into the ground to a depth of approximately 0.2–0.3 m. Figure 3a shows a typical flow canal that was realized on virtually every test section during the overflow experiment. Figure 3b shows the uppermost part at the maximum discharge.

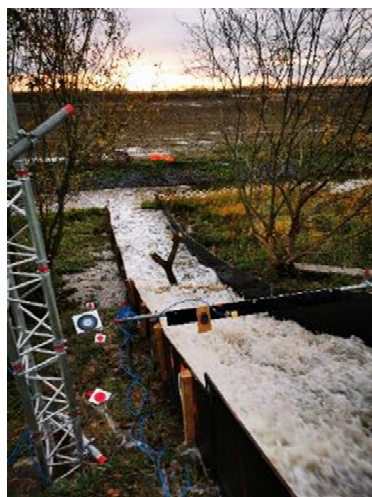
Figure 4. Anomaly test section with a tree trunk at the toe of the dike.

1. the presence of a tree at the toe of a dike in the test section (Figure 4);
2. a damaged dike profile at the toe, mimicking damage by animals like grazing sheep;
3. hard structures and transitions on the dike (e.g., concrete staircase).
