Factors favouring vegetation in quay masonry walls: A pilot field study

Building and Environment

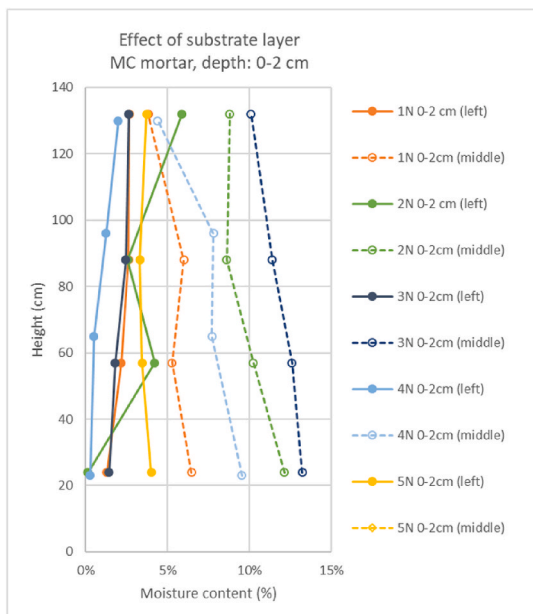
Fig. 10. Moisture content in mortar in the left and middle panel of N-walls.

Fig. 10 shows the difference between the MC in the middle panel, with substrate behind, and the left panel, with the same thickness but no substrate layer behind. The thickness of the substrate layer is enough to

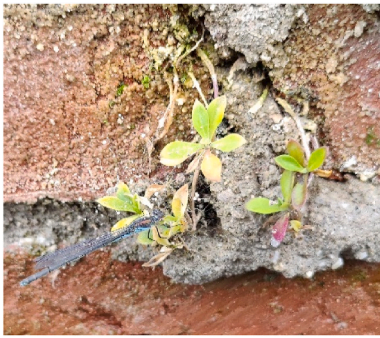
Fig. 11. Wallflower growing in the cracks present in a rough mortar joint.

Irregularities, such as protruding rough mortar joints, empty vertical joints and dilation joints, were shown to favour germination of seeds and subsequent plant growth. This is particularly evident in the left and right panels and it is probably related to the fact that these irregularities offer grip for plants (Fig. 11). This confirms the positive effect of surface roughness on bio-receptivity reported in the literature [13,37]. Germination of Wallflower is observed also in the frog of the protruding bricks, where rain water accumulates; however, seedlings did not develop into plants, due to insufficient supply of organic material.

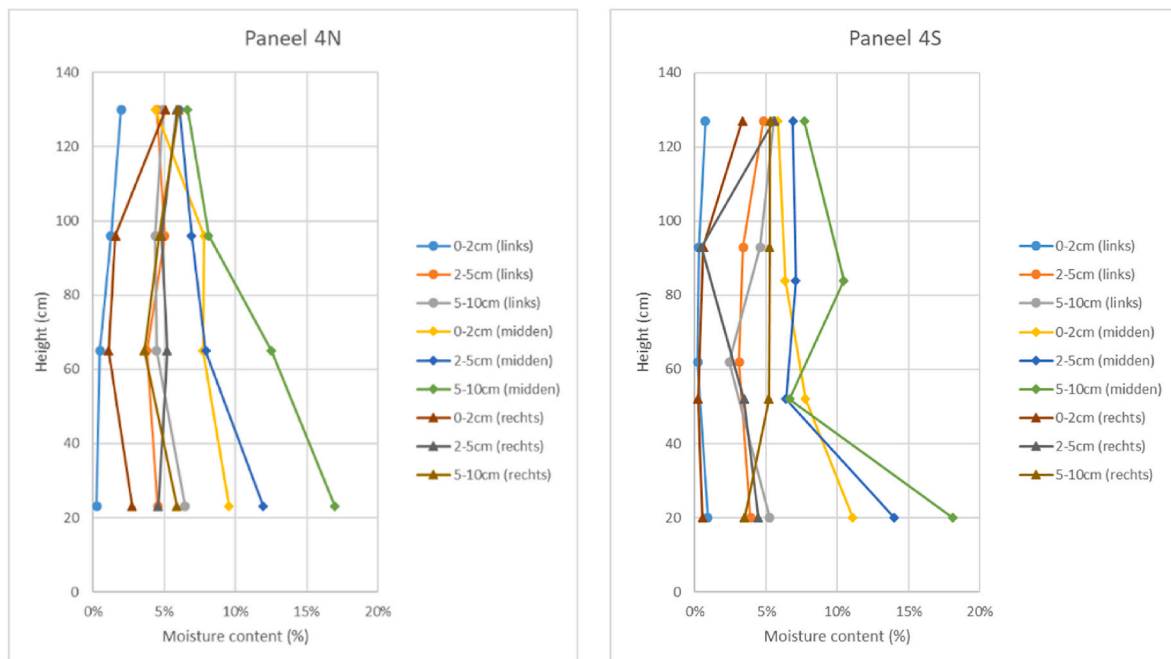
The effect of the orientation on the moisture content is assessed by comparing the MC measured in walls 4 N and 4S (Fig. 12). No significant and consistent effect of the orientation on the moisture content is observed. Orientation seems to have only a slight effect on vegetation. In the case of germination of the seeds, a slightly better behaviour is observed in N-walls. Similarly, the survival of potted plants is generally better in N-walls than in S-walls (apart for 1 N&S). A possible reason might be the reduced evaporation in N-walls, exposed to North.

Fig. 12. Moisture content in walls 4 N and 4S
