Investigation of compression after impact failure in carbon fiber reinforced polymers using acoustic emission

Biagini, Davide; Pascoe, John Alan; Alderliesten, René

Journal of Composite Materials

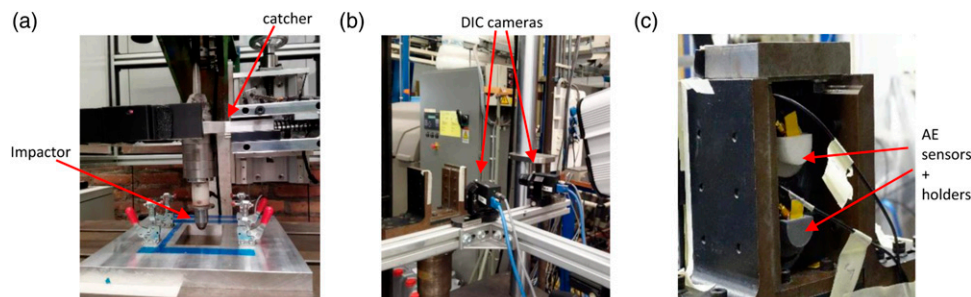
Figure 1. (a) Impact test setup with catcher to avoid bounce-back of the impactor; (b) 'Front' view showing two DIC cameras pointed at the CAI setup; (c) 'Back-side' view of the CAI setup with the two AE sensors positioned inside their holders.

Impact testing was conducted using a drop-weight tower according to ASTM D7136.²² The test set up is shown in Figure 1(a). The support fixture has a cut-out of 125 ± 1 mm in the length direction and 75 ± 1 mm in the width direction. To prevent the occurrence of multiple impacts, the impact tower was equipped with a catcher triggered by optical sensors. A hemi-spherical impactor with a diameter of 16 mm and a mass of 4.8 kg was used. A target impact energy of 34 J was used in all the impacts. This condition can be classified as LVI and produced a dent depth < 2 mm (BVID). After the impact, the size of delamination was measured by ultrasound inspection.

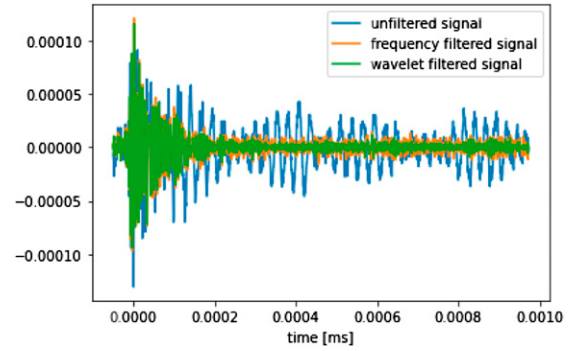
Figure 2. Comparison of different filtering strategies.

Considering the above, a filtering strategy composed of three stages was adopted. First, a maximum amplitude threshold for the acquisition was set to 45 dB. This threshold was selected due to a relatively high noise level during the test. It must be considered however that adopting a 45 dB filter could cut out some micro cracking events, which could affect the reported repartition between damage modes. The analysis of the waveforms recorded with this setting, revealed a low frequency (60 kHz) continuous-type signal (Figure 2), which we associated with friction. Considering this, a high pass filter allowing only frequencies >70 kHz was applied. Then, a four level discrete wavelet packet filter was applied using Daubechies 32 wavelets, setting a hard threshold at 10% of the maximum coefficient. As can be seen in Figure 2, thanks to the application of the two consecutive filters, it was possible to effectively remove acoustic energy that was not related to damage from the recorded signals.

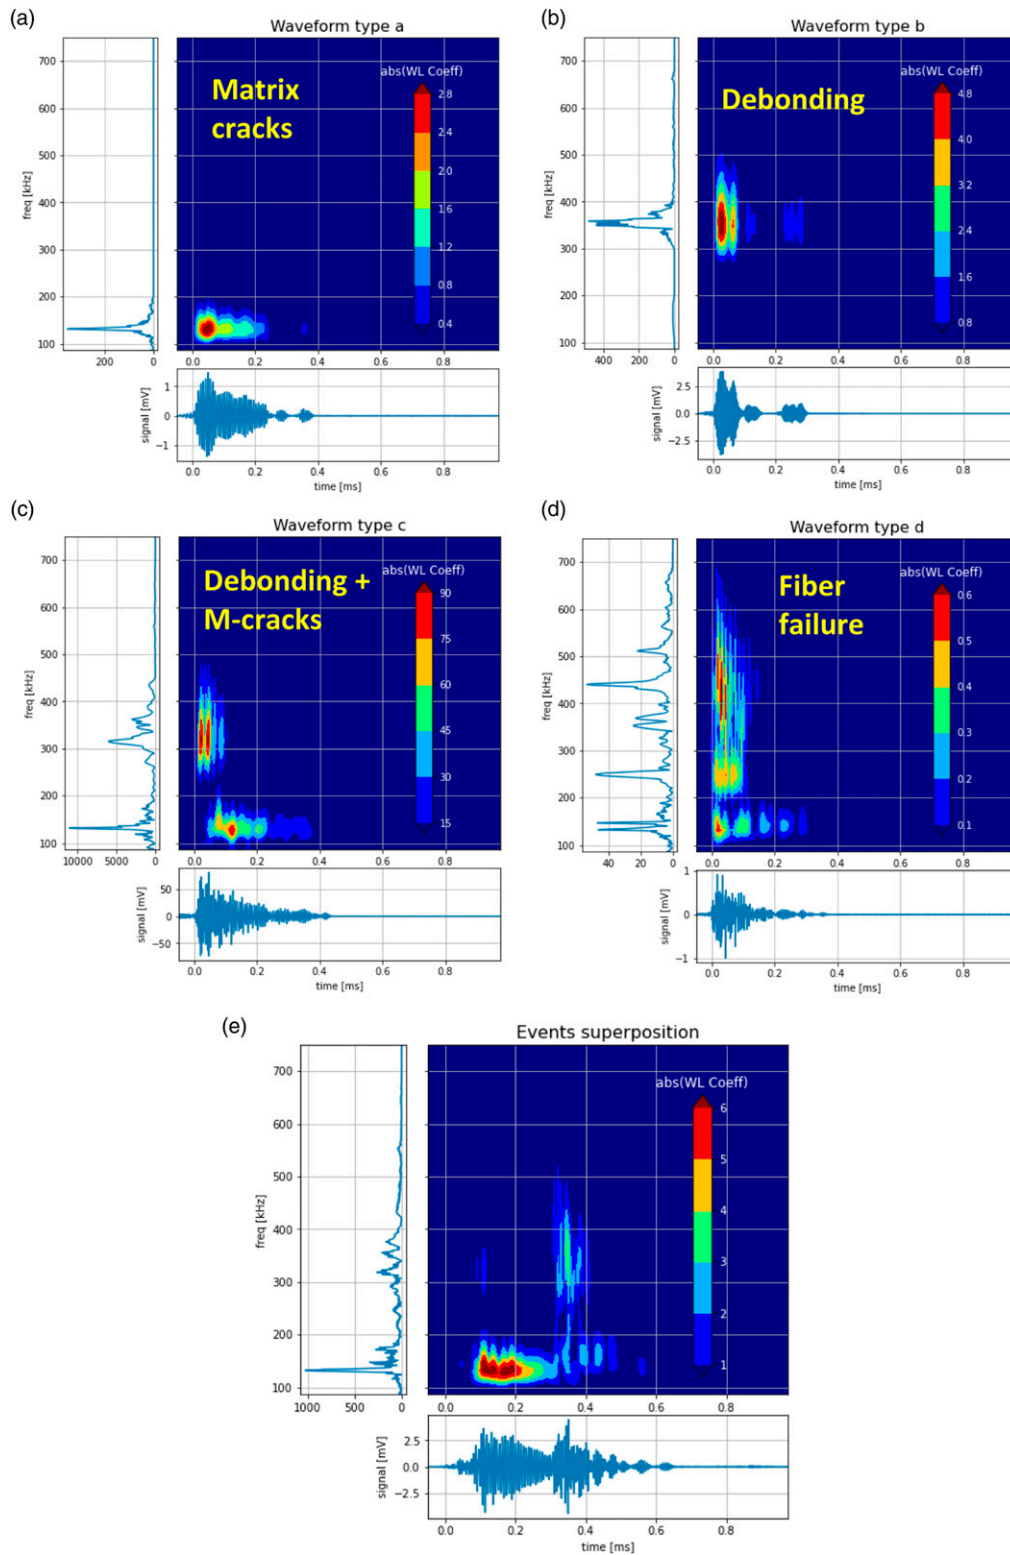
Figure 3. Continuum wavelet transforms of different types of waveforms ((a)-(b)-(c)-(d)) and an example of event superposition in CAI failure (e). In the colour plots, absolute value of continuous Morlet WL coefficients are plotted in time–frequency scale. Horizontal sub-plots are the original signals aligned in the time domain. Vertical sub-plots are the Fourier spectrum of the signals aligned in frequency domain.

- Type a) is characterized by low frequency (100–200 kHz) and long duration. It was present in tests [0], [90] and Teflon, but was predominant in [90] test. For this reason we associated this waveform with pure matrix cracking. A different tensile campaign also associated matrix cracking with low frequency events,²⁶ and numerical modeling of AE sources¹² confirms this assumption.

- Type c) appears to be a combination of waveform type a and b. It was the predominant signal in [0] test and Teflon-test, especially close to final failure, and less frequent in [90] test.

- Type d) spectrum is characterized by several local peaks, some of them at high frequencies (450–600 kHz). This waveform was totally absent in the [90] test. In [0] test and Teflon-test, it appeared only at relatively high stress. Considering this, we associated waveform type-d with fiber failure. A previous tensile campaign associated fiber failure with high frequency events,²⁶ and numerical modeling of AE source¹² seems to confirm this assumption.

There was good agreement between the damage modes identified in the preliminary tests and those observed in the CAI tests. In Figure 3(e) a typical signal recorded close to CAI failure is shown. It is evident that in this case, multiple burst-signals are reaching the sensor almost simultaneously. Unsupervised clustering and supervised classification of acoustic events are based on the assumption that each waveform represents a single damage mode. Figure 3(e) shows that this assumption does not hold close to final CAI failure. This makes both unsupervised clustering and supervised classification of damage modes unsuitable for separating different damage modes close to failure, which is the region we were most interested in investigating.

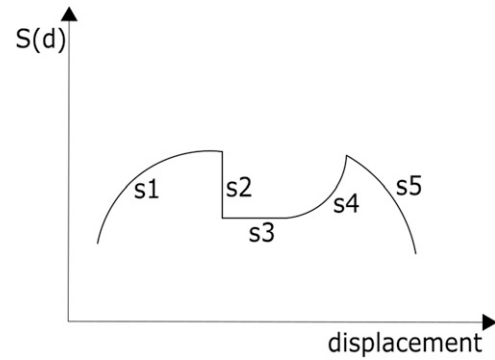
Figure 4. Sentry function/displacement plot. The possible trends that can be found in actual test are shown.

As the applied compression displacement increases linearly, different trends can be expected in the sentry function (Figure 4): *increasing trend* (s1) corresponds to a strain energy storing phase where mostly micro-damage is formed, this means that the capability to store strain energy is higher than the acoustic activity; *sudden drop* (s2) corresponds to a fast release of acoustic energy and possibly a drop in stiffness, this was associated with coalescence of micro damage leading to macro damage¹⁹; *constant trend* (s3) is a state of equilibrium between the storage of mechanical energy and the AEs activity; *increasing after drop* (s4) suggests that the previous event didn't cancel the capability of the material to store mechanical energy; *decreasing trend* (s5) the capability to store strain energy is now less than the acoustic activity. It is important to remark that the sentry function depends both on acoustic activity and mechanical energy. For example a sudden drop (s2) could be due to an increased acoustic activity and/or a stiffness drop.

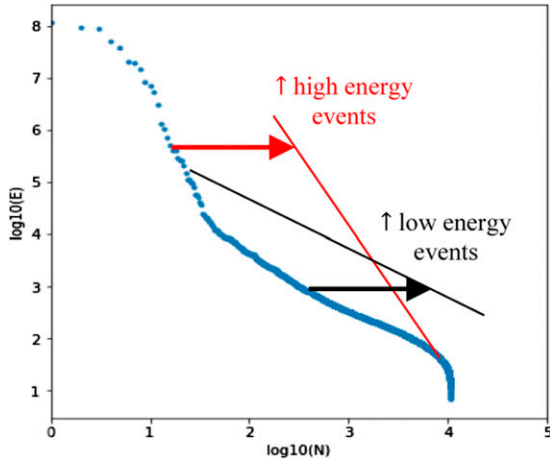
Figure 5. AE event occurrence versus event energy plot. In red a relative increase of high energy events is represented while in black a relative increase of low energy events is represented.

Where $N_{\bar{E}}$ is the number of events with energy $\leq \bar{E}$ and \bar{E} is the acoustic signal energy value. As in case of seismic events, in a log-log scale a linear relationship well fits the results for AE data. The value of the slope b can be seen as an indication of how frequent high energy acoustic events are compared to low energy events (Figure 5). As the compression displacement is increased during the test, an increasing number of AE hits are recorded and different trends can be expected in the b value (Figure 6). In case of *decreasing trend* (b1) AE activity has the form of accumulation of a large number of low energy events. In case of

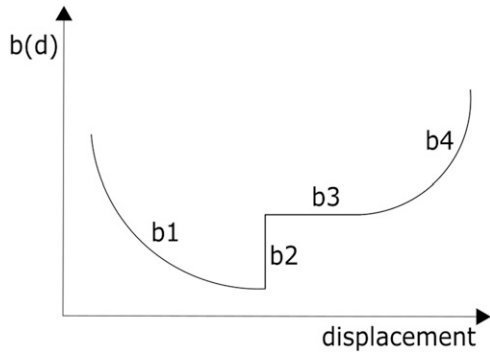
Figure 6. b-value/displacement plot. The possible trends that can be found in actual test are shown.

a *sudden increment* (b2) there is a fast release of great amount of acoustic energy in the form of high energy hits. If a *constant trend* (b3) is observed as acoustic activity continues, an equilibrium is present between the occurrence of high energy hits and of low energy hits. Finally, a *gradual increasing trend* (b4), suggests an AE activity gradually shifting towards high energy events. It is important to remark that the b value is a ‘cumulative’ quantity, which takes into account all the previous acoustic events and that the relationship is expressed in a log scale. A constant value of b does *not* mean that high and low energy events are added at the same rate. It means that new events occur following the frequency of occurrence that characterized the test until that point.

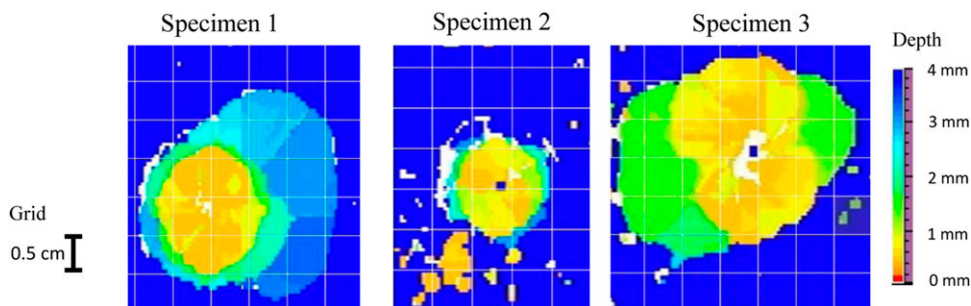
Figure 7. Close up C-scan images of the impacted specimens, showing multiple delaminations at different depths. The images are cropped to show the full delamination; the impact contact point was always in the centre of the specimen, in accordance with ASTM D7136.

The numerical study of CAI failure by Yang⁹ suggested that the CAI failure mode (delamination vs fiber kinking) could be highly dependent on the initial impact damage configuration. The high variability of the initial impact damage (Figure 7) together with the variability registered in damage mode repartition close to CAI failure suggests that this hypothesis formulated by Yang may be correct.

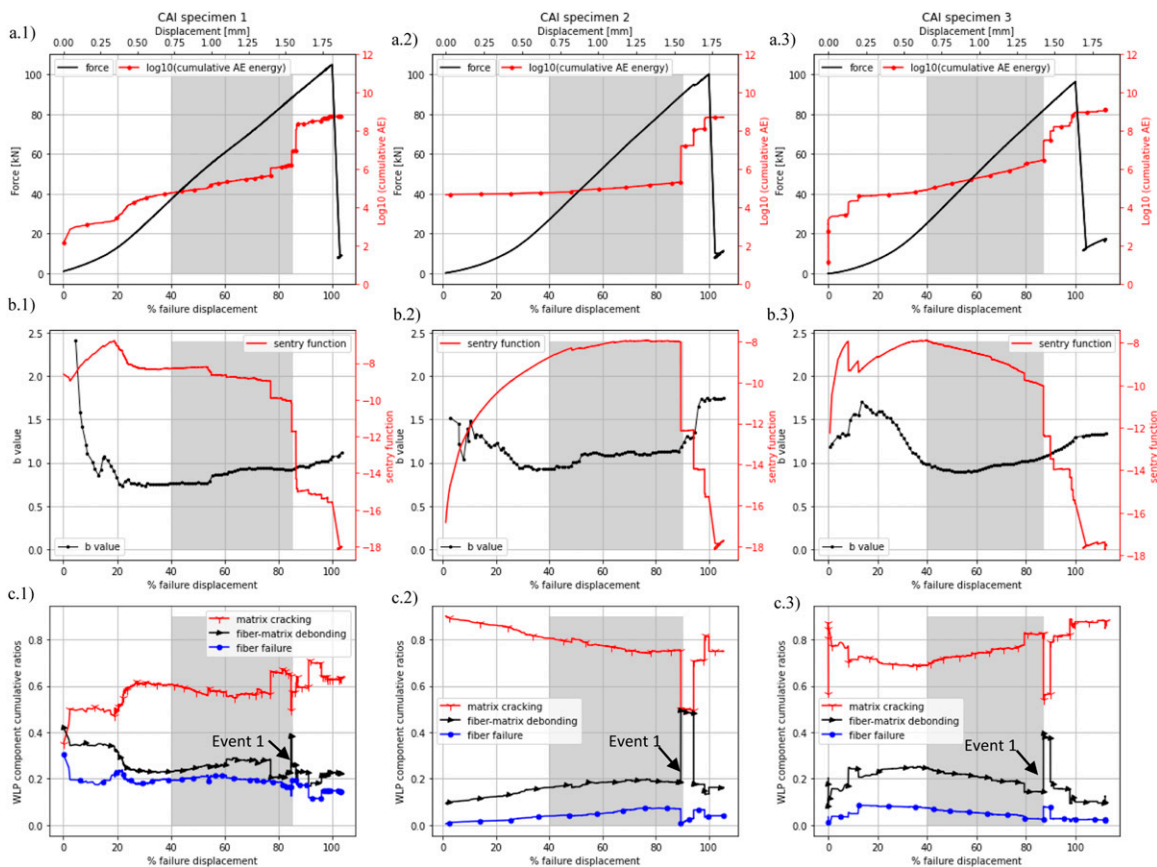
Figure 8. CAI tests of specimens 1-2-3. Images (a1)-(a2)-(a3) show the load displacement curve and the \log_{10} of cumulative acoustic energy. Images (b1)-(b2)-(b3) show the sentry function and b-value. Images (c1)-(c2)-(c3) show damage modes repartition. The grey area indicates the stable damage accumulation zone.

There is good agreement in load displacement curves between the three CAI tests (Figures 8(a1)–(a3)). The specimens showed a constant stiffness until final failure. Only in specimen two, a small drop in force is observed before failure.

Acoustic energy (measured in attoJoule) was released from the beginning of the test (Figures 8(a1)–(a3)). This early release of acoustic energy can be explained by the presence of a large impact damage, causing high local stress at the geometrical discontinuities, even at relatively low applied stress. In all three specimens there is a phase of steady accumulation of damage, where the cumulative AE energy appears to be linear in the logarithmic scale. After that, all tests show a sudden increase of cumulative AE energy, starting after 80% of CAI failure displacement, suggesting that an unstable mechanism could be triggering the increase of acoustic energy released (Figures 8(a1)–(a3)). It is noteworthy that this event was not accompanied by a noticeable drop of stiffness in any of the specimens.

Damage stabilization. In all the specimens, a first phase of increase of sentry function is observed (Figures 8(b1)–

(b3)). This can be attributed to a phase of strain energy storing and relatively low acoustic activity. Although damage is accumulated, as proven by the cumulative acoustic energy (Figures 8(a1)–(a3)), it does not degrade the capability to store mechanical energy, since no change in the global stiffness is observed. During this phase a decrease of the b-value is observed (Figures 8(b1)–(b3)). This suggests that mostly micro-damage is propagating during this phase, since AE energy is released in the form of many low energy events. During this phase, damage mode fractions are chaotic and there is no good agreement between the different specimens (Figures 8(c1)–(c3)). To explain this, it must be considered that wavelet ratios are cumulative quantities (equations (4) and (5)). A single fiber fracture happening at the beginning of the test, has more effect on the wavelet cumulative ratios compared to the same event happening at the end of the test. At the beginning of the test, all damage modes can potentially happen in weak areas of impact damage. Due to the stochastic nature of initial impact damage, no good agreement is found between the different tests. However, as the test goes on, the results converge towards a similar repartition between damage modes in different specimens.

In all the specimens a constant trend is observed in the b-value (Figures 8(b1)–(b3)). This means that the relative frequency of occurrence of the high energy peaks and low energy peaks does not change during the test as acoustic energy is progressively released.

The damage modes repartition evaluated with cumulative ratios of wavelet packet components, remains stable and assumes similar values in the different tests (Figures 8(c1)–(c3)). It can be observed that during this phase matrix cracking is the predominant damage mode but debonding is still not negligible in terms of energy dissipation.

Unstable damage accumulation. In all the specimens, the end of the stable damage accumulation is determined by a significant and sudden increase of the released acoustic energy (Figures 8(a1)–(a3)). It is interesting to observe how

During this phase an increase in b value is observed in all the specimens, meaning that new hits come in the form of relatively high energy events (Figures 8(b1)–(b3)). This indicates that larger scale damage is now formed, compared to the previous phase of the tests.

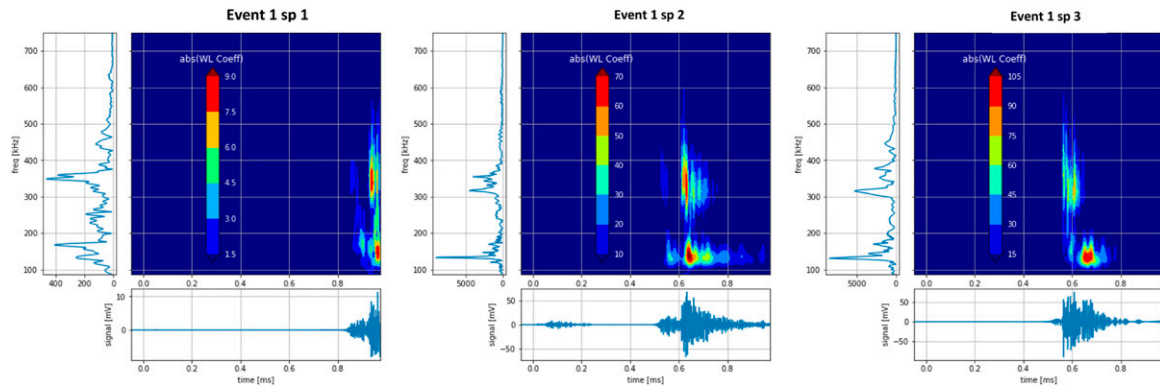
Figure 9. Continuous Morlet wavelet plot of event one in the three specimens.

debonding (intermediate frequency event). The event causing this change is called here ‘event 1’ and was studied in more detail using a continuum wavelet analysis (Figure 9). By looking at the scalogram in Figure 9, it is evident that the event one in all three tests looks very similar and can be classified as waveform type c (cf. Figure 3(c)), which we attributed to a combination of debonding and matrix cracking. In all tests a second event was observed, releasing a large amount of energy in the matrix cracking frequency range. After these events, the damage mode fraction evolution (as a function of displacement) largely differs in the different specimens. It must be considered that wavelet packet ratios must not be taken as an exact repartition between damage modes, since there are overlaps in the spectrum of the different waveform type (Figure 3) but they can be useful to analyze trends in the damage accumulation.

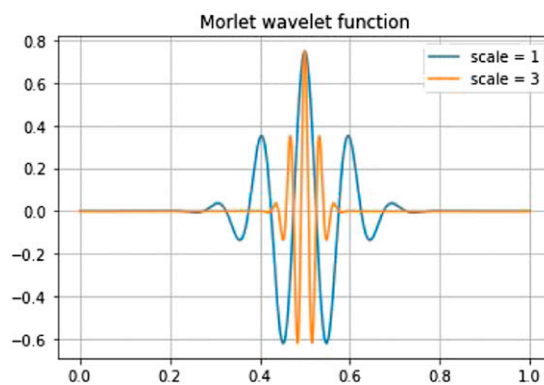
Figure 10. Example of Morlet wavelet function at different scales.

The big advantage of WT compared to traditional short time Fourier transform (STFT) is that it provides an adapted time-frequency resolution. This because the dilation of the mother wavelet, achieved by varying the scale parameter a , determines that short time windows are analyzed for high frequencies (detail components) while longer time windows are analyzed for low frequencies (approximation components) (Figure 10). If the scaling and translation parameter are continuous, $X_{a,\tau}$ is called a continuous wavelet transformation. This class of wavelets is useful in case the maximum information is needed to analyze a signal, but they are computationally expensive, hence difficult to apply to large data. To reduce the computational cost, a discrete wavelet transformation can be used instead, by analysing a reduced number of scales.

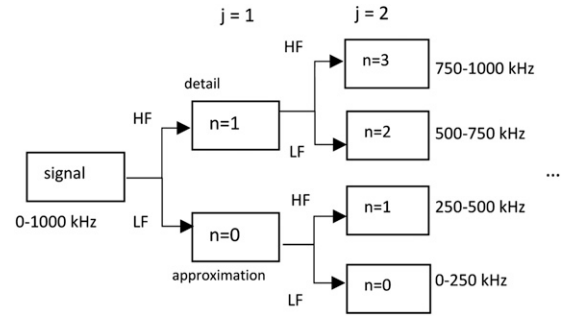
Figure 11. Example of wavelet packet decomposition tree; j are decomposition levels and n are components. HF stands for high pass frequency filtering while LF stands for low pass frequency filtering.

Wavelet packet transforms (WPT), are discrete wavelet transforms allowing to decompose the signal into wavelet packet components covering equal frequency sub-bands. This is achieved by decomposing the original signal into a low frequency component (approximation) and high frequency component (detail). This operation is repeated multiple times until reaching the desired decomposition level (Figure 11). Given a decomposition tree like the one showed in Figure 11, the frequency range f_{range} covered by each component can be determined knowing the level of decomposition j , the component number n and the sampling frequency of the original signal fs .
