Combining Architectural Conservation and Seismic Strengthening in the Wood-Based Retrofitting of a Monumental Timber Roof

The Case Study of St. Andrew's Church in Ceto, Brescia, Italy

Mirra, Michele; Gerardini, Andrea; Ghirardelli, Sergio; Ravenshorst, Geert; van de Kuilen, Jan Willem

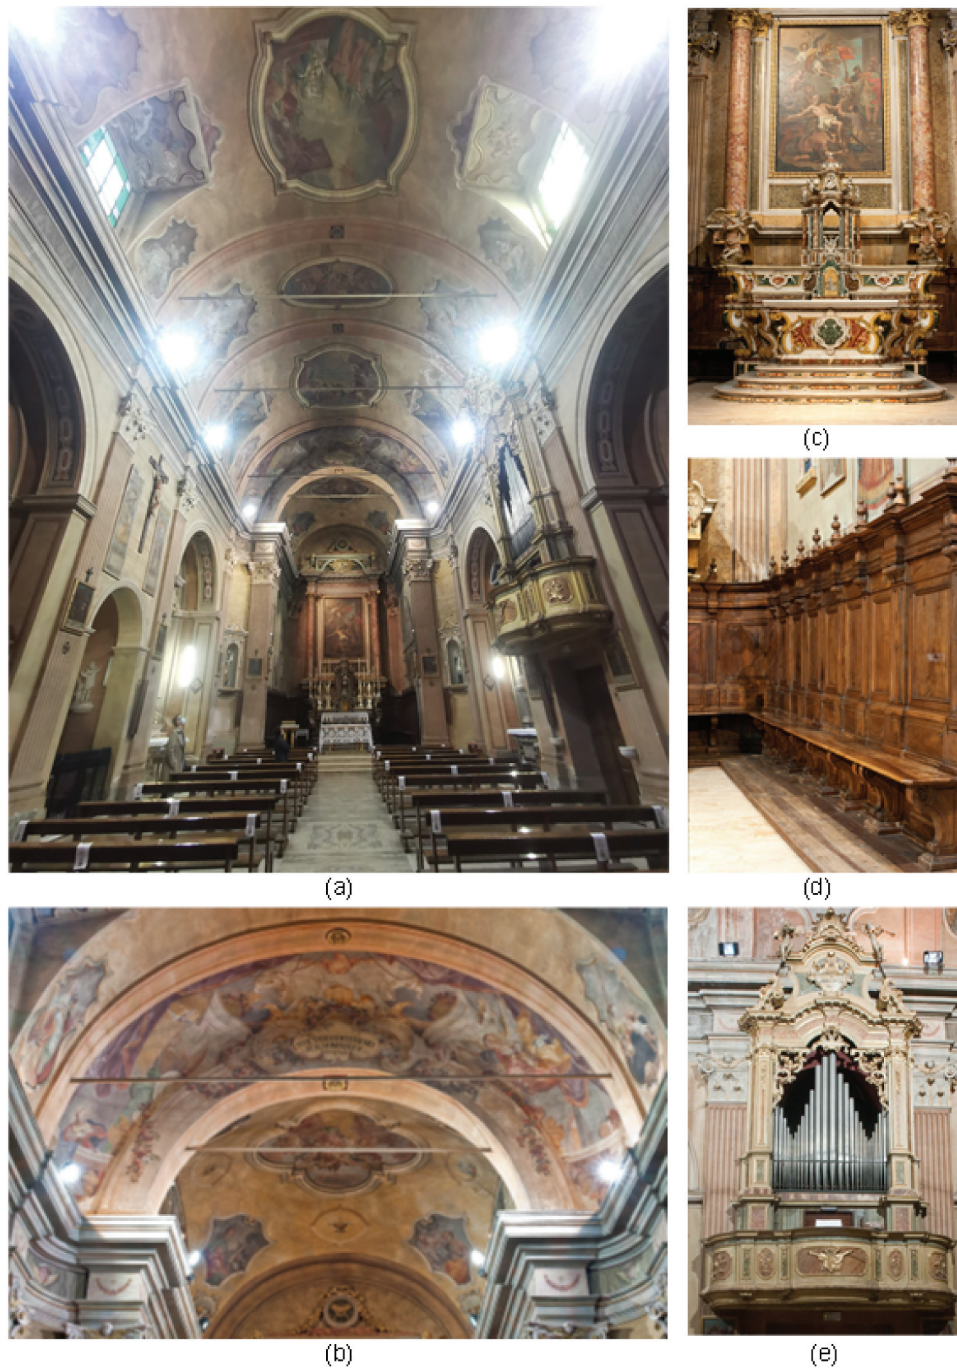
Figure 2. (a) View of the interior of the church; (b) particular of the frescoed triumphal arch; (c) high altar with polychrome marbles; (d) original walnut choir; (e) organ from 1779.

Bartolomeo Litterini. These finishing works provided the church with the present sober, but valuable appearance from both the artistic and the architectural point of view (Figure 2). The late-baroque façade features a stringcourse separating it into two portions, both embellished with pilasters; in the lower portion the entrance is present, surmounted by a semi-circular tympanum, while the upper one has a rectangular window and a curved pediment with acroteria. The 28-m-high bell tower is adjacent to the church but separated from its lateral buttresses and is made of granite blocks. The interior of the church has surfaces decorated in relief, wall paintings, and frescos, and consists of a single nave with four side chapels. The walls are marked by pilasters supporting a projecting cornice, above which a barrel vault with lunettes is found, having four openings in correspondence to the side chapels.

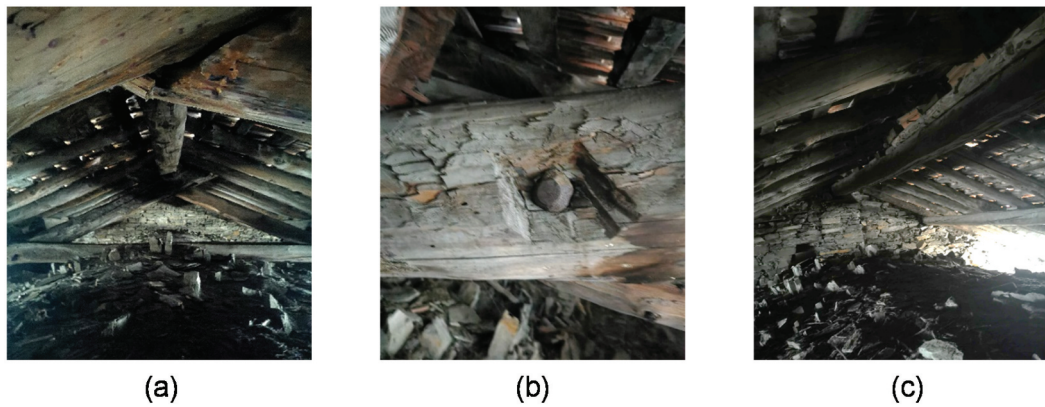
Figure 4. (a) Existing wooden roof structure; (b) existing metal pin between timber struts and ties; (c) ridge beam undergoing excessive deflection.

The original monumental roof (Figures 3–4), dated back to the beginning of 18th century, entirely consists of wooden structural elements, arranged as follows:

The wooden roof structure was found in fair state of conservation but was very difficult to inspect, as the attic of the nave and the apse is narrow and normally not accessible. The main rafters, including the ridge beam (Figure 4c), appeared to be very undersized, also considering the spans involved, up to 8 m: large deflections could be observed, which had been compensated over time by additional wooden blocks, to keep the support for the secondary beams as horizontal as possible. These secondary elements seemed better dimensioned and sound, but a small number of joists (approximately 15% of the total) were locally affected by biological degradation, caused by slight water infiltrations. The main wooden struts and ties were sound as well, and according to the static calculations performed, had adequate dimensions for their structural purpose. Yet, the existing connections with metal pins (Figure 4b) were not effective, because the holes in which they were located had become too large over time: thus, the ties could not fully absorb the horizontal thrusts induced by the struts, which seemed to be partly taken by the masonry buttresses.

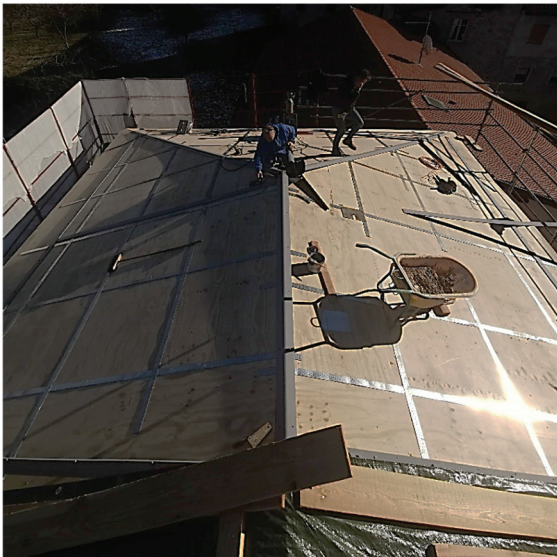
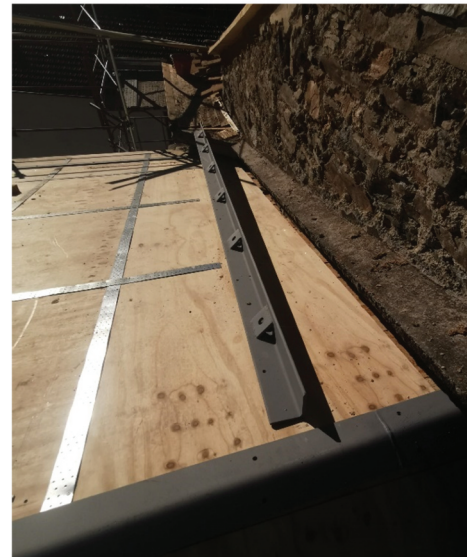
Figure 5. (a) Overview of the seismic retrofitting interventions; plywood panels overlay above the nave (b) and the apse (c); steel profile for the connection to masonry (d).

S275 100×10 mm perimetral steel plates

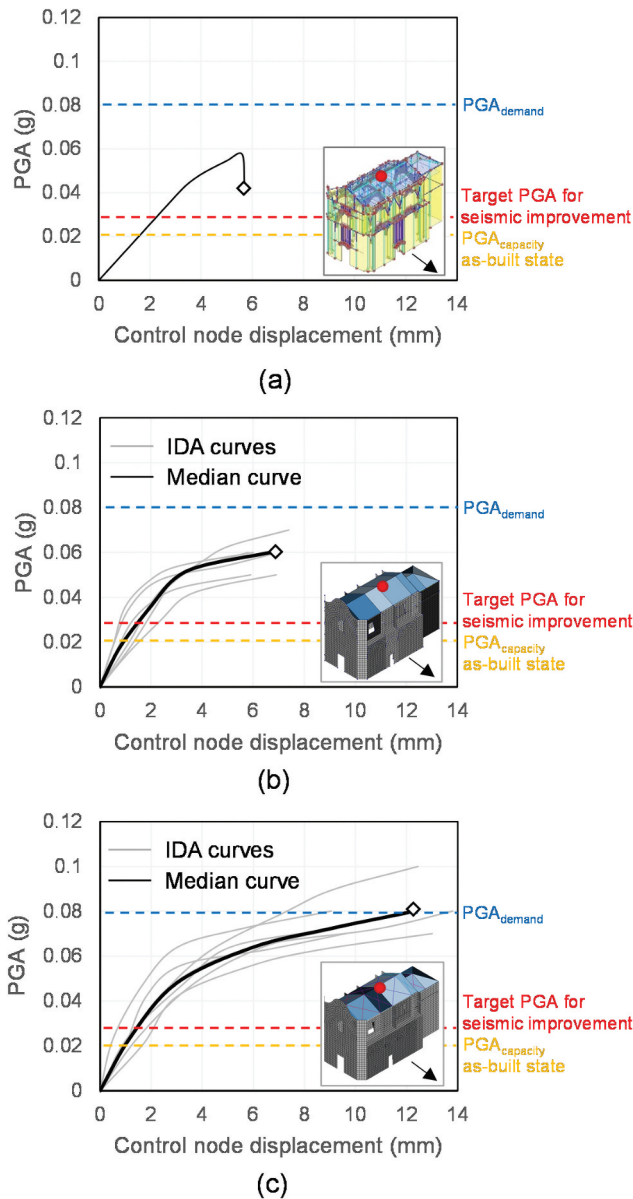
Figure 13. Results from incremental dynamic analyses (IDA) for the most vulnerable direction (X). As a reference, the governing pushover curve from the first model in PCM.Aedes scaled in terms of PGA is shown (a), together with the IDA curves of the configurations with rigid (b) and dissipative (c) roof modelled in DIANA FEA.

The modal analysis executed on the second configuration of the model led to slightly larger values of the periods, since the strengthened roof was not considered anymore as rigid. In this case, the obtained periods were 0.50 and 0.30 s along the X and Y directions, respectively. Besides, from the results of time-history analyses, accounting for the actual cyclic, dissipative response of the retrofitted roof, an average PGA at collapse of approximately 0.08 g ($\pm 12.5\%$) along the governing X direction, was obtained. In other words, it appears that the case-study church could be able to survive the expected design seismic action for Ceto. This highlights the great contribution of wood-based seismic retrofitting techniques able to increase the displacement capacity and activate energy dissipation in the roof, whose contribution is evident in this case (Figures 12c, 13 and 14).
