**Building water quality deterioration during water supply restoration after interruption
Influences of premise plumbing configuration**

Water Research

Building water quality deterioration during water supply restoration after interruption: Influences of premise plumbing configuration

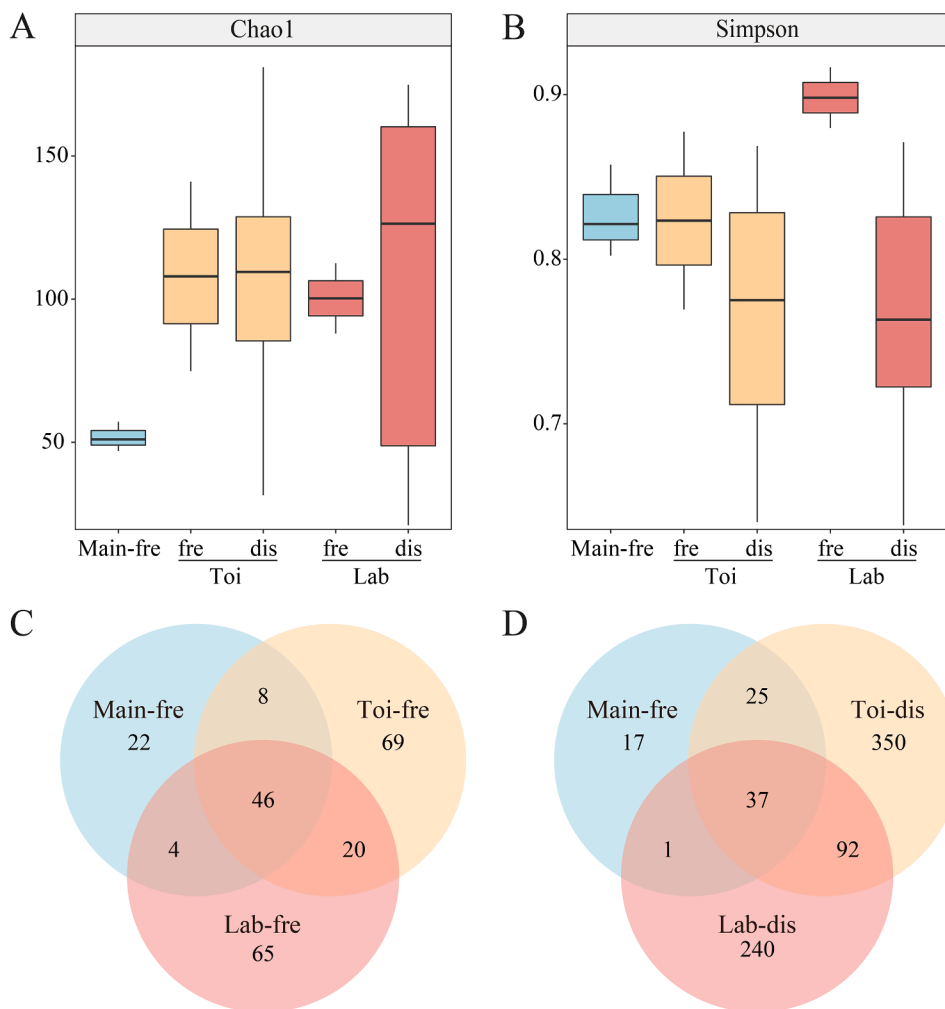
Fig. 3. A) Chao 1 indices of different sampling groups; B) Simpson diversity of different sampling groups; C) Venn diagram among fresh samples; D) Venn diagram among disturbed samples.

showed higher values and larger variations than the toilet samples. The higher species richness in disturbed samples during water supply restoration was better revealed by the Venn diagram in Fig. 3C and 3D.

Interestingly, although the species richness was higher in Lab-dis and Toi-dis, their Simpson diversities were much lower than those in Lab-fre and Toi-fre (Fig. 3B), indicating that the relative abundances of community members in fresh samples were more evenly distributed, while the community of planktonic bacteria during water supply restoration was possibly predominated by a few species. This is directly confirmed by the bacterial community composition results in the following section. Moreover, during regular water supply, toilet plumbing did not influence Simpson diversity, whereas laboratory plumbing clearly increased the Simpson diversity of the bacterial community (Fig. 3B).

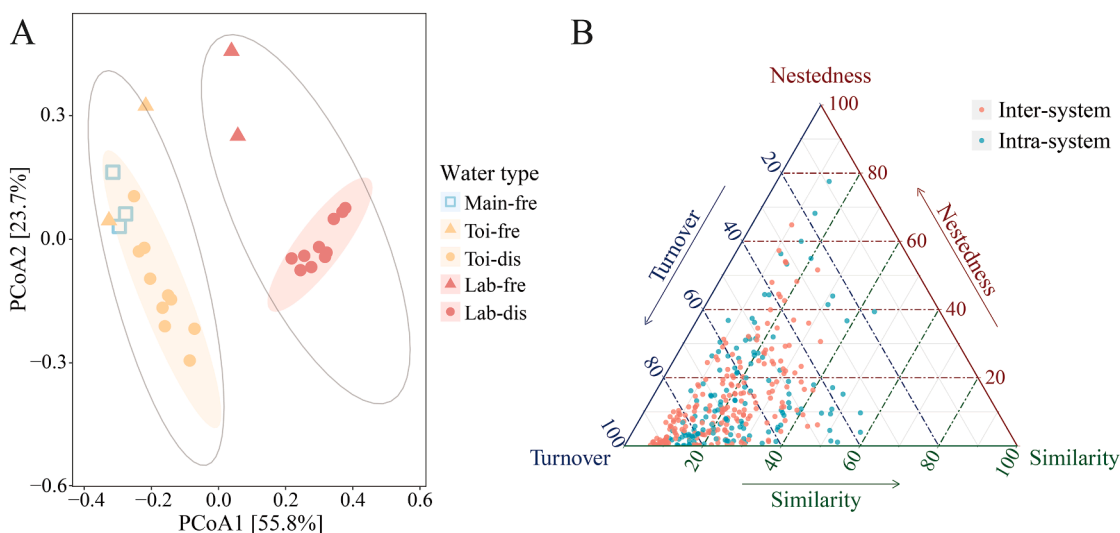
Fig. 4. A) PCoA plot based on Bray-Curtis dissimilarity; B) triangular plots of beta-diversity partitioning (using Jaccard dissimilarity index) comparisons for bacterial communities. Each point represents a pair of samples.

The PCoA plot showed clear clusters of sample groups, indicating the dissimilarity among their bacterial communities (Fig. 4A). According to statistical tests, both plumbing configurations and water supply interruption/restoration significantly influenced the planktonic bacterial community (PERMANOVA, $P < 0.05$, Table S1), while the variances were mostly explained by the former ($R^2 = 0.537$, Table S1). Comparing the fresh samples, the bacterial community of Main-fre is similar to that of Toi-fre (overlapping) but different from that of Lab-fre (different clusters), confirming the significant influences of the plumbing configuration. During the restoration of the water supply, Lab-dis clustered closely together and completely separated from Lab-fre, while Toi-dis is more dispersed and separated from Toi-fre samples. The differences between Lab-dis and Lab-fre are sharper than that of Toi system. This means sharper changes may occur in laboratory plumbing during water supply restoration, which complied with the visually observed discoloration in Lab-dis samples, as mentioned above.

To reveal the underlying mechanisms of variation in microbial assembly, the beta diversity was further partitioned into species turnover and nestedness (Fig. 4B). The average Jaccard pairwise dissimilarity
