Experimental and Numerical Assessment of Historical Steel-Concrete Composite Bridge Decks Without Mechanical Connectors

Poliotti, Mauro; Yang, Yuguang; De Boer, Ane

Abstract. In old Dutch inner cities like Amsterdam a large number of steel-concrete bridge decks built between 1880 and 1960 remain in service nowadays and currently need assessment of their bearing capacity. A significant number of these decks were designed without any mechanical connectors like shear studs in the interface between concrete and steel. Moreover, the concrete decks were designed with only shrinkage reinforcement in both directions on the top layer of concrete. No additional transverse reinforcement was placed that can ensure proper (re)distribution of loads after cracking. In order to study the bearing capacity of this deck typology, two specimens of an existing bridge were taken to the Stevin Lab of TU Delft and tested until failure. In this work, the experimental results of both tests are presented. Then, finite element models including nonlinear behaviour of the materials and the interface are presented and compared with the experimental observations. Experimental results show that the bearing capac

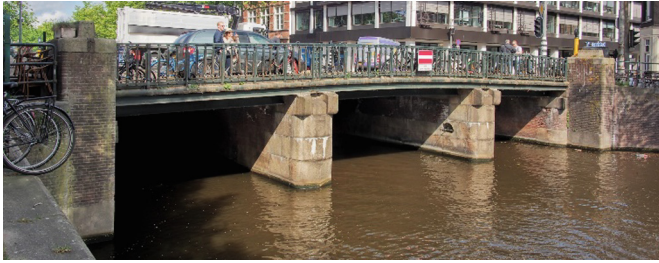
Fig. 1. Picture Bridge 70 Vijzelstraat, Amsterdam. Picture adapted from Google.

A particular type of bridges that has brought attention lately is the steel-concrete-composite slab deck. These bridges were designed and built between 1880 and 1960, and around 150 are still in operation in Amsterdam [1]. These bridges are multi-span bridges, and the cross-section of the deck is composed of partially encased steel beams, see Fig. 1 and Fig. 2.

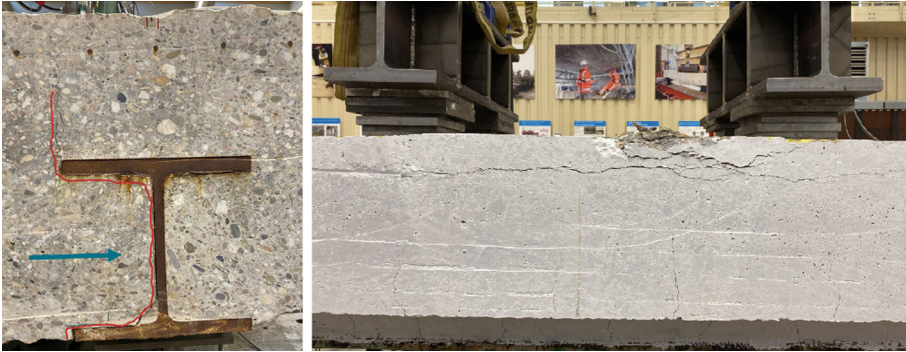
Fig. 7. Observed Failures. Left: Specimen LB1. Right: Specimen LB3

Specimen LB1 failed in a brittle manner after the development of plastic deformations in the steel beams. Interface failure occurred suddenly on one of the outer beams. This happened jointly with an increase of the transverse displacement between the outer and centre beams. Moreover, longitudinal cracks were observed between the beams. That also explains the increase of transverse displacements. In Fig. 7-left shows how the crack reached the end of the specimen at failure.

In the case of LB3, the specimen failed in a ductile manner exhibiting progressive concrete crushing on the top layer of concrete, see Fig. 7-right.

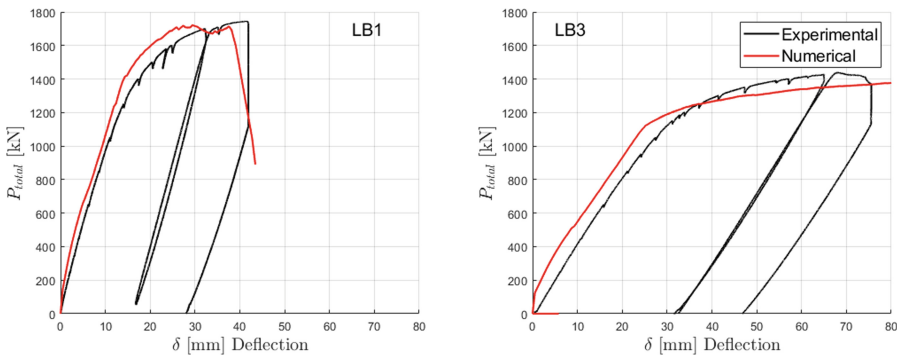
Fig. 8. Total applied load vs deflection curves obtained experimentally and numerically

The experimental load-deflection curves of both specimens are shown and compared with the simulation results from the numerical models in Fig. 8.

Comparing both experimental curves, it can be seen that LB3 has more ductile behavior, while LB1 shows a sudden drop of its bearing capacity with limited deformation. Further, it can be seen that good agreement is obtained between numerical and experimental results in terms of maximum load and stiffness. The ductility of LB1 is also well captured by the numerical simulation.

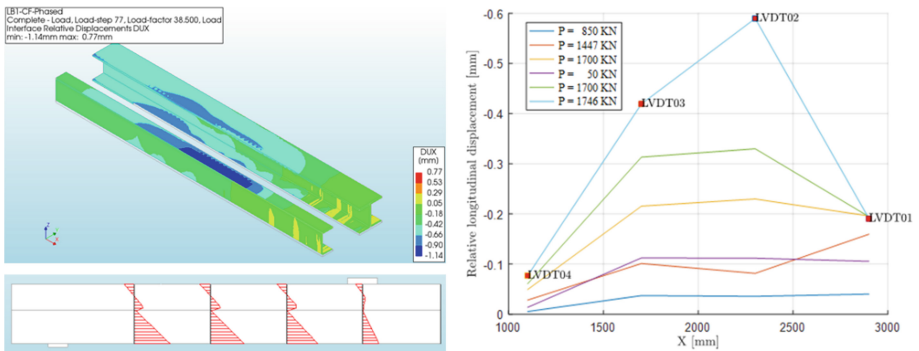
Fig. 12. Interface Behavior LB1 - Top Left: Longitudinal Interface slip. Bottom Left: Relative displacement profile at central beam. Right: Slip measurements at different locations

Another source of difference between both specimens was the interface behaviour. In LB3 minor slips were observed during the test and on the numerical models. LB1 exhibited interface activity at early stages of the test, see Fig. 12-right.

During testing of LB1 the interface slip was distributed longitudinally but without reaching the element ends. Full propagation of the interface failure occurred at ultimate stage and on one of the outer beams, contrary to the expectation of interface failure at the more loaded centre beam.

The overall interface behaviour was well captured by the numerical model. In Fig. 12 shows that partial interaction was simulated. A more accurate quantification of the interface behaviour requires the precise estimation of the interface parameters.
