Historical Wooden Pile Foundations in Amsterdam

An Integrated Approach for the Estimation of Structural Performance and Residual Service Life

Structural Analysis of Historical Constructions

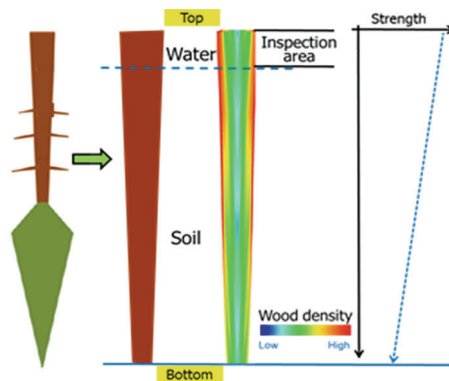
Fig. 2. Sketch of a sound tree stem as foundation pile upside down; possible density development along the length of the pile (colored picture); possible strength development along the length; accessible inspection zone at the top of the piles.

14 m in length. The piles are normally tapered. The wood species is mainly spruce (*Picea abies* (L.) H. Karst). In total, 60 complete piles were retrieved from different locations. The piles under the bridges are below the water table, surrounded approximately by 1.5 m of free water before entering the saturated soil (more than 85% of the pile) where the pile is not accessible for inspection. The physical and mechanical properties of the pile such as density and compression strength vary along the height and the cross-section, because of the natural variability of the stem of the tree (Fig. 2). In a sound foundation pile, higher mechanical/physical properties can be expected at the top (bottom of the tree) and lower properties at the bottom of the pile [1]. This is because of the natural growth of a tree. The foundation piles are placed in the soil by turning the tree stem upside down (Fig. 2).

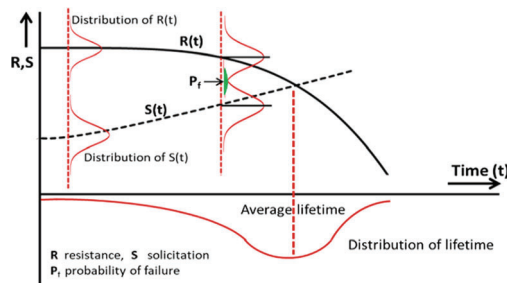
Fig. 4. Lifetime distribution of structures

Basically, strength and loads have to be far enough away from each other in order to avoid structural failures during the lifetime of the structure (Fig. 4). If the strength and loads are modelled as standard normal distributions, then Fig. 5 gives insight in the probability of failure. The greater the overlap between the two curves, the higher the probability of failure.

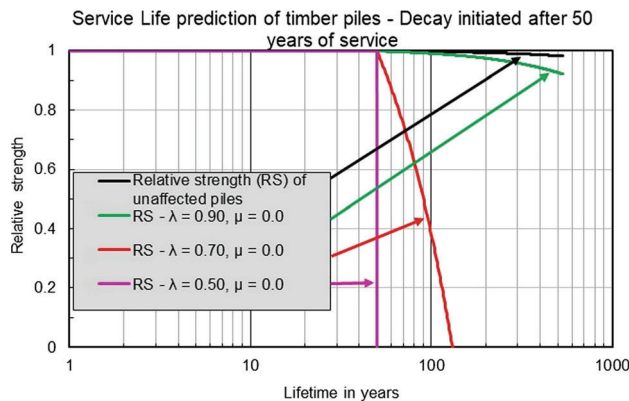
Fig. 5. Lifetime prediction of timber piles. Scenario: Biological decay initiated after 50 years, decayed wood has 0% strength of non-decayed wood, Cross section reduced by 10% (green line), 30% (red line) and 50% (pink line) [8]

In Fig. 5 an example is given for Service life calculation taking in consideration dead load, assumed live loads and biological decay with associated decay rates [8]. It can be clearly observed that the residual carrying capacity decreases over time while the accumulated damage increases (relative strength reduces).

In this example, it is assumed that the remaining strength of decayed wood is zero, which is a safe approximation, so $\mu = 0$. However, if that would not be the case, then the value of μ can be easily adapted in the model, and the remaining service life will automatically increase. By the way the model is formulated (Eq. 2), the stress on the remaining sound cross section will automatically increase when the decay progresses, so for each period Δt , the damage increase $\Delta\alpha$ will increase a bit more as the stress ratio $\sigma(t)/f(t)$ increases with the ageing process, see Fig. 6. From the analysis it follows that if half of the original cross section is degraded at $t = 50$ years, the residual lifetime drops to 0 almost instantly, but if it is reduced by 30% (so 70% remaining), the residual lifetime is still considerable with almost 100 years before structural failure. This shows that time to failure processes are really sensible for the load level on the one hand, directly influencing the remaining service life. These processes are logarithmic on the time-scale. For foundations the main load component is dead load. Variable loads from traffic are also present, but over the history of 100–300 years are less relevant. More important is to get an accurate estimate of the constant dead load over the pile's history. In that case the damage Eq. (2) is more straightforward to solve regarding the applied load. The failure process is then governed for long term static loading, without having the complexities of random variable loading. The assessment of parameters affecting the load bearing capacity is however, complex. Measurable assessment parameters are very limited, since only a very small 'window', approx. 10% of the whole pile at the top, is available for the assessment, and from this assessment, an estimate for the entire pile must be made.

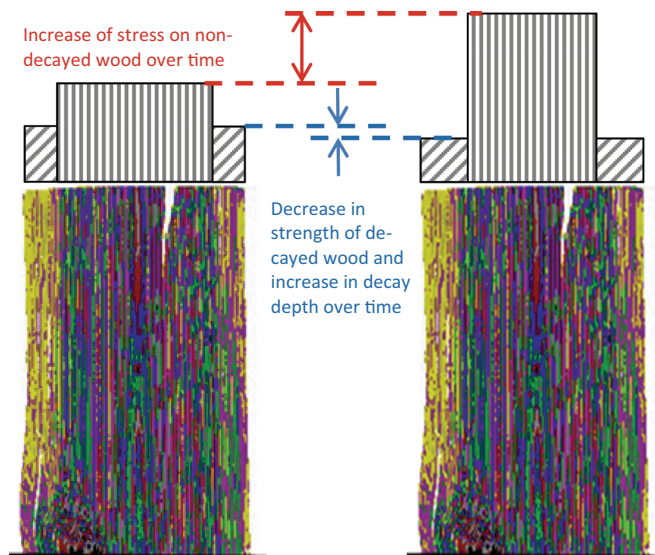
Fig. 6. Effect of stress redistribution over the pile cross section as a result of increasing decay, CT scan of a decayed pile section in longitudinal direction, low density: yellow, high density: blue)

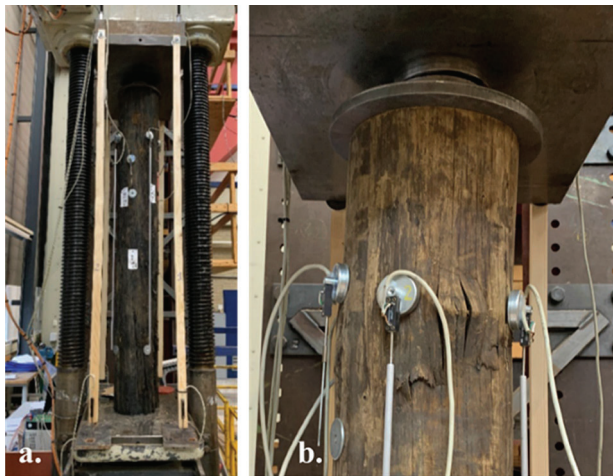
Fig. 9. a. Set-up for compression tests, b. LVDTs are mounted around knots.

Before testing, the piles are submerged to reach the wet condition for the compression test, which means a moisture content higher than 70%. Figure 9 shows the compression test set-up with pile sections up to 1800 mm length. LVDT sensors are placed between the plate heads and on the piles themselves to determine the static modulus of elasticity. In order to obtain both global and local strength and stiffness information, LVDT measurement devices are placed over the length of the section, over the section with the largest knots (location of whorls) or the section that is expected to fail in compression first. Because of eccentricities of knots in the cross section, failure may concentrate on one side of the pile only. Apart from compression wrinkles, longitudinal cracks also develop at later stages.

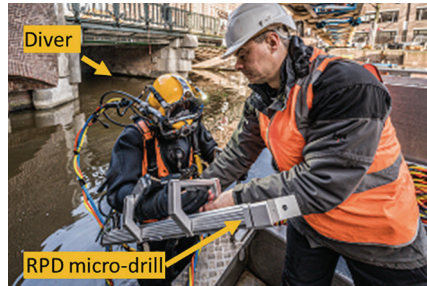
Fig. 10. RPD deployment underwater by a diver.

One of a few semi-non-destructive and in-situ methods that is available for wood inspection is micro-drilling, such as IML-RESI PD. An IML-Resi for underwater use (hereinafter RPD), is currently developed and in a trial stage on timber foundation piles under bridges and quay walls in Amsterdam/Netherlands (Fig. 10.). In [14] an extensive analysis of microdrilling resistance and some of the pros and cons of the technology

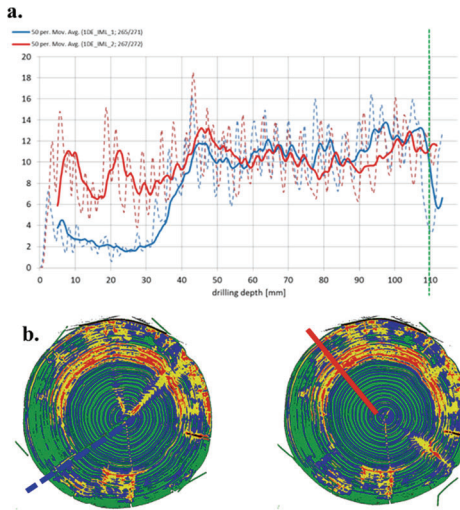
Fig. 12. a. microdrill measurements over half of the cross-section of the pile a 2 different spots of the circumference, b. CT scans of the cross-section confirming the density map (high density: red, low density: green).

The spectrum of the microdrilling measurements along half of the cross-section of the piles show annual ring profiles, with maximum amplitudes marking latewood and minimum amplitudes pointing towards earlywood (Fig. 12). There are also extreme maximums and minimums. Those with higher values can be associated with the knots and other high-density anatomical variations, and lower value extremes pointing towards piths and cracks. Figure 12 shows a not evenly decayed cross-section of a pile where 2 microdrillings were applied at different locations. The blue line (drilling amplitude) in Fig. 12. a. shows a considerable low density area at the outer layer of pile which is recognised as decay, in comparison to the red line shows a higher density which is recognised as less decayed. Both lines are confirmed by CT scans of the cross-section where high and low density areas can be identified. The blue and green colour indicates lower densities. Lower density areas towards to the pith of the pile indicates the juvenile wood and not decayed by bacteria.

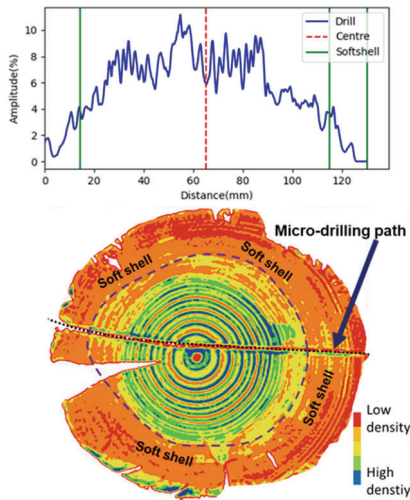
Fig. 13. Microdrill measurement along the whole diameter of the pile with a severe decay (soft shell) at both sides: left and right, blue line in the graph is the drilling amplitude.

The degree of decay is defined by the relative density differences compared to sound wood, which can be assumed in the centre part of the pile cross-section. For very severe decay areas the term 'soft shell' has been introduced. In Fig. 13. a microdrilling is carried out along the whole diameter of the pile. A 'soft shell' of around 18 mm is indicated from the outside towards the centre of the pile. Also here, the area of the juvenile wood can be identified.

Even if the inspection area at the pile top in-situ is very restricted, with the ‘new’ development of the RPD for under water use, relevant information about the state of the piles can be obtained. With these data a ‘pile model’ has been developed to determine the state of the wood along the whole pile length with regard to the decay, sapwood, juvenile wood, density and pile shape (taper). The ‘soft shell’, identified through micro-drilling at the top of the piles, can have a considerable influence on the remaining load carrying capacity and the average modulus of elasticity (MOE) of the pile cross section as shown Fig. 13. Also, the overall specific gravity shows a high correlation with the MOE ($R^2 = 0.70$) (Fig. 14).

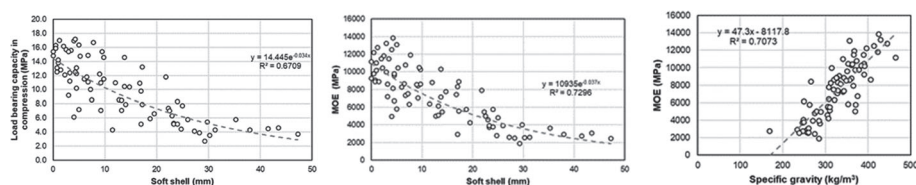
Fig. 14. Correlation between soft shell width and load carrying capacity in compression (left graphic) and the MOE (middle graphic) and the correlation between specific gravity and MOE (right graphic).
