## Chloride-induced corrosion of steel in concrete—insights from bimodal neutron and X-ray microtomography combined with ex-situ microscopy

Angst, Ueli M.; Rossi, Emanuele; Boschmann Käthler, Carolina; Mannes, David; Trtik, Pavel; Elsener, Bernhard; Zhou, Zhou; Strobl, Markus

Materials and Structures/Materiaux et Constructions

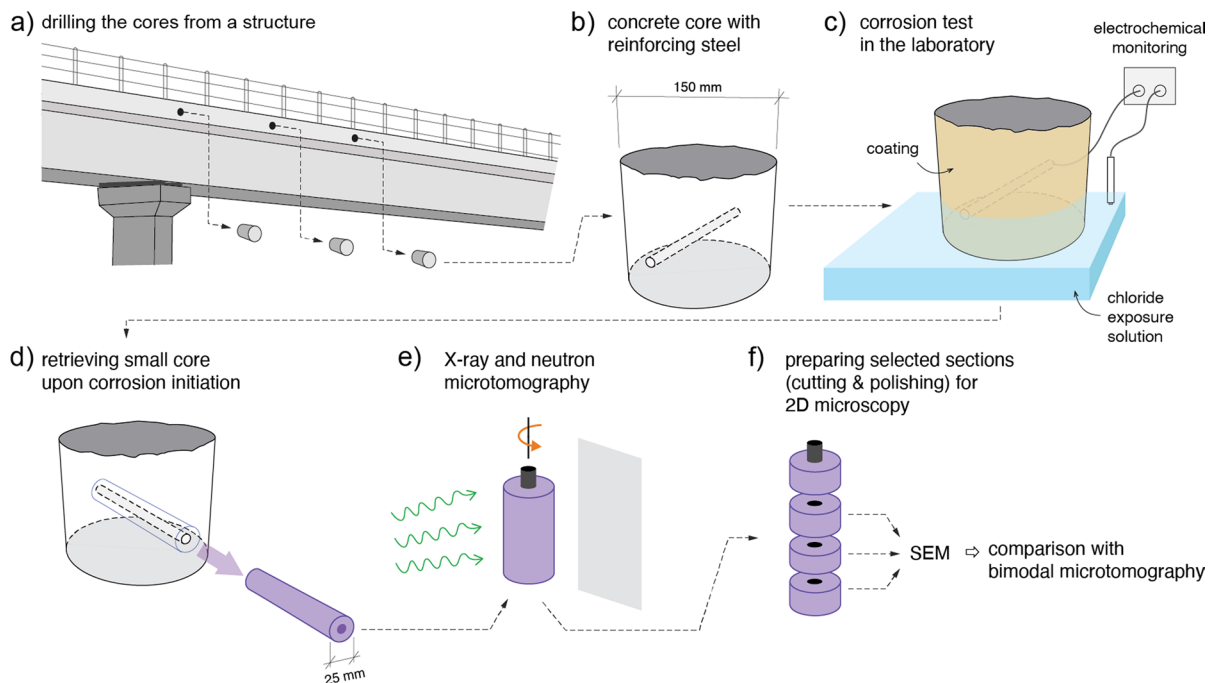
**Fig. 1** Sequence of experiments from retrieving samples from a reinforced concrete bridge (**a, b**) over corrosion testing in the laboratory (**b**) to the in-situ study of the samples in an early

stage of corrosion by means of X-ray and neutron microtomography (**d, e**) and comparison with classical ex-situ microscopy (**f**)

Four concrete cores were retrieved from the edge beam (top side) of a reinforced concrete bridge in Switzerland (labelled as B1-E1), the construction of which was completed in 2004 (Fig. 1a).

At the time of sampling, the age of the structure was ~15 years. The diameter of each concrete core was 150 mm, and it contained a ribbed reinforcing steel bar of diameter 10 mm (Fig. 1b). The rebar was oriented horizontally in the structure (first reinforcing steel layer). No sample was corroding at the time of coring, as evidenced by potential measurements [30] on the structure prior to sampling. More

To induce corrosion of the embedded reinforcement, the reinforced concrete samples were placed in a 10% sodium chloride solution to allow for chlorides to diffuse into the concrete and to trigger corrosion of the steel bar (Fig. 1c). The electrochemical potential of the embedded steel bar was continuously monitored with the help of a reference electrode and a data-logger (multimeter with input impedance > 1 MOhm), until a drop of the potential indicated initiation of corrosion, which occurred after around 2 years from the start of the exposure of the cores to the sodium chloride solution (Supplementary Figure S1). A more detailed description of the sample preparation protocol and the corrosion test can be found in Ref. [32].

After corrosion initiation, a core of 25 mm diameter was extracted from the tested specimen, such that the entire 150 mm long rebar was centrally located in the 25 mm core (Fig. 1d). A total of four such cores were obtained, labelled as B1-E1-H-1 to B1-E1-H-4. From that moment onwards, the specimens were generally (apart from the shipping time) kept in laboratory conditions (approx. 20 °C, 50% RH), which significantly limits corrosion and transport processes, that is, largely preserved the state after terminating the laboratory corrosion test described above. The cores were transferred to the facilities for neutron

and X-ray microtomography at the TU Delft (X-Ray microCT: Civil Engineering and Geosciences, neutron microCT: Reactor Institute Delft) as soon as corrosion initiated, so that the mechanism of corrosion of steel in concrete could be studied in a very early stage (shortly upon chloride-induced corrosion onset) and in-situ, that is, in a largely undisturbed state (Fig. 1e).

After tomographic in-situ imaging (Fig. 1e), the samples were transferred back to ETH Zurich, where selected sections were studied by conventional microscopy (Fig. 1f). These sections were selected based on the results of the segmentation of the bimodal microtomography to study sections with features of particular interest such as locations where corrosion initiated or where air voids were found close to the SCI. With the knowledge about the coordinates of these features within the sample, sections were cut with a water-cooled diamond saw. After sawing, the surface of the sections was firstly ground and then polished to further optimize the

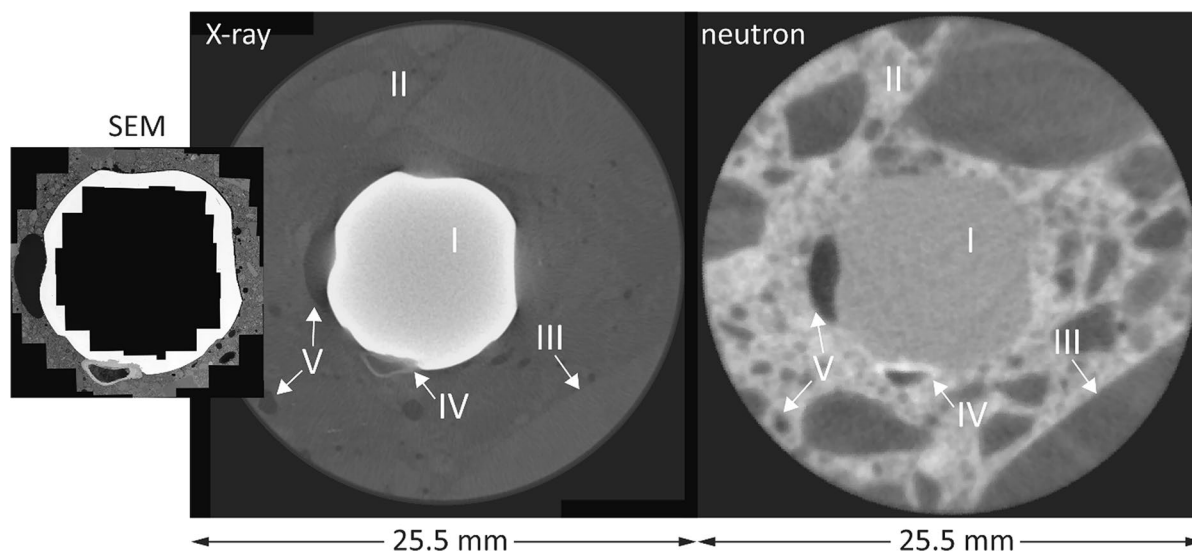
**Fig. 3** Comparison (at identical size and orientation) of cut and polished section viewed in SEM (stitched image) with the corresponding reconstructed sections from X-ray and neutron imaging modalities, illustrating the different specimen phases such as the rebar (I), cementitious phases (II), aggregates (III), corrosion products (IV), and voids (V). Note that through SEM only the steel–concrete interfacial region was imaged, while in both X-rays and neutron images the concrete matrix of the

core is fully visible. To better observe the characteristics of the SCI as well as the occurrence of corrosion pits, the SEM micrograph with higher magnification is also visible in Fig. 8a. Note that the orientation of the reinforcement in the images may be different from the actual orientation of the steel when it was embedded in concrete, of which no information could be obtained

Figure 3 shows an example of one inspected horizontal section where conventional ex-situ scanning electron microscopy was compared to the corresponding section as reconstructed from the X-ray and neutron tomography, respectively. The SEM micrograph shown here was composed by image

stitching (from recording numerous high-resolution images along the SCI region). The SEM image in Fig. 3 was adjusted to ensure identical size and orientation of the rebar and the features in the concrete matrix between all three imaging modes. It becomes apparent that the resolution of the images differs considerably. SEM yields the highest resolution of the different imaging modes, clearly in the submicron range. The pixel size of the microtomography was 25 and 49  $\mu\text{m}$  for X-ray and neutron imaging modalities, respectively. By directly comparing the reference images acquired through X-ray and neutron microtomography and the respective SEM micrograph representative of the same specimen portion, a number of observations can be made based on the geometry of the specimen herein

- X-ray shows considerable artefacts surrounding the rebar, where both darker and brighter regions are clearly apparent, which are absent in the SEM and neutron images. These artefacts are more pronounced than those observed in similar studies where cylindrical steel bars were used [15, 26, 36, 37] because of the ribbed geometry of the reinforcement embedded in the specimen herein investigated. Nevertheless, the availability of neutron images and SEM micrographs allows for a precise distinction of the constituents of the SCI. For specimens with similar geometry and characteristics, the calibration of X-ray images with complementary techniques is therefore advised.

- Through both X-ray and neutron imaging, macro-air voids (overall larger than around 80–200  $\mu\text{m}$ ) and corrosion product build-up at the SCI can be detected. However, the volume of corrosion products may be mis-estimated due to the interfacial artifacts in the case of X-ray imaging and by the similar gray scale value to that of hydrogen-rich components (e.g., cement hydration products) in the case of neutron imaging. Corrosion attacks at the reinforcement can also be reliably detected, especially in X-rays images. The extend at which this detection can occur mainly depends on the resolution (i.e., voxel size) of the image stack. In the present case, the smallest corrosion attacks that could be detected were around 50  $\mu\text{m}$  deep.

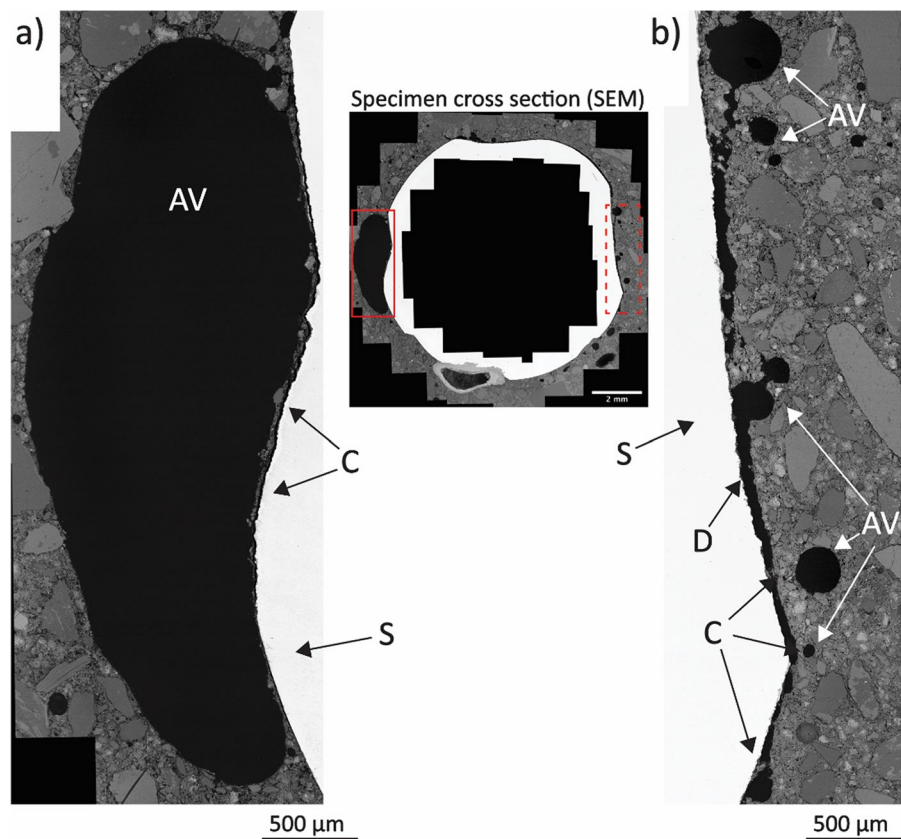
**Fig. 4** SEM image of the specimen cross section (center) with areas where interfacial air voids are found at higher magnification, showing the different phases (S = steel; C = cement paste; AV = air void; D = debonding between steel and concrete; the solid and dotted red boxes highlight the portions reported at higher magnification in (a) and (b), respectively); **a** interfacial macro-air void, separated from the steel by a thin layer of cement paste of around 20  $\mu\text{m}$  thickness; **b** multiple small interfacial voids separated from the steel by a layer of cement paste with variable thickness

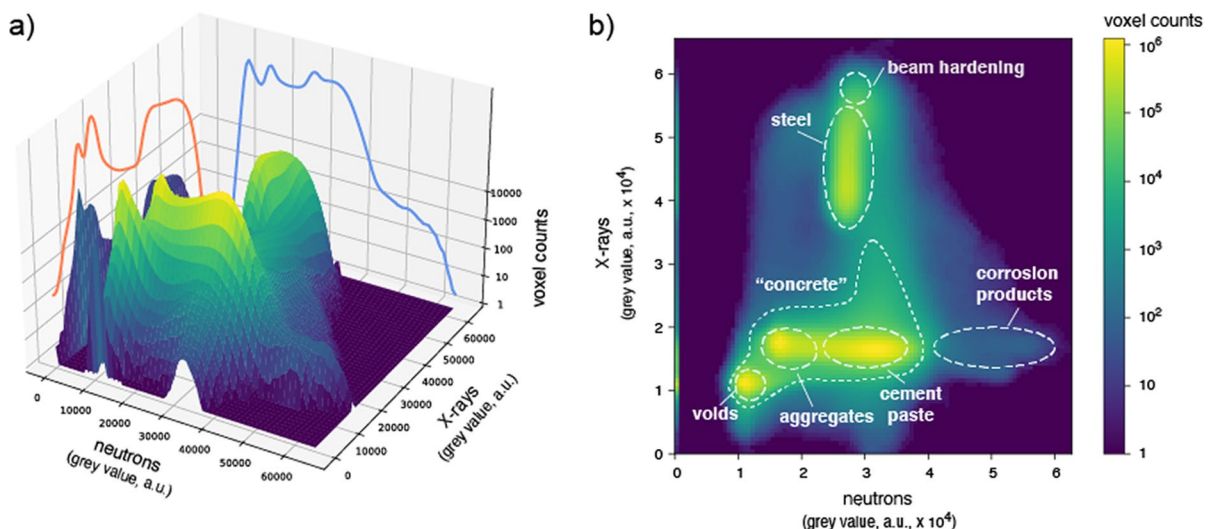
**Fig. 5** Bivariate histogram displaying the number of voxels associated with certain X-ray and neutron attenuation intensities of the whole image stack (representative of the whole specimen); **a** three-dimensional visualization, **b** two-dimensional

plot with indicated interpretations of the combined X-ray and neutron attenuation behavior in terms of features encountered

To improve the image segmentation and, therefore, the identification of different components of the specimens, a bivariate histogram composed of the X-ray and neutron attenuation coefficients can be used (Fig. 5). By coupling the X-ray and neutron attenuation coefficients in a bivariate histogram, regions of pixels (or voxels) can be segmented based on the behavior that the representative elements have when exposed to both X-rays and neutrons. Given the complementarity of the information that the two techniques provide when applied to reinforced concrete specimens, a more reliable segmentation can be potentially obtained through this methodology [38].

In Fig. 5 a bivariate histogram of the number of voxels associated with certain X-ray and neutron attenuation coefficients is visible for the whole image stack of a here imaged specimen. A three-dimensional visualization of the two X-ray and neutron attenuation coefficient histograms is visible in Fig. 5a, while the respective two-dimensional plot is reported in Fig. 5b. In this latter case, it is possible to identify areas that belong to certain components of the specimen based on the behavior observed when simultaneously

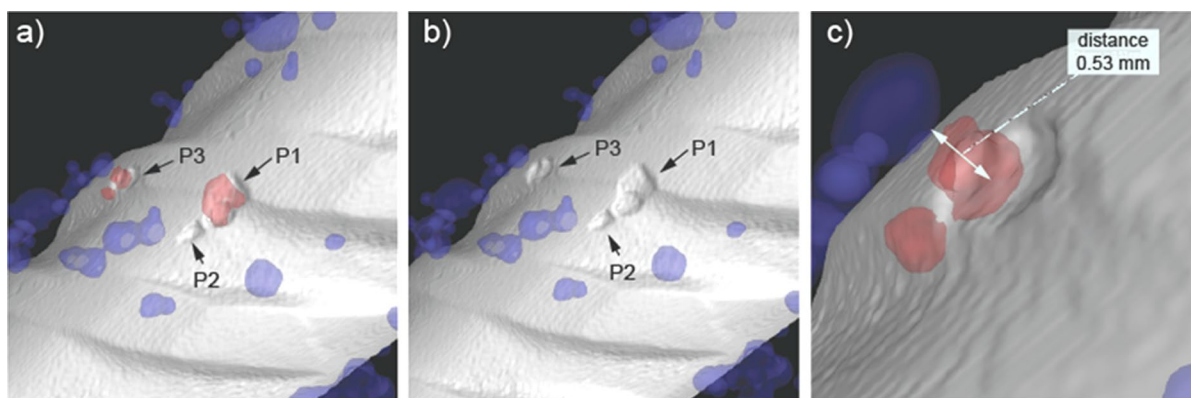
**Fig. 6** Examples of segmented 3D renders illustrating interesting features at the steel–concrete interface (cementitious matrix and aggregates suppressed in the displaying mode for clarity): **a** corrosion initiation pits in the rebar and presence of corrosion products (red) and macroscopic concrete voids

(blue); **b** same but without displaying the corrosion products, to better reveal the pits; **c** illustration of a measurement of the distance between a macroscopic concrete void and a pit (higher magnification than **a** and **b**). Rebar diameter = 10 mm

500  $\mu\text{m}$ ), as visible in Fig. 6c. The influence of air voids will be discussed in Sect. 3.3.2. Here, we will discuss features related to the size and geometry as well as the distance between individual corrosion attacks.

Figure 6 shows relatively flat and shallow “pits” (in the range of 50–100  $\mu\text{m}$  depth and 200–600  $\mu\text{m}$  width and length). The here apparent morphology of the localized corrosion attack was representative of the numerous other pits observed in the other specimens. The ratio pit width:depth and pit length:depth were generally clearly larger than 1. It may be questioned whether so shallow localized corrosion attacks may still be termed “pits”, considering classical pitting corrosion theory. According to the theory underlying pitting corrosion of passive metals, the stability of newly formed pits is significantly affected by the geometry of the pits. When the local conditions to depassivate the steel are present (e.g., the necessary chloride concentration in relation to hydroxyl ions), metastable pits form and grow at a rate that depends on various factors, including metal composition, pit electrolyte concentration, and pit bottom potential [39]. While autocatalytically growing, the anodic and cathodic corrosion reactions separate spatially during pitting. The local pit environment becomes depleted in oxygen, which shifts most of the cathodic reaction to the exposed surface where there is higher availability of this reactant. A consequence of this classical pitting corrosion mechanism is the in-depth growth of a corrosion pit while the rest of the metal surface remains passive [40]. Transport processes between pit bottom (where ferrous ions are released) and the outside areas (where cathodic reaction occurs) are an important factor in pit growth, which is markedly affected by the geometry of the pit (depth, width) [41]. Moreover, the availability of negatively charged ions different from hydroxyl ions (such as chloride ions) is crucial in order to maintain stable pit growth, as the migration of hydroxyl ions into the pit may lead to repassivation [42, 43].

The occurrence of corrosion “pits” close to each other as shown in Fig. 6 may raise further interesting points of discussion. Admittedly, it is unclear from the available in-situ images, which were taken at one point in time, whether the different visible corrosion “pits” had formed in a sequence (the first one forming, then repassivating, followed by formation of another one, etc.) or whether they occurred simultaneously. Additional information on this question is available from the electrochemical monitoring of the corrosion process, especially the transition from passive state to active corrosion. The potential of the rebars was continuously monitored during chloride exposure. According to the experimental protocol, a decrease of at least 150 mV, maintained over at least 10 days, was used as the criterion to determine stable corrosion initiation [32]. Supplementary Figure S1 shows the potential vs. time during this corrosion initiation period for the different specimens. These data show a clear drop in potential (by 200–300 mV). Moreover, in 3 out of the 4 specimens, it was clearly apparent from the potential measurements that no repassivation events occurred over the following approx. 10 days; in one case (B1-E1-H-1), some slight potential variations were visible, however, no full repassivation was apparent. This electrochemical data thus suggests that a sequence of initiation of

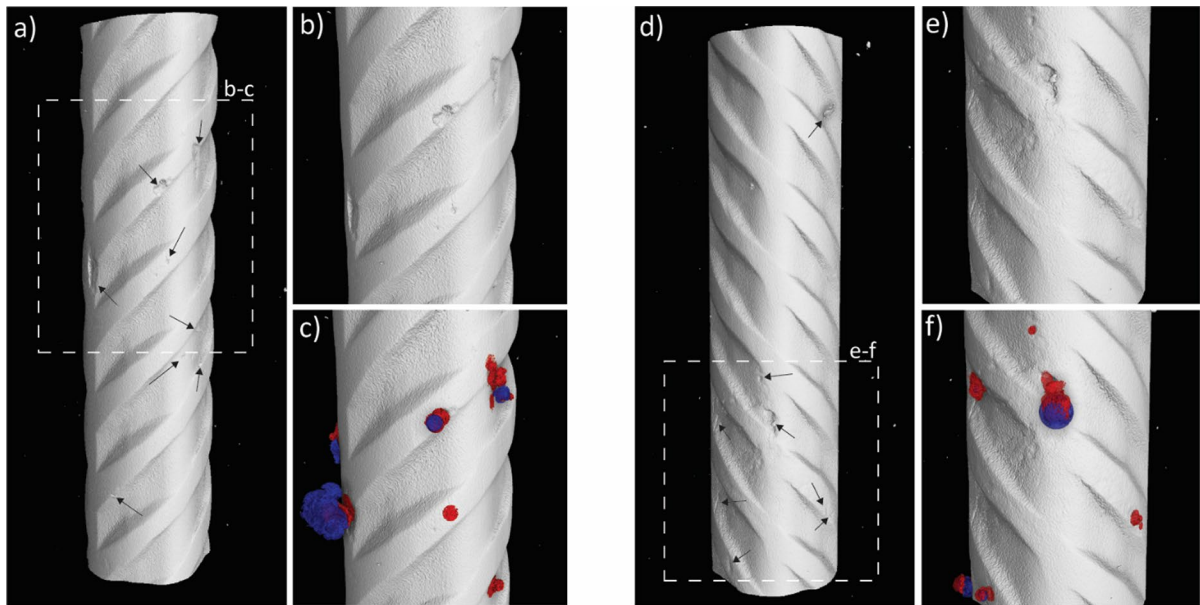
**Fig. 7** Examples of segmented 3D renders illustrating interesting features at the steel–concrete interface (cementitious matrix and aggregates suppressed in the displaying mode for clarity): **a** render of pristine steel of specimen B1-E1-H-2, indicating corrosion attacks with black arrows (the dotted square is the magnified portion of the specimen); **b** higher magnification portion of the corrosion attacks of B1-E1-H-2; **c** higher magnification portion of the corrosion attacks of B1-E1-H-2 showing corrosion products (red) and interfacial

voids (blue) in the proximity of the corrosion attacks; **d** render of pristine steel of B1-E1-H-3, indicating corrosion attacks with black arrows (the dotted square is the magnified portion of the specimen); **e** higher magnification portion of the corrosion attacks of B1-E1-H-3; **f** higher magnification portion of the corrosion attacks of B1-E1-H-3 showing corrosion products (red) and interfacial voids (blue) in the proximity of the corrosion attacks

From Fig. 7 and Table 3, relevant information about the factors influencing the mechanism of corrosion initiation of steel in concrete can be obtained. First, in every specimen several initiation spots were observed, on average between 6 and 11 per imaged

portion of each specimen. Second, a very large number of interfacial air voids was found (in total more than 150). Remember that these reinforced concrete specimens were taken from an engineering structure. It is important to highlight that out of the 31 identified corrosion spots, only about half of them occurred in the proximity of an interfacial void. It is also interesting to note that most interfacial air voids (> 90%)

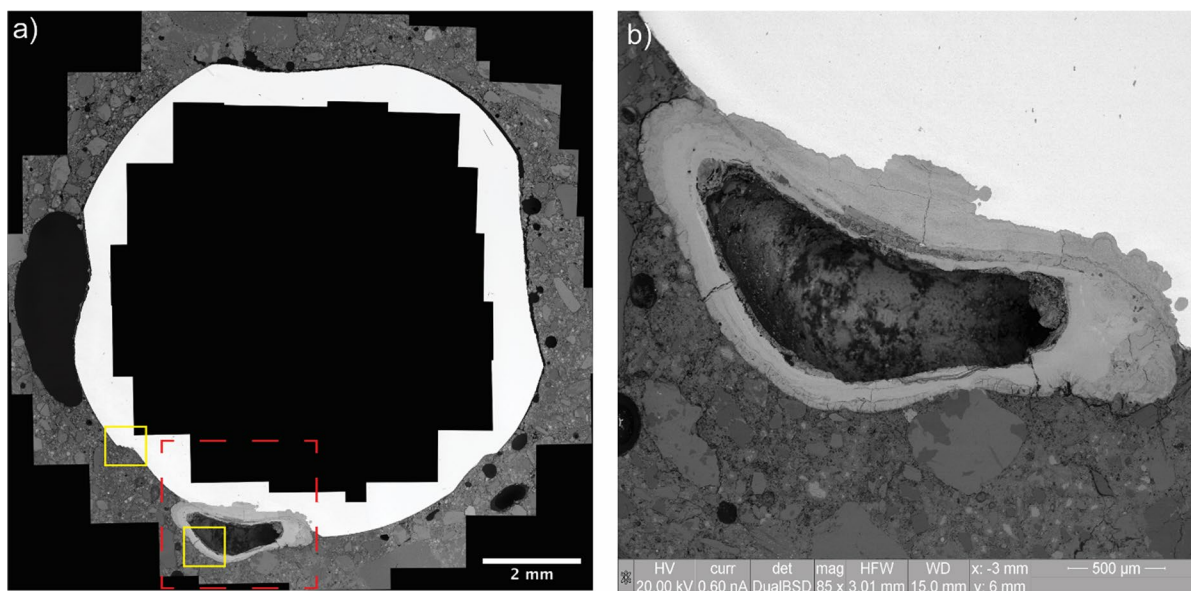
**Fig. 8** SEM micrograph of a corroding section (BSE detector, acquired at 20 kV and 85 $\times$  magnification): **a** overview of the corroding section made by stitching together the micrographs collected at the SCI, where the rebar is visible in white, the corrosion products in light gray, the concrete matrix in dark gray and the air voids in black (the red dotted-line box is representative of the zoomed-in area reported in Fig. 8b,

while the yellow boxes are areas shown at higher magnification in Fig. 9a–b); **b** Corrosion site in proximity to an interfacial air void, which is partially filled by corrosion products. Note that the orientation of the reinforcement herein reported may be different from the actual orientation of the steel when it was embedded in concrete, of which no information could be obtained

The results reported in Table 3 are in line with the findings related to the observations arising from the SEM observations reported below. In Fig. 8 the SEM micrograph of a corroding section is visible, highlighting some regions of interest (ROIs) at higher magnification reported in Fig. 9.

As it is visible from Fig. 8, different air voids are found at the SCI. Microscopic air voids with a diameter ranging between 50 and 200  $\mu\text{m}$  are visible at the right and top-right side of the steel bar, often separated by a thin layer of cement paste (10–20  $\mu\text{m}$  thick). A few small air voids are also visible at the bottom side of the steel. In the proximity of these interfacial microscopic voids, no corrosion sites can be observed. More interestingly, two macroscopic air voids are clearly visible at the left and

bottom side of the bar, both significantly bigger than 1 mm. While the latter one is partially filled by corrosion products that precipitated into it from a corrosion pit in its vicinity, the former one is completely empty, and it is not in proximity of any corrosion pit. These observations are in line with the results reported in Table 3, according to which most microscopic and macroscopic air voids at the SCI did not per se create the most sensitive locations for corrosion to occur. Nevertheless, Fig. 8 may suggest interesting points that need further analysis and experimental evidence to be clarified. Among others, an important reflection relates to the moisture conditions of the SCI. The growth of a corrosion site at one specific location and the lack of any corrosion attack where other interfacial voids are visible Fig. 8 may suggest that the moisture conditions at the SCI may significantly vary around the steel cross section, regardless the exposure of the bigger scale specimen. Variations in moisture state of the concrete at the steel concrete interface upon capillary water uptake may occur depending on variability in pore structure [24].
