Chloride-induced corrosion of steel in concrete—insights from bimodal neutron and X-ray microtomography combined with ex-situ microscopy

2024

Materials and Structures/Materiaux et Constructions

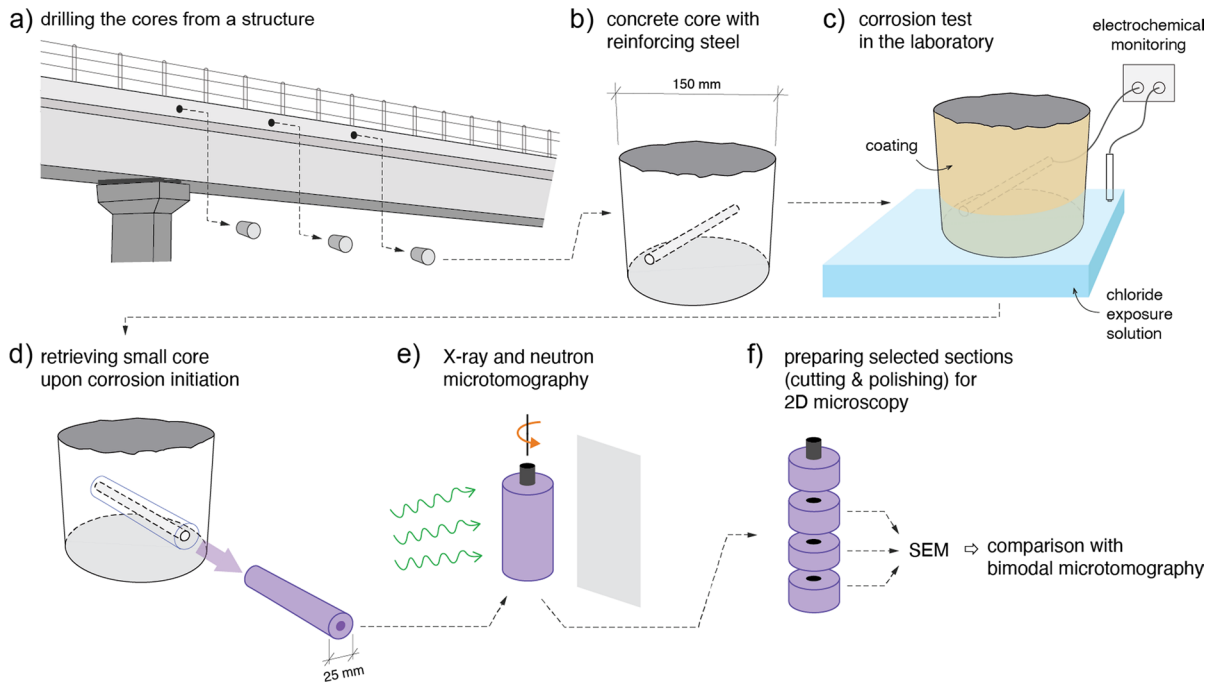
Fig. 1 Sequence of experiments from retrieving samples from a reinforced concrete bridge (a, b) over corrosion testing in the laboratory (b) to the in-situ study of the samples in an early

stage of corrosion by means of X-ray and neutron microtomography (d, e) and comparison with classical ex-situ microscopy (f)

Four concrete cores were retrieved from the edge beam (top side) of a reinforced concrete bridge in Switzerland (labelled as B1-E1), the construction of which was completed in 2004 (Fig. 1a).

At the time of sampling, the age of the structure was ~15 years. The diameter of each concrete core was 150 mm, and it contained a ribbed reinforcing steel bar of diameter 10 mm (Fig. 1b). The rebar was oriented horizontally in the structure (first reinforcing steel layer). No sample was corroding at the time of coring, as evidenced by potential measurements [30] on the structure prior to sampling. More

To induce corrosion of the embedded reinforcement, the reinforced concrete samples were placed in a 10% sodium chloride solution to allow for chlorides to diffuse into the concrete and to trigger corrosion of the steel bar (Fig. 1c). The electrochemical potential of the embedded steel bar was continuously monitored with the help of a reference electrode and a datalogger (multimeter with input impedance > 1 MOhm), until a drop of the potential indicated initiation of corrosion, which occurred after around 2 years from the start of the exposure of the cores to the sodium chloride solution (Supplementary Figure S1). A more detailed description of the sample preparation protocol and the corrosion test can be found in Ref. [32].

After corrosion initiation, a core of 25 mm diameter was extracted from the tested specimen, such that the entire 150 mm long rebar was centrally located in the 25 mm core (Fig. 1d). A total of four such cores were obtained, labelled as B1-E1-H-1 to B1-E1-H-4. From that moment onwards, the specimens were generally (apart from the shipping time) kept in laboratory conditions (approx. 20 °C, 50% RH), which significantly limits corrosion and transport processes, that is, largely preserved the state after terminating the laboratory corrosion test described above. The cores were transferred to the facilities for neutron

After tomographic in-situ imaging (Fig. 1e), the samples were transferred back to ETH Zurich, where selected sections were studied by conventional microscopy (Fig. 1f). These sections were selected based on the results of the segmentation of the bimodal microtomography to study sections with features of particular interest such as locations where corrosion initiated or where air voids were found close to the SCI. With the knowledge about the coordinates of these features within the sample, sections were cut with a water-cooled diamond saw. After sawing, the surface of the sections was firstly ground and then polished to further optimize the

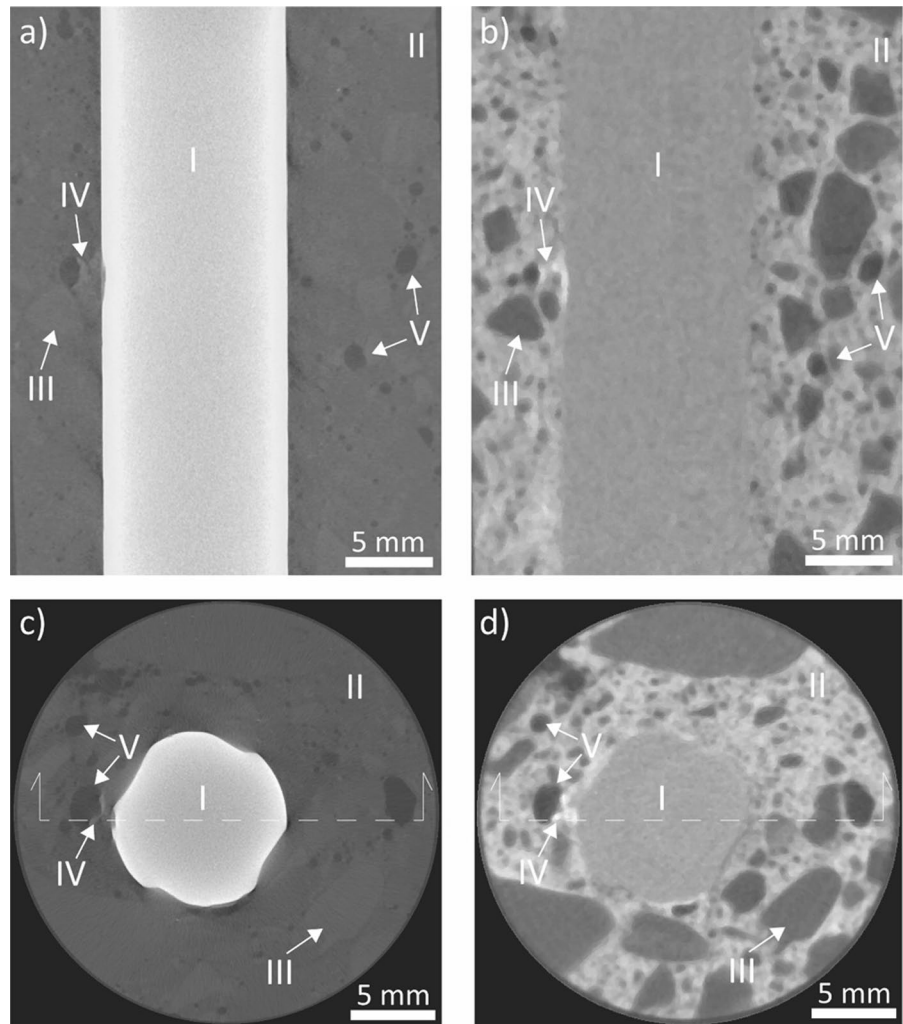
Fig. 2 Comparison of reconstructed sections of the two imaging modes X-ray (**a, c**) and neutrons (**b, d**), illustrating the pronounced differences in attenuation (grey level) between the two modes for different phases, such as the rebar (I), cementitious phases (II), aggregates (III), corrosion products (IV), and voids (V). The dotted lines visible in the horizontal slices of X-rays and neutron images, respectively, indicate the cross-section lines of the respective vertical images. Image analysis and detection of components were conducted on high-resolution data, of which image quality may differ from the one herein visible

while the neutron imaging mode is largely free from such artifacts.

It should be noted that the visual distinction of the different features based on grey values and shape may in Fig. 2 as shown here, namely in the form of a converted and compressed image format, possibly even printed on paper, not work as well as this was possible when the original images were viewed on a high-quality computer screen and with specialized software (VG studio).

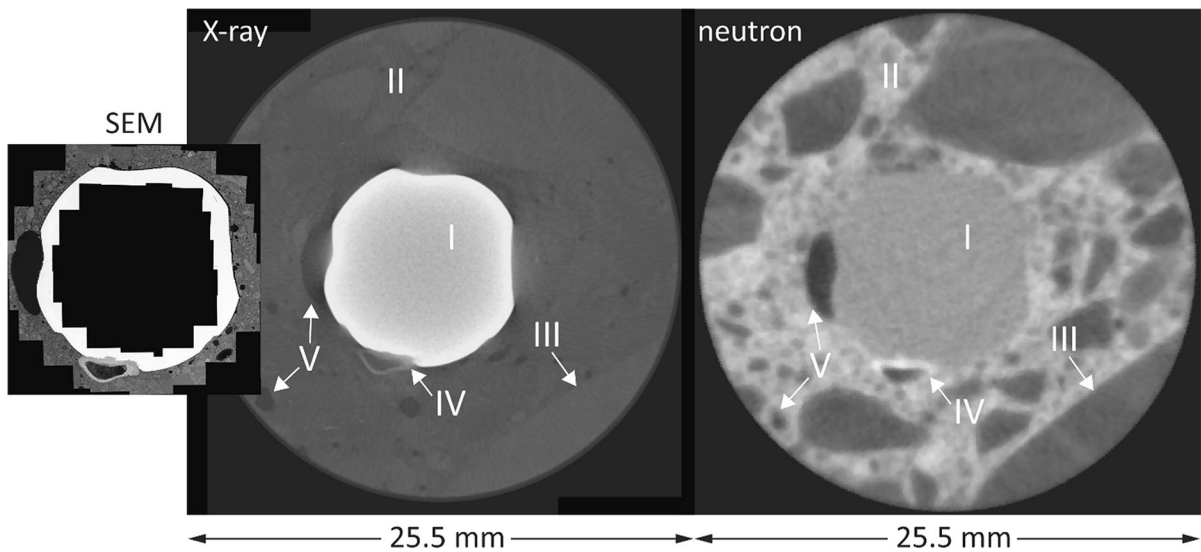
Fig. 3 Comparison (at identical size and orientation) of cut and polished section viewed in SEM (stitched image) with the corresponding reconstructed sections from X-ray and neutron imaging modalities, illustrating the different specimen phases such as the rebar (I), cementitious phases (II), aggregates (III), corrosion products (IV), and voids (V). Note that through SEM only the steel–concrete interfacial region was imaged, while in both X-rays and neutron images the concrete matrix of the

Figure 3 shows an example of one inspected horizontal section where conventional ex-situ scanning electron microscopy was compared to the corresponding section as reconstructed from the X-ray and neutron tomography, respectively. The SEM micrograph shown here was composed by image

stitching (from recording numerous high-resolution images along the SCI region). The SEM image in Fig. 3 was adjusted to ensure identical size and orientation of the rebar and the features in the concrete matrix between all three imaging modes. It becomes apparent that the resolution of the images differs considerably. SEM yields the highest resolution of the different imaging modes, clearly in the submicron range. The pixel size of the microtomography was 25 and 49 μm for X-ray and neutron imaging modalities, respectively. By directly comparing the reference images acquired through X-ray and neutron microtomography and the respective SEM micrograph representative of the same specimen portion, a number of observations can be made based on the geometry of the specimen herein

core is fully visible. To better observe the characteristics of the SCI as well as the occurrence of corrosion pits, the SEM micrograph with higher magnification is also visible in Fig. 8a. Note that the orientation of the reinforcement in the images may be different from the actual orientation of the steel when it was embedded in concrete, of which no information could be obtained

- X-ray shows considerable artefacts surrounding the rebar, where both darker and brighter regions are clearly apparent, which are absent in the SEM and neutron images. These artefacts are more pronounced than those observed in similar studies where cylindrical steel bars were used [15, 26, 36, 37] because of the ribbed geometry of the reinforcement embedded in the specimen herein investigated. Nevertheless, the availability of neutron images and SEM micrographs allows for a precise distinction of the constituents of the SCI. For specimens with similar geometry and characteristics, the calibration of X-ray images with complementary techniques is therefore advised.

- Through both X-ray and neutron imaging, macro-air voids (overall larger than around 80–200 μm) and corrosion product build-up at the SCI can be detected. However, the volume of corrosion products may be mis-estimated due to the interfacial artifacts in the case of X-ray imaging and by the similar gray scale value to that of hydrogen-rich components (e.g., cement hydration products) in the case of neutron imaging. Corrosion attacks at the reinforcement can also be reliably detected, especially in X-rays images. The extend at which this detection can occur mainly depends on the resolution (i.e., voxel size) of the image stack. In the present case, the smallest corrosion attacks that could be detected were around 50 μm deep.

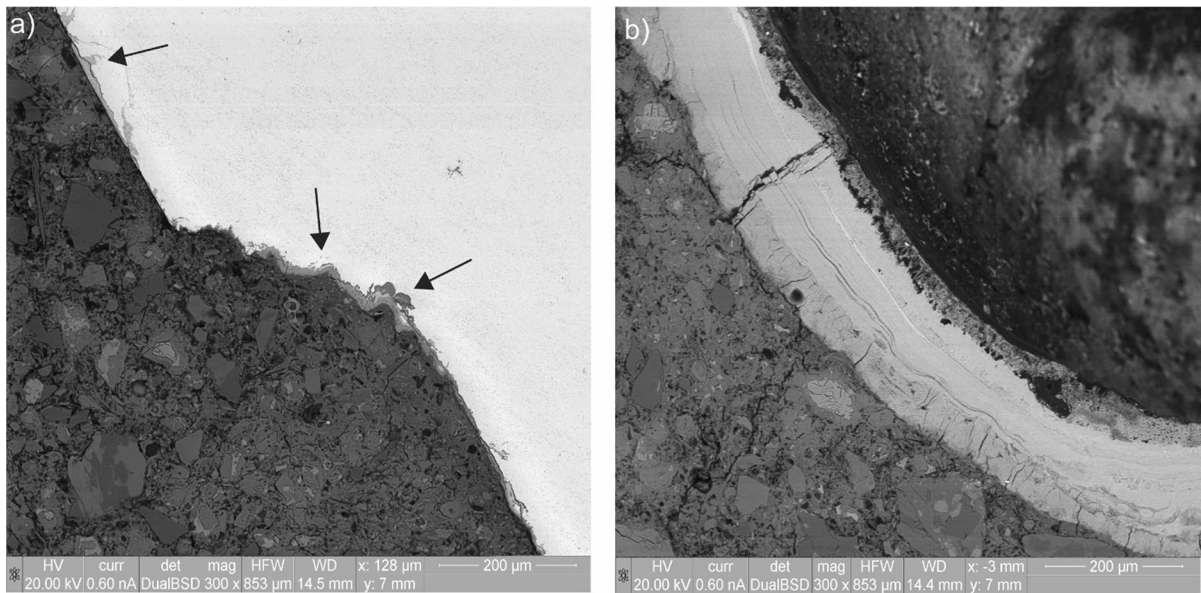
Fig. 9 SEM micrographs of corrosion pits at the SCI of a corroding rebar: **a** small corrosion pits formed at the SCI without any macro defect present; **b** layered morphology of corrosion products precipitated at the edges of an interfacial air void

The results reported in Table 3 are in line with the findings related to the observations arising from the SEM observations reported below. In Fig. 8 the SEM micrograph of a corroding section is visible, highlighting some regions of interest (ROIs) at higher magnification reported in Fig. 9.
