Combining Architectural Conservation and Seismic Strengthening in the Wood-Based Retrofitting of a Monumental Timber Roof: The Case Study of St. Andrew's Church in Ceto, Brescia, Italy

ABSTRACT

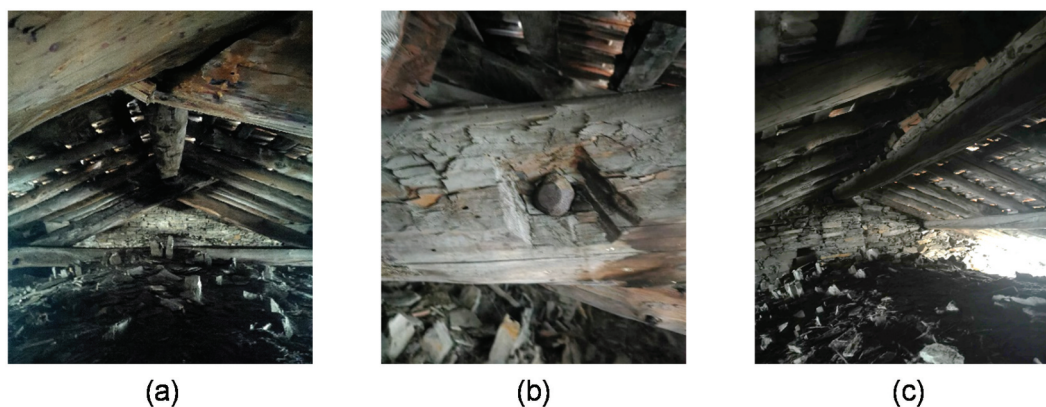
Figure 4. (a) Existing wooden roof structure; (b) existing metal pin between timber struts and ties; (c) ridge beam undergoing excessive deflection.

The wooden roof structure was found in fair state of conservation but was very difficult to inspect, as the attic of the nave and the apse is narrow and normally not accessible. The main rafters, including the ridge beam (Figure 4c), appeared to be very undersized, also considering the spans involved, up to 8 m: large deflections could be observed, which had been compensated over time by additional wooden blocks, to keep the support for the secondary beams as horizontal as possible. These secondary elements seemed better dimensioned and sound, but a small number of joists (approximately 15% of the total) were locally affected by biological degradation, caused by slight water infiltrations. The main wooden struts and ties were sound as well, and according to the static calculations performed, had adequate dimensions for their structural purpose. Yet, the existing connections with metal pins (Figure 4b) were not effective, because the holes in which they were located had become too large over time: thus, the ties could not fully absorb the horizontal thrusts induced by the struts, which seemed to be partly taken by the masonry buttresses.

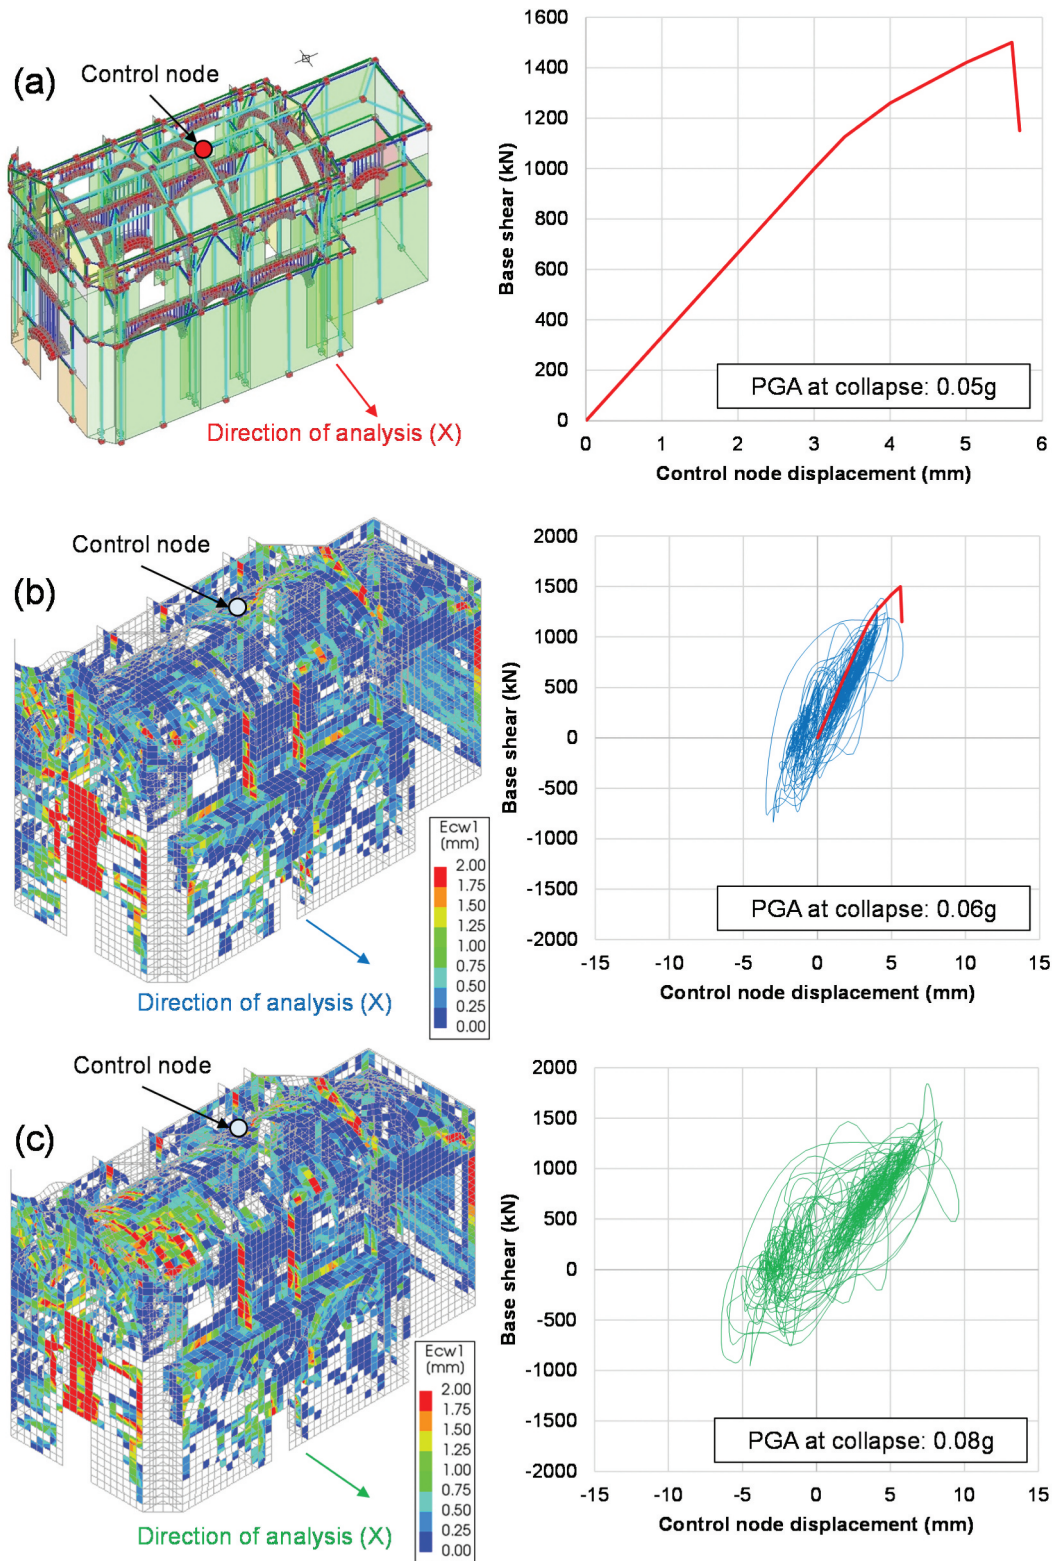
Figure 12. (a) Governing pushover curve from the first model in PCM.Aedes; (b) overview of crack pattern and base shear-displacement graph of the model in DIANA FEA with rigid roof, including comparison with pushover curve; (c) overview of crack pattern and base shear-displacement graph of the model in DIANA FEA with dissipative roof.

It is also interesting to compare the models in terms of damage to the masonry elements (see again [Figure 12](#)). The most loaded elements during the pushover analysis in the governing X directions were located in portions of the façade, and in the bottom part of the apse. This is also confirmed when examining the crack pattern from the second model, highlighting a large amount of damage in these areas. When considering the configuration featuring the actual cyclic response of the roof ([Figure 12c](#)), slightly more cracks are present on the vault as well, because the roof was not modelled as rigid in this case. Yet, even with a higher PGA, under the same signal the damage on the in-plane piers is comparable, if not even lower, to the configuration with rigid roof ([Figure 11](#)[Figure 12b](#)). This is an additional confirmation of the beneficial, dissipative role of the retrofitted diaphragm, whose contribution is also highlighted in [Figure 14](#).

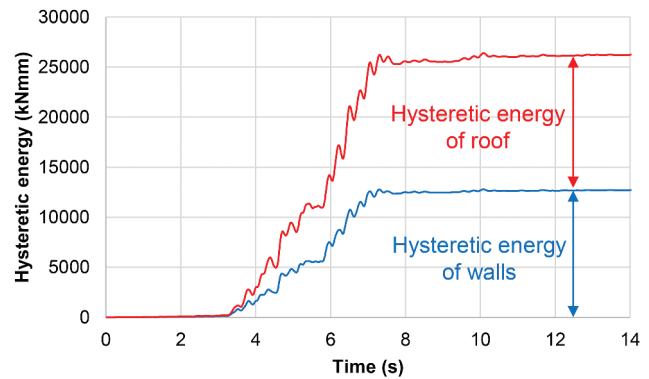
Figure 14. Accumulation of hysteretic energy in the case-study building over time under the 1976 Friuli earthquake; the activation of energy dissipation in the roof is noticeable.

The modal analysis executed on the second configuration of the model led to slightly larger values of the periods, since the strengthened roof was not considered anymore as rigid. In this case, the obtained periods were 0.50 and 0.30 s along the X and Y directions, respectively. Besides, from the results of time-history analyses, accounting for the actual cyclic, dissipative response of the retrofitted roof, an average PGA at collapse of approximately 0.08 g ($\pm 12.5\%$) along the governing X direction, was obtained. In other words, it appears that the case-study church could be able to survive the expected design seismic action for Ceto. This highlights the great contribution of wood-based seismic retrofitting techniques able to increase the displacement capacity and activate energy dissipation in the roof, whose contribution is evident in this case (Figures 12c, 13 and 14).
