**Acoustic emission measurement in the proof loading of an existing bridge affected by ASR**

# Acoustic emission measurement in the proof loading of an existing bridge affected by ASR

**ABSTRACT:** Proof loading has been considered as an effective approach in the assessment of existing concrete bridges. This paper presents a study of acoustic emission measurement in a proof loading of an ASR affected concrete slab bridge (Zijlweg bridge). Because of the uncertainty on the mechanical properties of the ASR affected concrete. The attenuation contours, the wave speed and the geometry effect were studied before the proof loading. During the proof loading, zonal location based on signal strength was applied to track the cracking active area. In addition, the combination of load ratio and calm ratio was used to assess the damage level caused by proof loading. The study showed that the additional damage caused by proof loading was limited. Besides, the presented approach appears to be a promising tool for proof loading.

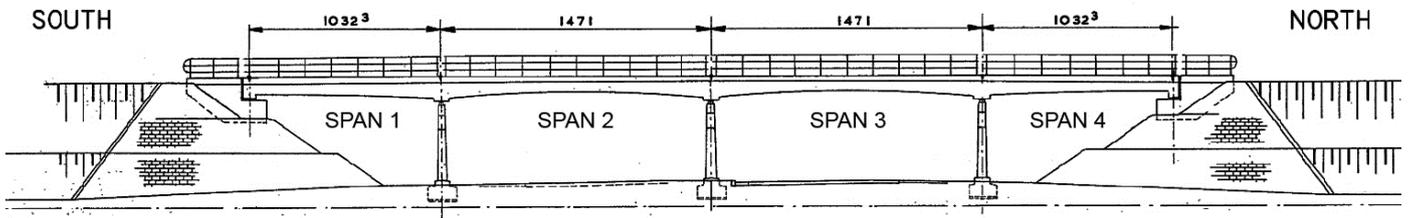
Figure 2 Side view of Zijlweg bridge.

For safety reason, the proof loading was carried out on one of the side spans, span 4 in Figure 2. The length of span 4 is 10.32 m. The width of the deck is 6.60 m, with a 4.00 m carriageway, see Figure 3. The limited total width results one driving lane on the bridge with two sidewalks. The slab thickness of the deck varies from 0.55 m next to the edge cross beam, to 0.85 m close to the intermediate cross beam. In the width direction, the deck thickness at the edge is slightly lifted at the carriageway.

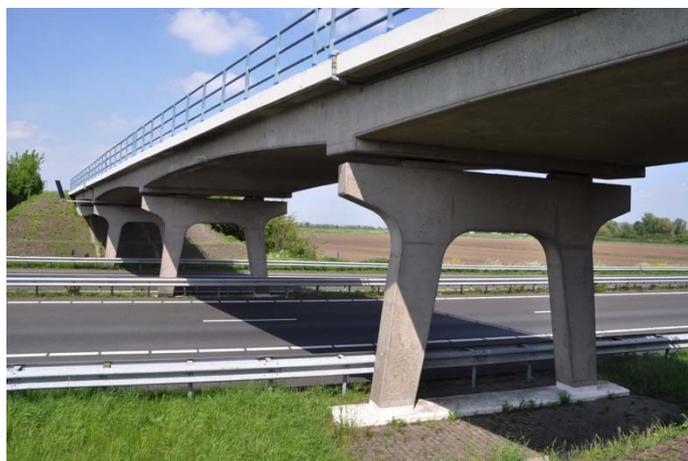
Figure 1. Zijlweg bridge (viaduct) in the highway A59 in the province Brabant, the Netherlands.

This paper presents the AE measurement on the proof loading on an ASR (alkali silica reaction) affected existing bridge: Zijlweg bridge in the Netherlands, see Figure 1. Because of the expansion effect caused by the swelling of the ASR product (CSH gel), a large amount of cracks were observed on the bottom surface of the deck before the test. The AE signals measured during the test are studied briefly in this paper. Recommendations on the execution of AE measurements and assessment of the measured results are given in the paper.

The Zijlweg bridge (viaduct) is a four span concrete slab bridge across the highway A59 in the southern part of the Netherlands. The bridge was constructed in 1965 and Alkaline Silica Reaction (ASR) was found since 1997. The traffic on the bridge was restricted since then. From 2003, the Ministry of Infrastructure and Environment in the Netherlands (Rijkswaterstaat) decided to apply an hourly monitoring on this bridge regarding temperature, moisture and expansion of the bridge deck. After more than 10 years of monitoring, it was found that the expansion of the deck caused by ASR is stabilized. In 2015, it was decided to proof loading the bridge in order to assess the residual capacity of the bridge. If the capacity of the bridge is proved to be sufficient, it is possible to remove the restriction of the traffic.

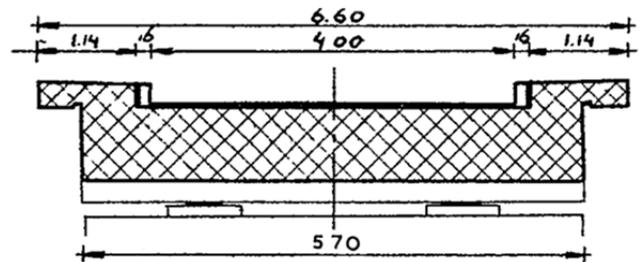
Figure 3. Cross section of the deck of Zijlweg bridge.

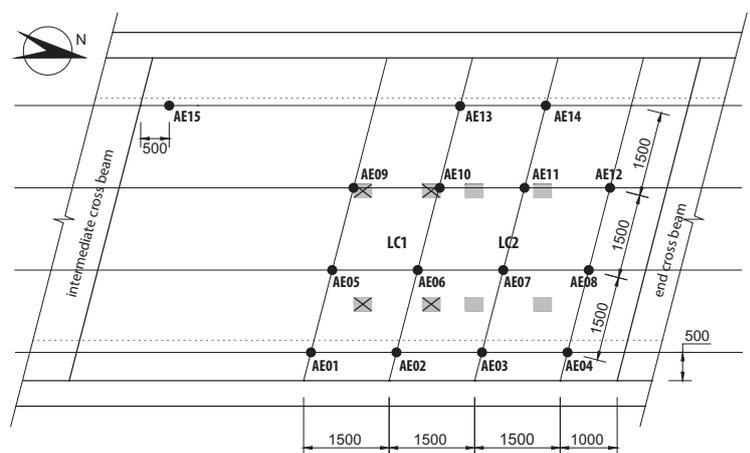
Figure 4. Locations of the wheel print in comparison with AE sensors.

During the proof loading, the flexural capacity (load case 1) and the shear capacity (load case 2) of the bridge deck were assessed. Two axel loads with wheel prints of  $230 \times 300 \text{ mm}^2$  were used to represent the Eurocode prescribed load model LM1. The size of the wheel print is based the recommendation given by Rijkswaterstaat (Rijkswaterstaat, 2013). The axel loads were placed at the locations that generate the maximum cross sectional action / capacity ratio. The locations of the wheel prints are indicated in Figure 4. A detailed description the proof loading process is reported in (Koekkoek et al., 2015).

In total 15 AE sensors were installed on the bottom surface of the bridge deck. Their locations formed a grid aligned with the edges of the deck. The distance between two neighbour sensors in one direction of the grid is 1.5 m. A reference sensor AE15 is located at the far end of the bridge deck. The locations and the numbers of the sensors are indicated in Figure 4. The grid was further evaluated on site taking into account the attenuation property of the concrete deck in section 3.1.

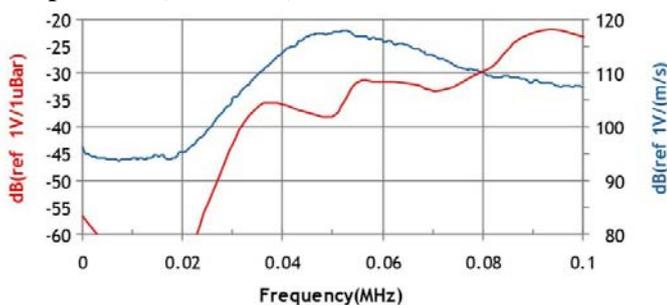
Figure 5. Transfer function of R6I-AST (Physical Acoustics, 2016).

The AE sensors that are employed in the proof load tests are R6I-AST, the transfer function of which is given in Figure 5. Its response frequency is up to 100 kHz. During the test, the low frequency components ( $< 20 \text{ kHz}$ ) were filtered.

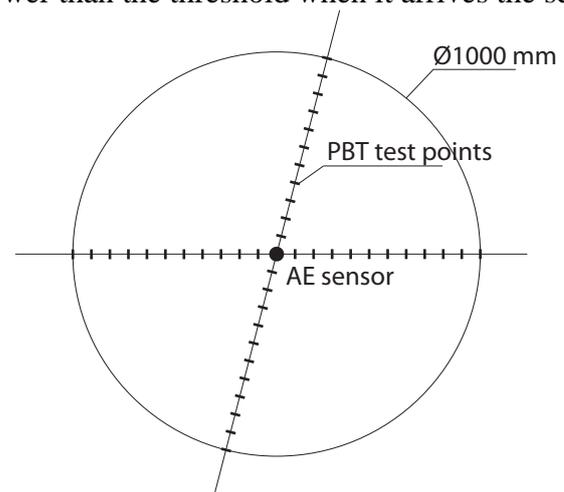
Figure 6. Pencil break test (PBT) position around an AE sensor.

curve was measured in four directions, two in the longitudinal direction of the bridge, and the other two in the transverse direction. In each direction, 10 PBT was carried out when the test location was accessible. The first test position was at 100 mm from the target sensor. The following ones were spaced at 100 mm. An indication of the positions of the PBT positions of one sensor is given in Figure 6.

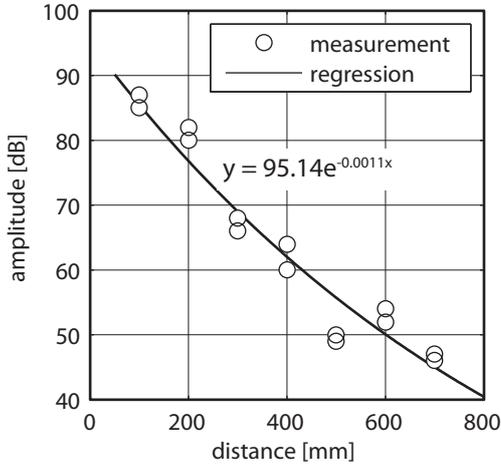
**Figure 7. Attenuation curve of AE05 in the western direction**

At each test point, the PBT were repeated twice, thus maximum 80 PBT were executed per AE sensor. The final attenuation curve in one direction is the exponential regression of the measured peak amplitudes from the PBT. As an example, the measured amplitudes of AE05 in the western direction and the resultant regression curve are given in Figure 7. As shown in Figure 8, despite the fact that many cracks were observed in the vicinity of AE05,

the attenuation of the amplitude of the hits from PBT was still quite consistent. It turns out to be possible to use a continuous function to represent the attenuation relationship, even when cracks are present. Although the curve fitting process smoothed the possible sudden change of the attenuation curve, the global trend can still be represented.

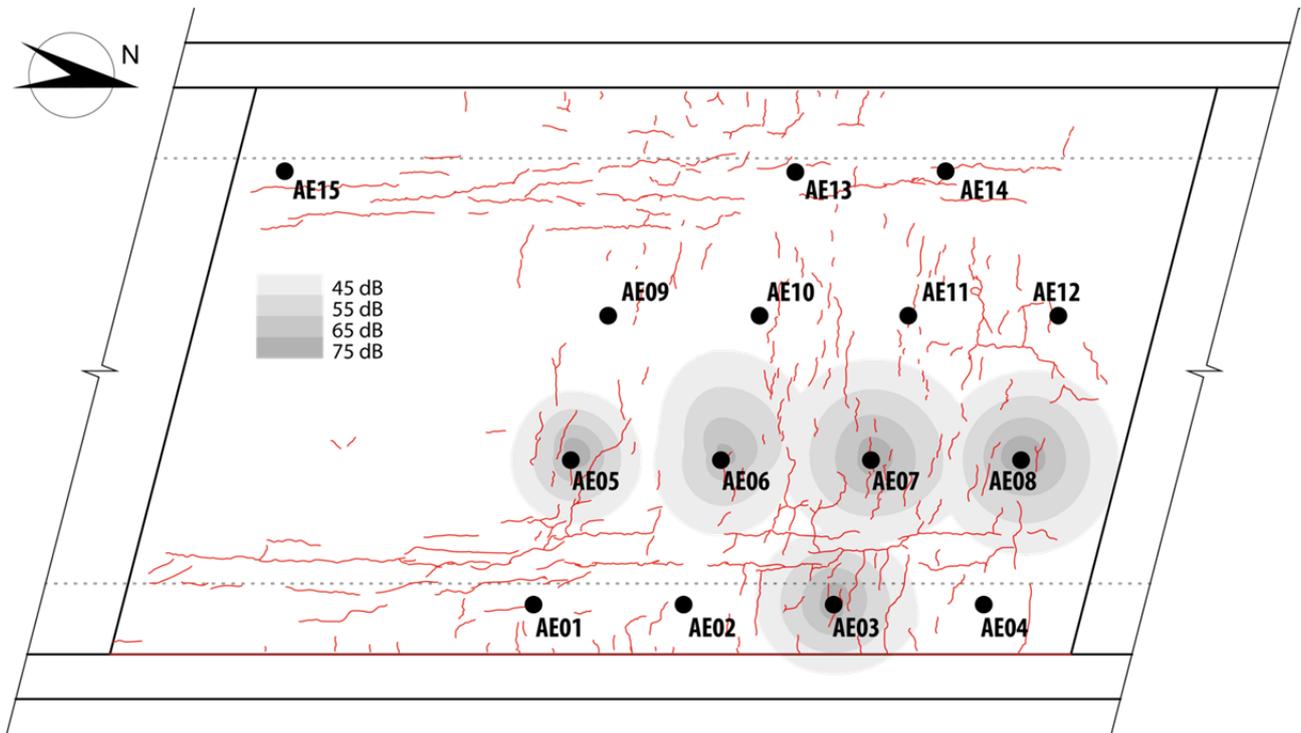
**Figure 8. Attenuation contour of sensor AE03 - AE08 in comparison with crack pattern before proof loading**

Before the test, a visual inspection was carried out. Based on that, the crack pattern on the bottom surface of the bridge deck was marked, see Figure 8.

dinal reinforcement results in cracking along the reinforcement directions. As shown in Figure 8, in addition to the bending cracks in the transverse direction, cracks along the longitudinal direction of the bridge deck were observed before the test. They locate mostly around the part of the bridge deck close to the side carriageway. All these aspects might affect the wave transfer properties in the deck. Besides, the surfaces of the structure and the existing cracks might influence the reflection of the AE signals. Thus further study on the transfer functions of the parameters of a hit was necessary before the execution of the proof loading. The two main aspects that were studied before the proof loading were: the attenuation properties around the sensors and the average wave speed.

With the regression curves in the four directions determined, the values of the amplitudes at the PBT testing points were recalculated. The four amplitude values with the same distance to the AE sensor are then used to linearly interpolate a distribution of amplitude along the entire perimeter. In this way an attenuation contour plot is determined around the measured AE sensors. In Figure 8, the attenuation contour of AE03, AE05, AE06, AE07 and AE08 are plotted. As comparison, the crack pattern of the bridge deck is included as well.

The comparison between the measured AE attenuation contour and the crack pattern shows that the two parameters are clearly related. At the part of the deck with fewer cracks or with the cracks propagates towards the sensor, the attenuation contour extended further, vice versa, see AE06 and AE03. Despite the influence of the cracks to the attenuation contour, the 45 dB contours of the measured 5 AE sensors covered the majority part of the deck between the sensors. Since the measured AE sensors are mostly located at heavily cracked part of the deck, it is safe to assume that the AE sensors are close enough for the proof loading.

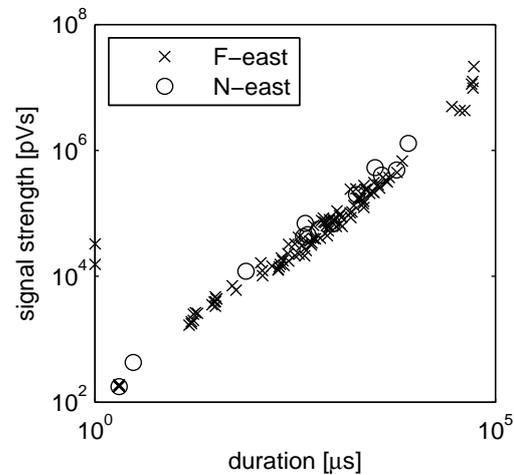
Figure 9. Duration vs. Signal strength of AE hits generated by walking above the bridge deck.

measurement. After the AE sensors was installed and calibrated, a fellow was asked to walk from the north end of the tested span to the south. The test was repeated for 6 times. The person walked with two different manners: walking with normal steps or trying to make additional slips at every step, and at three parts of the driving lane: the middle, the west side and the east side. The study showed that the friction between the shoe and the bridge surface is already sufficient to generate recognizable AE hits. When additional slips were made during walking, the amount of hits was enormously increased. Thus during the proof load, any unnecessary activities above the bridge deck should be forbidden. Nevertheless, the hits that are caused by the friction on the deck are mostly located in a very narrow band in the signal strength – duration diagram (Figure 9), which makes it possible to filter out such type of hits.

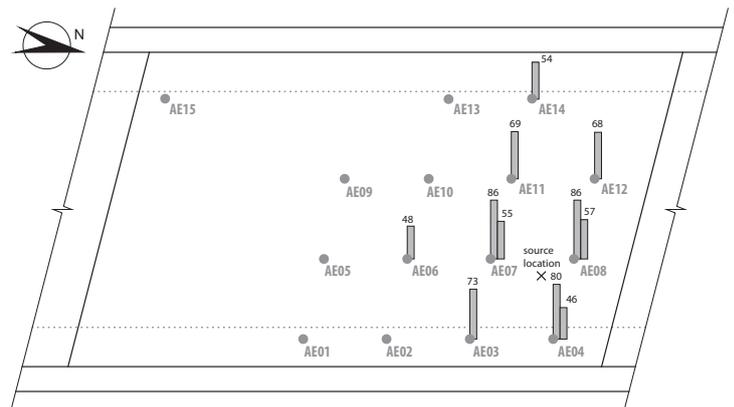
Figure 10. Distribution of the measured amplitude from a hammer hit.

In the second part of the study, the AE hits generated by hammering on the top surface of the bridge deck were studied. The study was to evaluate the influence of the deck geometry on the signal transfer. As an example, one of the hammering tests with its location indicated in Figure 10 is discussed. The recorded peak amplitudes from the sensor grid are indicated in the same figure. It turned out that due to the reflection of the wave at the top surfaces,

a single event could indeed result in two hits, see AE07, AE08 and AE04 in Figure 10. The amplitude of the second hit received by these sensors is significantly reduced. Since the amplitude is calculated with log scale, summation of the parameter is not possible.

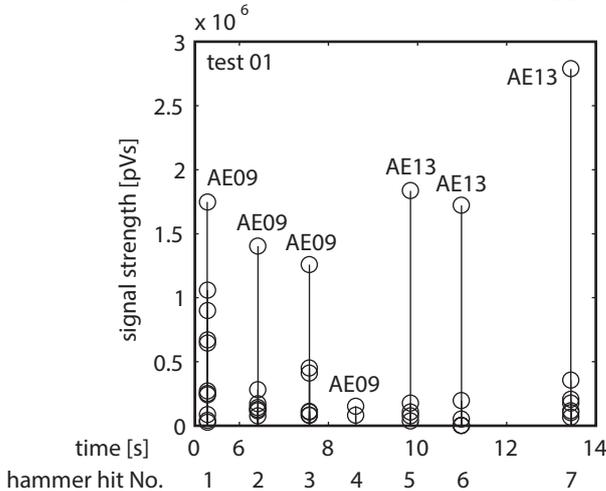
Figure 11. Signal strength of the hits recorded during the hammering tests

On the other hand, the signal strength seems to be a better parameter to represent the location of the cracking activity. The definition of signal strength is the integral of the rectified acoustic emission signal voltage within the duration of the burst signal. It represents the energy of an AE hit. In the study of the hits generated by hammers, only the sensors that are very close to the signal source would receive hits with large signal strength. The signal strength of those that are further away from the source location dropped very fast. As an example, the signal strengths of the entire AE sensor grid during seven hammering tests are plotted in Figure 11. Where, the hits are always clustered after the corresponding hammer hit. Therefore they can be easily linked to a hammer hit. The figure shows that in most cases, the hit recorded by the sensor closest to the hammer hit location was with significantly larger signal strength than the other sensors. It implies that since the signal strength of an event decreases fast with the increase of the distance, the accumulative hit rate only rises when the cracking activity is close the sensor. Therefore, the accumulative signal strength rate vs. time can be used as a parameter to represent the cracking activities in the zonal location approach.

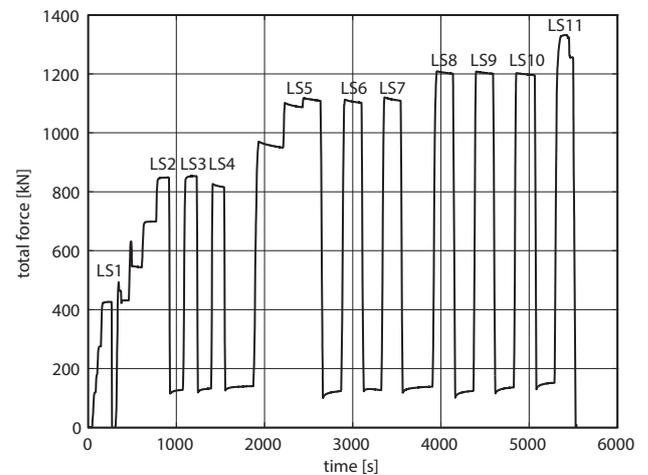
Figure 12. Loading program of LC1.

The loading procedure of load case 1 is shown in Figure 12. In the loading procedure, 11 load steps (LS) with more or less 5 load levels can be distinguished. For the convenience of further study, the load steps are numbered in Figure 12. The 5 load levels are listed in Table 1. As comparison, the equivalent load level with respect to the different safety levels of Eurocode and the requirement of Rijkswaterstaat are given as well. Table 1 shows that from LS2 on, the maximum bending moment was already larger than the moment generated by Eurocode SLS load. At the maximum load step, the applied load was 73 kN higher than that generated by the Eurocode ULS load.

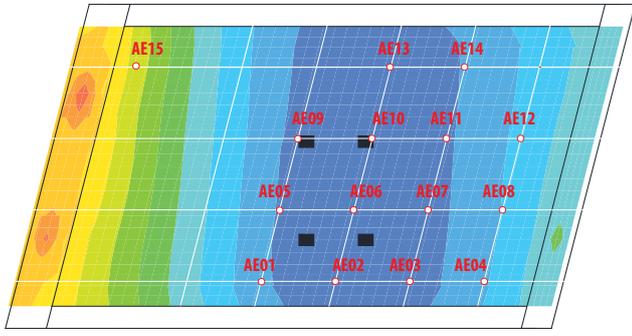
**Figure 13. Moment  $M_{xx}$  distribution of the deck under LC1 in comparison with AE sensor locations.**

Based on the linear elastic FEM analysis performed prior to the proof loading, the AE sensors were classified according to the bending moment at their locations, see Figure 13. The sensors located at positions with larger bending moment are of higher importance.

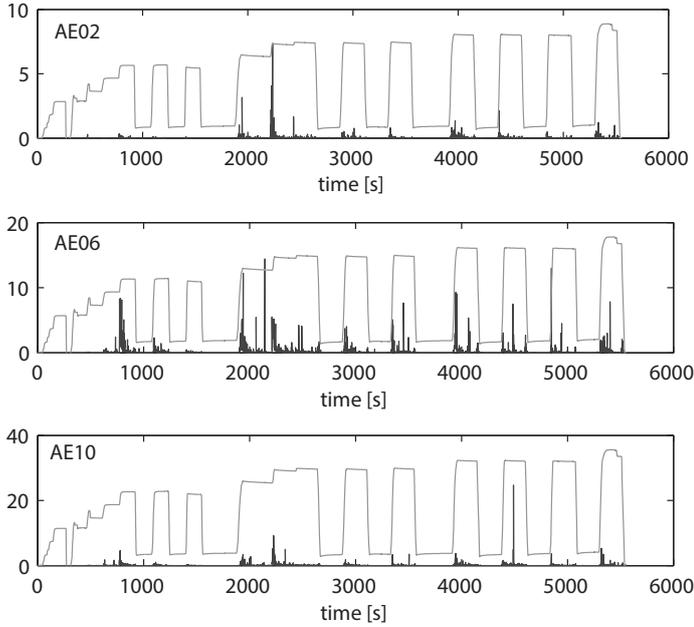
**Figure 14. Cumulative signal strength [ $\mu$ Vs] per second against time per sensor.**

Take AE02, AE06 and AE10 as example, the cumulative signal strength rate (cumulative signal strength per second) is plotted against time in Figure 14. The loading scheme of LC1 is plotted in the same figure. This assumed that the AE hits were mainly caused by the cracking activities in the concrete deck. When the cumulative signal strength ratio of  $5 \mu\text{Vs/s}$  is set as a threshold. Figure 14 shows that the cracking activity started at the maximum load level of LS2 in the vicinity of AE06. The cracking active area extended to AE02 and AE10 when LS5 was reached. While the sensor AE10 only became active at LS9, which was the second time the load level reached about 1200 kN. Similarly, the activities of all the AE sensors at the 5 load levels are listed in Table 2. In general, the development of

the cracking activities extended from the location with the maximum bending moment (AE) towards the supports and the sides according to the signal strength approach. That was in line with the estimation given by the FEM analysis.

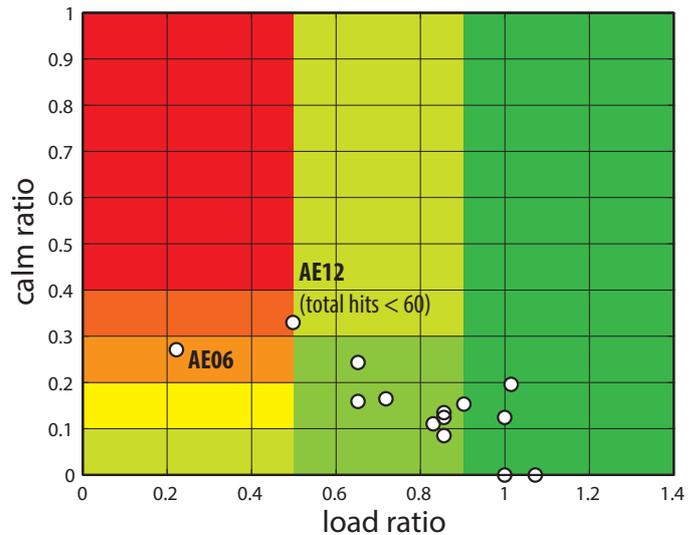
**Figure 15. Load ratio - calm ratio of AE01-AE14 at load step 11.**

The load – calm ratio coordinate calculated in each load step can be plotted to represent the damage level. As an example, the values at LS11 are plotted in Figure 15. In addition, a damage scale calibrated by the previous study (Ruytenschildt Bridge)

is given in Table 5. Figure 15 shows that the additional cracking was still at a moderate level even at the last load step, although in that load level the maximum bending moment in the deck was already higher than that can be generated by the ULS load according to Eurocode. That is in line with the conclusion made by the study of the other parameters in (Koekkoek et al., 2015). Since the concrete strength was not affected by ASR, it turns out that the scale developed from structures with normal concrete can be applied on the ASR affected deck as well.
