Measuring damage in physical model tests of rubble mounds

Coasts, Marine Structures and Breakwaters 2017

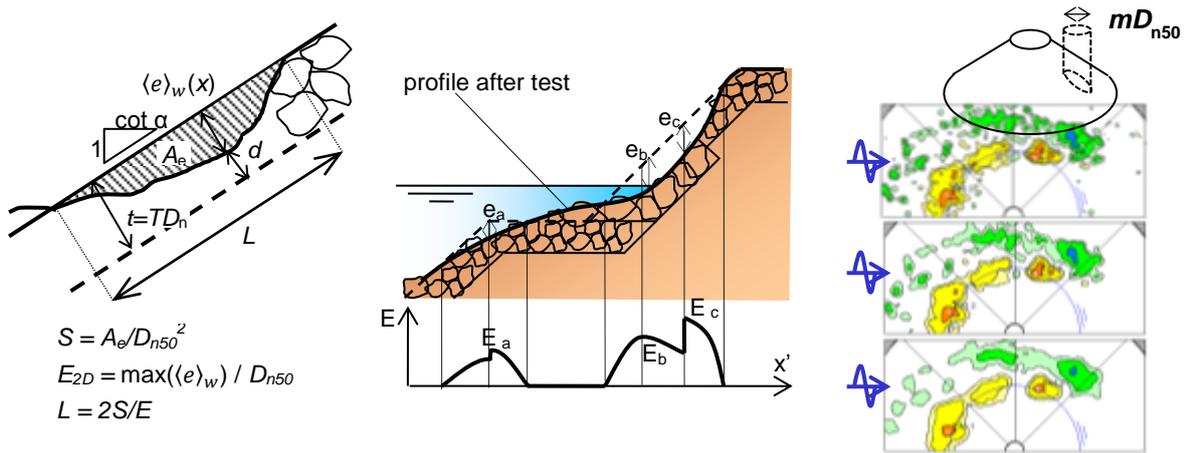
Figure 1. Left: definition of damage numbers S and E_{2D} on width-averaged 2D trunk profile. Middle: variation of E_{2D} on a non-standard cross-section. Right: pattern of E_{3D} on a roundhead smoothed with different filter size ($2D_{n50}, 3D_{n50}, 5D_{n50}$ – from top to bottom). From Hofland *et al.* (2011, 2014).

where α is the structure slope. In this definition, erosion of the profile is positive. Damage to rubble mound structures is classically based on either the number of rocks that are displaced during a test (storm), or by the area of the cross-section of the damage hole (dimensionless erosion area S , Broderick, 1983; Van der Meer, 1988; see left panel in Figure 1):

where $\langle \rangle_{mD_{n50}}$ indicates a spatial average over a circular area with mD_{n50} diameter. In the right panel of Figure 2 the influence of the filter size m on the determined damage depth at a roundhead is illustrated. The optimal size of the filter size, a compromise between accuracy and resolution, is not known yet, but is expected to be in the range of 3 to 5 times D_{n50} . As a flume test from which E_{2D} is determined is typically $20D_{n50}$ wide, the filter size for E_{3D} would have to be about $m=4$ or $m=5$, in order to obtain a similar accuracy (determined by the number of potentially moving rocks).

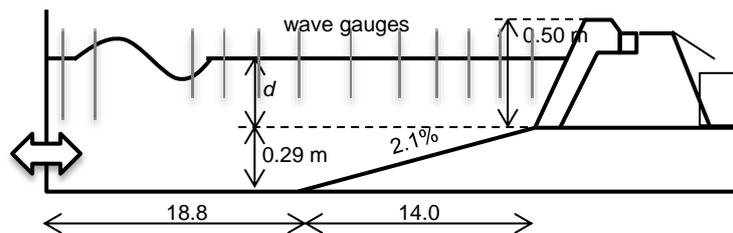
Figure 2. Model setup in LNEC flume.

A first test series was carried out to obtain damage scans for a standard wave flume case. These tests were done at the LNEC laboratory in a 50 m long, 1.2 m deep wave flume with an operating width of 0.8 m. The flume is equipped with a piston-type wave-maker that combines both irregular wave generation and dynamic absorption of reflected waves through the use of two wave gauges located in front of the paddle. Ten additional resistive-type wave gauges were deployed along the flume and an extra gauge was placed on the model armour layer slope to measure run-up levels (not analyzed presently). The breakwater model was built and operated according to Froude’s similarity law, with a geometrical scale of 1:30, to ensure reduced scale effects (the wave height-based Reynolds number was $D_{n50}\sqrt{gH_s}/\nu > 3 \times 10^4$). The reference breakwater cross section was built on a 14 m long and 0.29 m high foreshore. The breakwater model was 0.8 m ($18D_{n50}$) wide and composed of a main armour slope of 1:2, $2D_{n50}$ thick, with $D_{n50} = 0.0445$ m, with a single filter layer and permeable core below, as shown in Figure 2. The armour crest was 0.5 m above the structure toe. A concrete superstructure was also included, with its crest level 1.7 cm below the armour crest. The width of the armour layer crest seaward of the crest element was 19.7 cm.

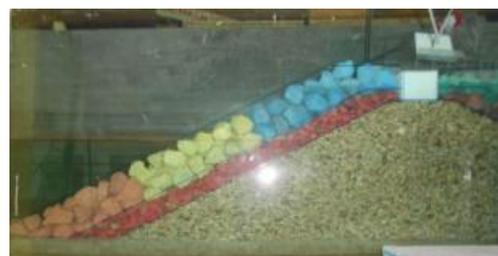
Figure 3. Model setup in LNEC flume.

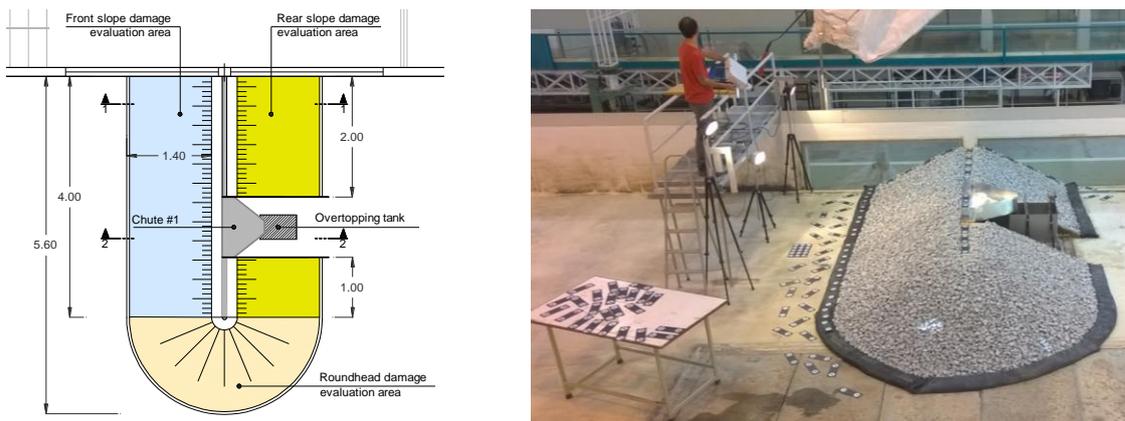
Figure 4. Model setup in FEUP basin. Left: plan view, right: damage measurement.

The tests were carried out in the multidirectional wave basin of the Hydraulics Laboratory of the Hydraulics, Water Resources and Environment Division of FEUP (28.0 m long, 12.0 m wide and 1.2 m deep), which is equipped with a 12.0 m wide segmented wavemaker with active reflection absorption. A reference rubble mound breakwater was reproduced on a geometric scale of 1:35. The breakwater model was 5.6 m long, 3.1 m wide and 0.68 m high, Figure 4. The armour layer was composed of a double layer of rock ($2D_{n50}$ thickness), with $D_{n50} = 32$ mm and $D_{n85}/D_{n15} = 1.25$, placed on a rubble mound core, with $D_{n50} = 11.6$ mm. The slope angle was 1:2. The overall crest width was 0.42 m and a 0.10 m wide superstructure was placed at its centre. The armour was supported by a toe materialized by cylindrical sand bags. The breakwater core was enclosed in a mesh to avoid movement of the core materials, while maintaining the desired level of permeability (~40-50%). A 4.0 m wide trunk section was placed perpendicularly against the straight sidewall of the basin, and a semi-circular roundhead was placed at its other side. The slope angle and the armour layer thickness were equal for all trunk and roundhead sections. The armour layer on the rear side was interrupted to allow the installation of a reservoir to collect the overtopped water, allowing the measurement of the overtopping discharges and volumes, which are treated in a companion paper (Silva *et al.*, 2017).

The water free surface elevation was measured using standard resistance-type wave gauges. A set of four aligned gauges was placed in front of the model in order to determine the characteristics of the incoming waves. For the tests with short-crested waves, a setup with six gauges in a CERC6 array was applied (Davis & Regier, 1977). The damage in the structure was measured using a stereo-photography technique (Raaijmakers *et al.* 2011). The structure was photographed with a set of hand-held double-cameras in a drained wave basin. Using a typical number of 50 photo pairs, point clouds of measurements were created before and after each test run. These point clouds were filtered and interpolated on a 1x1 mm grid. The post-processing steps are described in Hofland *et al.* (2011).

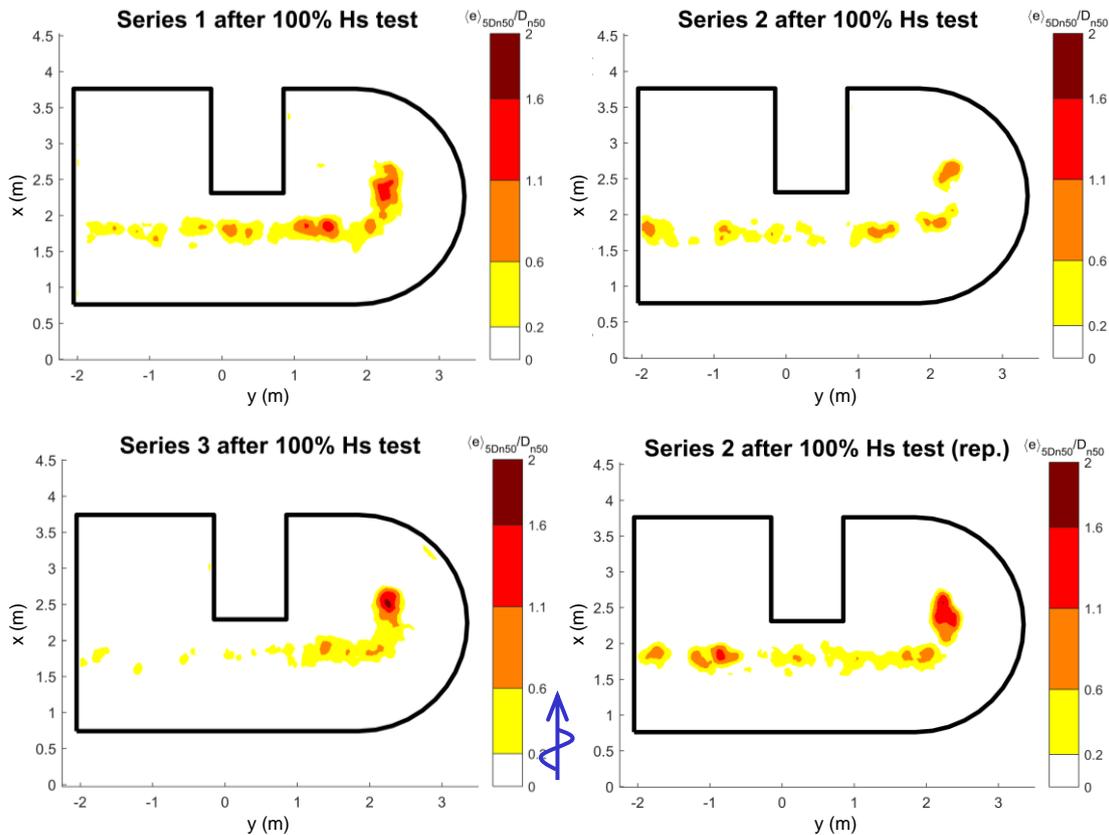
Figure 5. Erosion depth after the 100% test condition for Series 1, 2 (including repetition) and 3.

The trunk section of the breakwater model tested in FEUP wave basin was 4.0 m wide in order to get a large section where statistical convergence can be obtained for damage results. The damage after the 100% condition for the three test series and one repetition is depicted in Figure 5.

Some observations can be made based on Figure 5 results. On the seaward trunk slope adjacent to the roundhead, the damage is consistently larger for all test series. Therefore, this area is not taken into account for the analysis of the trunk section. Moreover, the two identical repetitions of the 100% condition of the second test series still give rather different results, so the scatter seems to be large. The results for Test Series 2 were obtained without the damage of two preceding tests (for 60% and 80% test conditions), while Test Series 4 was carried out with short-crested waves and in Test Series 3 the effect of SLR was already included.

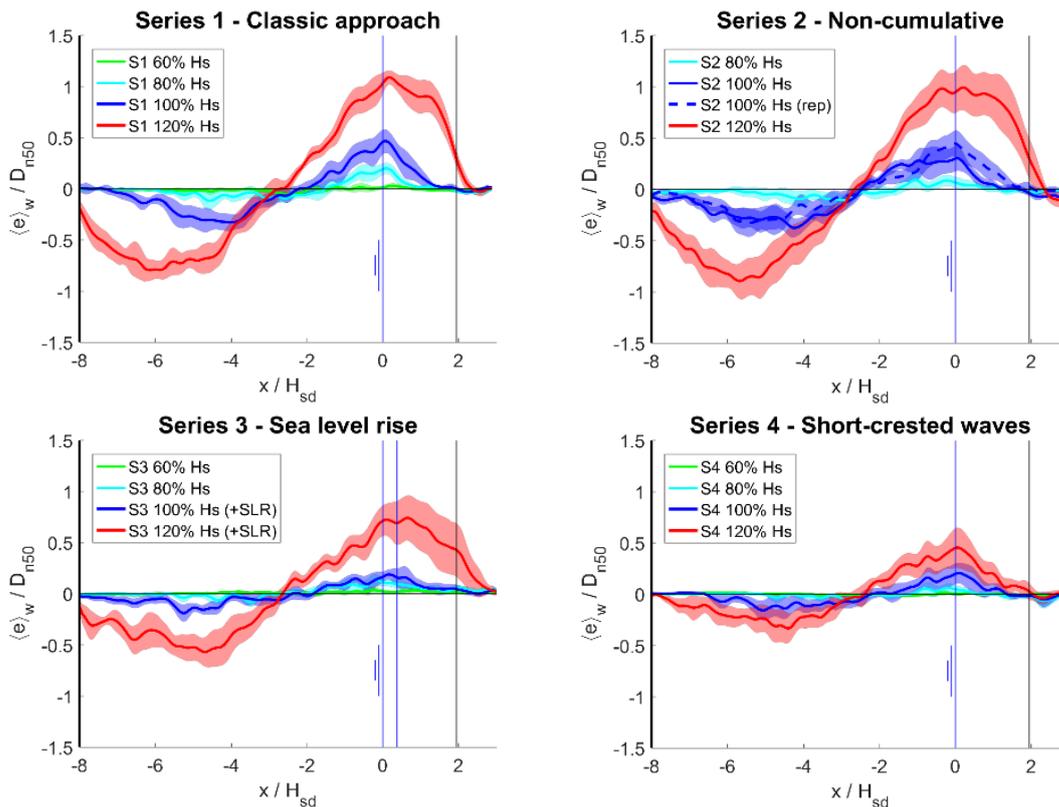
Figure 6. Width-averaged erosion profiles for the four test series with confidence band (shaded areas). Here x is the horizontal cross-shore coordinate, with its origin at the waterline.

It can be observed that the damage hole is deepest around the water line, see Figure 6. The size of the hole increases, as expected, with the wave height. For the last test (120% condition) the damage hole extends up to the crest (vertical black line). It can be noticed that for the wide measurement section that is applied, with a width of more than $100D_{n50}$, the confidence band of the results is narrow enough to clearly distinguish the damage stages for the various tests. For the test with the smallest wave height also the damage around the water line is determined with confidence, while at lower elevations (where rocks are both deposited and removed) the confidence band is wider.

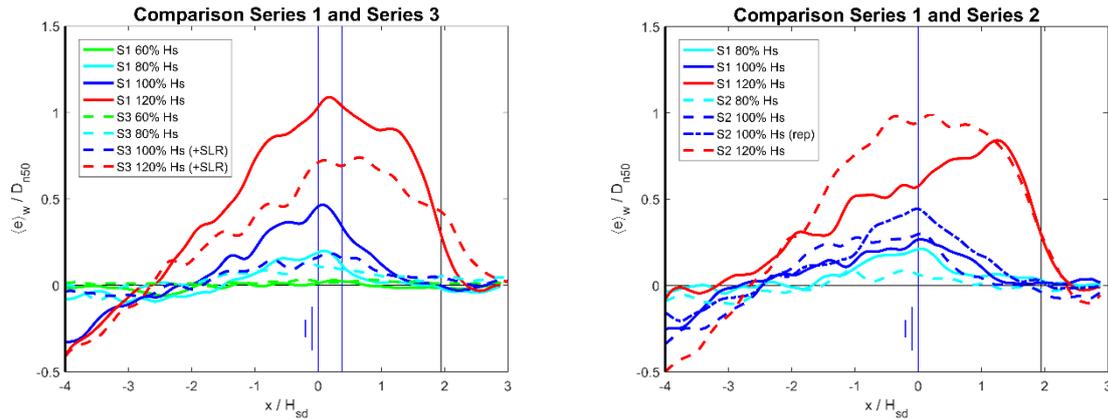
Figure 7. Left: width-averaged erosion profiles for Series 1 (constant WL) and 3 (SLR). Right: width-averaged erosion profiles for Series 1 (cumulative) and 2 (incremental).

The influence of a limited sea level rise (SLR) is demonstrated in the left panel of Figure 7 where Series 1 and 3 are compared. The first two tests (60% and 80%) are repetition tests with the same conditions. After the first two tests with a constant water level, the 100% and 120% tests are performed for a 2.3 cm higher water level in Series 3 (0.80 m SLR at prototype scale). The water level difference is relatively small (about 20% of the design H_s). Still a rather large difference might be observed in the results of Test Series 1 and 3: less damage in the tests carried out for the higher water level, while for the same water level very comparable damage levels were obtained.

The comparison of the cumulative damage case (no rebuilding after each test run) with rebuilding (a newly constructed slope for each test run) is shown in the right panel of Figure 7. As the damage in the model is not repaired before each test run in Test Series 1, the new inflicted damage is added to an already damaged slope. In this right panel only the additional damage that occurred during the specific test run is shown. There are clearly visible differences between the two test series. However, the test run that was repeated in Test Series 2 shows a much larger damage level.

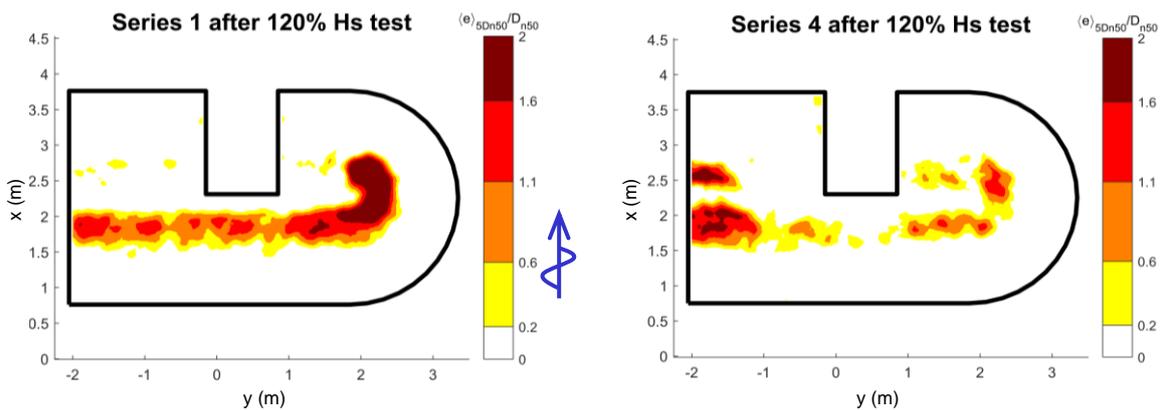
Figure 8. Erosion depth on breakwater trunk and roundhead after Test 4. Left: Series 1 (long crested waves). Right: Series 4 (short crested waves).

The damage to the structure for long-crested and short-crested waves is compared in Figure 8. In the tests with short-crested waves, extra damage occurred in the vicinity of the sidewall, due to the energy concentration resulting from the imperfect reflection on the sidewall of waves travelling with a direction not perpendicular to the breakwater. However, in the remainder part of the trunk, the wave conditions were similar and the results obtained can be considered valid. It can be concluded that the damage to the trunk is lower for the tests with short-crested waves. Also, the size of the damage hole created at the roundhead is smaller. The damage does seem to extend further around the roundhead.

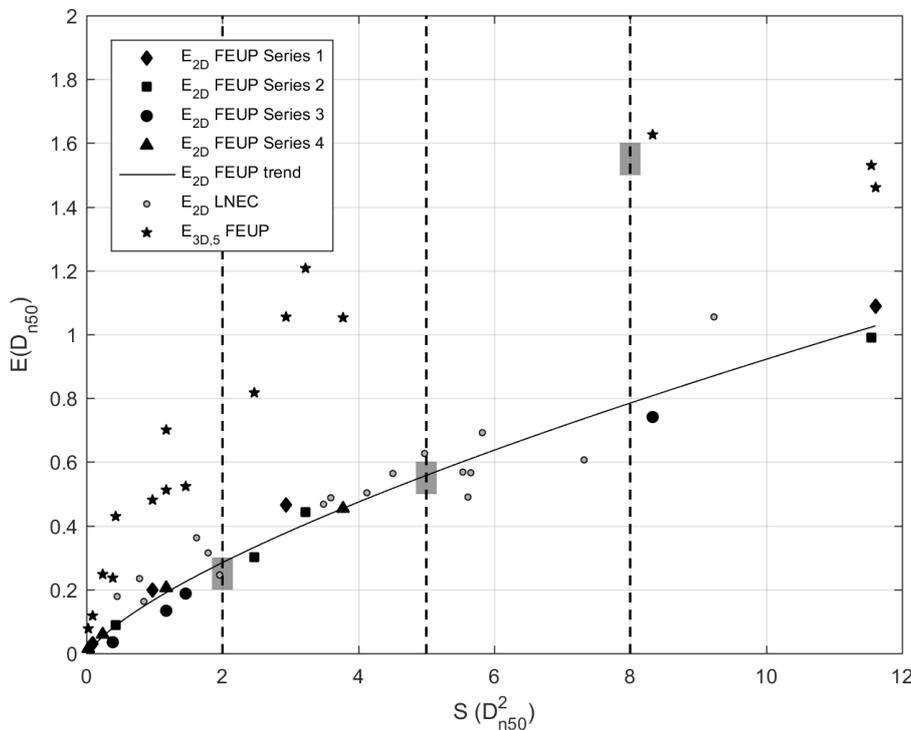
Figure 9. E_{2D} and $E_{3D,5}$ versus S . Dashed lines and grey areas: design values for S and previous design values for E_{2D} (Hofland *et al.*, 2011), respectively.

The results for FEUP and LNEC tests are depicted in Figure 9. The LNEC results, which were based on depth-limited conditions and varying wave steepness collapse with the deep water FEUP results. The scatter in the LNEC results seems somewhat larger. This might be due to the smaller width of the LNEC test section. Note that the parameter E_{2D} can be used for any slope angle, or combination of slope angles (*e.g.* berms). It can be seen that those tests give comparable values for E_{2D} as given in Hofland *et al.* (2011) for the initial and intermediate damage levels. Only the E_{2D} value for “failure” does not seem to match the definition of 2011. As the background of this definition is most objective, *i.e.* the exposure of the filter layer, this can be checked. Indeed for Test run 4 some locations were visible on the trunk where the erosion depth is $2D_{n50}$. Hence it seems that the design value for the mean erosion depth E_{2D} should be much stricter, around 0.8. It seems better to use this definition for

In addition to the E_{2D} values, $E_{3D,5}$ values for the trunk section are presented for all the test runs, obtained considering a circular spatial moving average of $5D_{n50}$ diameter. These values can also be used as design limits in 3D situations. It can be seen that these values are about two times larger.

Broderick stated that $S = 2$ (equivalent to $E_{2D} \approx 0.3$) was applied as start of damage, as that was the lowest discernible damage that could be measured. It can be seen that much lower damage quantities (i.e. $S \approx 0.5$ or $E_{2D} \approx 0.1$) can be measured using the presently used high-resolution techniques and wide test section.
