Conversion of office buildings;

A cross-case analysis based on 14 conversions of vacant office buildings

Hilde Remøy, MSc Arch, PhD candidate¹
Theo van der Voordt, Associate professor²

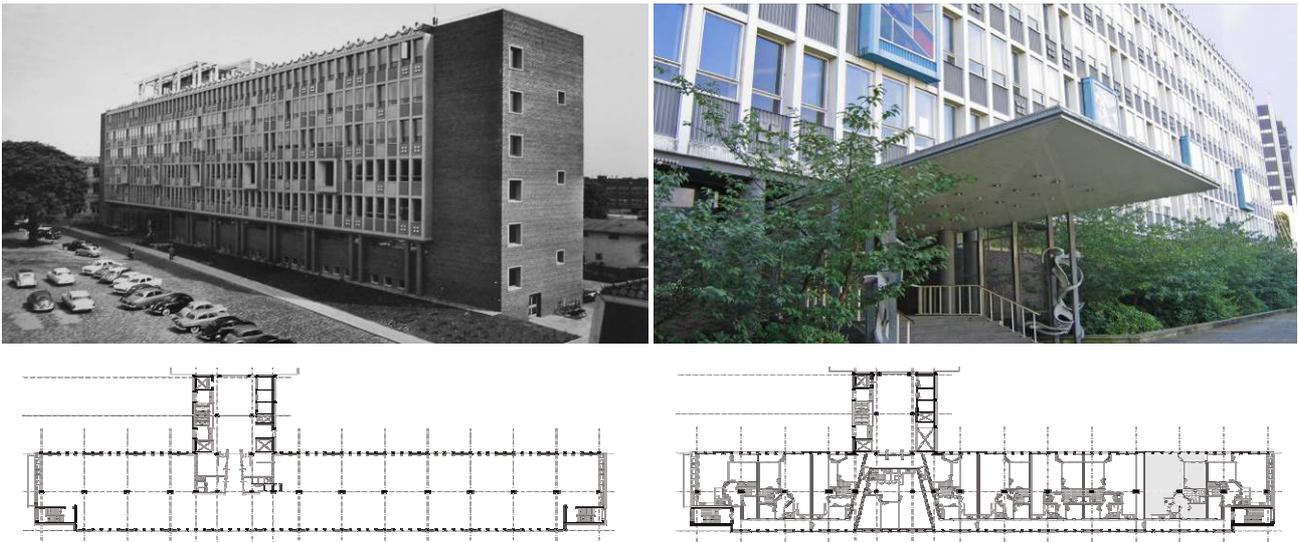
Figure 1: De Enk. Left: the building before conversion, to the right the building after conversion.

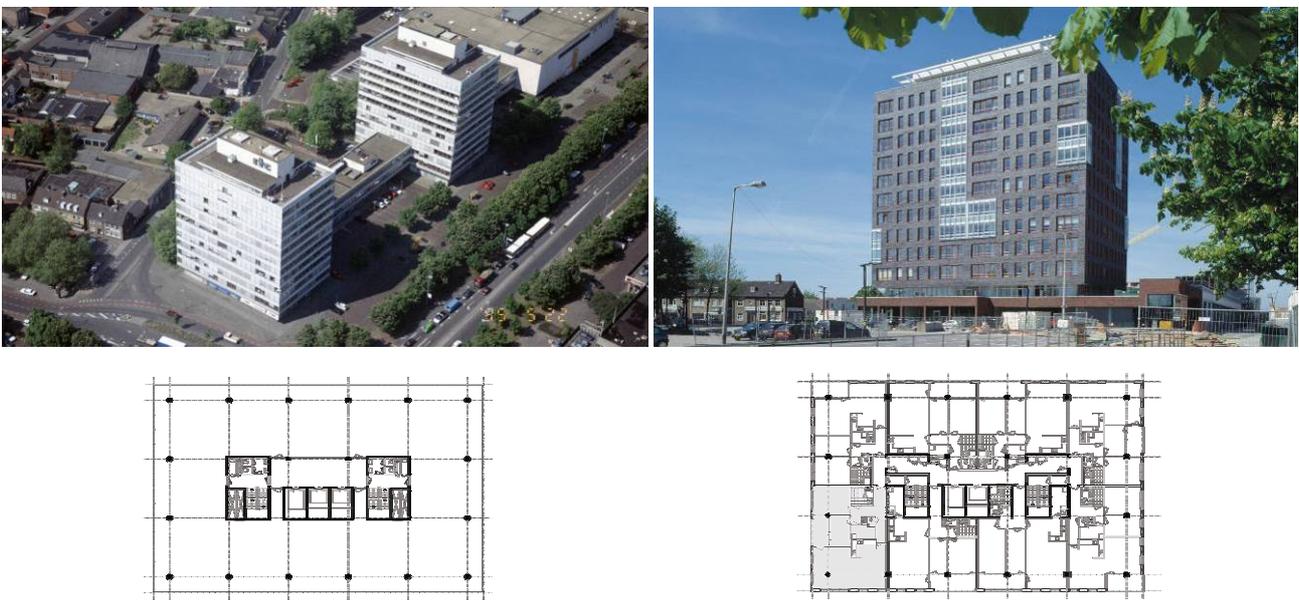
Figure 2: Twentec building. Left the building before conversion, to the right the building after conversion.

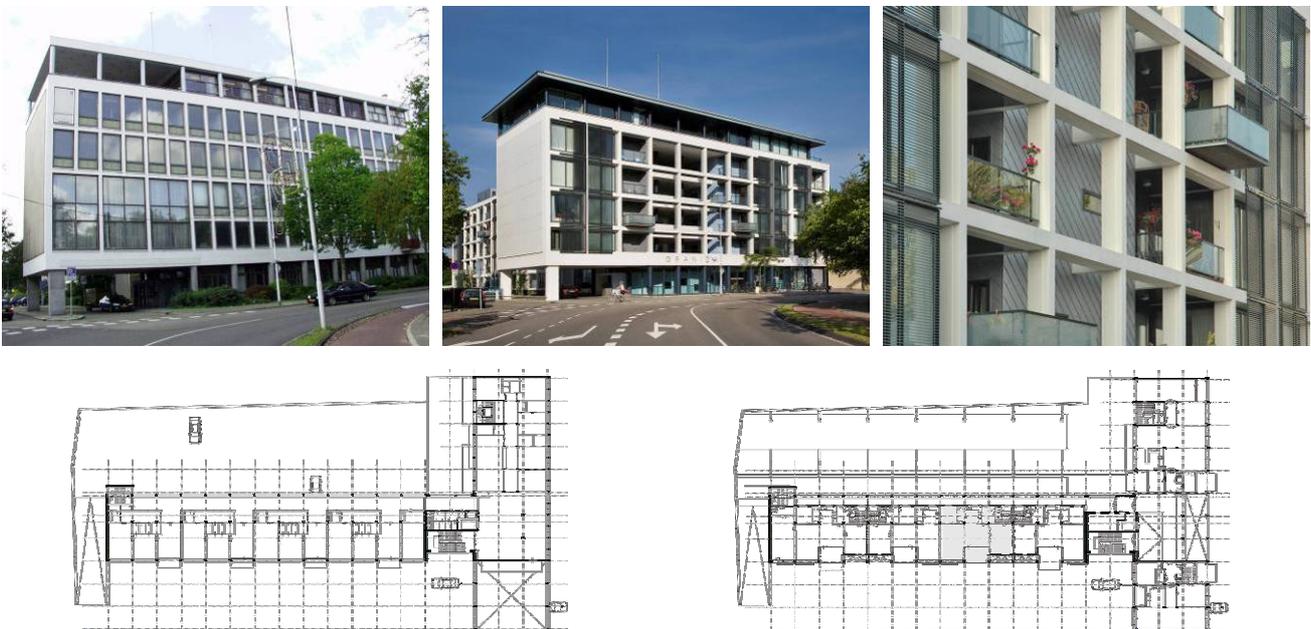
Figure 3: Granida. Left the building before conversion, to the right the building after conversion.

The main construction was found in unsatisfactorily state only in one of the 14 projects [Granida]. The concrete of the external columns was rotting and was renovated and reinforced. The repair itself forced extra costs onto the project, but additionally, as a result of the repairs the columns got wider, and the design needed modification. In another project [Billiton], concrete rot was found in part of the facade but took a minor investment to repair. Rotting wood or concrete, or oxidising steel can raise the price of a conversion, but in most cases, these problems can be seen in the preliminary phase and will not be a risk. Adding weight to the construction was problematic in one single case only. Office buildings are constructed to carry more weight than housing, hence in most cases, an additional floor can be carried by the existing construction.
