Experimental investigation of reinforced bonded joints for composite laminates

Bisagni, Chiara; Furfari, Domenico; Pacchione, Marco

Journal of Composite Materials

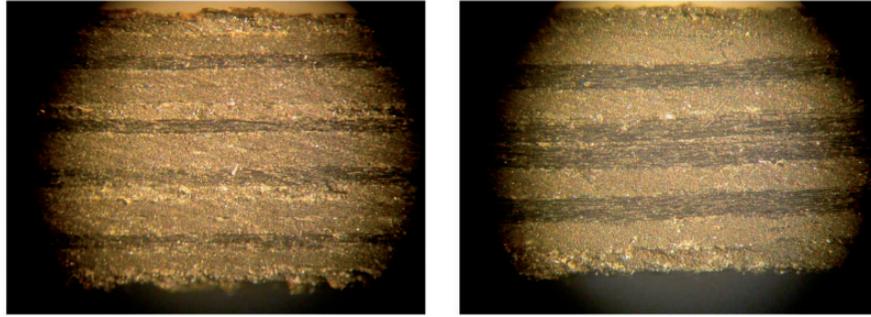
Figure 1. Photographs at the microscope of a laminate consisting of 16 plies and of a laminate consisting of 10 plies.

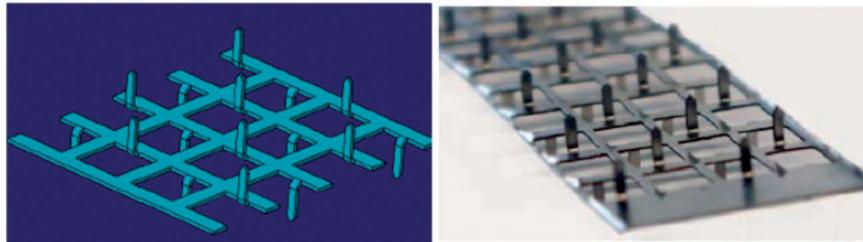
Figure 2. A sketch and a photograph of Redundant High-Efficiency Assembly (RHEA).

RHEA consists of spiked metal sheet reinforcement, sketched in Figure 2, that can be produced out of cold formable titanium alloys or stainless steel by metal stamping process with thickness from 0.2 to 0.4 mm. The reinforcements used for the tested specimens here

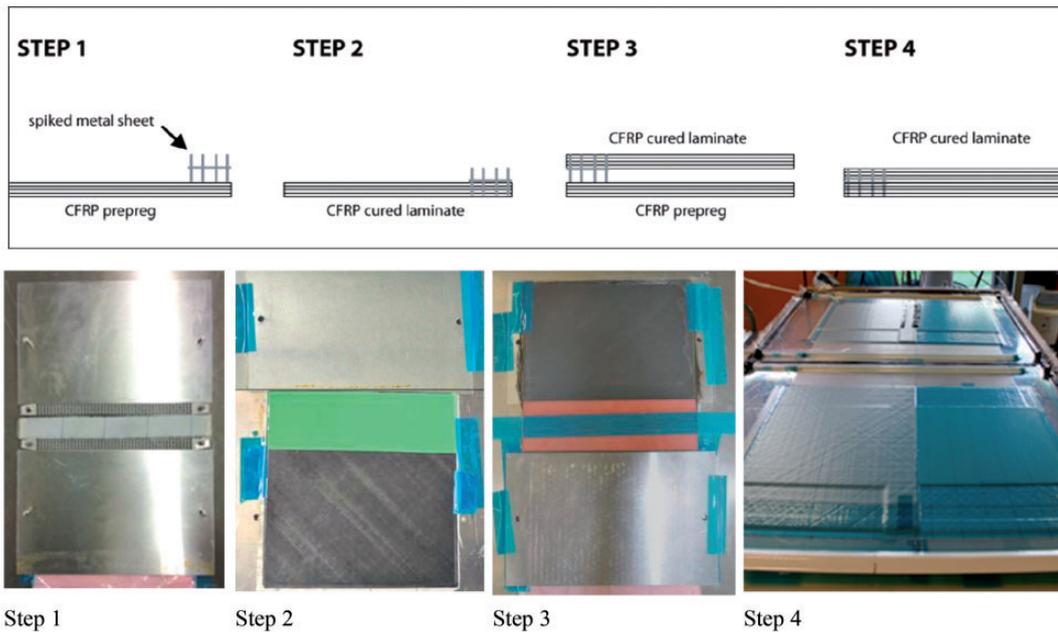
Figure 3. Co-bonding manufacturing process for RHEA joints.

pressure and temperature lead to the insertion of the spikes into the prepreg (Step 2). In this way, the fibres are not cut but simply realigned. Once this first curing cycle is completed, the 3D reinforced cured part is joined with another uncured part or with another 3D reinforced cured part through the use of an additional uncured doubler (Step 3). The high shear strength modified epoxy adhesive from Cytec is also added during the joining of the two parts. At the end, the different parts have a sandblasting surface pre-treatment before the last curing process that allows completing the insertion of the spikes through the thickness of the entire laminate (Step 4).

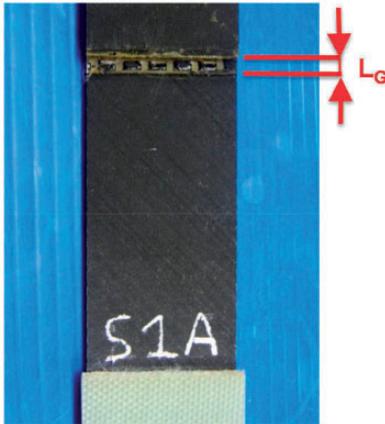
Figure 5. Photograph of a specimen with RHEA extended outside the joint run-out.

From the first preliminary tests in fatigue done in a previous study,¹⁷ it was found that delamination growth started at early fatigue cycling when metallic reinforcement ended at the joint run out. The presence of metal sheet without pin row at the very first millimetres was not providing benefit for the fatigue initiation. Consequently, it was decided to extend the metallic reinforcement outside the joint run out for a few millimetres (about 2.5 mm), with a one-sided row of spikes, as shown in Figures 4 and 5, because it was found that it delays significantly the damage initiation. The reinforcement was in any case limited to the run out and not extended along the entire bonding line to limit additional weight.

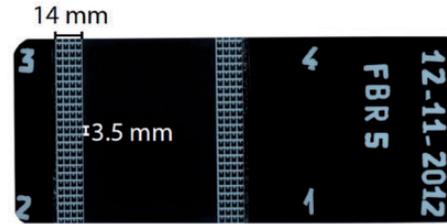
Figure 6. X-ray scan of a RHEA specimen.

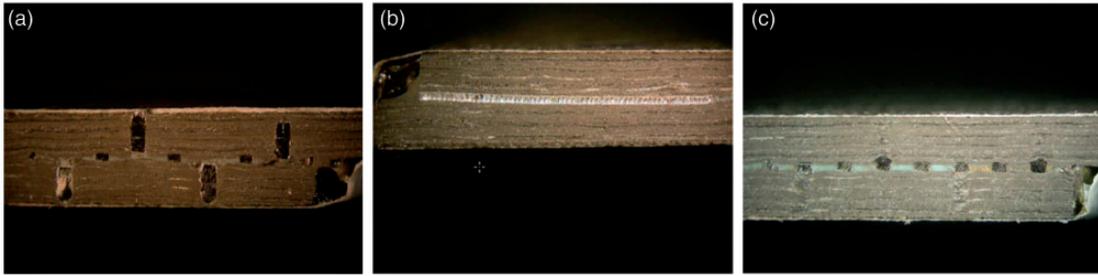
Figure 7. Photographs through the thickness taken at microscope showing different views of RHEA.

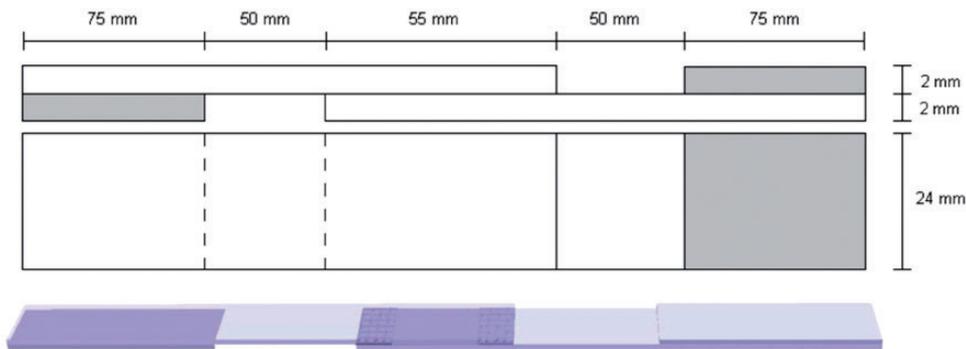
Figure 8. Single lap shear joint specimen.

The first type of specimens that was tested consists of unsupported single lap shear joints with overlap distance of 55 mm to represent a load transfer condition similar to the one at typical high load in aircraft structural components. Both specimens without any metallic reinforcements and with RHEA were tested. These types of specimens allow assessment of the static and fatigue behaviour of the new joint design under tensile loading with high peel stresses at bonded line run out.

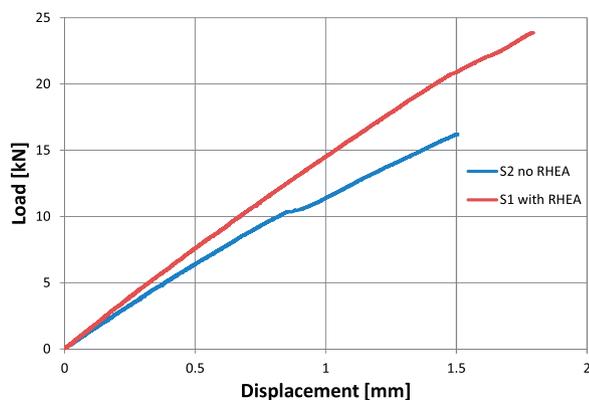
Figure 9. Load-displacement curves of specimen S1 with RHEA and specimen S2 no RHEA.

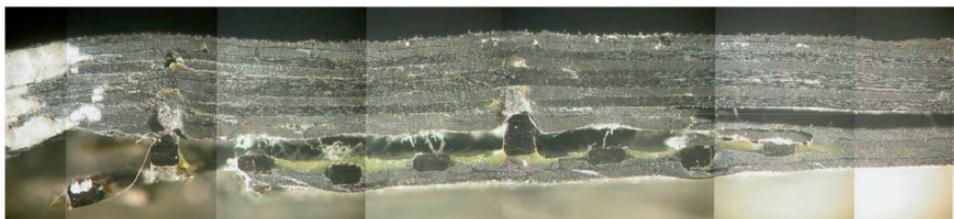
Figure 10. Photograph of specimen S1 with RHEA after the static test.

Mode II, but there is also a large contribution of fracture Mode II. A photo taken at the microscope of specimen S1 with RHEA after the test is shown in Figure 10.

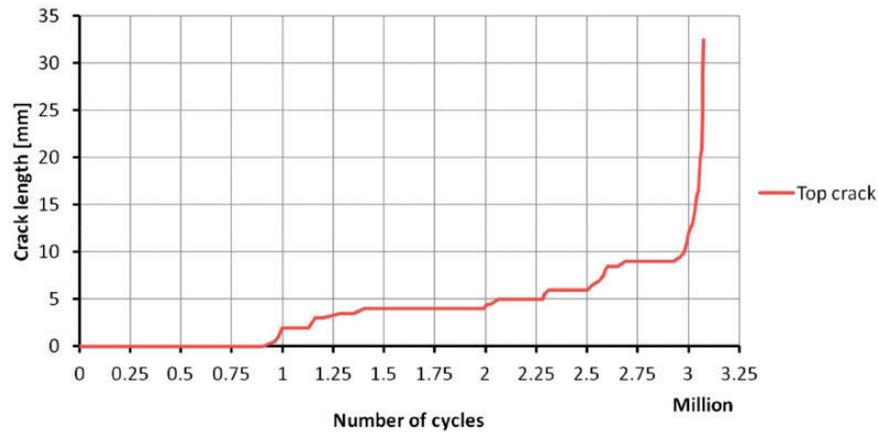
Figure 11. Crack growth measured during the fatigue test on specimen F3 with RHEA.

The crack growth was monitored during the tests, and the crack length was measured, using photographs and image analysis, thanks to marks drawn on the specimens. The growth measured during the fatigue test on specimen F3 with RHEA is reported in Figure 11 in function of the number of cycles, and some photos taken on the specimen are shown in Figure 12.

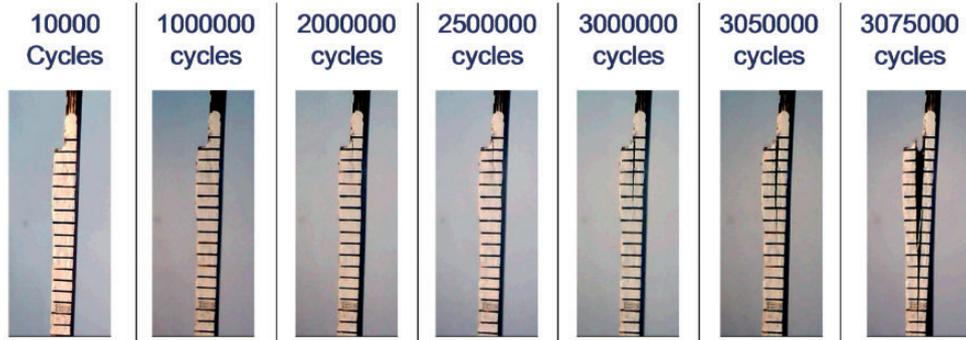
Figure 12. Photographs taken during the fatigue test on specimen F3 with RHEA.

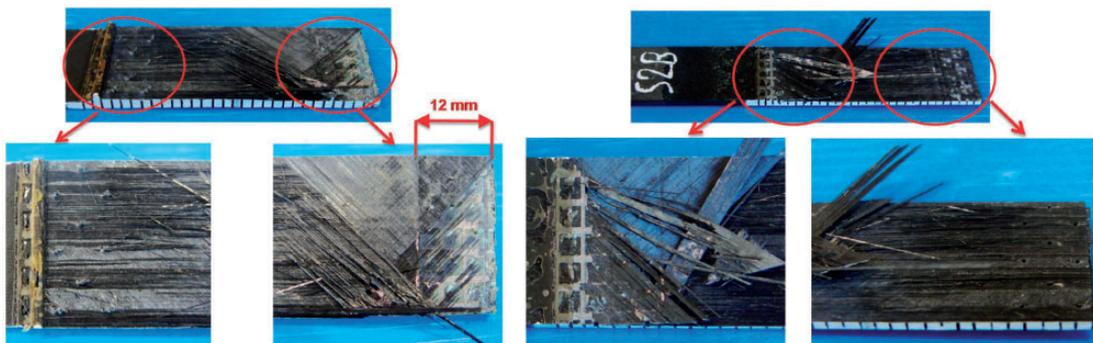
Figure 13. Photographs of the two parts of specimen F1 with RHEA after the fatigue test.

interfaces. Figure 13 reports some photos of the two parts of specimen F1 with RHEA after the test. In particular, it is possible to see that the metal pins pulled out from one of the two parts. The failure mode is characterised by delamination at different interfaces, fibre breakage and fibre pullouts.

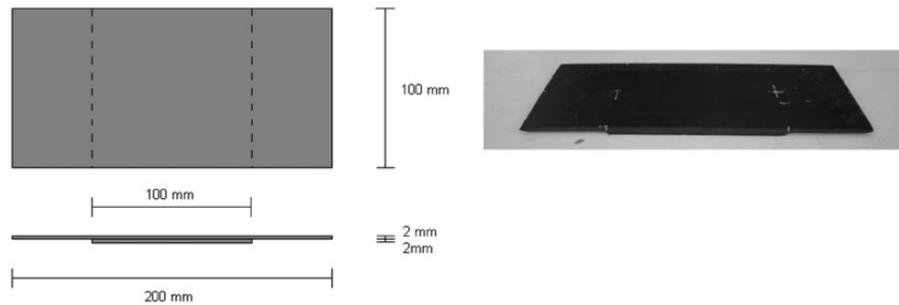
Figure 14. Geometry of bonded flange specimens and photograph of one of the specimens.

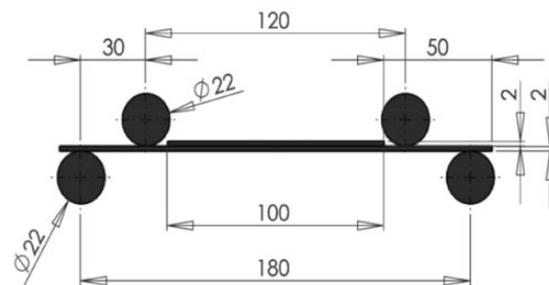
Figure 15. Set-up for four-point bending tests.

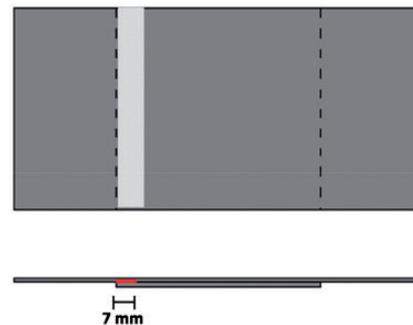
Figure 16. Position of the Teflon insert.

In order to study the influence of an embedded defect at the bonding layer, specimens with a 7 mm Teflon insert at the adhesive level in one side of the specimens were also manufactured. The position of the Teflon insert is shown in Figure 16. The Teflon insert simulates a manufacturing defect during the bonding, and the specimens with Teflon inserts were studied to understand the damage tolerance characteristics in four-point bending conditions, considering both purely co-bonded flange specimens and co-bonded flange specimens with reinforcements.

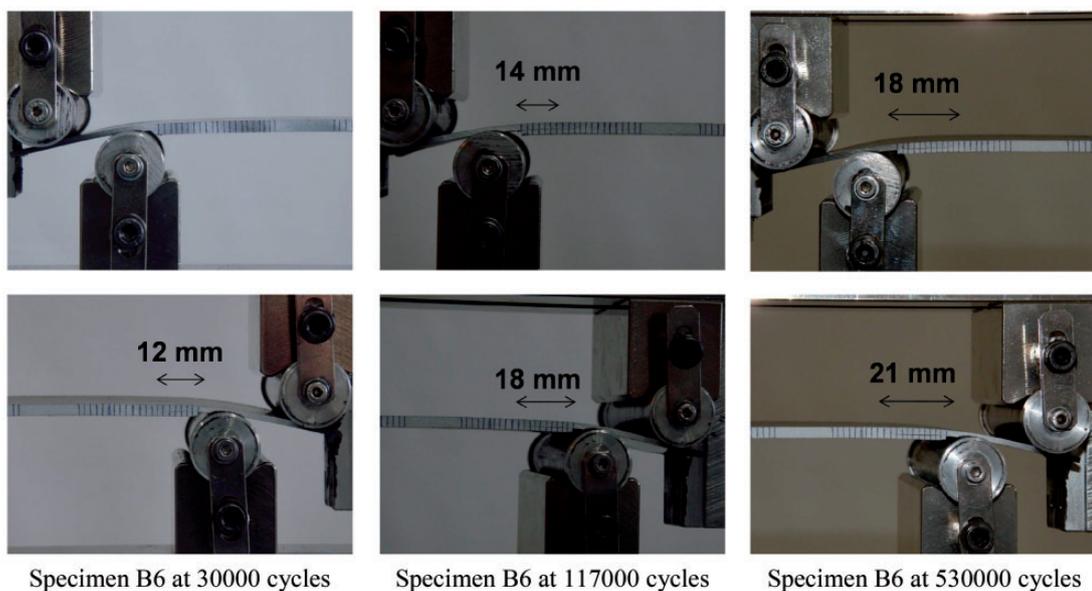
**Figure 17.** Debonding growth on co-bonded specimen B6.

The debonding growth is shown, as an example, in Figure 17 for specimen B6. Specimen B6 was tested in fatigue with maximum load equal to 2000 N. In specimen B6, a pure debonding was observed, without any delamination between the plies, as can be observed in the zoom images of the debonding areas in Figure 18.

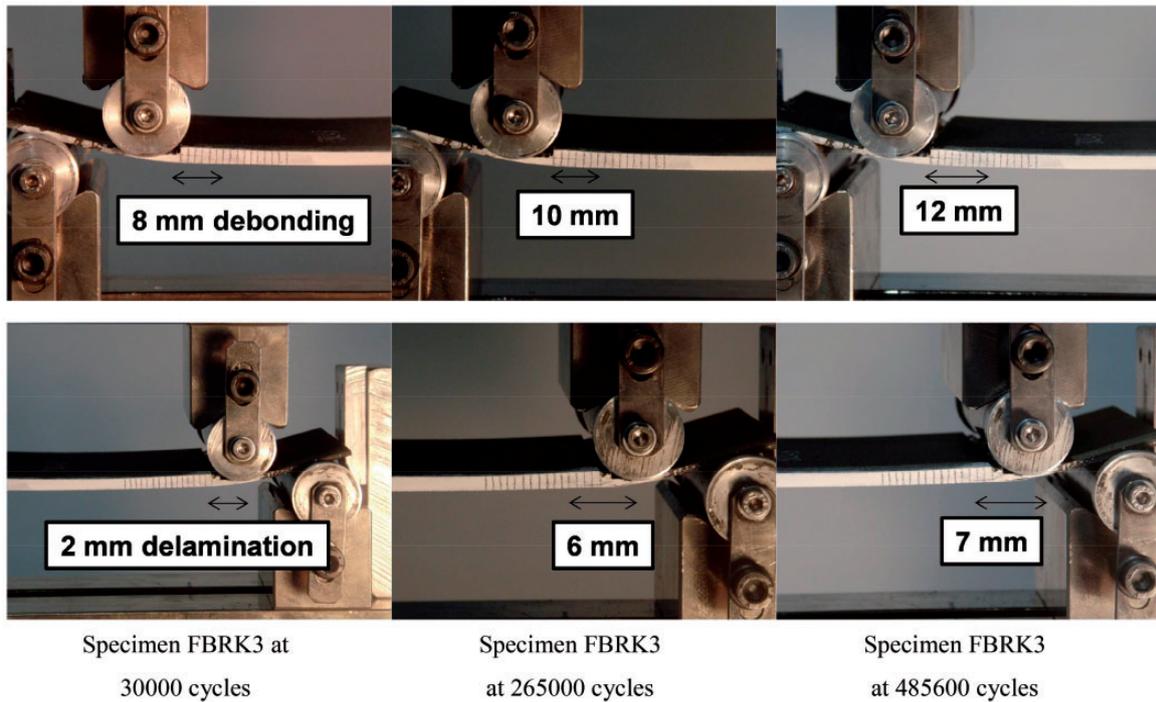
Figure 19. Debonding and delamination growth on reinforced specimen FBRK3.

A different behaviour was observed, for example, for specimen FBRK3, a co-bonded specimen with RHEA and Teflon tested in fatigue with maximum load equal to 2000 N, where both debonding and delamination were present on the two different sides of the specimen, as reported in Figure 19, that shows the damage growth.

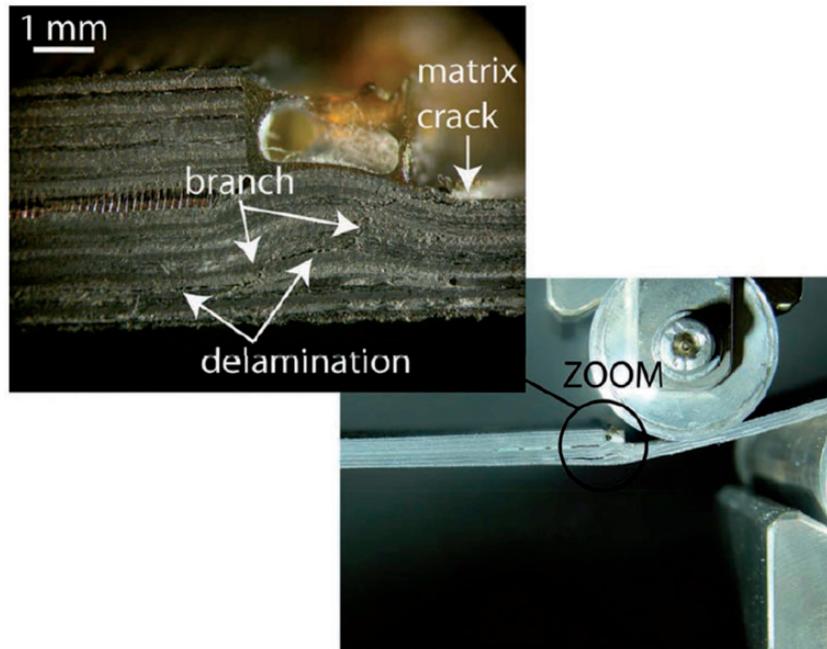
Figure 20. Details of initial damage in specimen FBR1.

A resin pocket in front of the bonded layer was observed in some specimens. Initial matrix cracks

were noticed in these specimens near the resin pocket. They initiated further matrix cracks in lower plies. A detail of this type of damage is shown in Figure 20 for specimen FBR1 with RHEA.

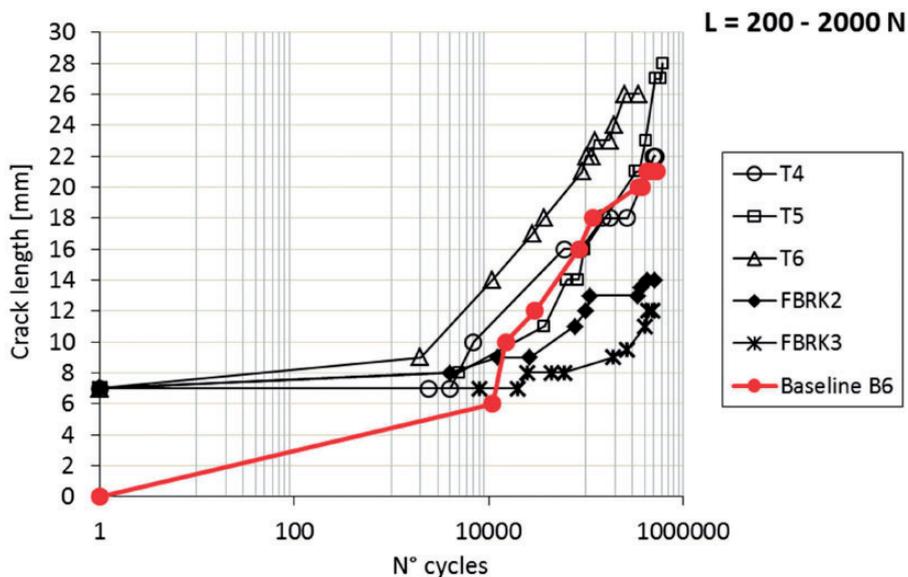
Figure 21. Comparison of crack length growth of co-bonded specimens with Teflon (without and with RHEA) with baseline configuration.

Damage growth for all specimens tested between 200 and 2000 N with Teflon insert, both T and RHEA configurations, are shown in Figure 21. Specimen B6 (completely co-bonded specimen) is taken as baseline

Comparing the typical behaviour of the FBRK specimens to that one of the T specimens, it is observed that in both sets of specimens, the damage started to propagate at the Teflon side, but different damage modes followed for the two sets. Debonding on the opposite side is observed for T specimens, while it is

not noticed for the FBRK set, which is characterized by delaminations at a higher number of cycles.

The debonding growth in the FBRK specimens is more controlled and the maximum debonding lengths is equal to 12–14 mm. For low number of cycles the debonding length for the different specimens is comparable, then for the high number of cycles the debonding length measured for both FBRK specimens is shorter than the one of T specimens at the same number of cycles. Besides, the debonding rate does not increase rapidly. In particular, it is interesting to notice that, at the end of the test, the debonding reaches about the length of the RHEA insert at the interface and does not show the steep behaviour typical of the co-bonded set.

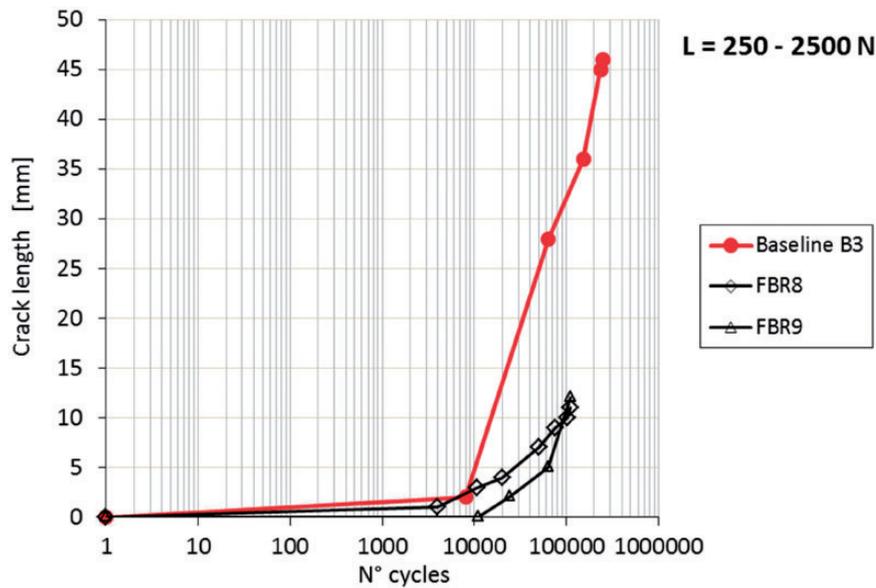
Figure 22. Comparison of crack length growth of co-bonded specimens with RHEA with baseline configuration.

The damage growth of two RHEA specimens tested between 250 and 2500 N (FBR8 and FBR9) are examined in Figure 22 taking specimen B3 as baseline (B3 is a co-bonded specimen tested within the same loading range). Also for this load level, it is possible to see that the damage growth is quite limited compared to the baseline configuration, that, after about 10,000 cycles, shows a remarkable and controlled growth. For specimen B3, the crack length refers to debonding of the flange, while no debonding was recorded for the RHEA specimens. The critical length refers to interlaminar damage, developed more or less in the pin area, in the skin laminate. This phenomenon can be due to the fact that the combination of adhesive and mechanical load allows a more progressive transfer in the area

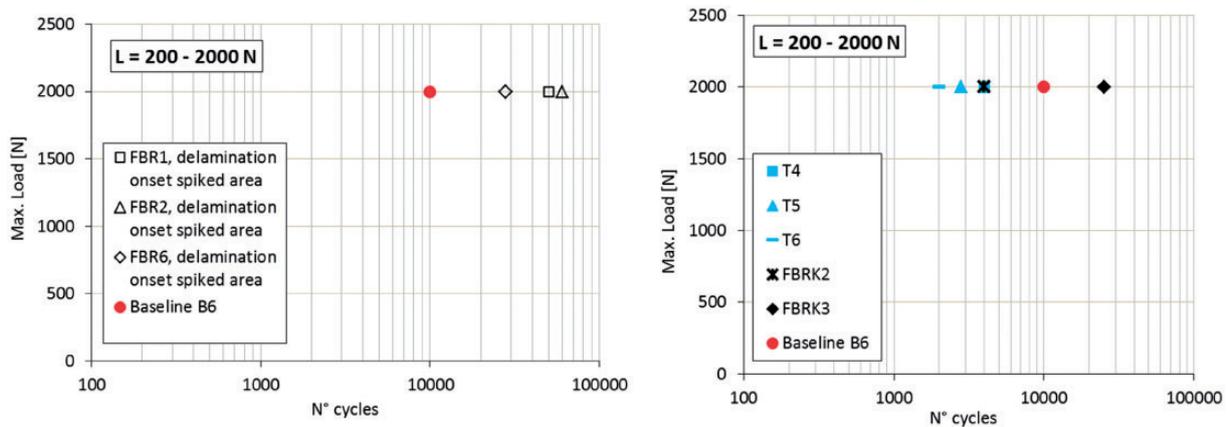
Figure 23. Damage onset for RHEA specimens without Teflon insert and damage onset for Teflon insert specimens, both co-bonded specimens and RHEA specimens, tested between 200 and 2000 N, always compared with baseline specimen B6.

The damage onset for RHEA specimens without Teflon insert tested between 200 and 2000 N is represented in Figure 23 together with the baseline specimen B6. The same figure reports also the damage onset for the Teflon insert specimens, both co-bonded specimens and RHEA specimens, tested between 200 and 2000 N, compared with the baseline specimen B6.

It is possible to note that for the specimens without Teflon inserts the damage onset of the baseline happens significantly before that one of the specimens with RHEA. In the case of specimens with Teflon, the damage onset of the baseline specimen happens to be within the same range of cycles as for the RHEA specimens.

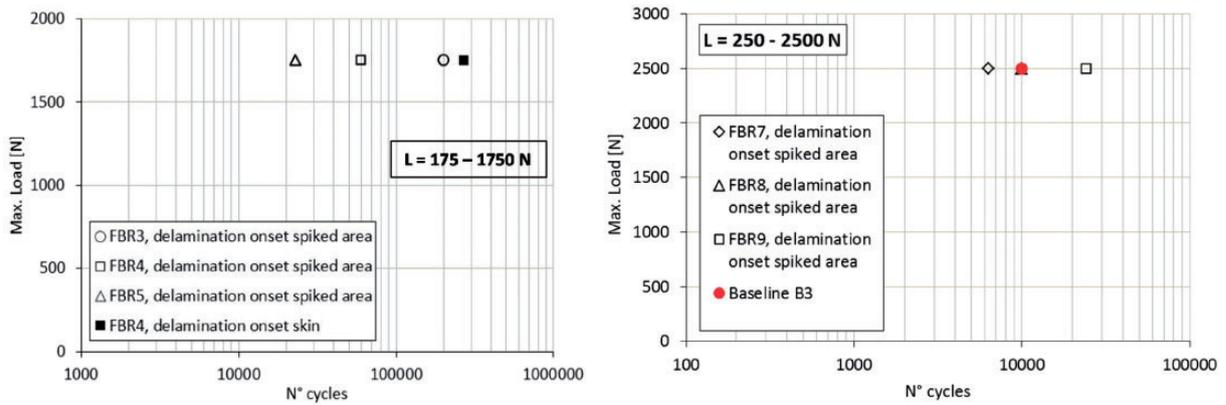
Figure 24. Damage onset for RHEA specimens without Teflon insert, tested between 175 and 1750 N and between 250 and 2500 N, respectively.

In order to better appreciate the statistical scatter, the damage onsets for RHEA specimens without Teflon insert tested between 175 and 1750 N and between 250 and 2500 N, respectively, are represented in Figure 24. For the tests between 250 and 2500 N, the data are compared with the baseline specimen B3.

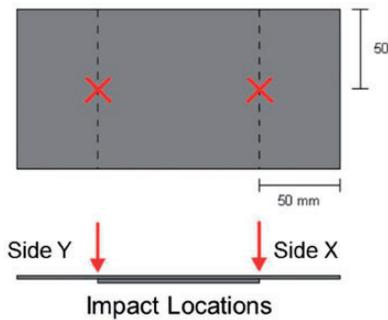
Figure 25. Impact locations of the low-energy impact test.

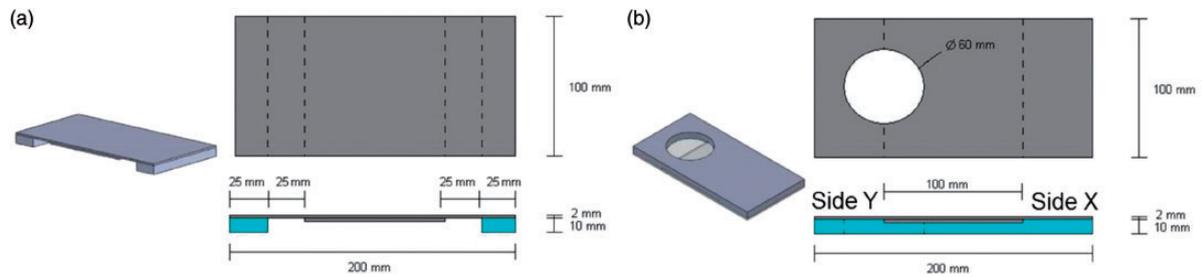
Figure 26. Boundary conditions used for impact tests: (a) simply supported; (b) fully supported on side X and fully supported with a hole on side Y.

The impactor had a tip diameter of 25 mm and a mass of 1.022 kg. Rebound hits were prevented by sliding a rigid plate between the impactor and the specimen, after the impactor had hit the specimen surface. Two symmetrical locations on the top of the skin laminate were chosen to be impacted for each specimen, as shown in Figure 25. Three different boundary configurations were tested. In particular, two different supports were designed and manufactured. The first one allowed conducting simply supported tests both on side X and on side Y, while the second one allowed conducting fully supported tests on side X and fully supported tests with a hole on side Y. The supports for the different boundary conditions are illustrated in Figure 26.

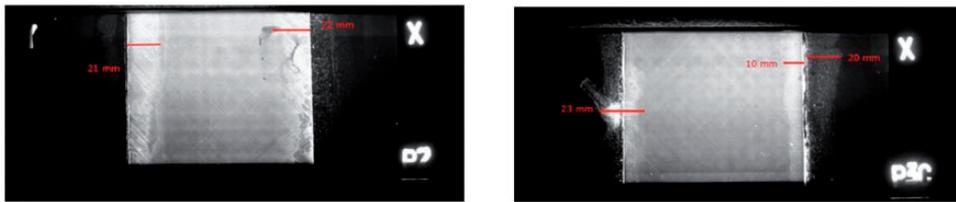
Figure 27. X-ray scan of baseline specimens: simply supported at 10 J and fully supported with hole at 20 J.

The extent of the damage caused by the impact event was evaluated by visual inspection and by X-ray techniques. Example of X-ray scans of the baseline specimens are reported in Figure 27. In some cases, at the high energy level, it was possible to notice also fibre breakage, as shown in Figure 28. Figure 29 reports the X-ray scans of one of the specimens with RHEA

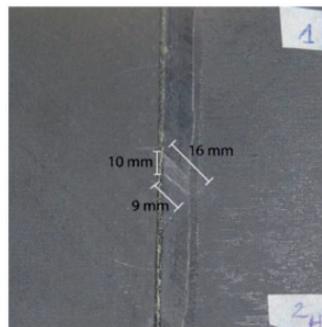
Figure 28. Fibre breakage obtained in one of the specimens.

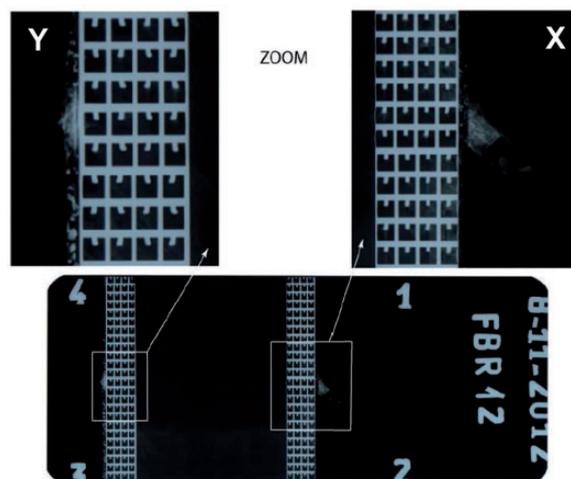
Figure 29. X-ray scan of specimen FBR12 after impacts at 20 J: fully supported on X-side and fully supported with hole on Y-side.

at the energy level of 20J for two different boundary conditions. The main results of the impact tests on the co-bonded and RHEA specimens are summarized in Table 4. The terms P and FBR are chosen to describe co-bonded specimens and RHEA specimens, respectively. Six P specimens and six FBR specimens were tested.

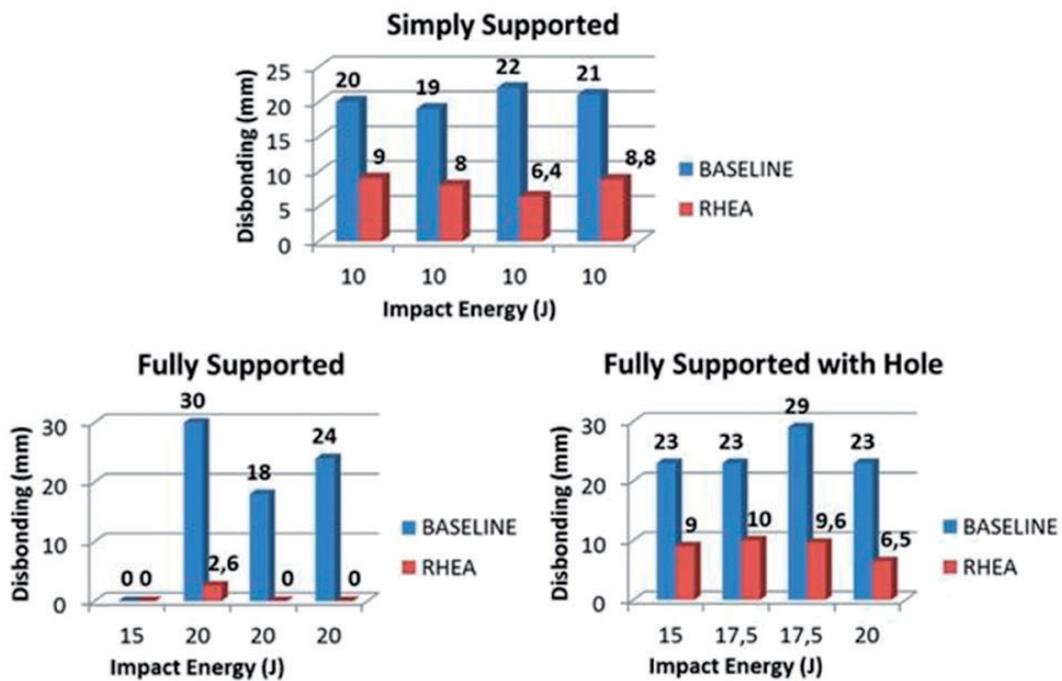
Figure 30. Summary graphs of impact tests account damage size only for disbonding at bonded flange run out.

The impact behaviour of the joints reinforced by the metallic spiked sheets is compared with the same impact energy levels demonstrating the capability of the novel design to contain the damage size. Depending on the energy levels, different failure modes were detected at reinforced joints: delamination, fibres breaking and split at the impact area indicating that the metallic reinforcement is inducing different damage patterns due to the local change of the stiffness driving the different failure modes. This suggests that an optimum design of the metallic reinforcement can be investigated to further reduce the damage size or to address the most appropriate failure modes depending on the load to be transferred. Figure 30 summarizes the results of the impact tests in graphs accounting damage size only for disbonding at bonded flange run out.
