# Fatigue strength of repaired welded connections made of very high strength steels

A.Akyel<sup>1</sup>, M.H. Kolstein<sup>1</sup>, F.S.K. Bijlaard<sup>1</sup>

<sup>1</sup>Delft University of Technology, Delft, Netherlands

## Abstract

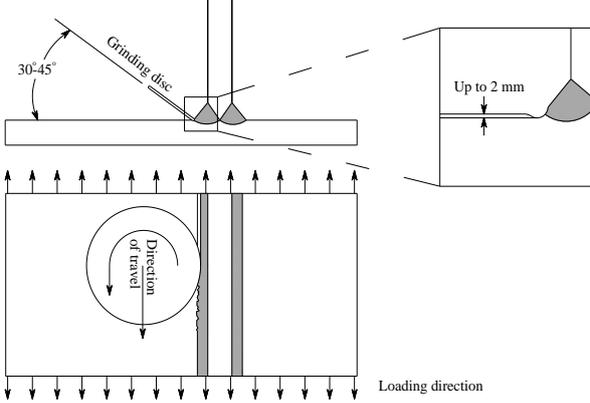
<p><b>Grinding:</b></p> <p>Applicable for the fatigue cracks with the depth up to 2 mm.</p> <ol style="list-style-type: none"> <li>Advantageous <ul style="list-style-type: none"> <li>improve weld toe, reducing stress concentration</li> <li>cost effective</li> </ul> </li> <li>Disadvantageous <ul style="list-style-type: none"> <li>not possible to apply for complex joints</li> <li>risk to mask the crack tip</li> </ul> </li> </ol>

the repair methods for shallow fatigue cracks. The grinding process is also used as a fatigue strength improvement method for welded connections by removing discontinuities at the weld toe and reshaping the weld to create a smooth transition between the weld material and the base material for the stress concentration reduction. According to Dexter, et al. (2013), the grinding method can be applied for the repair of fatigue cracks with a depth up to 2 mm. In addition, the execution of the grinding procedure for the fatigue strength improvement of welded connections is described by Haagensen et al. (2001) in the IIW recommendations. Peening is a cold working process which creates a plastic deformation at the surface of the material by impacting a tool or metal balls and it is mainly used as a fatigue strength improvement method. The application process and quality control procedure are extensively given in the IIW recommendations [Haagensen et al., 2001]. Peening is an effective method for repair of surface cracks with a depth up to 3 mm [Dexter et al., 2013]. The GTA process remelts a small amount of the weld toe and the base material by using a gas-shielded tungsten electrode to liquefy material and to re-establish the connection after the solidification. This method is effective for the repair of the surface cracks with a depth up to 5 mm. In addition, the GTA remelting process is also used as a fatigue strength improvement method by reshaping the weld toe to create smooth transitions between the base material and the weld material. The effectiveness of the method depends on the penetration of the remelting zone. Fisher, et al, (1994) concluded that the application with the argon helium shielding gas and a cone angle applied with 60° respect the material surface results in the most effective penetration of the remelting zone.

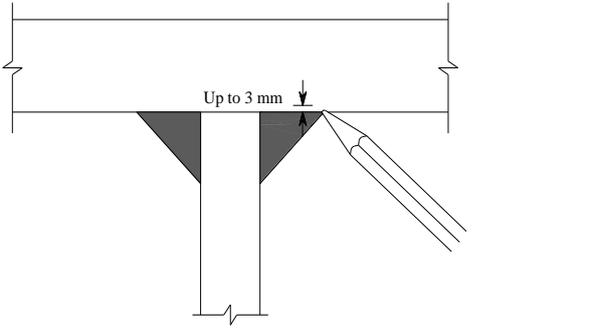
<p><b>Peening:</b></p> <p>Applicable for the fatigue cracks with the depth up to 3 mm.</p> <ol style="list-style-type: none"> <li>Advantageous <ul style="list-style-type: none"> <li>improve weld toe, reducing stress concentration</li> <li>introduce compressive stresses</li> </ul> </li> <li>Disadvantageous <ul style="list-style-type: none"> <li>required highly skilled professionals</li> <li>difficult to apply to complex joints</li> </ul> </li> </ol>

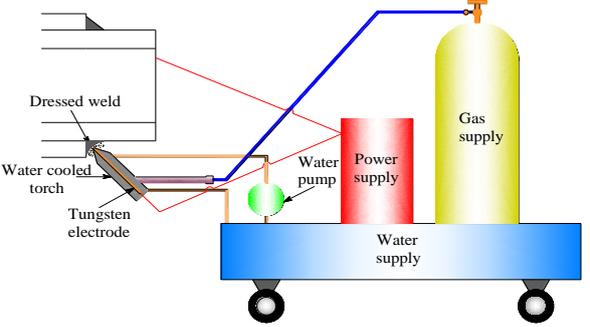
<p><b>Gas Tungsten Arc melting:</b></p> <p>Applicable for the fatigue cracks with the depth up to 5 mm.</p> <ol style="list-style-type: none"> <li>Advantageous <ul style="list-style-type: none"> <li>improve weld toe, reducing stress concentration</li> <li>no additional filler material required</li> </ul> </li> <li>Disadvantageous <ul style="list-style-type: none"> <li>required highly skilled welders</li> <li>difficult to apply to complex joints</li> </ul> </li> </ol>

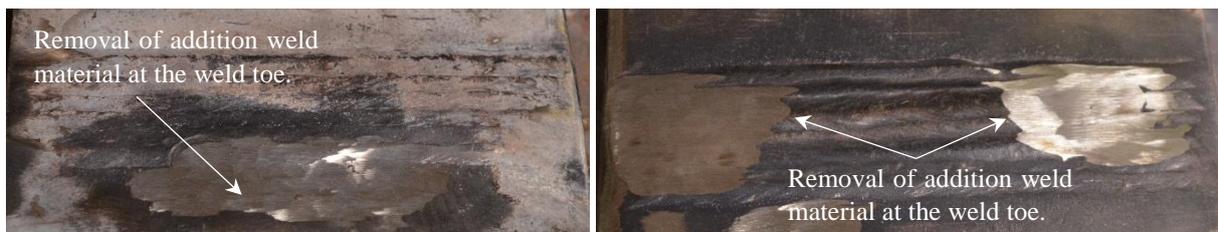
Figure 8. Weld shape after the repair and the repaired weld geometry after reshaping and HiFIT.

In practice, repair of fatigue cracks in structures is carried out at service conditions where the repaired connections are constrained by the surrounding structural elements. For the simulation of realistic repair conditions, the specimens were constrained during the application of the repair weld. The repair welds were examined by a magnetic particle and ultrasonic inspection for the weld qualification. After the repair of the weld toe cracks, the repair welds cause geometrical changes of the welded connection and it consequences a disruption of the stress distribution around the welded connection (see Figure 8a). Especially, the intersection between boundaries of the repair weld and the original weld cause a sharp geometrical change and consequently a high stress concentration. For the elimination of these undesired effects of the stress concentration, the repaired welded connections were reshaped by grinding to smooth transition between the original and repair weld (see Figure 8b). The grinding process is limited with the removal of the start-stop points of the repair weld and additional weld material at the weld toe (see Figure 8c). Furthermore, after the fatigue crack repair, the repaired side of the connection has a new weld toe and the other side of the weld contains the weld toe of the original weld which still contained the cyclic load history from the fatigue crack creation stage. According to the cumulative damage rule of Miner, fatigue crack initiation in the original weld toe is highly possible after the repair. The main purpose of the research is to investigate the fatigue strength of the repaired welded connections made of very high strength steels. Therefore, the cracks initiation in the original weld toe needs to be prevented. For this purpose, the weld toe of the original weld was treated by the high frequency impact treatment (HiFIT) weld toe improvement method.
