# Reengineering history: What can we learn from a photographed B-17 “Flying Fortress” in-flight structural failure?

Michiel J. Schuurman\* and Christos Kassapoglou†

*Delft University of Technology, Faculty of Aerospace Engineering, Delft, 2629HS, The Netherlands*

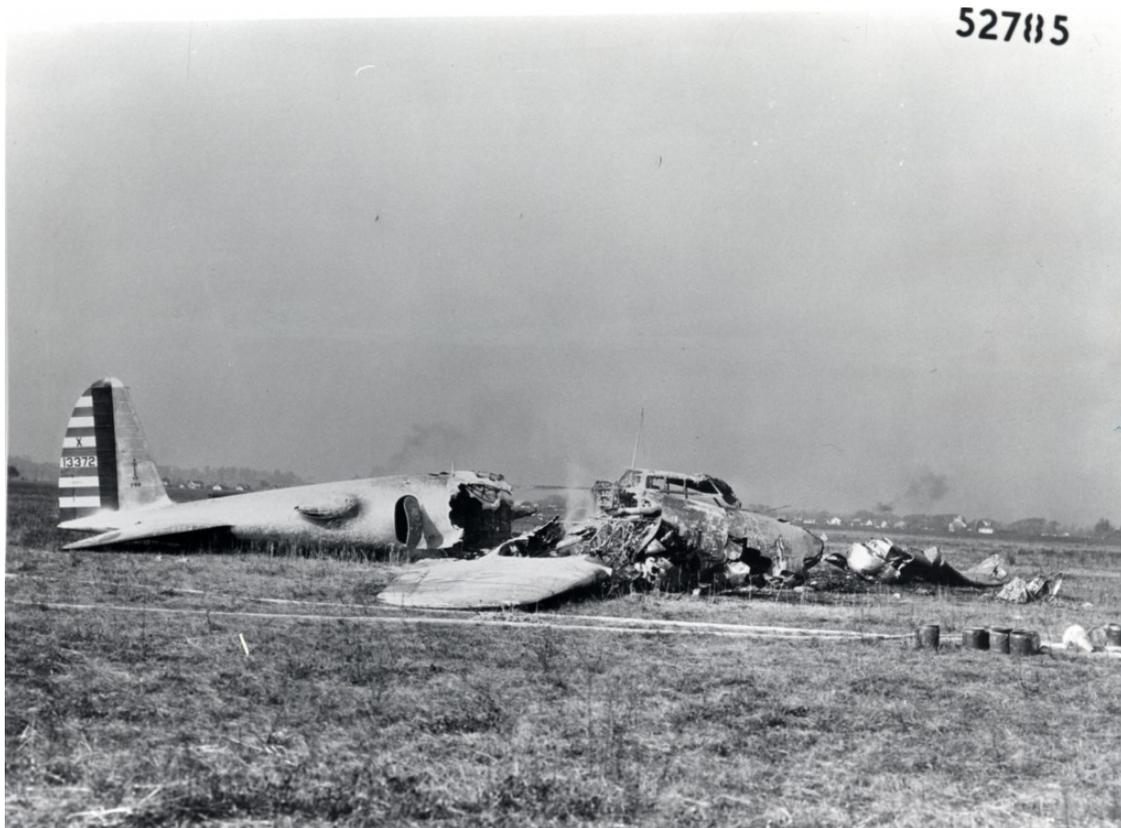
On October 30<sup>th</sup>, 1935, during evaluation exercises for the USAAC, the 299 crashed shortly after take-off (Fig. 1). The gust locks were left engaged and this oversight resulted in the aircraft entering a steep climb and stall immediately after take-off. The official investigation into the cause of the crash was concluded in December as pilot error and the Model 299 was absolved of having any defect contributing to the crash [3].

**Fig. 1** Side view Model 299 after the crash during evaluation exercise [4].

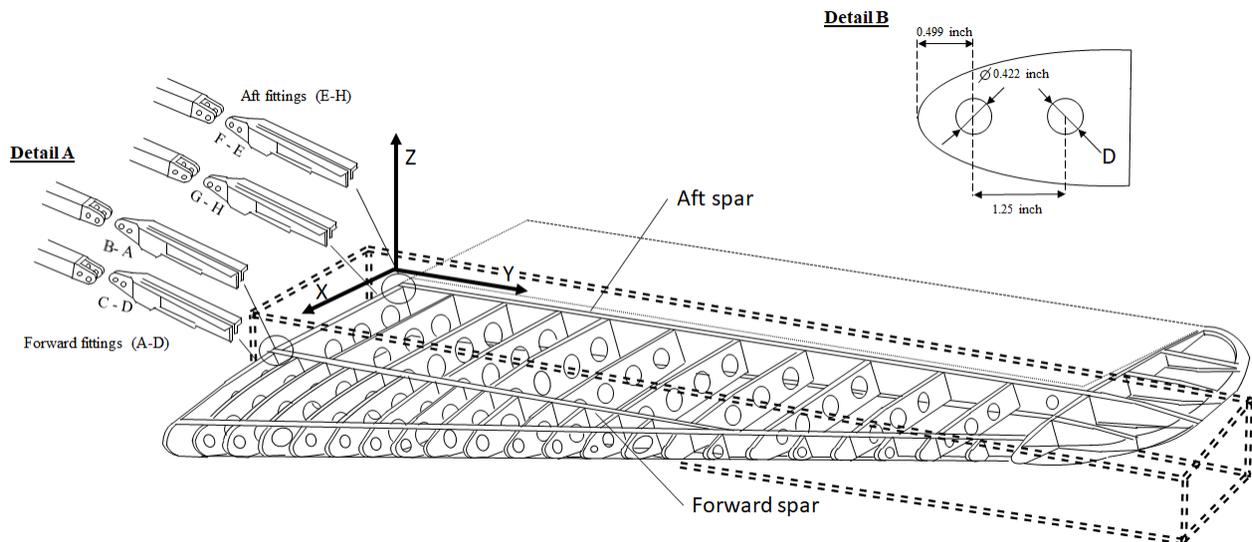
The B-17 horizontal stabilizer Fig. 2 has an area of 250.6 sq. ft. and is set at 0° relative to longitudinal axis. The front spar extends 19.167 feet to within 8 feet of tip end. The longer rear spar extends to the tip joining point. From the point where the front spar stops to the end of the tip, the leading edge and rear spar take over as the torsion-carrying structure. The two I-type spar beams have hydro-pressed webs with at the end a steel male attachment fitting. These end fittings can be joined with a steel taper pin onto bulkhead section 8 and 9 of the rear fuselage which has a female type fitting. The stabilizer has a NACA 0012 symmetrical profile which allows the stabilizer to be interchangeable on the left and right hand side. The flying characteristics of the B-17 were good as it was designed as a bomber flying long missions. The B-17 was not designed for spins and steep dives care must be taken to recover the aircraft [8]. A limit load factor of 3 is given for a design gross weight of 48,726 pounds [9].

**Fig. 2 Horizontal stabilizer assembly B-17 with fittings (Detail A) and lug measurements (Detail B).**

The third scenario that is considered is a partial separation of the left stabilizer due to bomb impact. By reviewing the B-17 stabilizer design the four terminal fittings (stabilizer-to-fuselage connection points), see 2, have been identified as the weakest link. Examination has shown that at this point all the forces and moments are transferred into the fuselage. It is proposed that the bomb impact could break one or more but not more than three terminal fittings. This failure scenario would break the two upper attachment points and the two lower attachment points would have sufficient strength to carry the stabilizer weight and aerodynamic loading. The sequence of this failure mode would be very elaborate as aerodynamic twisting and force loading may cause a multiple breaking scenario. Similar to scenario B the belly turret gunner who witnessed the event did not mention or provided any information pertaining to the stabilizer after it was hit by the bomb. Examining the post impact photograph Fig. 4b, 4c and 4d a black (shadow) structure, resembling part of the stabilizer can be seen hanging downwards from the tail section 4c. Subsequently, photographic evidence suggest a partial failure of the left hand stabilizer as a likely scenario and should be investigated further.

The two-spar horizontal stabilizer consists of a center structural box section with two outer sections, the leading edge section and aft elevator section. The aft spar serves as the connection point for the elevator. The leading edge consists of the ribs shaping the nose which are connected to the forward spar and the skin. It is assumed no major structural load can be carried by leading edge because it is designed for much lower loads than the bomb exerts during impact and thus would fail immediately. The elevator is a separate element connected by two hinges and a torsion bar for elevator and trim control. Similar to the nose section the elevator is considered to be able to carry a bomb impact load and would fail immediately. As such this approach uses a symmetrical structural box section consisting out of the forward and aft spar to assess the forces and moment at the stabilizer root to fuselage connection. As a result, the bomb impact location (X and Y-direction) which is a model input should be within the wing box outline shown in Fig. 2. This is supported by close examination of Fig. 4a.

A third failure mode that is considered is a lug-out-of-plane loading resulting in a fitting failure. The male lug connection will be loaded in X-direction (see Fig. 2) resulting in a shear force and a bending moment. Substituting stress criterion Eq. (13) in Eq. (12) and given the lug material properties the maximum applied  $F_x$  can be derived. By using Eq. (14) the maximum normal stress capability can be calculate for the applied load  $F_x$ . This yielding two maximum  $F - X$  forces given in table 1

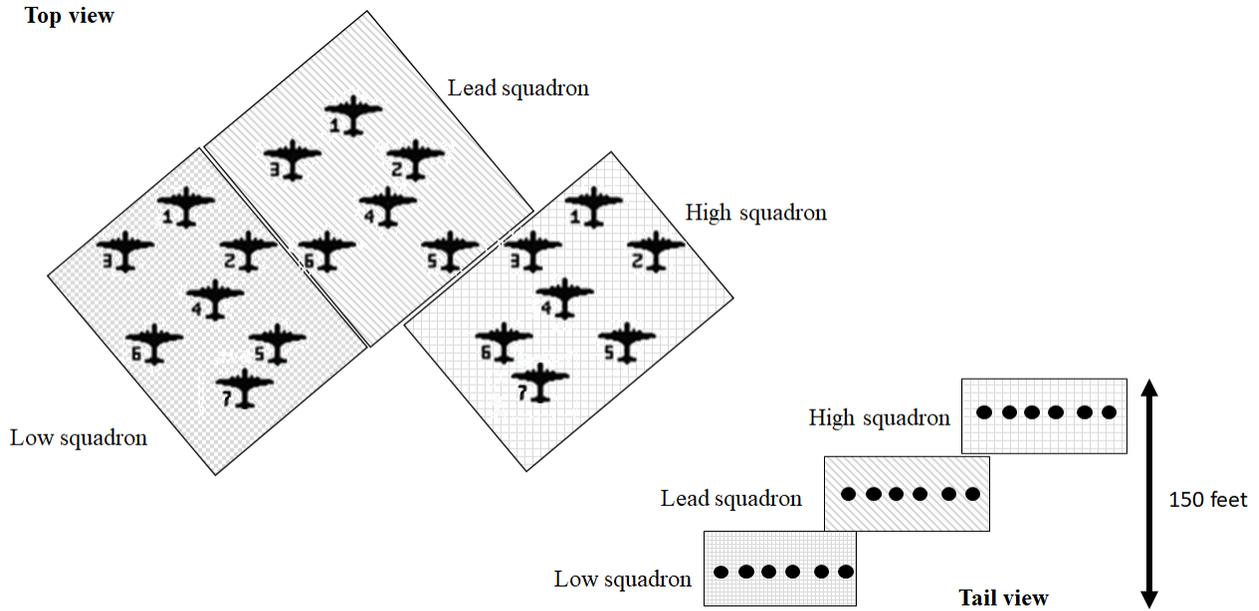
In January 1944 the box formation was adopted as general practice and was used for missions. The box formation was tuned to best use the B-17 armament and defend the formation. The formation also needed to be close together to give a better bomb pattern and minimize the time over heavy flak defenses and anti-aircraft guns which could only fire on a few number of the units at the time. The three squadrons element flew in a box of 160 feet wide by 150 feet high, the distance was close and staying in formation was essential Fig 3.

**Fig. 3 “Box formation“ flown by the B-17s with aircraft position numbers.**

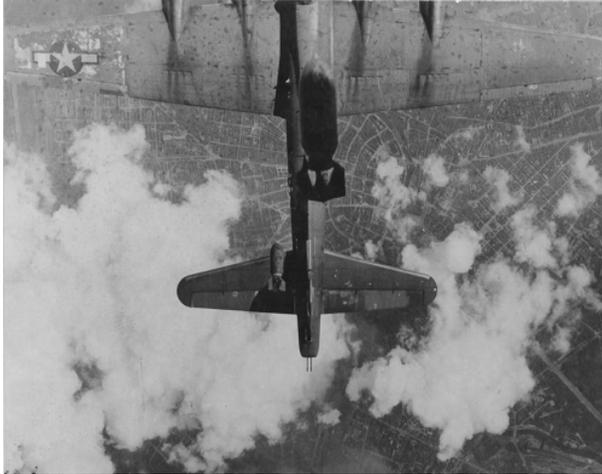
(a) Photograph showing stabilizer before bomb impact.

**Fig. 4** Photographs (a)-(d) showing the B-17G "Miss Donna Mae II" left horizontal stabilizer hit by bomb [17].

Two other model input variables are the X and Y-coordinate of the bomb impact point on the stabilizer. Using Fig. 4a an estimate of the bomb impact location can be determined using scaled distances. Figure 4a is a top view of the B-17, where the Bomb c.g. is at 1/3 from the nose. Assuming no lateral movement occurred before impact the impact

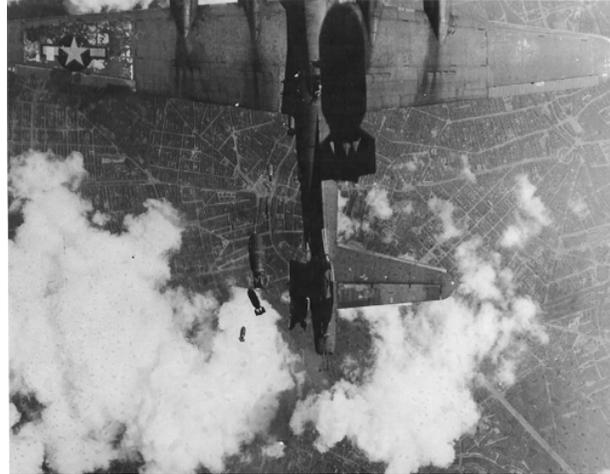
(b) Photograph 1 showing stabilizer after bomb impact.

After reviewing the photographs in Fig. 4 three main scenarios were developed which could explain the stabilizer failure. The first scenario will look at the possibility of an explosion of the bomb when it hit the stabilizer. The second and third scenario will look at the failure caused by bomb impact, where the distinction is made between a partial and a full separation of the horizontal stabilizer.

The second scenario that will be looked at is a full separation of the left stabilizer due to the bomb impact. This scenario has been suggested by several sources including the MACR[18] report and the original photograph descriptions Fig. 4. Following this scenario and given the time interval between the photographs it would be likely to observe the separated stabilizer falling down. Examining the three post impact photographs Fig. 4b, 4c, and 4d no debris can be observed. Evaluating this information Scenario B – full separation of the left stabilizer by impact is possible but given photographic evidence unlikely.

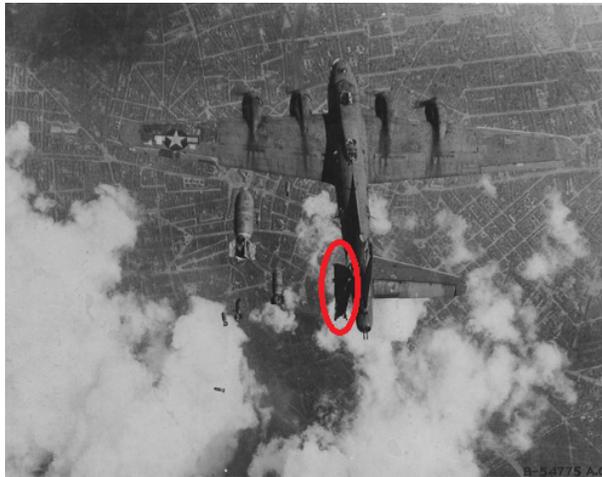
(c) Photograph 2 showing stabilizer after bomb impact.

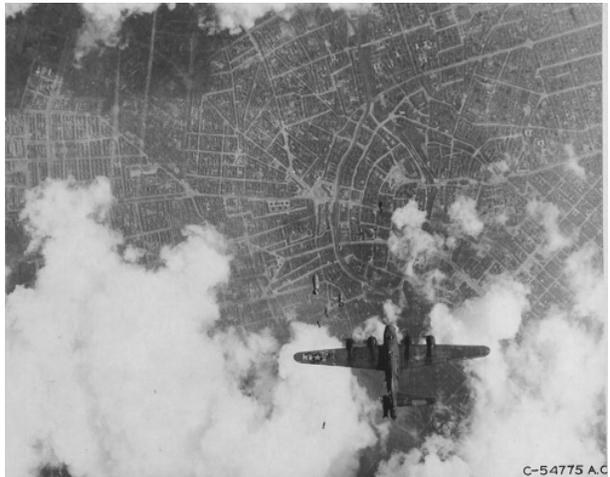
(d) Photograph 3 showing stabilizer after bomb impact.

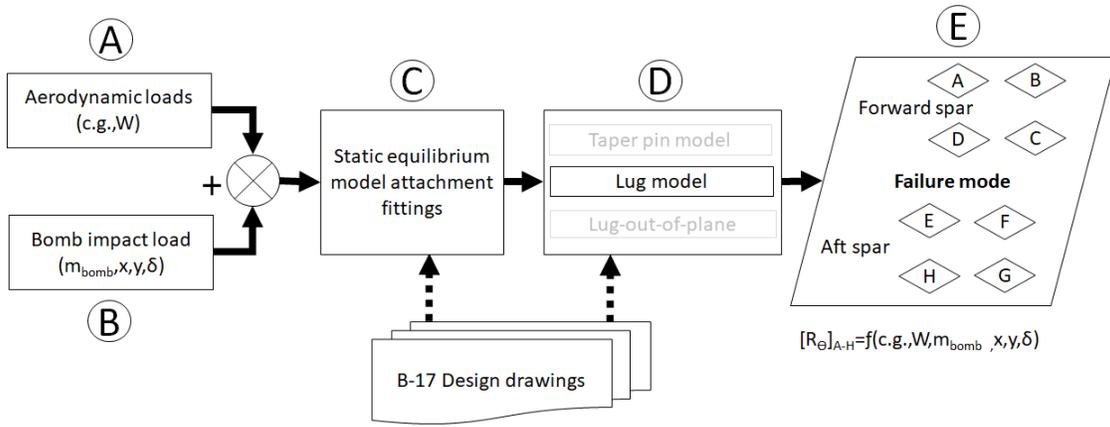
Fig. 5 Structural modeling approach diagram.

Figure 5 shows the model setup with the inputs consisting out of the estimated aerodynamic loads (A) and the force resulting from the bomb impacting the stabilizer (B). The stabilizer static equilibrium model for the connection points (C) represents the mechanical characteristics of the stabilizer connection points to the main fuselage. In the failure model (D) the taper pin, lug and male fitting connection base maximum forces are calculated. The analytical model was created using B-17 design drawings and component specifications [23]. Given model inputs an assessment of possible failure mode(s) (E) can be evaluated. A more detailed description of the modeling approach is provided in the next sections.

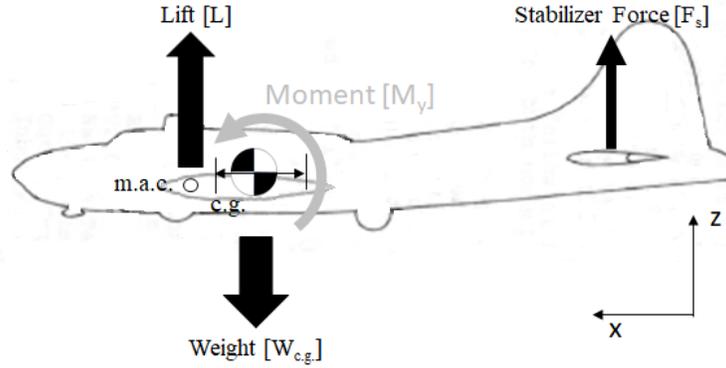
For a balanced flight condition, the external forces and moments acting in the vertical plane on an aircraft can be determined using the simplified scheme depicted in Fig. 6. The B-17 aircraft can be simplified to a fuselage, main wing and stabilizer. The aircraft weight ( $W_{c.g.}$ ), lift ( $L$ ) and the stabilizer force ( $F_{stabilizer}$ ) are assumed to be aligned in the Z-direction. A balancing calculation can be executed to determine the stabilizer vertical force or lift. Using the aircraft weight and balance data the center of gravity (c.g.) and mean aerodynamic chord (mac) are described [24]. As the B-17s' center of gravity and weight range are known the load balancing calculation Eq. (1) and Eq. (2) yields the stabilizer vertical force for its full operational flight range. The balancing calculation output is the total stabilizer force or vertical force created by the stabilizer during flight.

**Fig. 6 The vertical forces and moment for the B-17 weight and balancing calculation**

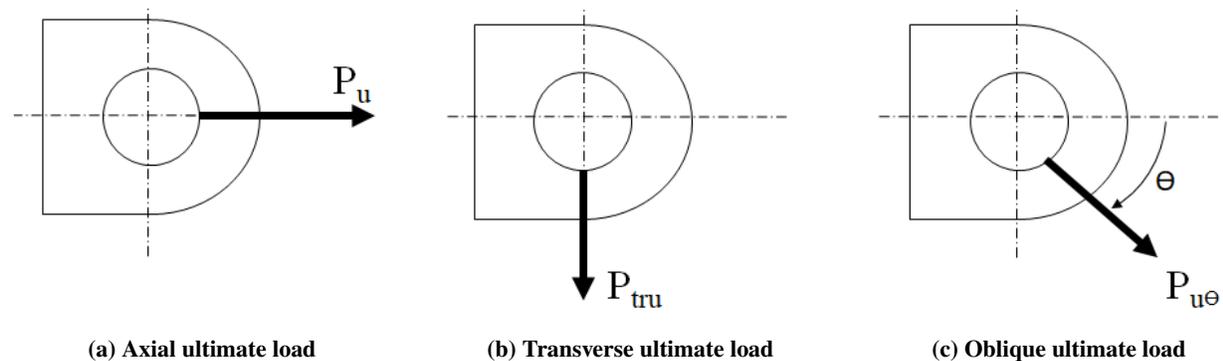
Fig. 7 Lug loading.

The maximum load able to be carried by the lug connection can be calculated using standard calculation methods [26–28]. Three different load cases can be distinguished an axial, transverse and an oblique load failure Fig. 7. For axial load failure three failure modes can be distinguished, a net section failure which can be described by Eq. (8), a shear-out or bearing failure which can be calculated by Eq. (9).

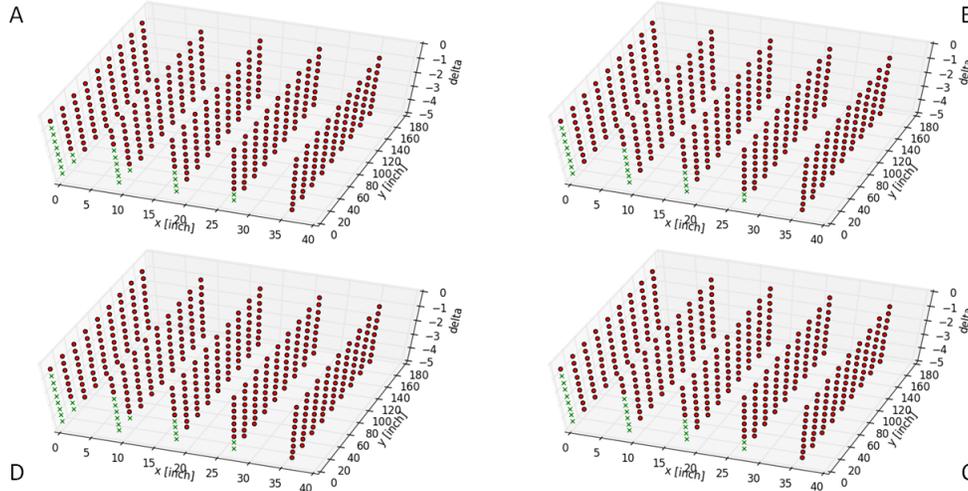
**Fig. 8** Oblique load failure for lug element A-B-C-D ( $m_{bomb} = 1000lb$ ,  $F_s=2000N$ ).

As can be seen from the Fig. 8 and 9 where  $m_{bomb} = 1000lb$  a small area exists where the oblique lug load is not exceeded, this is near the root at large  $\delta$  values. Reducing the bomb mass to  $m_{bomb} = 100lb$  shows an increase in area where the lug load is within the  $R_\theta$  threshold as shown in Fig. 10 and Fig. 11. This is also the case when the bomb is dropped at  $y = 35$  inches, the estimated impact location from Fig. 4c. In this case however the calculated resultant  $F_x$  for fitting D and E are beyond the established normal load threshold for impact distance  $\delta = 0.5$  and a failure would still occur.

The model results show that in most cases a  $m_{bomb} = 1000lb$  would separate the stabilizer as shown in Fig. 8 and 9. This finding is not entirely consistent with the photographs of the event Fig. 4. By reducing the bomb mass to  $m_{bomb} = 100lb$  the same study was performed. What one concludes from 10 and 11 is a relatively narrow range of impact locations exist where  $R_\theta$  is above the threshold and the stabilizer would separate. A reverse outcome compare to

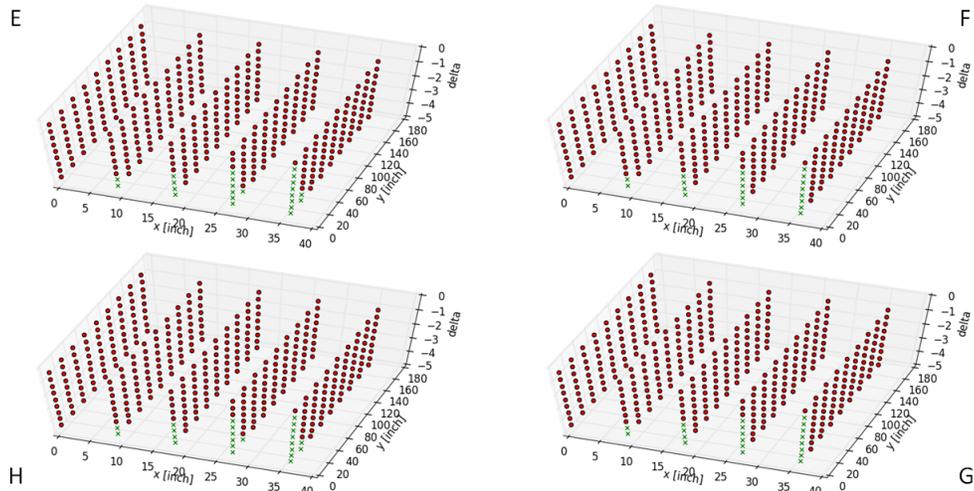
**Fig. 9 Oblique load failure for lug element E-F-G-H ( $m_{bomb} = 1000lb$ ,  $F_s=2000N$ )).**

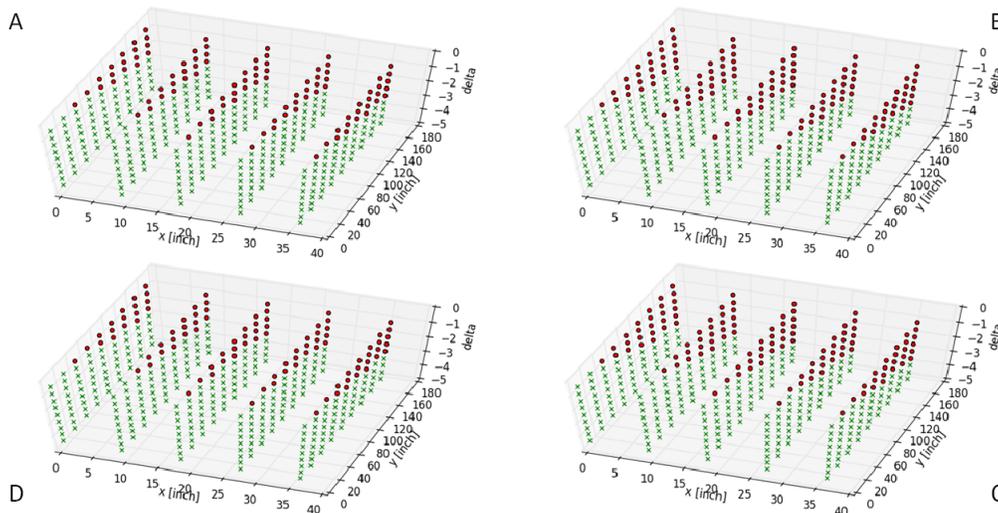
**Fig. 10 Oblique load failure for lug elements A-B-C-D ( $m_{bomb} = 100lb$ ,  $F_s=2000N$ )).**

$m_{bomb} = 1000lb$ , which shows that  $m_{bomb}$  mass influences the lug failure mode. Similar to Fig. 12 where the bomb mass  $m_{bomb}$  was simulated to vary the study outcome shows a small area where the stabilizer would not shear off. However this calculation shows the result of the forward spar when the bomb impacts the aft spar. This is an ideal case which is not consistent with Fig. 4a where it was estimated that the bomb impact was at  $y=35$  inches between the forward and aft spar. Figure 8 and Fig. 9 clearly show that in that case the  $R_\theta$  threshold was exceeded. Thus for the vast majority of cases it is expected that the stabilizer would separate.

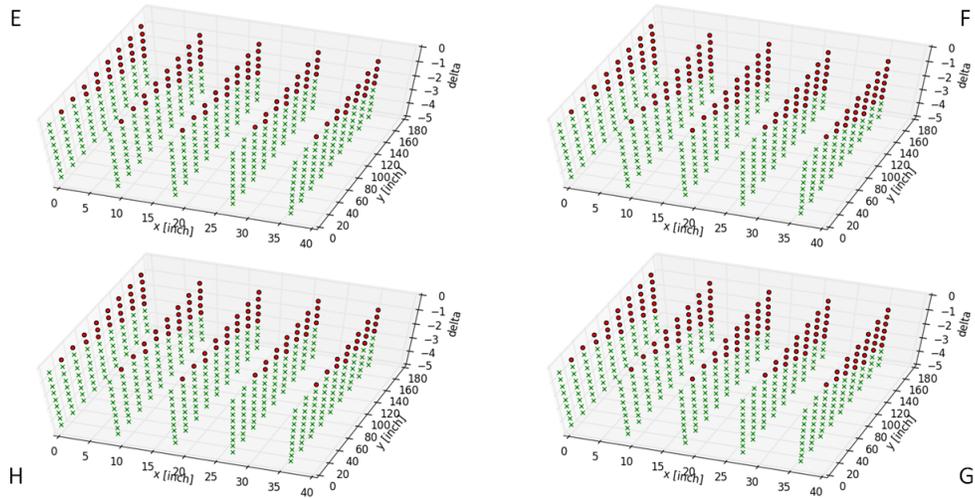
Fig. 11 Oblique load failure for lug element E-F-G-H ( $m_{bomb} = 100lb$ ,  $F_s=2000N$ ).

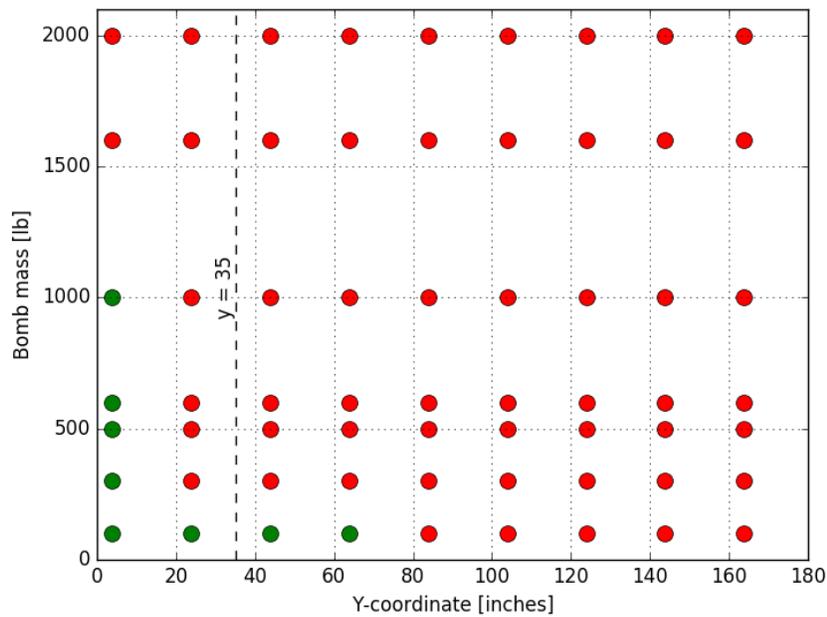
Assuming a bomb impact location on the forward spar  $x = 36$  inch, an impact distance  $\delta = 1$  and varying the bomb masses  $m_{bomb}$  which can be carried by the B-17 will result in Fig. 12. It can be concluded that a small area will not result in failure of the horizontal stabilizer and the lug load is within the  $R_\theta$  threshold. What should be noted is that in this case the  $R_\theta$  threshold is not exceeded for a  $m_{bomb} = 1000lb$  when the bomb impacts the aft spar ( $x = 0$ ).

Fig. 12 Forward spar with varying bomb mass  $m_{bomb}$  and y-coordinates ( $F_s = 2000N$ ,  $\delta = 1$ ,  $x=0$ ).
