Fatigue life and damage tolerance of postbuckled composite stiffened structures with indentation damage

Dávila, Carlos G.; Bisagni, Chiara

Journal of Composite Materials

Dávila, C. G., & Bisagni, C. (2018). Fatigue life and damage tolerance of postbuckled composite stiffened structures with indentation damage. *Journal of Composite Materials*, 52(7), 931-943.
<https://doi.org/10.1177/0021998317715785>

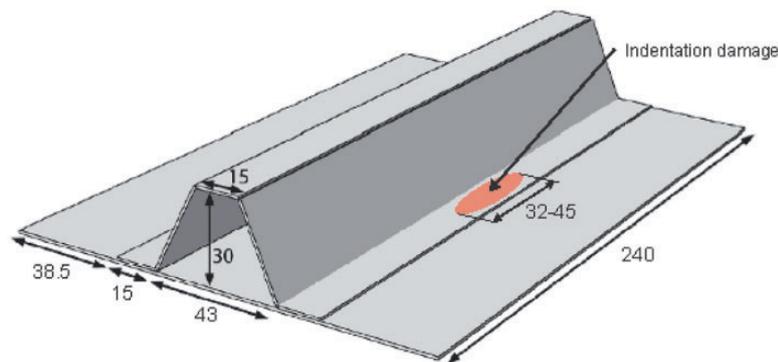
Figure 1. Single-stringer compression specimen (all dimensions in millimeter).

The SSC specimen is composed of a skin and a hat-shaped stringer. The dimensions of the test section of the specimen are shown in Figure 1. The skin consists of an eight-ply quasi-isotropic laminate with a stacking sequence of $[45^\circ/90^\circ/-45^\circ/0^\circ]_S$ and a total thickness of 1 mm. The stringer consists of a seven-ply laminate with a symmetric stacking sequence of $[-45^\circ/0^\circ/45^\circ/0^\circ/45^\circ/0^\circ/-45^\circ]$, which results in a nominal thickness of 0.875 mm. The skin and stringer are cocured in an autoclave and the material is IM7/8552 prepreg tape. Tabs for load introduction are potted and machined at the ends of the specimen after the curing cycle. A more detailed description of the SSC specimen can be found in the literature.^{12–16}

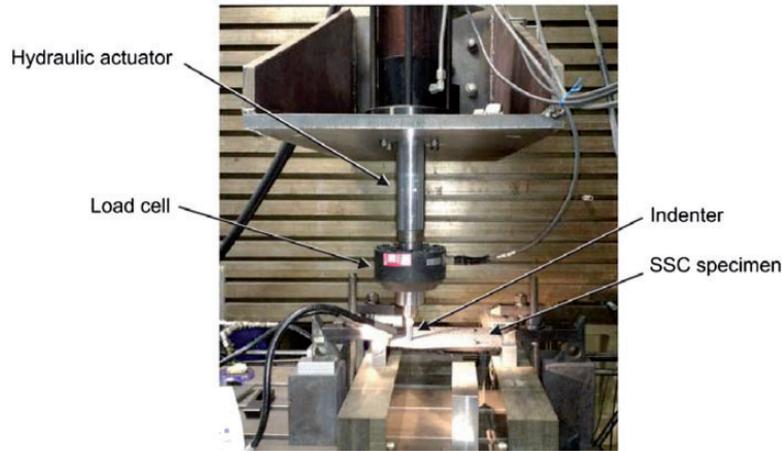
Figure 2. Hydraulic indenter used to induce initial damage onto flange of SSC specimens.

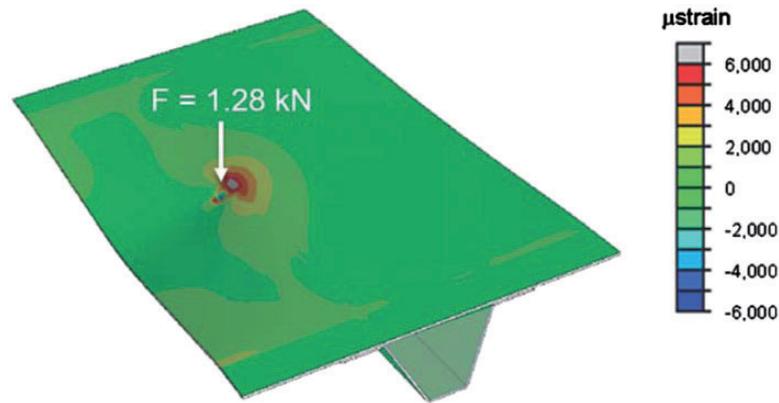
Figure 3. Strain plot for finite element damage model of indentation with an applied load of 1.28 kN.

To ensure that the indentation force would not cause damage in locations outside of the indentation zone, a finite element model of the indentation process was constructed using Abaqus/Std v6.14 finite element code.¹⁷ The model of the SSC specimen developed in the previous studies^{12,13,16} was used for this investigation. This model consists of two layers of S4R shell elements representing the skin and the stiffener. Wall offsets were applied so that the nodes for both shell layers were coincident in the flange sections of the stringer. The two layers are connected with COH3D8 cohesive elements. The material properties used are listed in Table 1. The analysis results, shown in Figure 3, indicate that at 1.28 kN, the predicted load for initiation of indentation damage, the strains do not exceed 4000 μ strain anywhere outside of the immediate indentation zone. Since the fiber and matrix strains to

failure for IM7/8553 are greater than 10,000 μ strain, these results indicate that no damage other than local indentation damage will occur in the panel for loads below 2.8 kN. The analysis was not carried past the damage initiation load because the shell model is inadequate for larger amounts of damage.

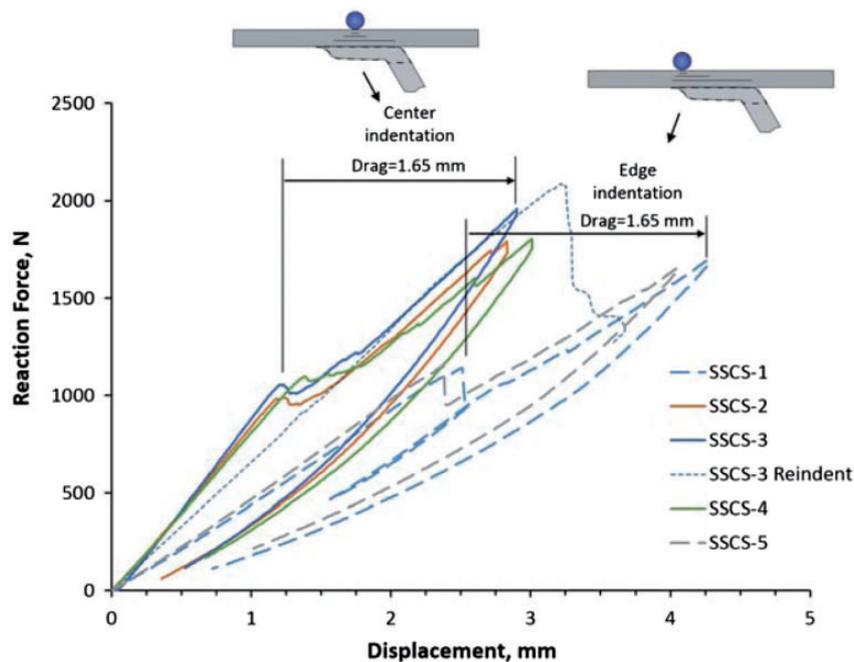
Figure 4. Force–displacement curves of indentations performed on specimens SSCS-1–5.

Five specimens, referred to as SSCS-1–5, were tested. Specimens SSCS-1 and SSCS-5 were indented under the flange termination (edge indentation), and the three remaining specimens were indented at the center of the flange (center indentation). Representations of the locations of both indentations are shown at the top of Figure 4.

one of two locations: at the center of the flange and at the edge of the flange. The load–displacement responses of the indentation process for all five specimens are shown in Figure 4. Although the center and edge indentation points are only 7 mm apart, the stiffness of the response for center indentations is considerably higher than that for edge indentations, as can be observed in Figure 4.

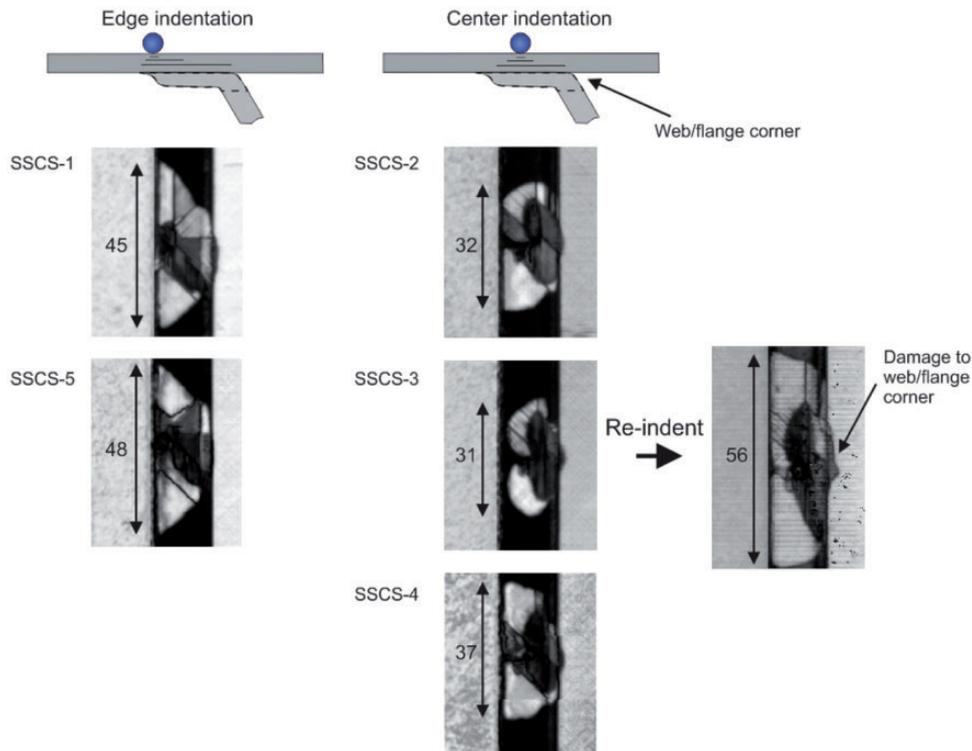
Figure 5. UT images of damage induced in specimens SSCS-1–5 by indenting at either the edge or the center of stringer flange. UT: ultrasonic testing.

UT images of the induced indentation damage for the five specimens are shown in Figure 5 with arrows illustrating the damage length in millimeter. An indenter drag of 1.65 mm induced a damage length of approximately 45 mm along the skin–stringer interface for the edge indentations, and approximately

35 mm for the center indentations. The longer damage length for the edge indentations, compared to the center indentations can be observed in Figure 5.

The damage length obtained by indenting SSCS-3 was considered too small for fatigue testing, so it was reindented using the same procedure as for the initial indentation. However, the initial 31 mm damage length grew unstably to 56 mm during reindentation. Additional damage was also observed at the web/flange corner, as called out in Figure 5.

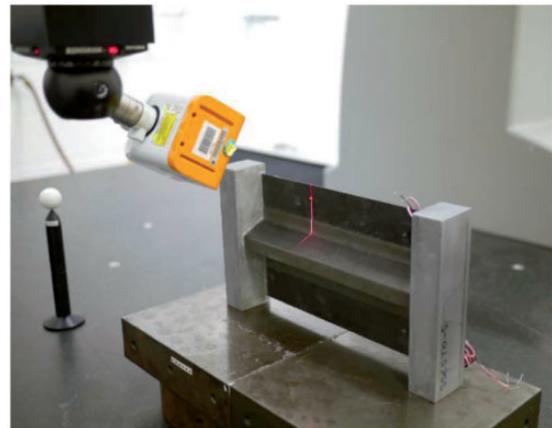
Figure 6. Laser scanning of indentation damage with CMM. CMM: coordinate measuring machine.

different postbuckling deformations,^{13,14} the flatness of the skin of the specimens after the damage indentation was measured using the VIC-3D digital image correlation system.¹⁸ In order to capture more detail, the depth of the indentation was also measured in a coordinate measuring machine (CMM), as shown in Figure 6. The resolution of the measurements taken with the laser scanning head shown in the figure is approximately 10 μm .

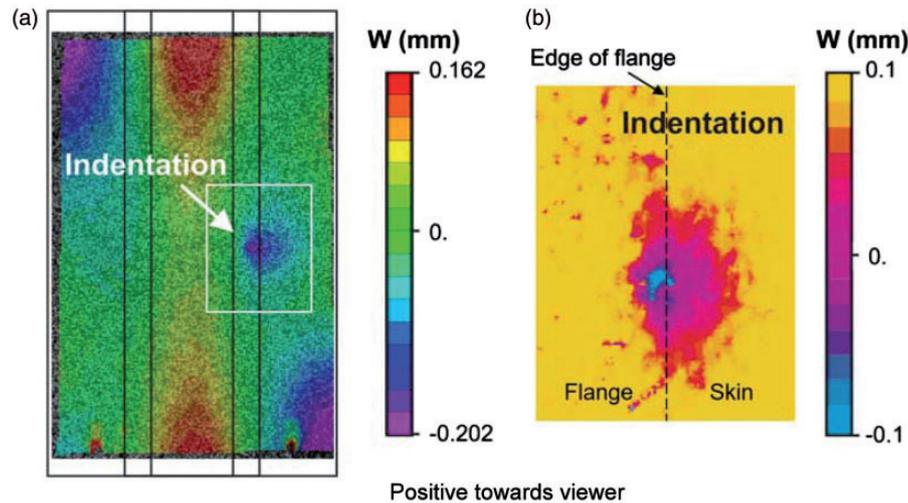
Figure 7. Global and local out-of-plane deformation after indentation for specimen SSCS-3. (a) Panel initial imperfection from VIC-3D and (b) local indentation depth measured from CMM. CMM: coordinate measuring machine.

A typical out-of-plane initial deformation of the skin measured with VIC-3D is shown in Figure 7(a). The nonflatness of the skin is mostly due to the residual thermal strains that develop from the curing process. It can also be observed that the panel has a slight twist. The amplitude of the deformations is approximately 0.4 mm, which is 40% of the skin thickness. A typical result from the CMM that provides details for the residual dent depth is shown in Figure 7(b). The residual indentation depth is approximately 0.1 mm.

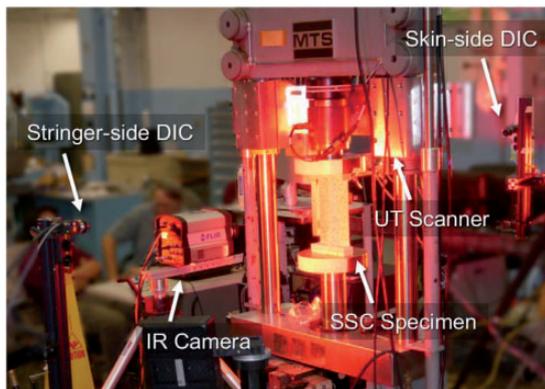
Figure 8. SSC specimen, load frame, and test instrumentation.

The tests were conducted using a uniaxial test frame and with instrumentation that allows a precise evaluation of the postbuckling response and damage. The test frame and the instrumentation shown in Figure 8 is the same as used in the previous test campaign conducted on SSC specimens with Teflon films and described in Dávila and Bisagni.¹⁶ The primary instrumentation consists of (i) two three-dimensional digital image correlation (VIC-3D) systems¹⁸ that are used to measure the postbuckling full-field deformations and strains on the skin and stringer sides of the specimen, (ii) an infrared camera for the passive thermal monitoring¹⁹ with a frame rate of 60 Hz that can track the position of a delamination front during fatigue cycling, and (iii) an in situ UT scanner²⁰ mounted on the load frame which is used to obtain detailed measurements of the damage. The digital image correlation system acquired images at a rate of 0.2 Hz, the infrared camera at 60 Hz,

and the UT scanner at selected intervals. Finally, two back-to-back pairs of strain gauges placed on the skin near the top of the specimen were used to ensure that the load introduction platen was properly aligned.

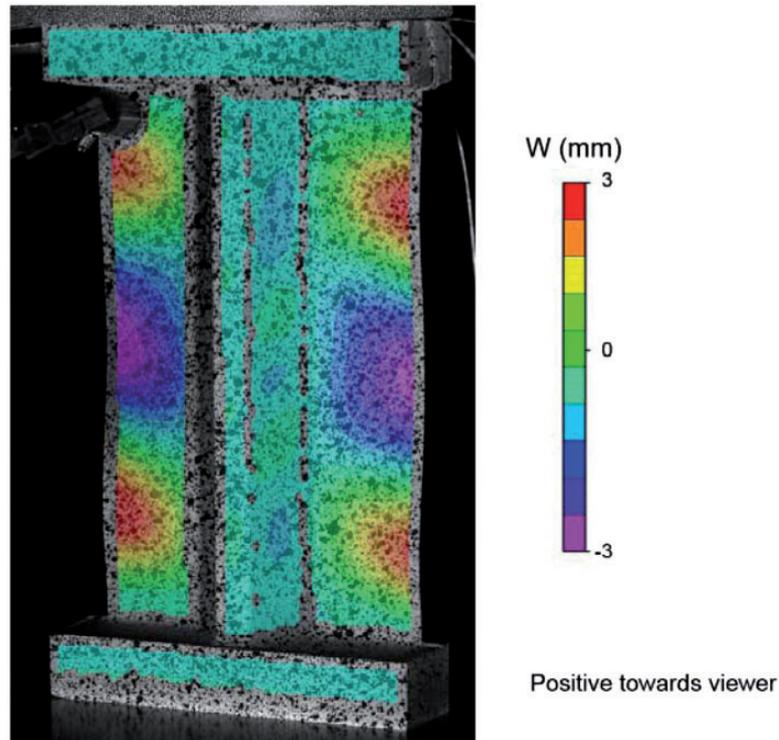
Figure 9. Out-of-plane displacement during quasi-static test of specimen SSCS-2 taken with VIC-3D from stiffener side immediately before collapse (34.5 kN).

The postbuckling deformation was characterized by a mode composed of three half waves along the length in the skin on both sides of the stiffener. The deformation at a load of 34.5 kN immediately before collapse is shown in Figure 9 using the out-of-plane displacements measured by the digital image correlation system. The deformation was symmetric with respect to two orthogonal planes and no damage was detected. The maximum amplitudes of the out-of-plane displacements at the center of the free edges were approximately 3 mm in the direction opposite to the viewer. The specimen collapsed suddenly, and the failure was characterized by a separation of the stringer from the

skin at the mid-length. The collapse load magnitude of 34.5 kN was used as an upper bound when determining the loads at which the fatigue tests were run.

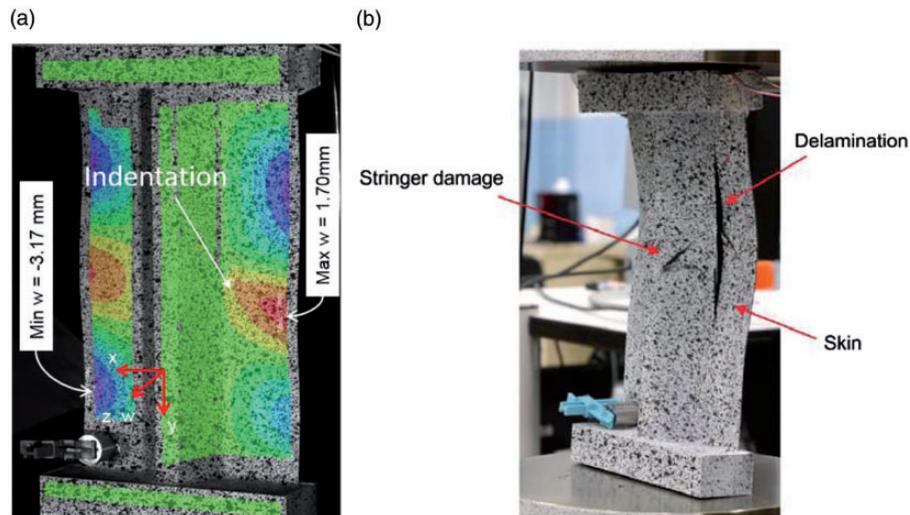
Figure 10. Fatigue and posttest assessment of specimen SSCS-1: (a) deformation at 96,000 cycles and (b) after collapse.

An image captured by the digital image correlation system on the skin side of a typical panel (SSCS-1) after 96,000 load cycles is shown in Figure 10(a). When subjected to a load of 31.1 kN, the maximum out-of-plane displacement is equal to 3.42 mm in the direction opposite to the stringer and 1.79 mm in the direction of the stringer. It can be observed that the deformation is similar to that for panel SSCS-2 but of opposite amplitude. Differences in the postbuckling response of two nominally identical specimens are common and attributable to small differences in the initial imperfections of the panels and, possibly, to minute differences in the alignment of the specimen in the test platens. Therefore, it is extremely difficult to predict the mode that will develop in a particular panel.

Specimen SSCS-1 failed suddenly at 117,506 cycles as a consequence of an unstable delamination between the skin and both stringer flanges. The posttest deformation is shown in Figure 10(b), where it can be observed that there is separation at the skin-stringer interface and crippling damage in the stringer.

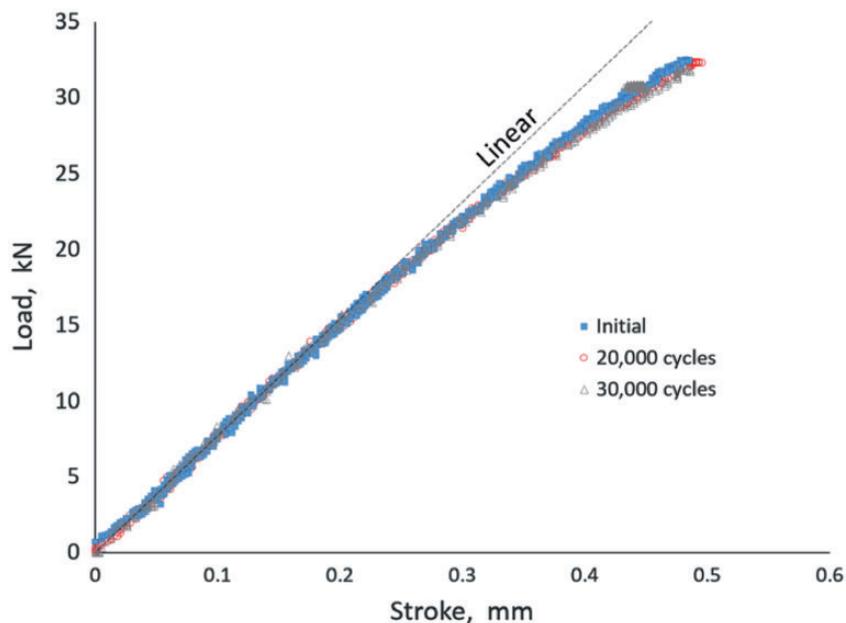
Figure 11. Quasi-static load-stroke curves at three stages of the fatigue life of specimen SSCS-5.

Quasi-static load-shortening curves for specimen SSCS-5 are shown in Figure 11, which is representative of what was observed for all specimens. It can be seen that the initial response is nearly identical to that at

20,000 and 30,000 cycles. Clearly, the global response of the SSC specimens retains a constant nonlinearity and is only mildly affected by the progression of fatigue damage. The specimen collapsed at 33,623 cycles.

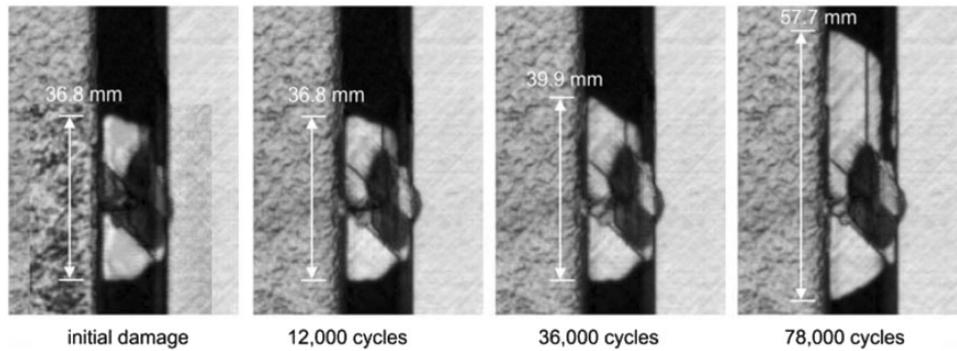
Figure 12. UT images showing damage propagation for specimen SSCS-4 at different cycle counts. UT: ultrasonic testing.

As was described earlier, the fatigue tests were conducted in stages so that UT scanning of the indented area of the panel could be performed at regular intervals. To illustrate the typical propagation of damage, a sequence of images for SSCS-4 obtained by the UT scans immediately after indentation and at 12,000, 36,000, and 78,000 cycles are shown in Figure 12. The

images show an extension of the initial skin–stringer separation along the length of the specimen. Collapse of the specimen occurred at cycle 78,135, shortly after the last image was taken.

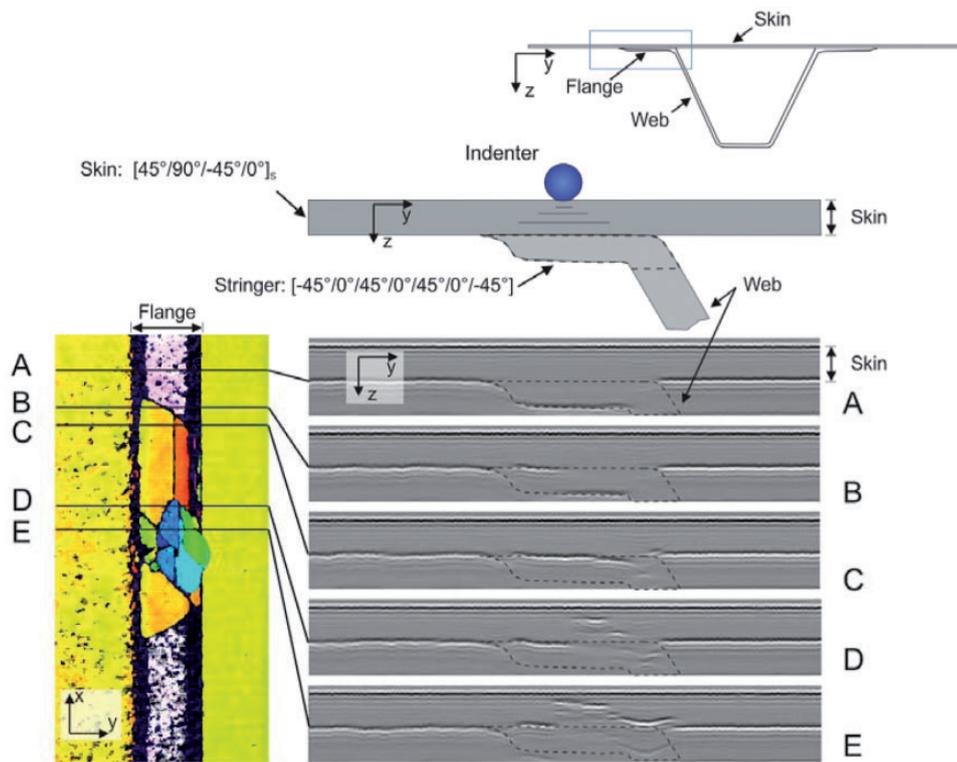
Figure 13. UT images using “time-of-flight” processing for depth location of delaminations (SSCS-4). UT: ultrasonic testing.

To examine the morphology of the damage, the UT scan of specimen SSCS-4 at 78,000 cycles was processed and colorized according to “time of flight” (TOF). TOF is the delay between the emitted ultrasonic sound wave and the reflected echo, which is a relative measure of the depth of the surface closest to the probe. The resulting image, shown in Figure 13, identifies the

depth of the various delaminations. Five cross-sections of the skin and stringer flange are examined. The results indicate that only two delaminations propagate during cyclic loading and that both delaminations propagate together: one interface is at the skin–stringer interface, and the other one is one-ply deep into the stringer flange, at the $-45/0$ interface. The smaller delaminations in the skin do not appear to grow under fatigue.

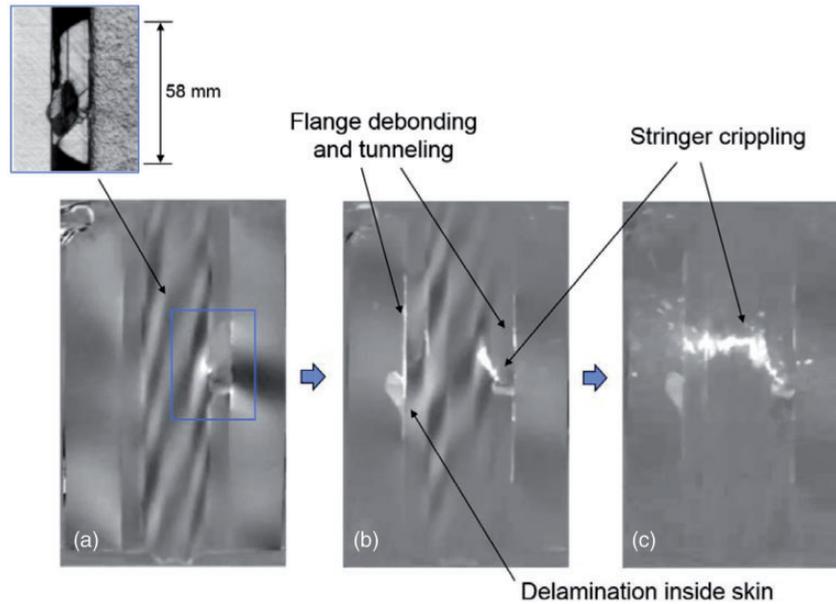
Figure 14. Infrared images illustrating sequence of collapse (SSCS-4). (a) Delamination reaches critical size, (b) unstable tunneling, and (c) stringer crippling.

loading, it was found to be particularly capable for capturing the sequence of damage events that occur during collapse. The sequence of three infrared images shown in Figure 14 illustrates the collapse of specimen SSCS-4 after 78,135 cycles. The heating, represented by lighter regions of the image, can be seen at the strain gauges and along the delamination front at the skin–stringer interface. The postbuckling deformation of the stringer appears as oblique lines in Figure 14(a). A faint outline of the damage at the skin–stringer interface can also be observed. A UT

image of the damage zone recorded after 78,000 cycles is shown for comparison, and the area of the UT scan is highlighted with the blue rectangle in Figure 14(a). Note that the thermal image was captured from the stringer side of the specimen, while the UT scans were performed from the skin side of the specimen. Therefore, the UT image was flipped horizontally to match the orientation of the infrared image.

The images in Figure 14(b) and (c) indicate that the collapse of the specimen, which occurs in about 1/60th of a second, consists of debonding of both flanges of the stringer, followed by the crippling failure of the stringer. In addition, a delamination internal to the skin grew in the region of the flange opposite to the initial indentation damage during the final instances of the collapse.

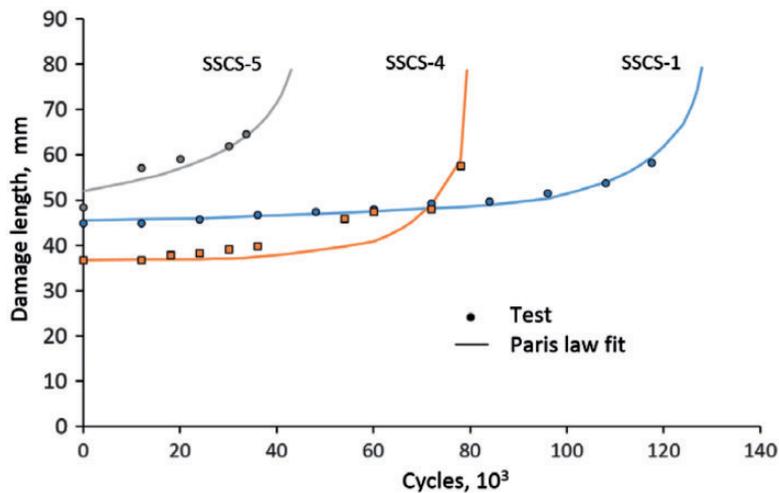
Figure 15. Damage length as a function of loading cycles for specimens SSCS-1, SSCS-4, and SSCS-5.

The results of the fatigue damage propagation are illustrated in Figure 15, where the experimental results are represented by symbols, and the lines correspond to the damage lengths calculated with the Paris law. Two values of *C* were determined by curve fitting: one for edge indentation and a different one for center indentation: $C_{Edge} = 1 \times 10^{-36}$ and $C_{Center} = 50 \times 10^{-36}$. For simplicity, the exponent $m = 14.9$ was kept the same for both types of indentations.

As can be observed in Figure 15, a single set of Paris law parameters provides a good fit to both specimens

with edge indentation (SSCS-1 and SSCS-5). This indicates that similar propagation laws characterize the damage growth in both specimens in spite of the differences in initial damage size and cyclic load. It is also apparent that the rate of propagation for center indentation (SSCS-4) is about 50 times higher than for edge indentation, perhaps because center indentation causes more damage toward the highly loaded web/flange corner than edge indentation.

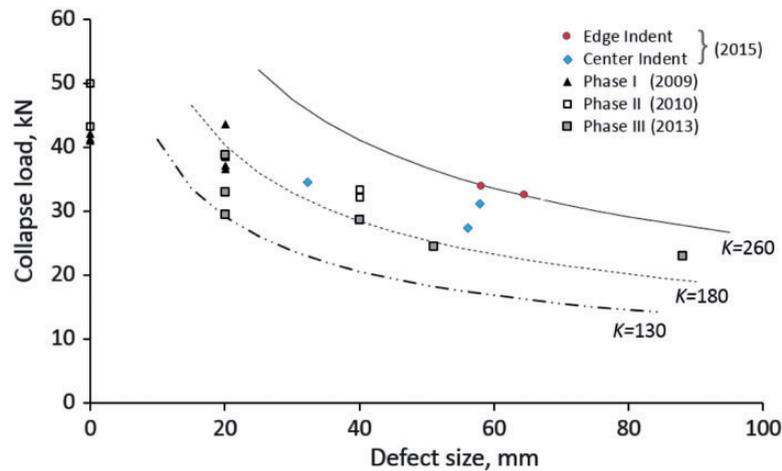
Figure 16. Effect of defect size on collapse load of SSC specimens.

a critical load that causes a collapse of a SSC specimen. The collapse load as a function of defect size is shown in Figure 16. In addition to the results from the phase IV test campaign, results from the three previous experimental phases^{12,14,16} are included. For quasi-static tests, the defect size is the initial defect size, and for fatigue tests, the defect size is the damage length at the moment of collapse. The damage length at the moment of collapse is estimated by adding an incremental extension of the damage length calculated from the Paris Law equations determined above to the last measured damage length.

Following the concept used in the previous section, it may be useful to compare the results of different tests according to the stress intensity measure. Using Figure 16, it can be observed that the edge indentation specimens collapsed at approximately $K = 260 \text{ kN} \times \text{mm}^{0.5}$. The center indentation specimens failed within the range $196 \leq K \leq 237 \text{ kN} \times \text{mm}^{0.5}$. It appears that specimens from previous test campaigns failed at lower values of K , which indicates that indentation damage may be less severe than a Teflon insert of the same size. A number of additional contributing factors that deserve the attention of future work, such as the shape of the postbuckling deformation, also contribute to the damage tolerance of a postbuckled panel. Therefore, the proposed classification of the collapse strength of similar specimens according to their stress intensity measure provides a useful means to assess different aspects of the response on the damage tolerance of stiffened structures with defects.
