## Bank erosion processes in waterways

**Book of abstracts**

**NCR days 2017**  
**February 1-3, 2017**  
**Wageningen University & Research**

# Bank erosion processes in waterways

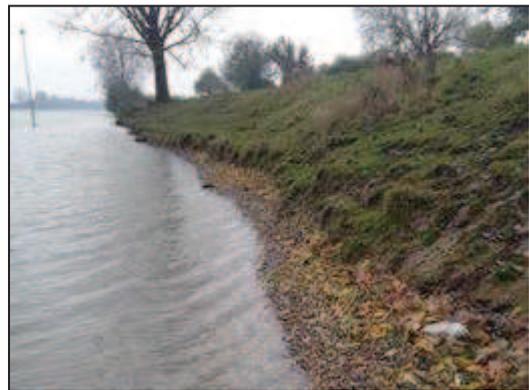
Figure 1. Uniform erosion pattern characterized by short grass-covered banks with gravel at the toe.

Two distinct patterns are identified after six years of their restoration: uniform (Fig. 1) and bay-shaped (Fig. 2). The uniform pattern has low or zero erosion rates at present, hypothetically due to the toe protection of a gravel layers, whereas the embayments are hit by ship waves, especially in areas where the base level is low enough to allow them reach the banks virtually without energy dissipation. The primary ship waves also induce shear stresses onto the banks, in particular over terraces where the wave energy dissipation occurs. It is noticeable the presence of trees along the banks that delays the erosion rates in some cases, but not in others.

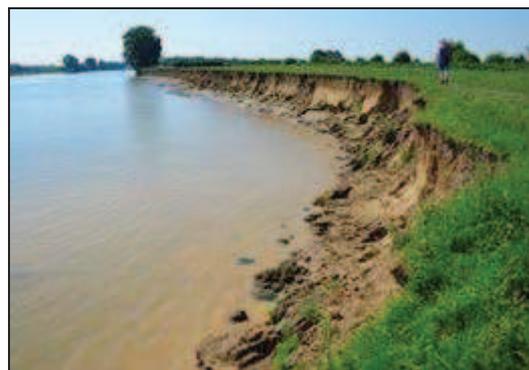
Figure 2. Bay-shaped erosion pattern characterized by high banks and contrasting erosion rates.
