# Comparing overflow and wave-overtopping induced breach initiation mechanisms in an embankment breach experiment

**Abstract.** As part of the SAFElevee project Delft University of Technology collaborated with Flanders Hydraulics Research, and Infram B.V. in the preparation and execution of a full scale embankment breach experiment in November 2015. This breach experiment was performed on an 3.5m high embankment with a sand core and clay outer layer situated along the tidal river Scheldt in Belgium near Schellebelle. During the experiment a wave overtopping simulator and overflow simulator were used to initiate a breach. Both simulators were placed near the top of the waterside slope. The use of the simulators facilitated comparison between the effects of continuous overflow and the effects of intermittent wave overtopping. This paper presents the data collected during the experiment, describe the development of hypotheses on the failure processes using the latest insights, and comment on the failure initiation process of a grass covered flood embankment with a clay outer layer and a sandy core.

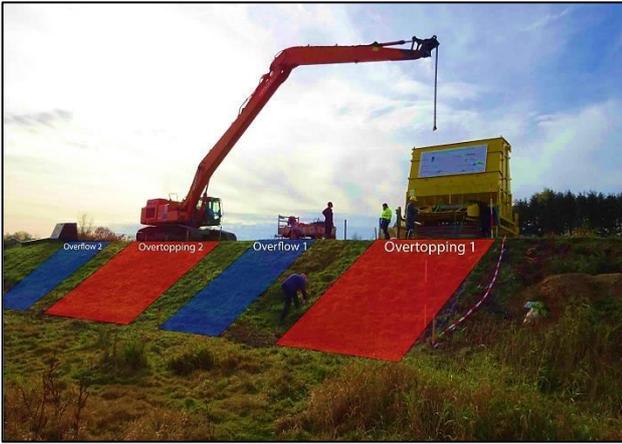
**Figure 1.** Overview test locations on embankment.

Over an approximate 50m long stretch of embankment, two tests were performed on breach initiation due to wave overtopping using the 4m wide wave overtopping simulator developed by Van der Meer [5], [6][7]. Also two breach initiation experiments had been performed using a 2m wide overflow simulator developed specifically for this experiment by Delft University of Technology. An overview of the test sections has been depicted in Figure 1.

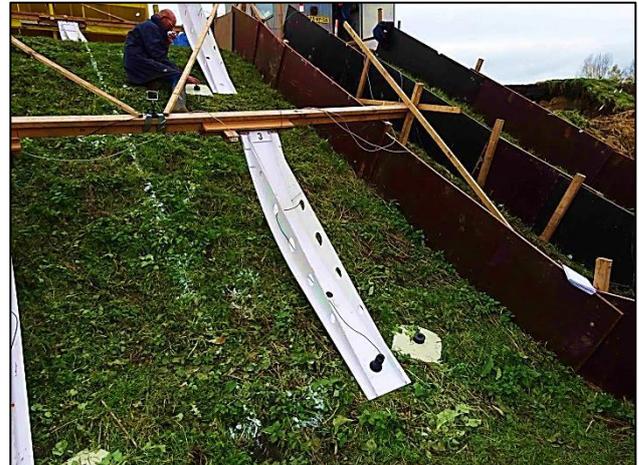
To assess the roughness parameters on the embankment, hydraulic measurements were performed with waves of respectively 500, 1000, 1500, 2000, 2500, 3000, and 3500 l/m. During the hydraulic measurements the flow velocities were continuously measured at the bed and surface of the waves using paddle-wheels. To measure the change in depth profile of a wave over time, a surf-board like construction was used (see Figure 2). The

water depth was derived from measuring the change in angle of the surfboards when a wave passed under it. The paddle-wheels were placed near the downstream tip of the surfboard, both in the embankment surface and on the tip of the surfboard. This way both the flow velocity at the bed and at the surface could be measured. The front velocity of the wave was derived by measuring the time lapse in signal from the surfboards and the known distance between two surfboards.

**Figure 2.** Setup for performing hydraulic measurements during wave overtopping tests.

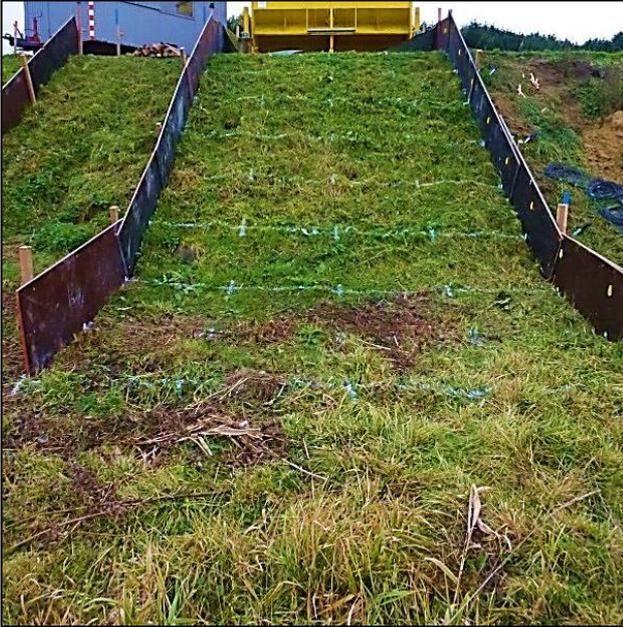
**Figure 3.** Overview picture taken prior to the first wave overtopping experiment

Prior to the tests the embankment was divided into 1x1m quadrants (see Figure 3). The first quadrant (1A) started on the far left hand side of the outflow point of overtopping simulator. The flow channel was 4m wide. Across, it was divided into Sections A through D with A being on the left hand side looking upstream. In total 11 cross sections were created. During the first test cross sections 1, 2, and the first half of cross section 3 were fully covered with a plastic sheet to prevent erosion of the gravel road. Between the end of the plastic sheet and the top of the landside slope some flattened grass cover was present. On the landside slope several stones were present. In Section 4A a small hole was visible. In cross sections 6A and 8C stones were visible from the surface. In section 7 the nettles and moss were visible. In general the grass cover was not nice and smooth but represented a rough surface. Characteristic of the behaviour of grass under the wave loading was that every time the wave had passed the grass bounced back into an upright position. This could therefore have contributed to a higher roughness experienced by the waves and hence higher shear stresses.

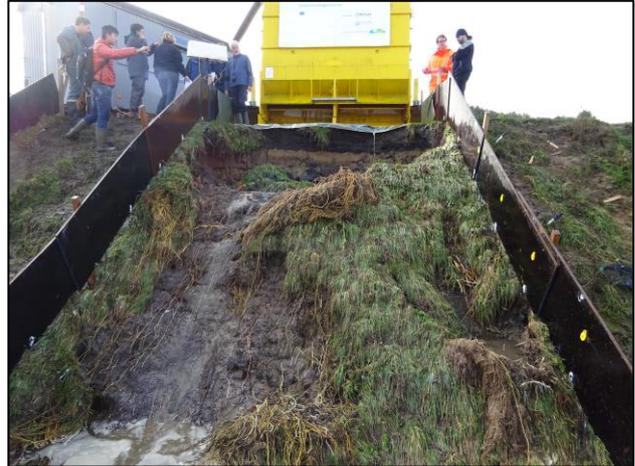
**Figure 4.** Overview picture taken at the end of the 25 l/m/s tests at the first test section

site. At the end of the 10 l/m/s test, the hole had grown to approximately 0.5m deep. During the 25 l/m/s the hole in on the slope increased in size. After 3 minutes, part of the grass cover came loose near the hole. After 12 min the sand layer was reached in the hole. Once the sand layer was reached a trench developed due to erosion downstream of the hole (see Figure 4)

Simultaneously headcut erosion caused for the upstream progression of the hole. The sand under the clay layer acted reasonably cohesive maintaining near vertical slopes. The processes observed during the retreat of the landside slope were similar to the underwater breaching process as observed during dredging at sand pits. Here the dilation of soil due to water infiltration in combination with the reduction of negative pore pressures determine the rate of erosion and prevent large scale slope failures from occurring.

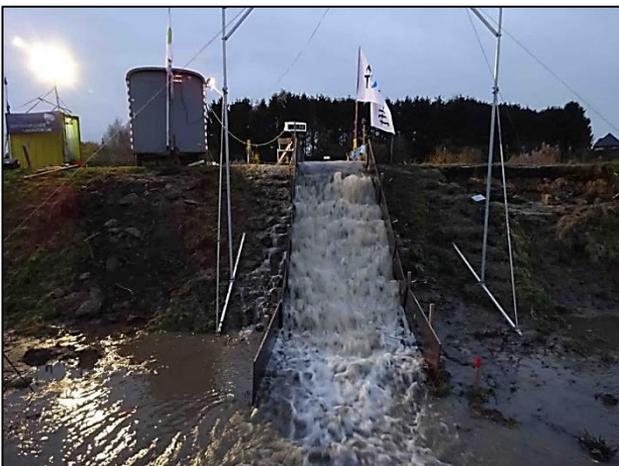
**Figure 6.** Observed aerated flow during the overflow experiment

Due to limitations in the minimum allowable frequency at which the pump could be operated, tests with the overflow simulator started at 10 l/m/s, followed up by 25, 50 l/m/s and 85 l/m/s. Contrary to expectations, the damage that occurred to the grass cover at overflow discharges of 50 l/m/s and 85 l/m/s was negligible. Instead of the theoretical nice smooth flow of constant density, during all overflow tests the flow became highly aerated down the landside slope (see Figure 6). This could be of influence to the spatial velocity distribution down the slope. Between changes in the discharge the flow was stopped during which became apparent that contrary to the behaviour of grass during wave overtopping the grass cover remained in a flattened position and did not bounce back upwards. Another noticeable, and potentially important observable difference with the wave overtopping tests, was that during overflow the reattachment point of the flow was closer to the crest than during wave overtopping. The normal impact at the reattachment point is therefore also expected to be smaller during overflow than during wave overtopping. These differences with wave overtopping could potentially help in better explaining the difference in timing in failure initiation of the grass cover.
