## Damage characterization of rock slopes

de Almeida, Ermano; van Gent, Marcel R.A.; Hofland, Bas

Journal of Marine Science and Engineering

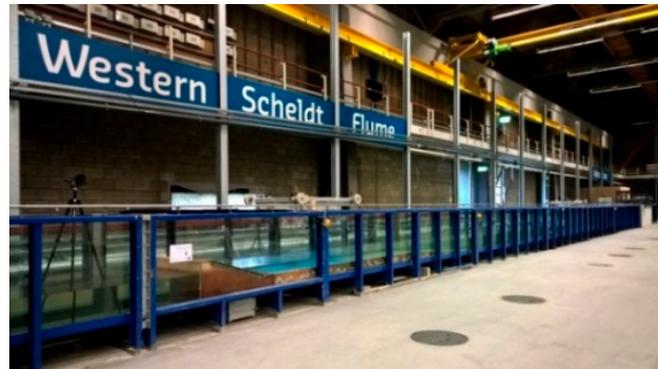
**Figure 1.** Scheldt Flume, Deltares.

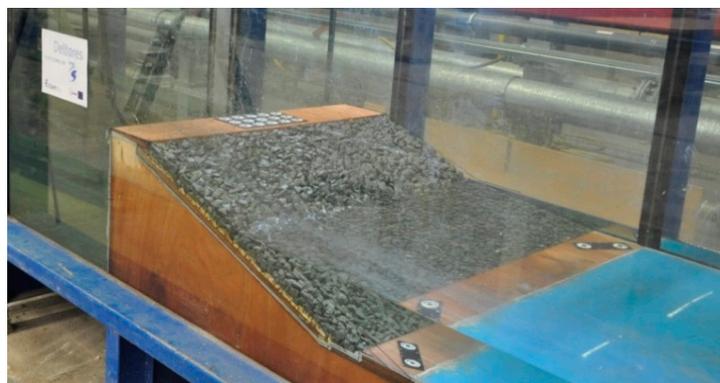
This set-up consisted of a non-overtopped rubble mound structure with an impermeable core, a filter ( $D_{n50} = 9.4$  mm), a 1:3 two-layer rock armored slope ( $D_{n50} = 16.3$  mm and  $D_{n85}/D_{n15} = 1.19$ ), and a foreshore (see Figure 2). In addition, the main particularity of these tests for shallow coastal areas is that the generated wave was equal for all test runs, and only the change in the water depth at the toe of the structure defined the incident wave height. This way, the effect of the sea level rise in the damage to the structure was clearly represented. Thus, this set-up provided a large amount of data given the number of tests carried out, which allowed the testing of different slope configurations and a number of repetition tests. The testing conditions included the following:

**Figure 2.** Deltares shallow water tests set-up.

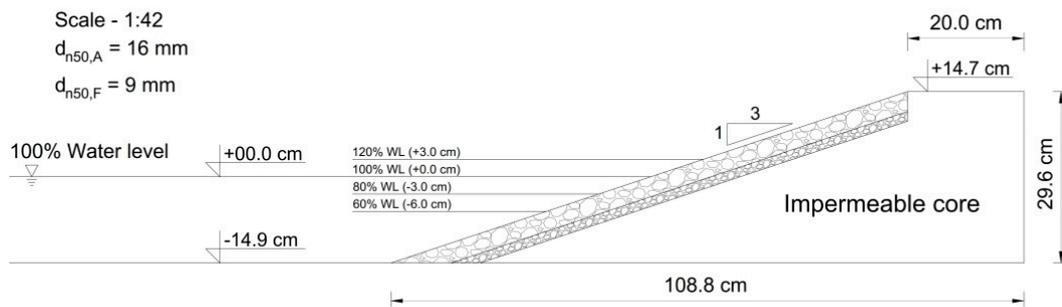
The cross-section of the model set-up used in the Deltares tests is shown in Figure 3. During these tests, only the damage to the front slope was evaluated. In this study, only the straight slope configuration is considered. The test program, including slope configurations with a berm, is described in the works of [8,9]. Incident wave heights were depth-limited given that an 8 m long foreshore was present in this model. The model (considering reference wave climate in the Dutch coast) followed the Froude criterion. Moderate Reynolds ( $Re > 1 \times 10^4$ ) ensured turbulent conditions in the filter and armor (no permeable core) and negligible scale effects. In addition, the wave generation equipment included active compensation for the reflected wave at the wave board.

Figure 3. Deltares tests cross-section.

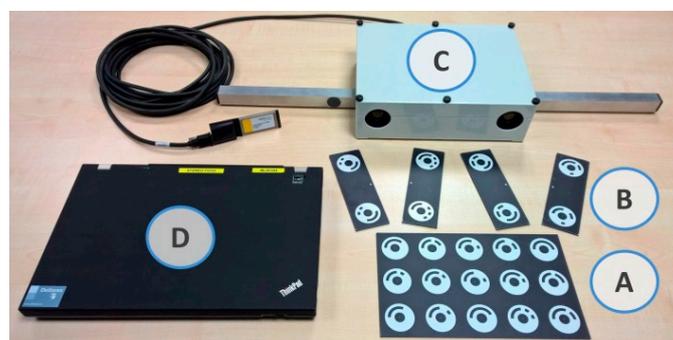
During those tests, the measurement of damage to the armor layer was done using the digital stereo photography (DSP) technique. This method used the following equipment described in Figure 4 and in the list hereafter.

- A—Markers base plate: fixed origin of coordinates for the 3D reconstruction and comparison between test runs, to be kept fixed during the complete testing period.
- B—Additional markers: pairs of reference points used in the 3D reconstruction, to be randomly placed before a measurement and removed after it (if necessary, they can also be fixed).
- C—Cameras: two digital cameras with a fixed distance between each other.
- D—Laptop: used for obtaining the pairs of images and carrying out the post-processing.

Figure 4. Digital stereo photography (DSP) equipment.

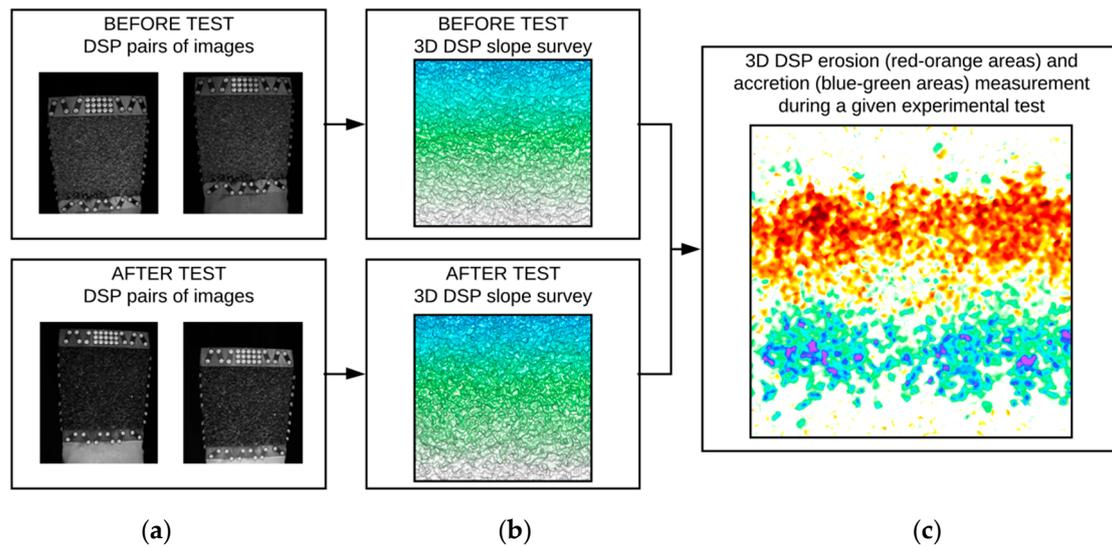
Figure 5 shows the workflow for the characterization of damage to rock slopes using digital stereo photography. The images and measurements shown in Figure 5 are obtained from the measurement

campaign carried out during this research (see tested rock slope in Figure 2). From about 10 pairs of images (Figure 5a) before and after a given test run, the 3D reconstructions of the structure are obtained (Figure 5b). Comparing those 3D models from before and after the given tests, the 3D damage reconstruction is obtained (Figure 5c). This method for measuring damage is used during this research. From those measurements, the erosion areas (in yellow-orange-red in Figure 5c) are assessed and characterized (for more details on the DSP technique, see [6,7,10])

**Figure 5.** Digital stereo photography (DSP) workflow. (a) Pairs of images from the surveyed slope, before and after a test, (b) 3D slope survey before and after a test (white color being the lower part of the slope, and blue color being the higher part of the slope), (c) erosion and accretion measurement following a given test (red-orange areas being erosion areas, and blue-green areas being accretion areas).

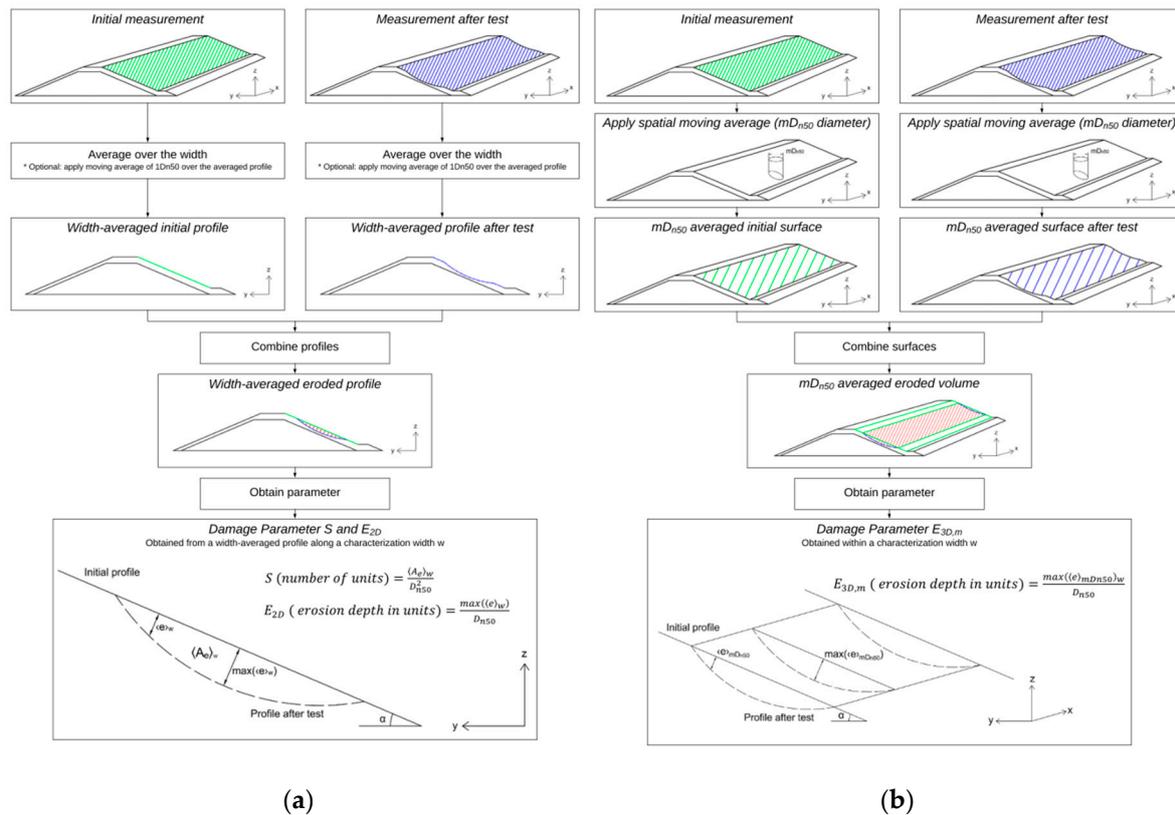
where  $\max(\langle e \rangle_w)$  (m) is the maximum erosion depth from the averaged profile obtained over a given characterization width  $w$ ,  $\max(\langle e \rangle_{mD_{n50}})_w$  (m) is the maximum erosion depth averaged over an area of  $mD_{n50}$  diameter obtained over a given characterization width  $w$ , and  $D_{n50}$  (m) is the nominal median diameter.

**Figure 6.** Damage parameters methodology. (a)  $S$  and  $E_{2D}$  parameters obtained from a width-averaged profile, (b)  $E_{3D,m}$  parameters obtained from the maximum erosion depth observed within a given characterization width.

This section has the aim of validating the damage characterization methods, which include the damage concepts (Section 3.1), damage parameters (Section 3.2), and measuring techniques (Section 3.3). For that, the physical modelling tests presented in the previous section are used. As a first step, the damage parameters considered in this study are described in more detail, including the procedure for their calculation in Figure 6, for the  $S$  and  $E_{2D}$  parameters (6a) and for the  $E_{3D,m}$  parameters (6b).

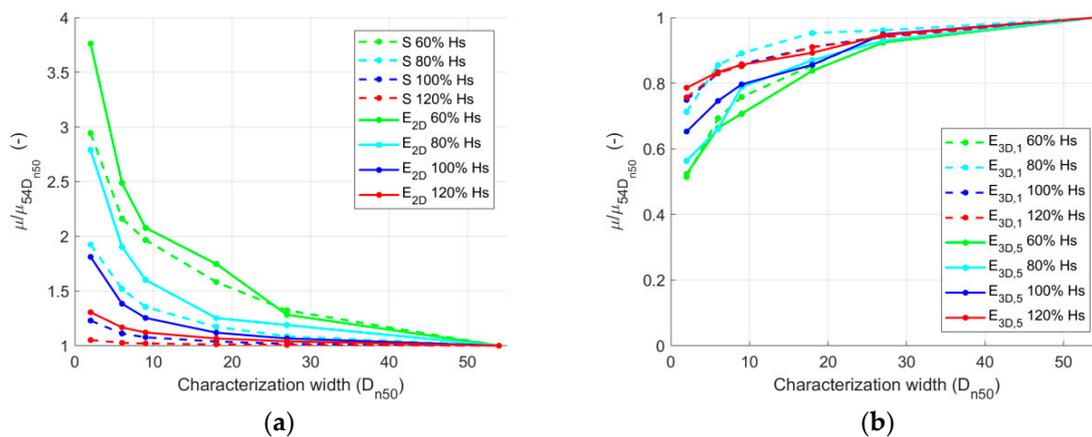
The influence of the characterization width on the mean measured damage can be observed in Figure 7, obtained from the survey of a  $54D_{n50}$  wide slope in the Deltares tests Series 1 (see Table 1), carried out five times in five identical repetitions. The values for each characterization width are obtained as the average of all the values for that given width, being between 135 values for the  $2 D_{n50}$  width and 5 values for the  $54 D_{n50}$  width. This average damage is then normalized by the damage obtained for the  $54 D_{n50}$  characterization width.

Regarding the parameters obtained from width-averaged profiles (S and  $E_{2D}$  in Figure 7a), it can be observed that the measured mean damage reduces with increased characterization width because the damage to certain areas is hidden by the accretion in other areas. Regarding the parameters obtained as the maximum erosion depth observed within a given characterization width ( $E_{3D,1}$  and  $E_{3D,5}$  in Figure 7b), it can be observed that the measured damage increases with increased characterization width.

The main observation for the damage parameters  $E_{3D,1}$  and  $E_{3D,5}$  (also referred in general form as  $E_{3D,m}$ ) is that the measured damage continues to increase with increasing characterization widths. This suggests that there is no upper limit for the damage to the structure and that when considering wider structures, the probability of observing a larger extreme damage will continue to increase. Thus, besides considering the characterization width, this length effect for the design and characterization of coastal structures should then be taken into account (see Section 3.2.2 and [9]).

**Figure 7.** Characterization width. Mean damage variation (bias), calculated as the mean damage from each characterization width ( $\mu$ ) divided by the mean damage from the  $54D_{n50}$  characterization width ( $\mu_{54D_{n50}}$ ). (a) S and  $E_{2D}$  parameters, (b)  $E_{3D,1}$  and  $E_{3D,5}$  parameters.

- Mean evolution: as shown in Figure 7, different characterization widths will affect the measured damage (bias). Thus, ideally, a suitable characterization width will be the one that shows a smaller difference in mean measured damage compared with what is obtained when considering different characterization widths.

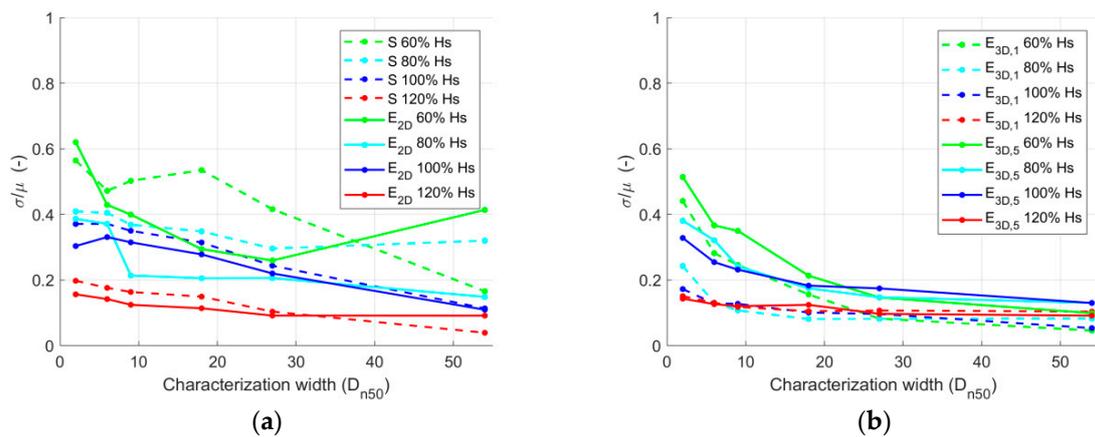
The variability of measured damage is evaluated for different characterization widths. The five identical realizations of Deltares tests Series 1 are considered again, which consists of four test runs each (see Table 1). In Figure 8, the standard deviation normalized by the mean for the four parameters can be observed.

Regarding the parameters obtained from width-averaged profiles (S and  $E_{2D}$  in Figure 8a), it can be observed that the increase in the characterization width leads to a general reduction of the variability in the measurements. Regarding the parameters obtained as the maximum erosion depth observed within a given characterization width ( $E_{3D,1}$  and  $E_{3D,5}$  in Figure 8b), they also show a reduction in the variability (mainly because of an increase in the mean values) with increasing characterization width, with significantly less variability than for parameters S and  $E_{2D}$ . For additional details on damage variability, consider the work of [9].

**Figure 8.** Characterization width. Standard deviation of the damage ( $\sigma$ ) divided by the mean of the damage ( $\mu$ ), for each characterization width (random error). (a) S and  $E_{2D}$  parameters, (b)  $E_{3D,1}$  and  $E_{3D,5}$  parameters.

- Variability evolution: as shown in Figure 8, it should be considered that different characterization widths will present different variability in the results when the same condition is tested several times (random error). Thus, ideally, a suitable characterization width will be the one that shows a smaller variability in the results.

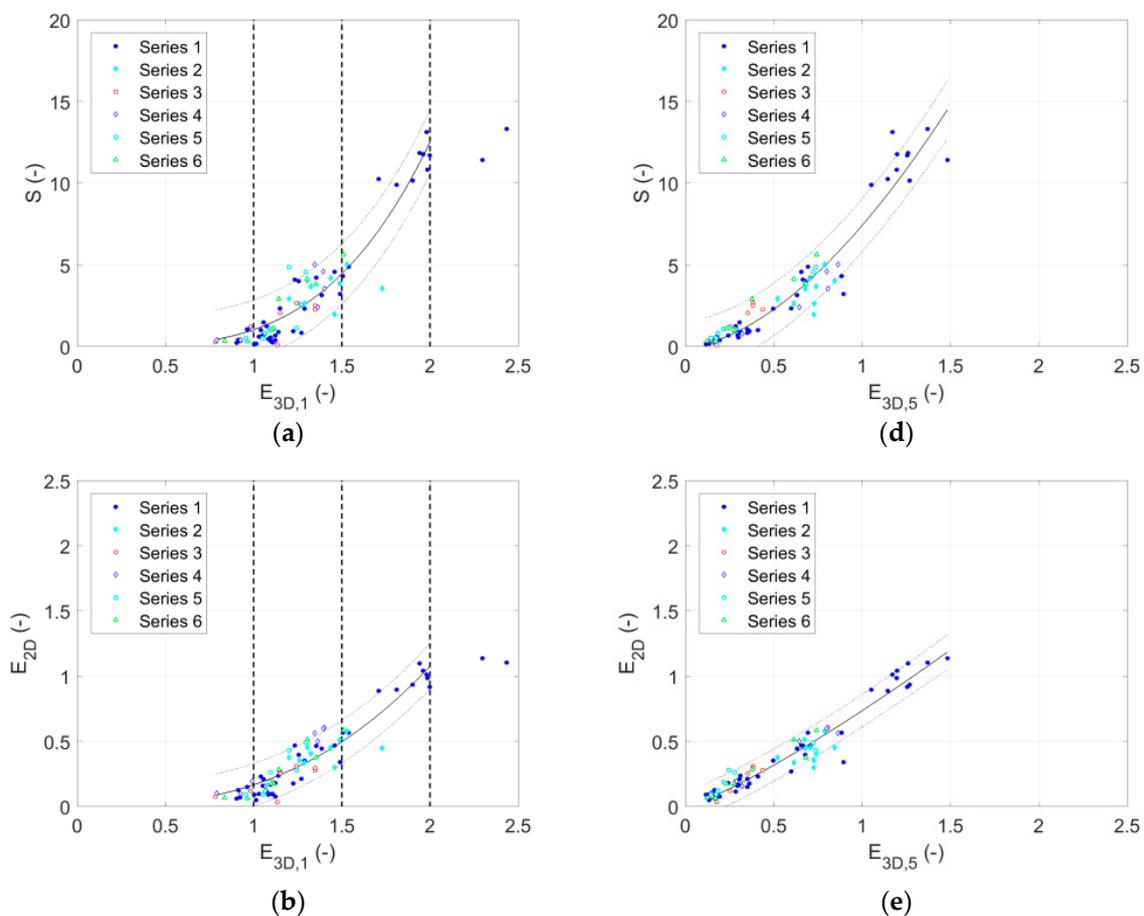
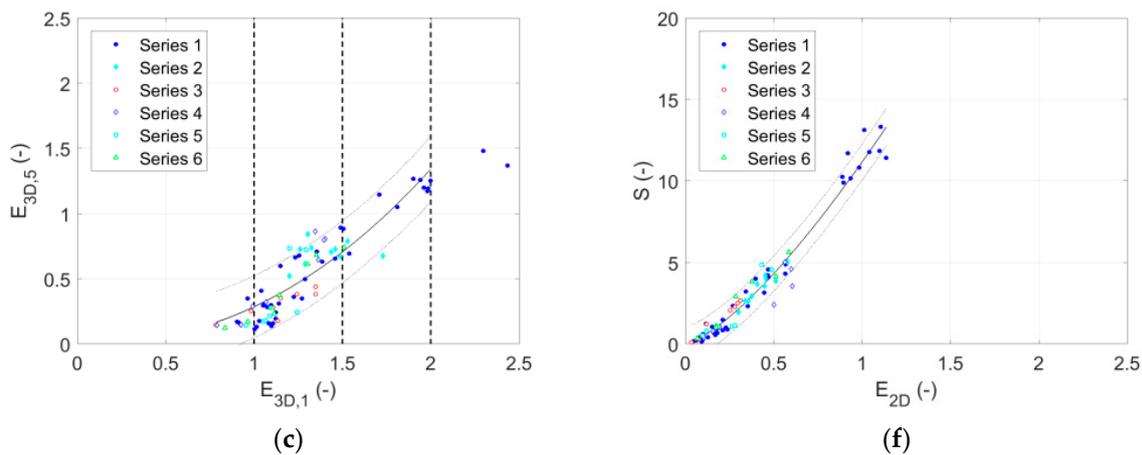
**Figure 9.** Cont.

Thus, considering all the measurements carried out with a high resolution technique (DSP) and the damage parameter  $E_{3D,1}$ , the damage limits can be calibrated based on the Deltares tests (characterization width of  $27D_{n50}$ ), see Figure 9 and Table 2.

**Figure 9.** Comparison of all damage parameters (for  $27D_{n50}$  characterization width). (a)  $E_{3D,1}$  vs.  $S$  parameters, (b)  $E_{3D,1}$  vs.  $E_{2D}$  parameters, (c)  $E_{3D,1}$  vs.  $E_{3D,5}$  parameters, (d)  $E_{3D,5}$  vs.  $S$  parameters, (e)  $E_{3D,5}$  vs.  $E_{2D}$  parameters, (f)  $E_{2D}$  vs.  $S$  parameters.

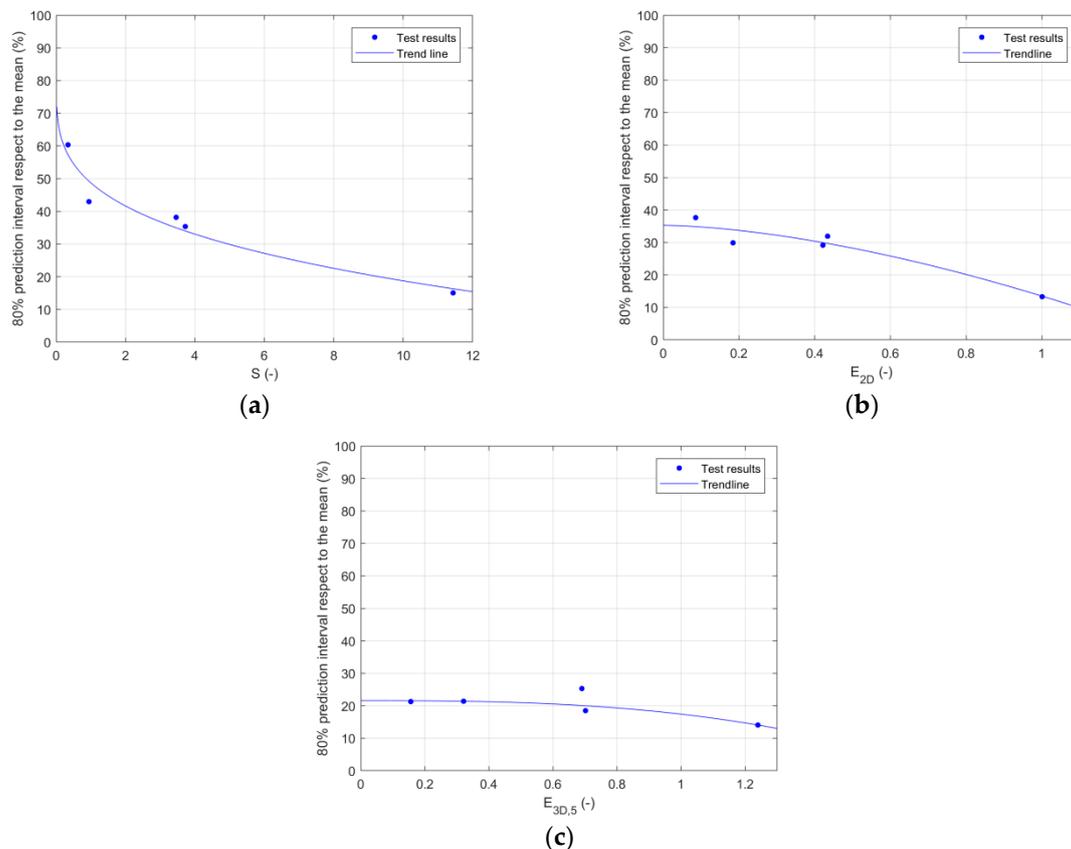
**Figure 10.** Eighty percent prediction interval with respect to the mean (for  $27D_{n50}$  characterization width). (a) *S* parameter, (b)  $E_{2D}$  parameter,  $E_{3D,5}$  parameter.

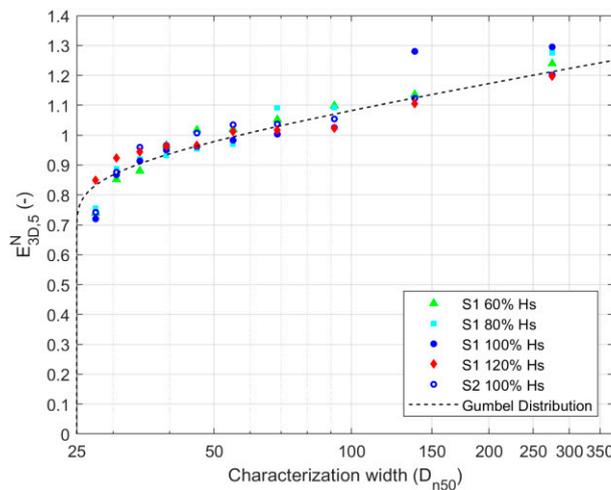
The exceedance probability for the damage is translated to a return width in a similar form to that used for the study of extreme wave climate (see Equation (4)). The combined extreme distribution for the normalized damage parameter  $E^N_{3D,5}$  is shown in Figure 11.

**Figure 11.** Gumbel extreme distribution for  $E_{3D,5}^N$  parameter (for  $27D_{n50}$  characterization width).

Figure 11 shows that a single realization of a test run for a characterization width of  $27D_{n50}$  is expected to present damage of approximately 0.8 as the mean damage (calculated from 10 realizations), while for a structure 10 times wider (approximately  $270D_{n50}$  wide), damage of 1.2 as the mean damage is expected. Thus, according to this study, the damage to a structure  $270D_{n50}$  wide is expected to present damage up to 50% ( $1.2/0.8 = 1.5$ ) larger than that obtained in a single realization in a  $27D_{n50}$  characterization width. Detailed guides on how to account for the length effect on rock armored structures are presented in the work of [9].
