# Case Studies in Construction Materials

# Colour alterations of historic concrete surfaces during the Dutch Interwar Period

Herdis A. Heinemann

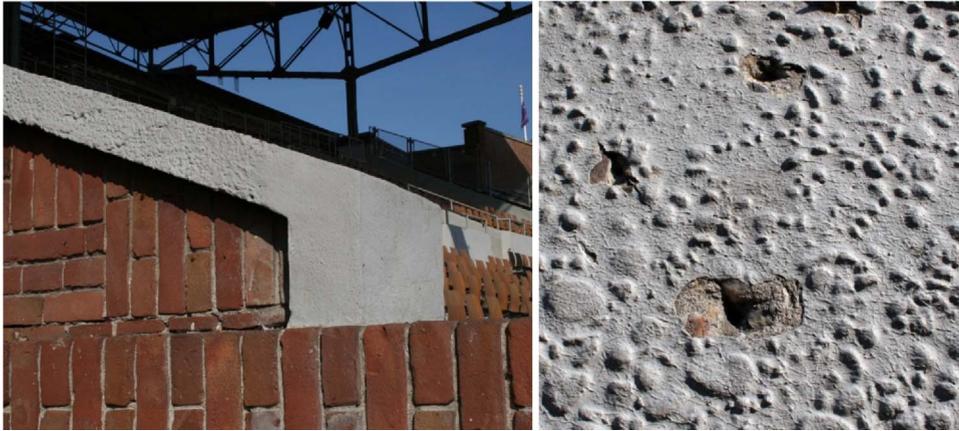
Fig. 1. Example of an aesthetically incompatible repair of historic concrete. Left: Due to a monochrome, grey layer of paint and local smooth repair, the original colour and textural scheme of brickwork and concrete is impeded. Right: Close up of the surface; where the paint has detached, the original polychrome surface influenced by the gravel and cement is visible (Olympic stadium Amsterdam, architect J. Wils, 1928).

The appearance of monuments, including their surface, influences strongly their heritage values and social acceptance. Concrete heritage still faces prejudices on whether it is entitled to be preserved [2]. Recognition of the spectrum of historic concrete surfaces would positively influence the appreciation of historic concrete buildings. In addition, a correct characterisation of the historic surface is relevant to evaluate the concrete durability. In practice, this would require a sound investigation of how the original surface was achieved, the influence of time on the surface (e.g., erosion, discolouration) and the impact of both damage and repair on the surface (Fig. 1).

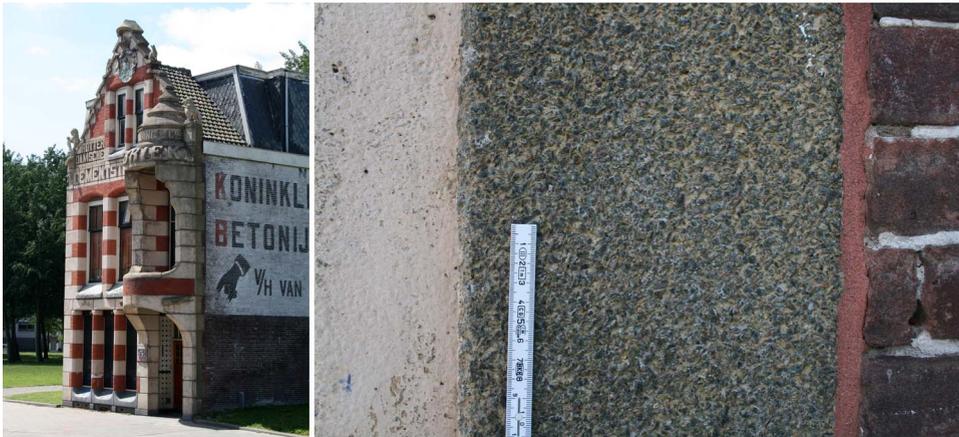
Fig. 2. Former head office of the artificial stone company Rotterdamsche Cementsteenfabriek Van Waning & Co (1898). Left: Overview of the main façade with artificial stone elements painted white. Right: Detail of the corner showing the original, tooled concrete surface made with greenish aggregate.

Experience with precast coloured concrete had been previously gained with natural stone imitations, a variation of precast concrete. By using a variety of coloured constituents and by tooling the surface, the concrete could resemble a variety of natural stone. In Germany, for example, an entire artificial stone industry existed, with several recipes for imitating different natural stones like sandstone, grey wacke, porphyry, tuff, limestone and granite [14]. Dutch examples are the products of the company *Rotterdamsche Cementsteenfabriek Van Waning & Co* (Fig. 2) [15].

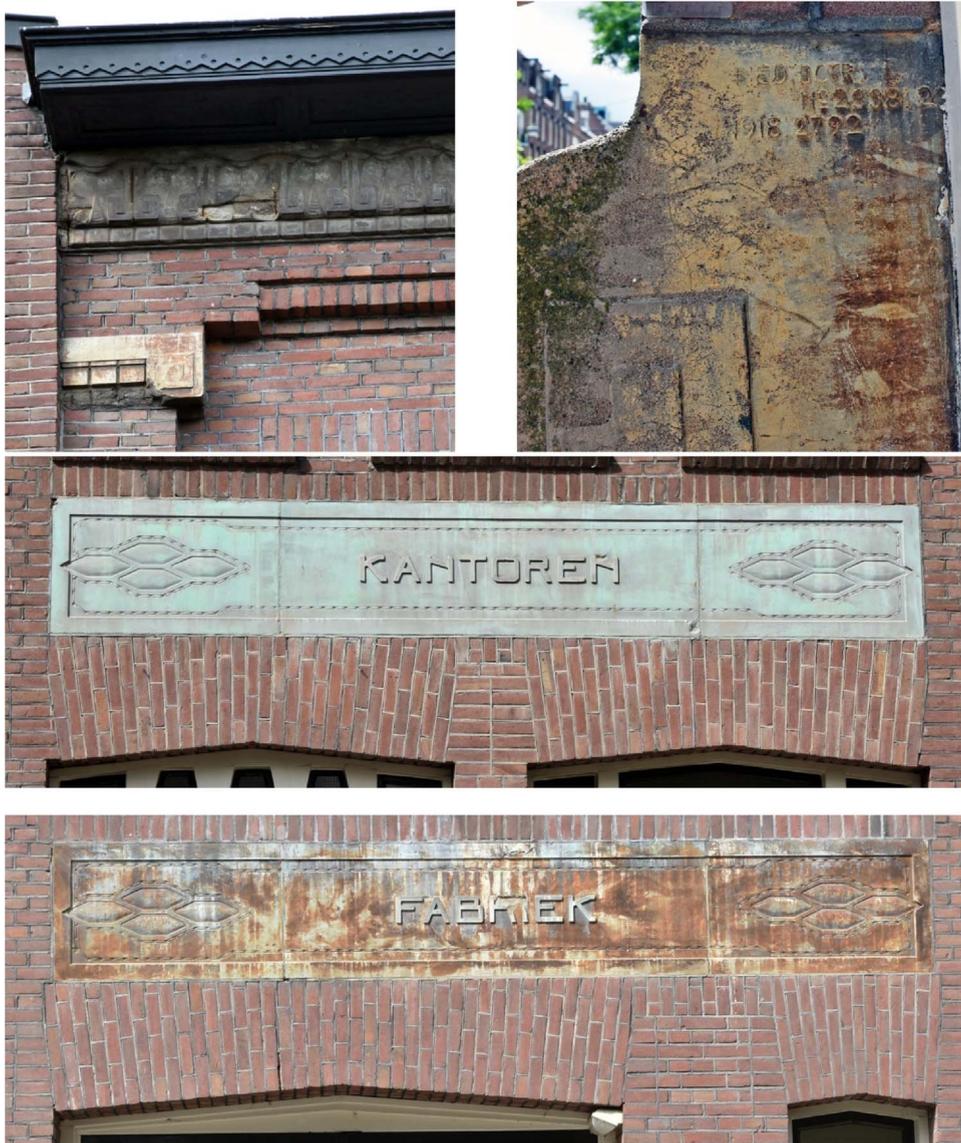
Fig. 3. Overview of precast metallised concrete elements in a former factory (architect C. Tenenti, Amsterdam, 1921). Top left: Cornice made with dark coloured concrete and capital with a sand stone coloured metallised concrete with local darker patches. Top right: detail of a yellow-brown coloured base, with visible inscription of the year and patent number. Middle: Green copper coloured precast metallised concrete sign above entrance for offices. Bottom: Multicolour (green, rust coloured) sign above the entrance to the factory.

A rare collection of metallised concrete can be found in Amsterdam; the decorative façade elements of a former factory building dating from 1921 are made of precast metallised concrete (Fig. 3). On the bases, the number and year of the patent for metallisation is still visible. It cannot be stated whether the present colours are similar to the original, as the effects of ageing on metallised concrete are not known. Local colour variations influenced by the geometry of the elements indicate that the colour changed during time. For example, the yellow-brown bases and capitals are darker in more protected zones. The green copper colour of the signboard for the entrance to the offices however is still rather homogenous. The green might have been made with a copper salt and the brown colours with an iron salt. This indicates that not all shades of metallised concrete possess the same durability. The concrete itself, however, shows damage which affects the surface. Besides spalling and visible corroded reinforcement, the surface is locally eroded. In these areas, no traces of metallisation can be seen.

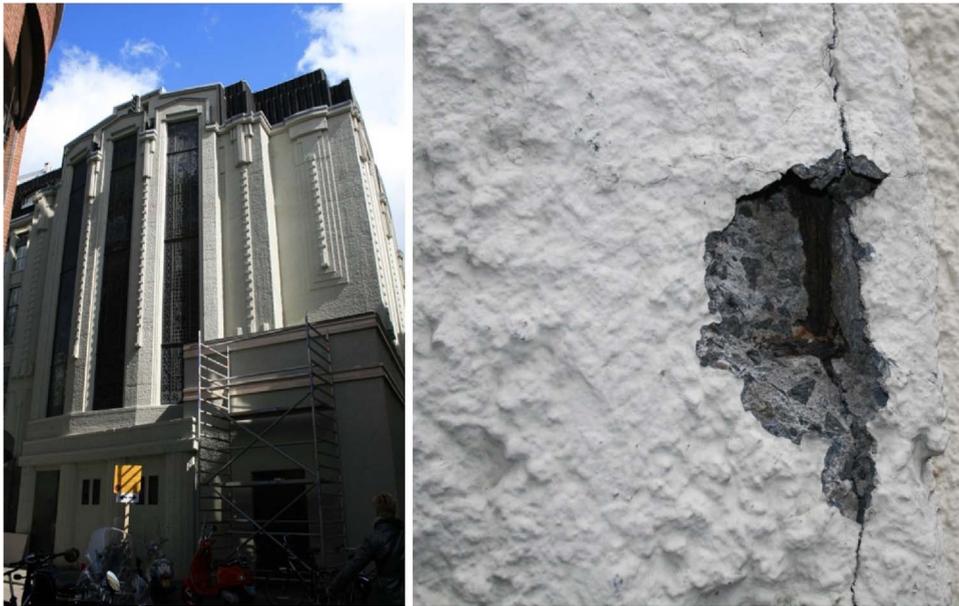
Fig. 4. One of the first Dutch buildings with exposed concrete, yet currently painted (architect A. Moen, 1915). Left: Overview of the rear façade. Right: Detail of a pilaster with spalling, cracking and corrosion, showing the original concrete made with crushed porphyry and with a tooled surface under a layer of paint.

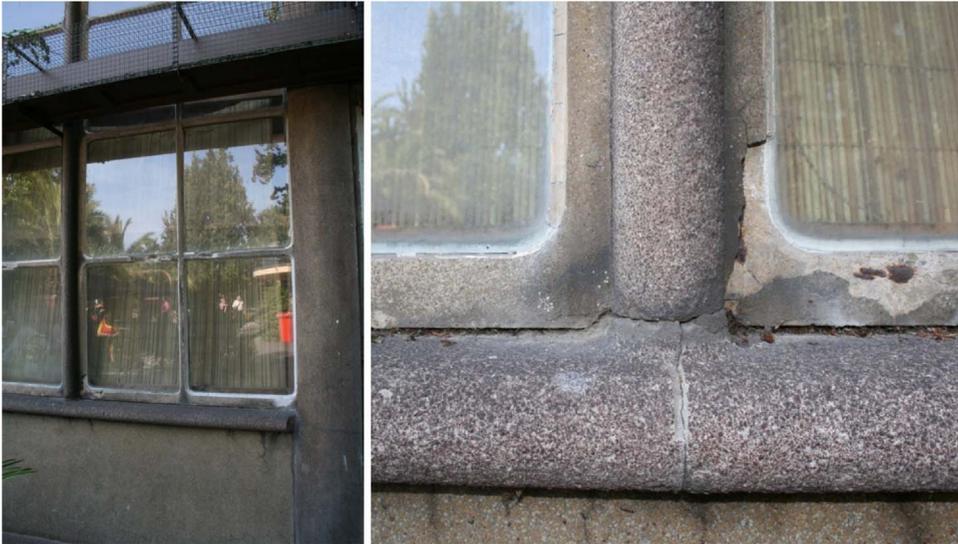
Fig. 5. Precast concrete elements (window frame and sill, plinth, columns etc.) made by Schokbeton N.V., using different ground aggregates to alter the colour of the concrete (Zoo Blijdorp, architect S. van Ravesteyn, 1939). Left: overview façade. Right: beige-sandstone coloured window frame and a more pink-purple coloured windowsill and column. Partially spalling and cracking has occurred, exposing the reinforcement, and discolouration due to soiling.

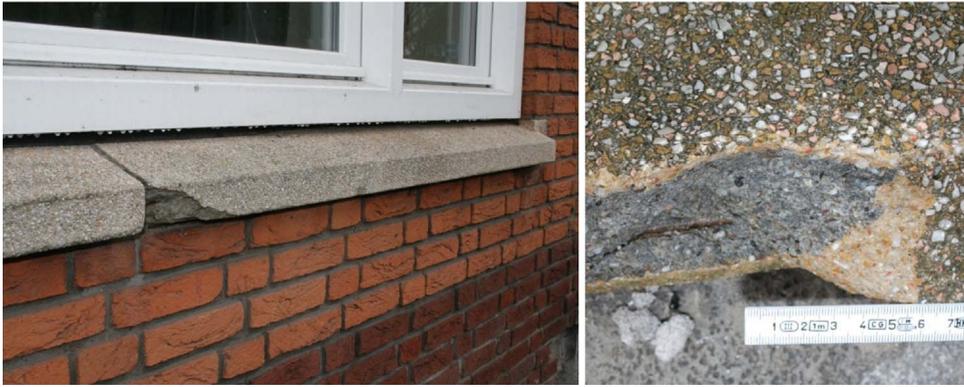
Fig. 6. Typical mass-produced precast concrete windowsill dating from the 1930s. Left: Overview of a windowsill with a broken off corner. Right: Close-up of a damaged windowsill showing a coloured facing layer and a grey backing concrete. Due to soiling, the original colour changed from a beige-orange colour to a more dirty shade of green.
