## Effect of moisture on tuffstone weathering

Lubelli, Barbara; Nijland, T.G.; Tolboom, H.J.

Use and conservation of Rhenish tuff in the Netherlands, Germany, Flanders and Denmark

### Effect of moisture on tuffstone weathering

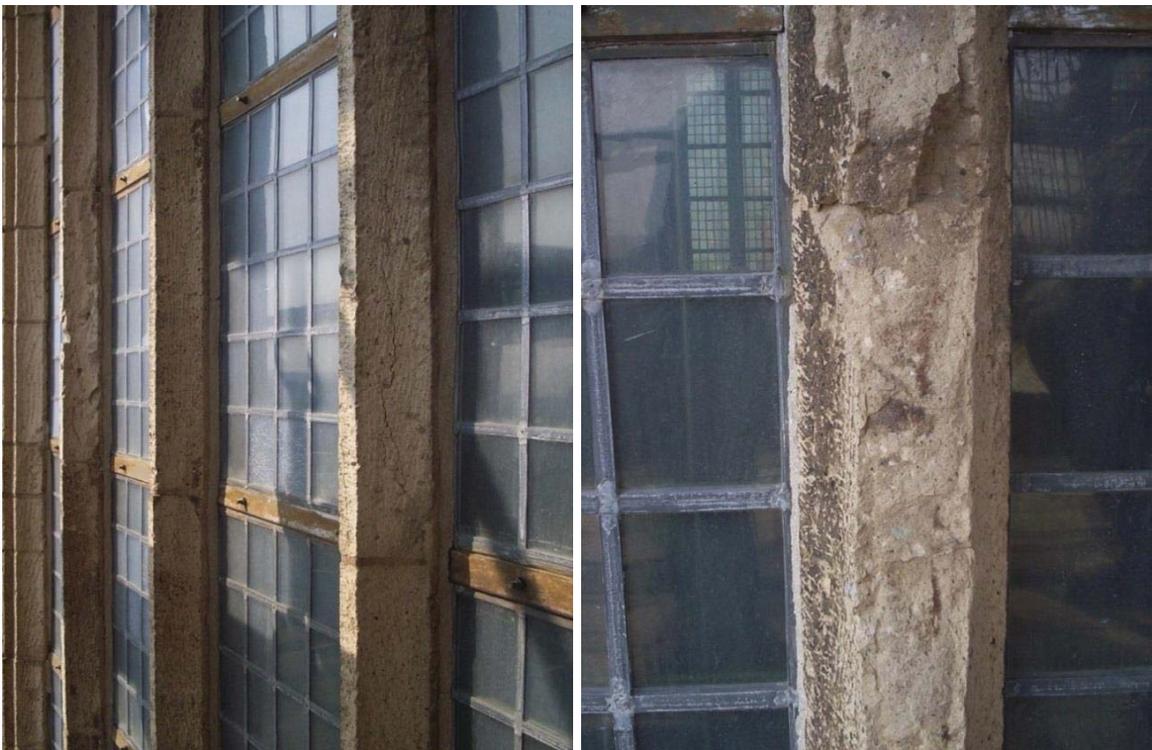
*Fig. 2. Typical longitudinal cracking (left) and final damage in mullions of Weibern tuff at the nave of St. Peter's church in Leiden, The Netherlands (pictures T.G. Nijland, 2005).*

on Ettringen tuff elements (Fig. 1). It is unclear whether this is due to the nature of the stone itself, or, at least in part, an artefact of the architectural use (Römer tuff is, for example, never used a larger elements in mullions or sills, but nearly always in block) This type of damage also (but much more rarely) occurs on Weibern tuff (Fig. 2), that has been used for similar building elements as Ettringen tuff.

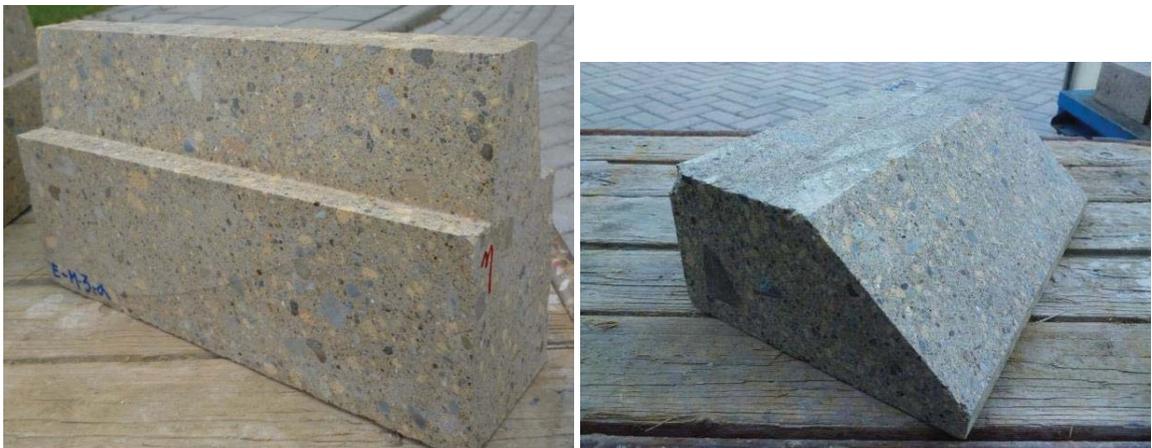
*Fig. 3. Examples of cut mullion and window sill.*

The test plan consisted of a weathering test, aiming at simulating in laboratory the wet-dry cycles occurring in the field, and a series of characterization tests, some of them carried out before and after the weathering test. Specimens of different sizes were used for the tests: cubes, prisms, and small scale mullions and window sills. Part of these were simply cut by a saw, and untooled (Fig. 3). Part of the samples have been made in a traditional way by hand a stone mason (Fig. 4), and tooled by a chisel (Fig. 5) for reasons given above.

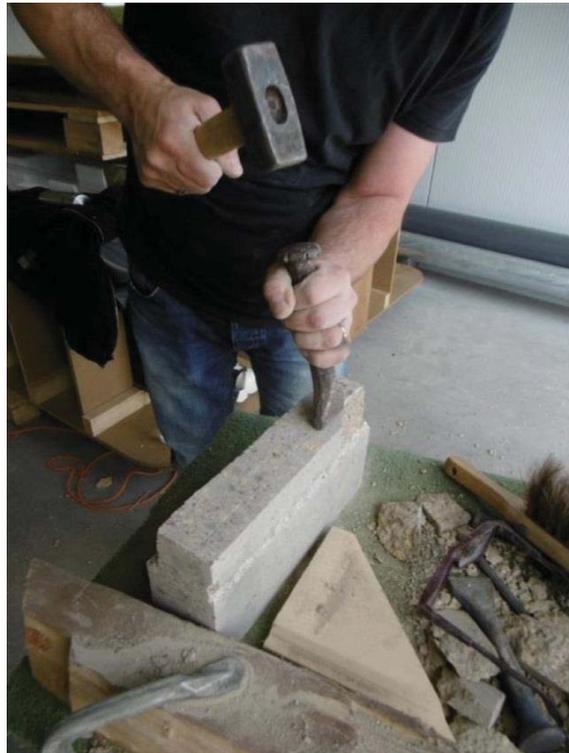
*Fig. 4. Making of a mullion by hand.*

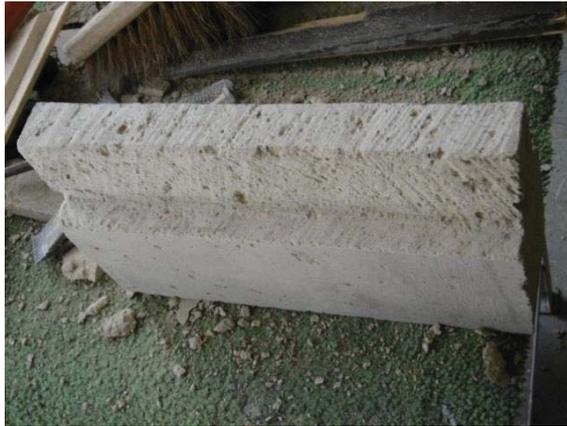
*Fig. 5. Example of a tooled mullion.*

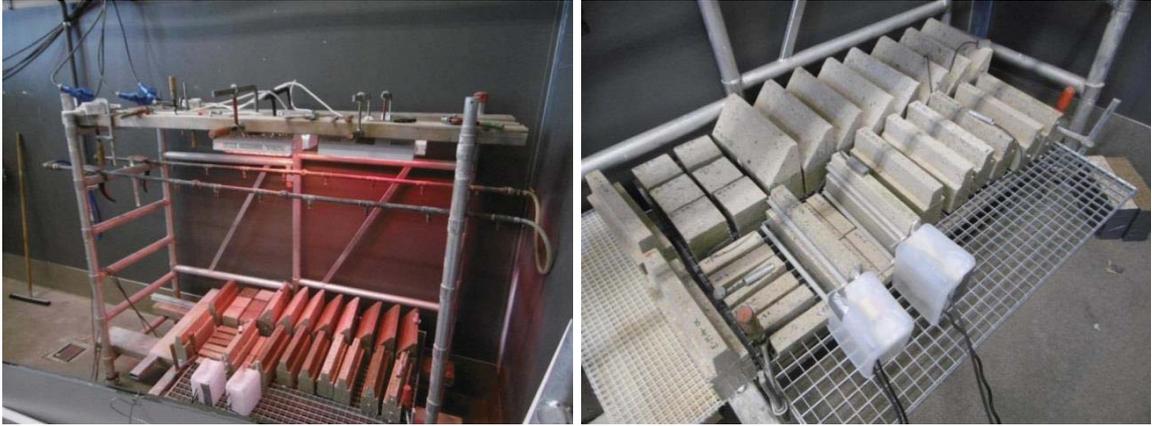
*Fig. 6. Overview of weathering test (left) and specimens used for the test (right).*

The weathering test aimed at reproducing the wet-dry cycles to which tuffstone mullions and window sills are subjected when positioned in building masonry. A test set-up was developed to this purpose (Fig. 6) consisting of:

- A frame, on which the specimens were placed, positioned on an angle in order to allow flowing away of the water.
- Two pipes with hoses to sprinkle the specimens with water (reproducing rain)
- Four infrared lamp to lighten and warm up the specimens (reproducing the effect of the sun)
- Thermocouples to measure the surface temperature of the specimens. The thermocouples were connected to a computer, so that the intensity of the infrared lamps could be automatically adjusted to keep the temperature constant at 40 °C during the "sunny" period.

The specimens were sealed with resin on those sides which are normally encased in masonry.

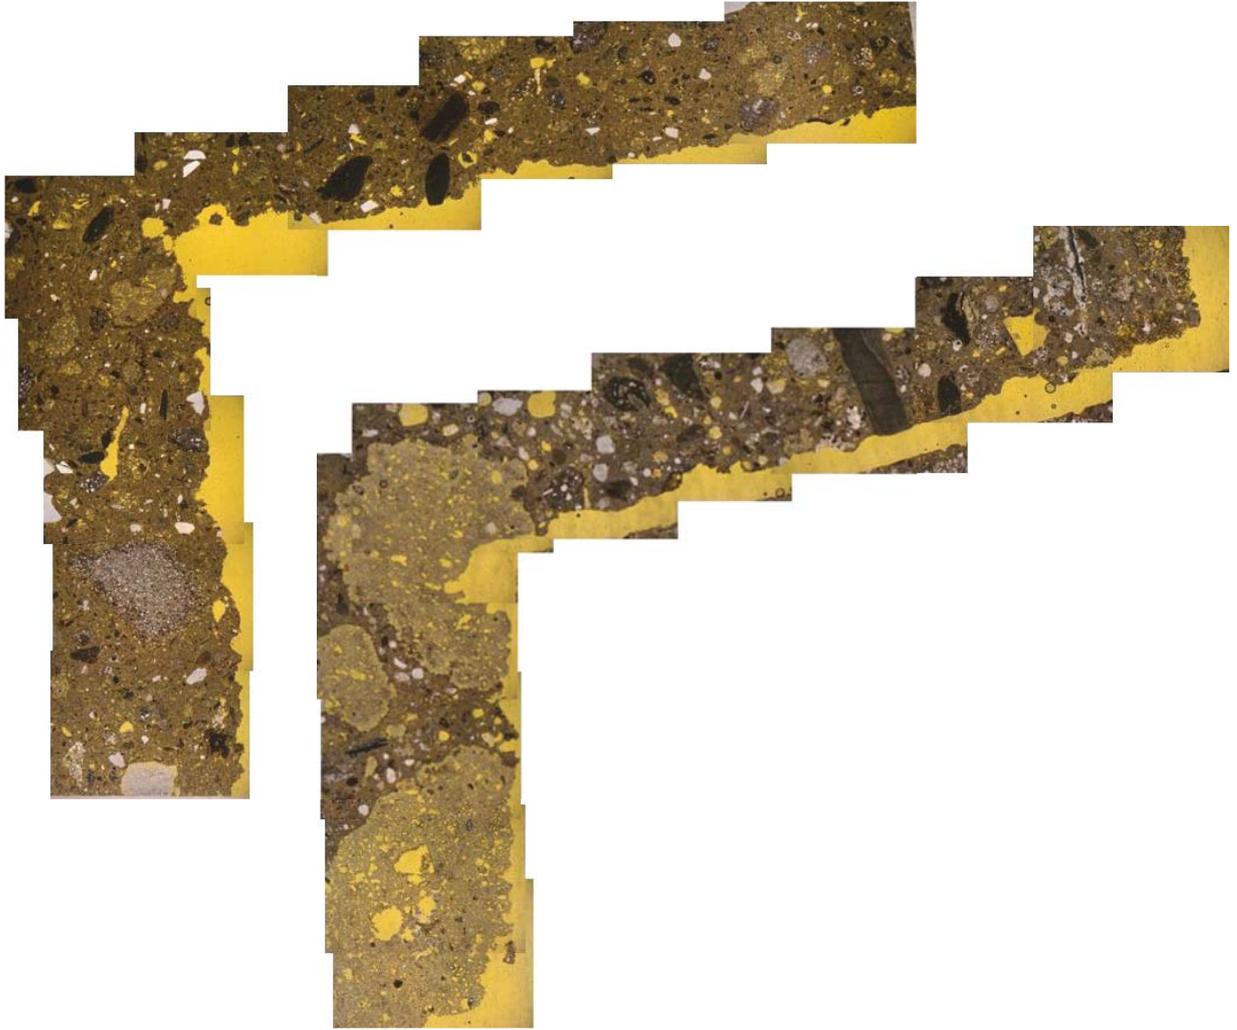
*Fig. 19. Microphotographs over the bend in a tooled Ettringen (above) and Weibern (below) tuff mullions. Note the absence of any microcracks.*

In order to evaluate the effect of tooling, i.e. the possibility of crack initiation by a stone mason prior to weathering, samples have been investigated means of thin sections. Neither in the case of Ettringen tuff, nor in the case of Weibern tuff, any cracks have been initiated, confirming previous results on Weibern tuff and Portland stone (Fig. 19; Nijland 2005).
