4th International Conference on Service Life Design for Infrastructures

DURABILITY OF FIBRE REINFORCED CEMENTITIOUS COMPOSITES: COUPLING MECHANICAL AND CHLORIDE ENVIRONMENT LOADS

Abstract

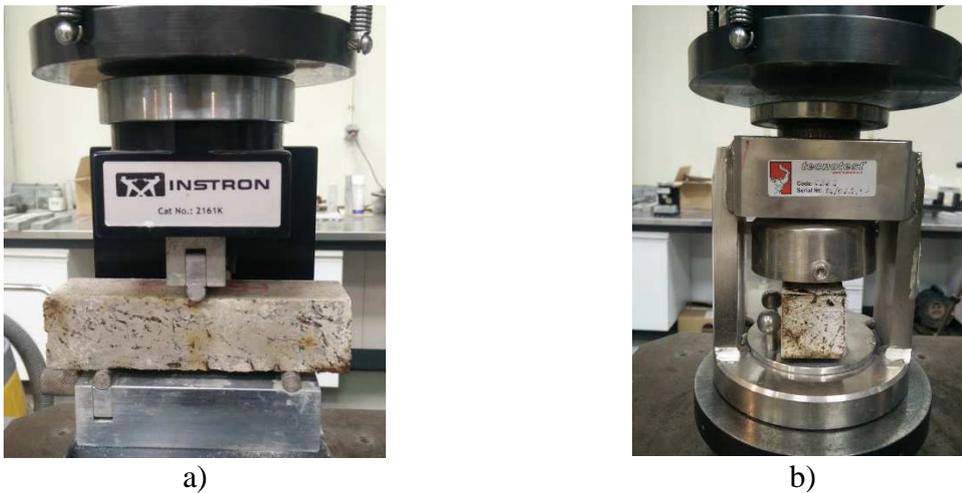
Figure 2: Determination of strength at 9, 36 and 180 days according to EN 196-1 [7]: a) flexure strength (3 point bending); b) compressive strength.

After wet-dry cycles, the flexure and compressive strength were accessed (according EN 196-1-Figure 2) on chloride exposed specimens, as well as, on specimens kept in curing room all the stage (CTL). Results are presented in Figure 10 and it can be observed a significant decrease in flexure behaviour, namely on cracked and loaded specimens (Frame,300µm), in which approximately 50% of flexure strength was compromised. A significant recovery of these specimens would not be expected due to the continuous damage (crack) during chloride exposure. In cracked specimens (Res,250µm) the flexure behaviour was not affected in the same level, and performed equivalent to reference specimens (not cracked-Ref,0µm). Some crack closure due to the CaCO₃ precipitation (autogenous healing) or latter hydration from the matrix might have occurred. Concerning compressive strength slighter deleterious effect was noticed presenting losses above 10 MPa maximum, comparing CTL and Frame,300µm

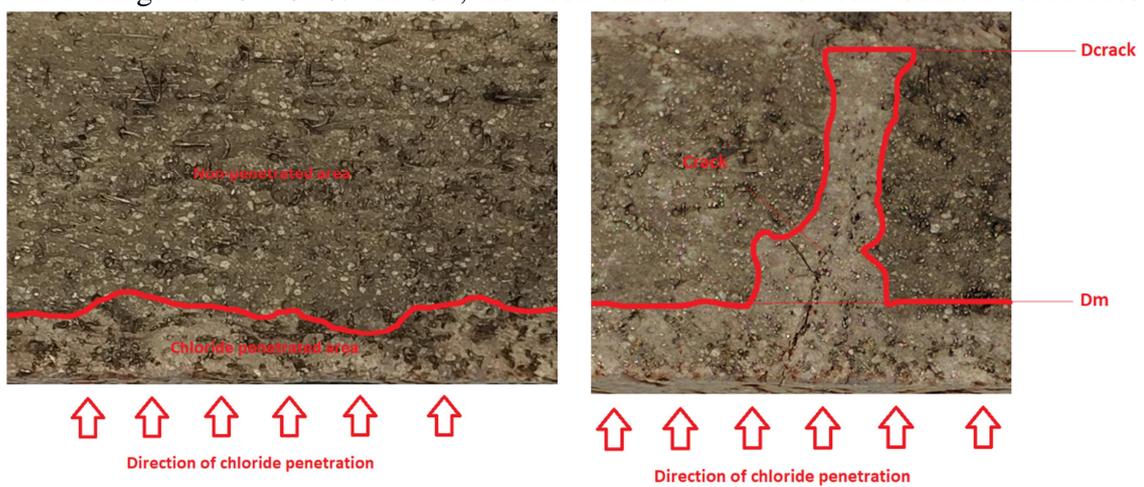
a) b)

Figure 7: Chloride penetration profiles on: a) Reference specimen and b) cracked specimen.

Specimens were dry cut longitudinally in two parts with a diamond saw. After removing powder on the specimen surface, a 0.1M silver nitrate solution was sprayed on one of the cut sections. The chloride penetration depth can then be measured from the visible white silver chloride precipitation. A border between the chloride contaminated area and non-contaminated was found, when compared with typical boundary obtained in accelerated tests, see Figure 7. This can be explained by the slowly entrance of chloride, not forced by an electric potential difference, as well as, by the lower concentration of chloride solution used (3.5% NaCl in the present long term test and 10%NaCl in accelerated test according NT Build 492 [12]). For cracked specimens, two measures of chloride penetration depth can be drawn, the penetration in unfractured zone (D_m) and in the fractured zone (D_{crack}), see Figure 7-b), as presented in Table 3: Chloride penetration depth in unfractured (D_m) and fractured zone (D_{crack}).

In the cracked specimens, a localized and significant chloride penetration (30mm) was observed in the fractured zone, while in reference specimens an uniform penetration has occurred.

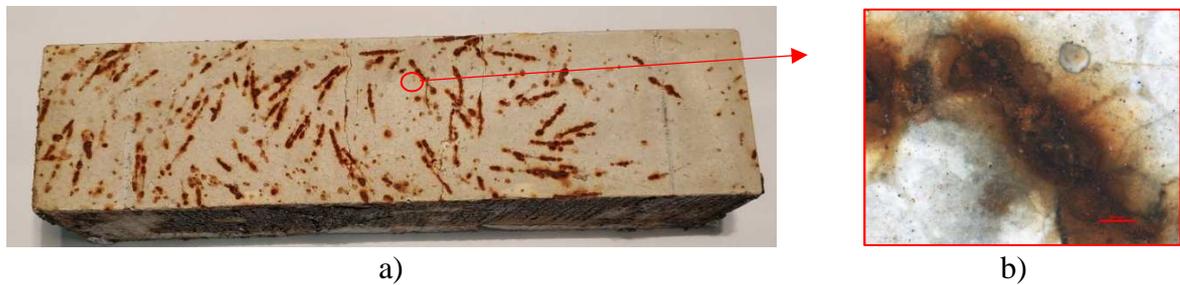
Figure 5: a) Exposed specimen surface after wet-dry cycles; b) Detail of fibre corrosion on specimen surface.

At the end of 20 wet-dry cycles, it was generally observed the fibre corrosion on the exposed surface, an example of that is shown in Figure 5-a). Using a Microscope Multizoom Nikon AZ100 it was possible to observe in detail the fibre corrosion, as well as, the corrosion products, see Figure 5-b). In addition, micro-cracking due to the fibre corrosion was found, as depicted in Figure 6. For fibre cementitious composites, it is inevitable that some of the fibres will be very close to the surface. Thus, these have an almost negligible, cover depth. This should make fibres especially susceptible to external agents and, consequently, high degradation would be expected for these fibres when exposed to extreme environments. Previous research experimentally confirmed that fibres located at depths up to 3 mm suffered severe corrosion whereas the rest of the fibres, i.e. those fully embedded inside of the concrete, remained free from corrosion [10], [11].

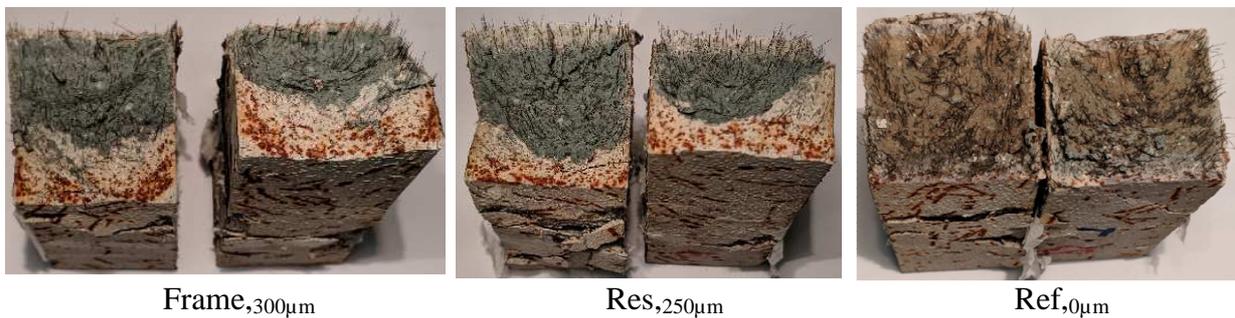
Figure 9: Corrosion of short steel fibres after wet-dry cycles.

specimens. Blast furnace slag presents hydraulic activity (slow “hydration” ratio), which provide a continuously development of the degree of hydration when incorporated in cement based materials. Consequently, an enhancement on compressive strength is achieved by Ref,_{0μm}. After splitting the specimens it was possible to visualize the chloride effect on previous cracked cross section for Frame,_{300μm} and Res,_{250μm}, as well as, on Ref,_{0μm} specimens, as shown in Figure 9. A serious damage due to chloride penetration was observed, namely for Frame,_{300μm} specimens, in which fibre corrosion achieved almost 20mm. This phenomenon explains the loss of flexure strength. Concerning Res,_{250μm}, considerable chloride penetration was also notice, however lower than the Frame,_{300μm}, giving rise to a lower deleterious action on flexure behaviour. Ref,_{0μm} present lower chloride penetration, though also compromising the bending performance.
