Tabaković, Amir; O'Prey, Declan; McKenna, Drew; Woodward, David

Case Studies in Construction Materials

Microwave self-healing technology as airfield porous asphalt friction course repair and maintenance system

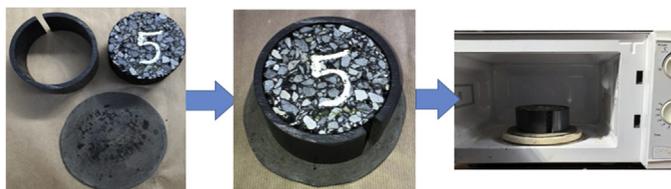
Fig. 3. Microwave healing test system set up.

Fig. 3 illustrates the main elements of the test programme. The microwave oven used was a Tesco Solo, Model No: MM08 with 700 W power output. The defrost setting of 300 W for 3 min was found to be the optimum healing condition for the PFC mix. Some sparks were visible during the first healing cycle probably caused by some of the fibres not being fully coated with bitumen. No sparks were observed for the second healing cycle. This is different to that found in literature where the test specimens are healed by heating for 40 s on the highest microwave power setting of 600 W. The study summarised in this paper observed that at this laboratory microwave setting intense sparks and smoke were emitted as the healing began. Subsequent attempts to reduce power had little effect on the samples.

- 1 Specimens are first tested for non-destructive ITSM at 10 °C and destructive ITS at –5 °C.
- 2 After completion of the ITS testing the two halves of the test specimen are recombined. It is then placed into a specially designed cylindrical plastic collar with 100 mm internal diameter and conditioned for 1 h at an ambient temperature of 20 ± 3 °C.
- 3 The plastic collar and recombined cracked specimen is then placed in a micro-wave oven and heated for 3 min using the Defrost setting at 300 W.
- 4 The plastic collar is removed and the specimen is left undisturbed to cool to room temperature 20 ± 3 °C during which the healing process takes place.
- 5 This testing and healing procedure is repeated twice.

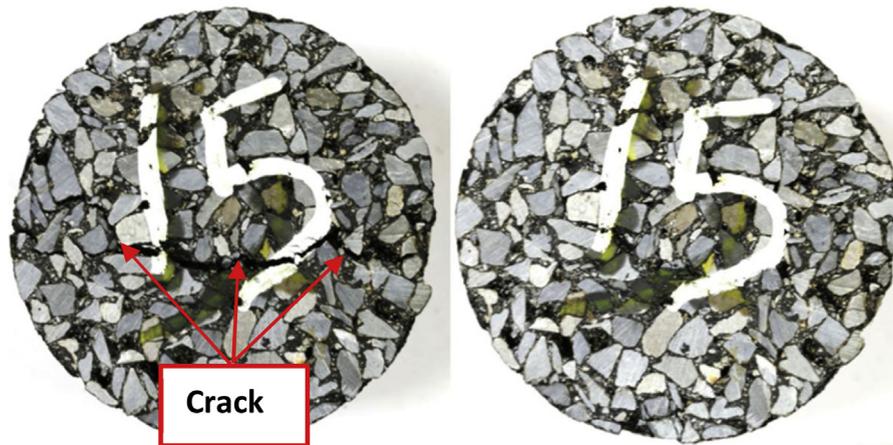
Fig. 13. PFC specimen #15 with 15% steel fibre: Left: before healing and Right: after healing with fully repaired crack.

The PFC test specimens with 5% steel fibres increased stiffness value after the healing cycles. **Fig. 12** shows PFC sample #6 containing 5% steel fibres before and after healing cycle 2. Compared to **Fig. 11**, the crack is completely healed. The increase in heat has probably reduced binder viscosity allowing it to flow not only into the visible cracks but also into other microcracks within the specimen. This agrees with the major healing mechanism of induction heating being capillary flow [23] and diffusion of the asphalt binder at high temperatures. **Fig. 13** shows PFC sample #15 which contains 15% steel fibres. The crack is fully repaired.
