Example of Proof Load Testing from Europe

Chapter 15. Example of proof load testing from Europe

ABSTRACT: This chapter describes the proof load testing of viaduct Zijlweg at a position that is critical for bending moment and at a position that is critical for shear. The viaduct Zijlweg has cracking caused by alkali-silica reaction, and the effect of material degradation on the capacity is uncertain. Therefore, the assessment of this viaduct was carried out with a proof load test. This chapter details the preparation, execution, and evaluation of viaduct Zijlweg. The outcome of the proof load test is that the viaduct fulfils the code requirements, and that strengthening or posting is not required.

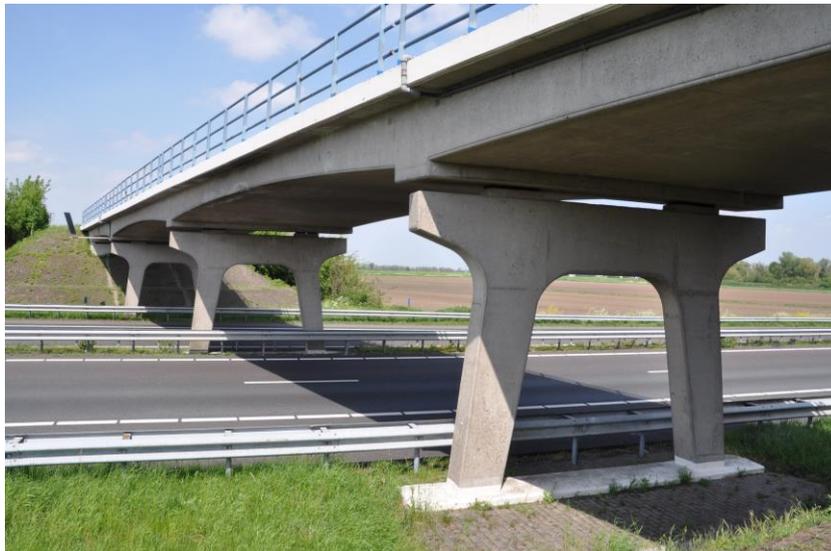
Fig. 1: Viaduct Zijlweg in the highway A59 in the province Noord Brabant.

The Ministry of Infrastructure and the Environment commissioned the TU Delft to perform a proof load test on the viaduct Zijlweg (Fig. 1) over the highway A59 in the Zijlweg between Waspik and Raamsdonksveer, see Fig. 2. Viaduct Zijlweg is a reinforced concrete slab bridge with 4 spans. The spans are supported by concrete piers at the mid supports and by an abutment at the end supports. The forces from the deck are transferred via elastomeric bearing pads to the piers and abutments. It was built in 1965 for the province of Noord Brabant with a design life of 80 years.

Viaduct Zijlweg is one of a series of viaducts in and over the A59 highway with Alkali-Silica Reaction (ASR). This viaduct was field tested as the influence of ASR on the capacity was uncertain and complicated the analytical assessment. In 1997, ASR was detected in the viaduct Zijlweg (Projectteam RWS/TNO Bouw 1997b). Material testing at that time led to the observation that the uniaxial tensile strength is very small, which, in addition to the large number of cracks observed, resulted in concerns with regard to the shear capacity. As typical for reinforced concrete slab bridges, the structure does not contain shear reinforcement. Moreover, the bridge was designed for class 30 from VOSB 1963 (Nederlands Normalisatie Instituut 1963) but is currently in use as class 45.

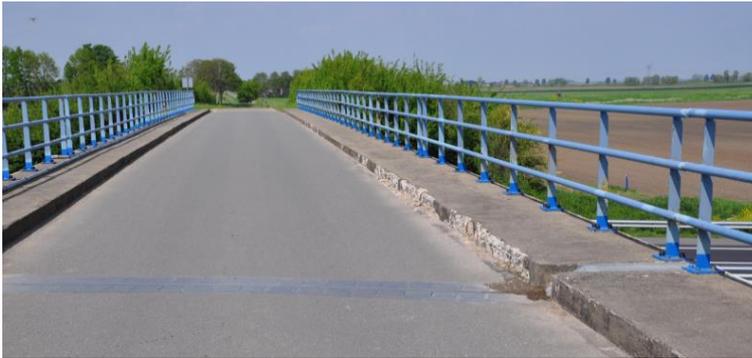
A visual inspection was carried out during the preparation stage of the proof load test. Fig. 8 shows the deterioration of the top deck, present in the pedestrian sidewalk. Fig. 9 shows an impression of the bottom of the deck. The typical cracking pattern of ASR (map cracking) is not clearly visible from the distance at which the inspection was carried out. Closer observations on scaffolding right before the execution of the proof load test allowed for the drawing of the full crack map, see Fig. 10. Fig. 11 shows the small distance remaining in the joint, resulting from the expansion in the longitudinal direction.

Fig. 8: Top deck

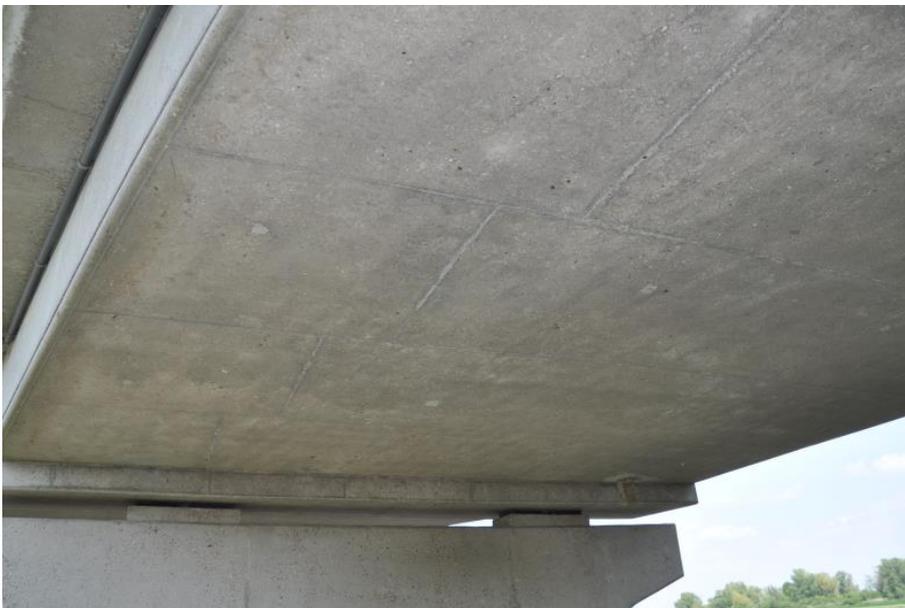
Fig. 9 Bottom of deck.

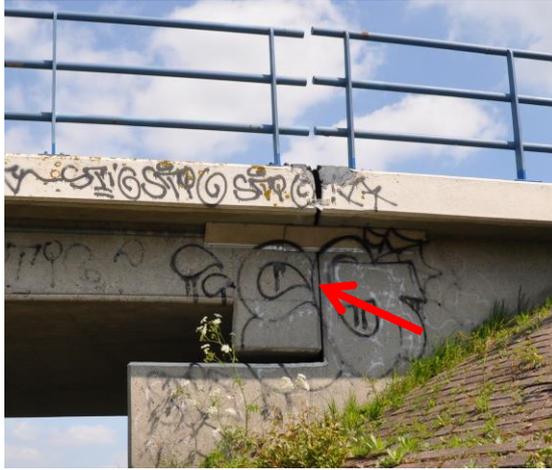
Fig. 11 Expansion joint at the South side of viaduct Zijlweg.

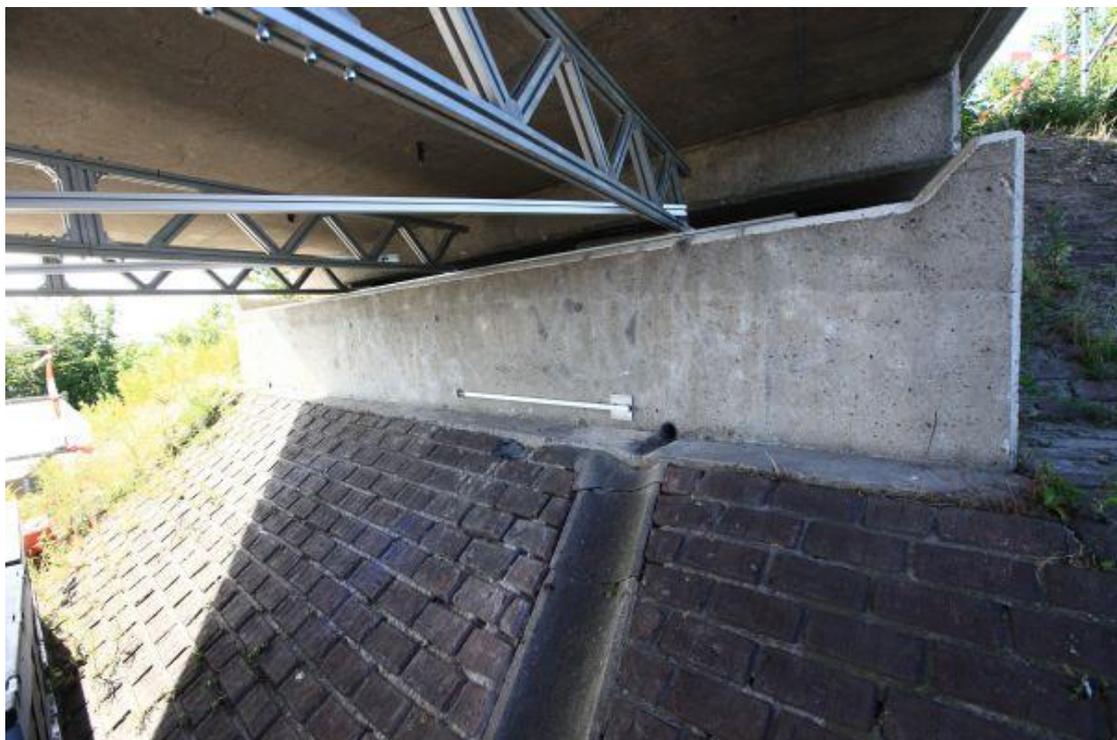
Fig. 18: Position of reference LVDT to measure influence of temperature and humidity. Picture showing support 5.

The strains caused by changes in temperature and humidity are measured by the reference LVDT (see Fig. 18). The information of the ambient temperature can be taken from the Dutch meteorological institute (Royal Dutch Meteorological Institute 2017). The measurement of the temperature of the bridge deck is part of the monitoring system for ASR, as discussed in §2.3.3. During the bending moment test, see Fig. 29a, the bridge deck temperature and ambient temperature increased similarly. The measured strain is inversely proportional to the temperature. As

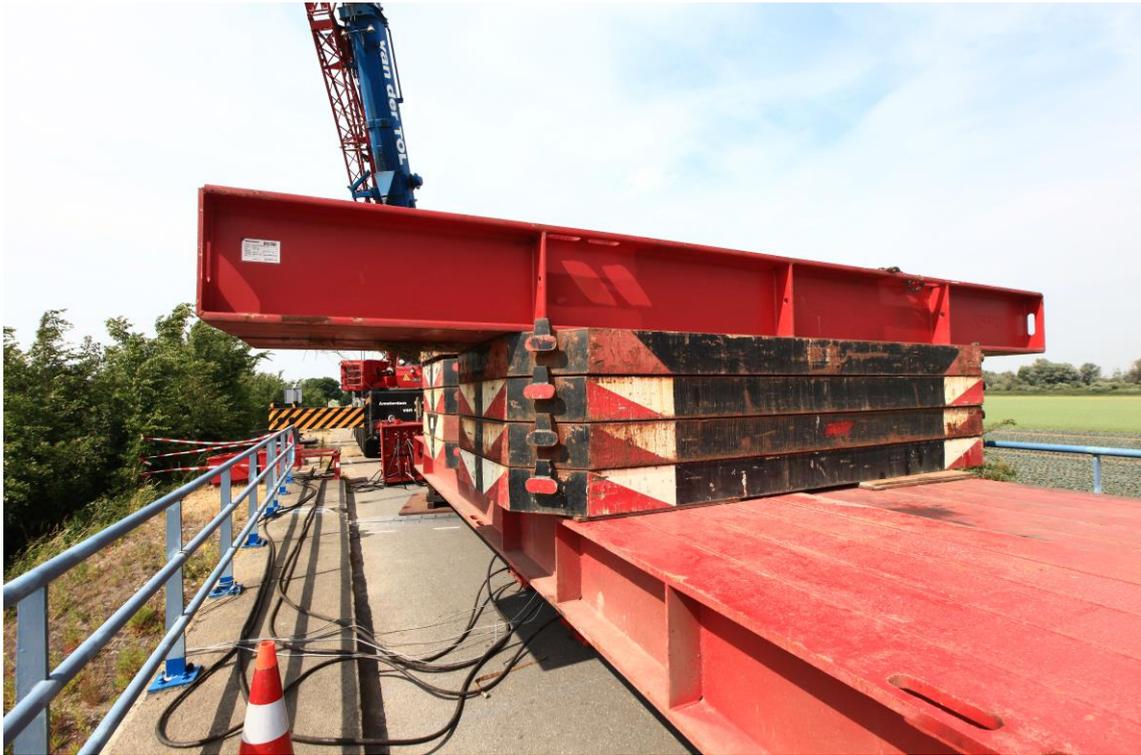
For the proof load tests at the shear- and flexure-critical positions, a setup with a load spreader beam, counterweights, and four hydraulic jacks was used. Fig. 21 shows a photograph of the load application system. Before the beginning of the proof load test, the jacks are not extended, and the load caused by the applied counterweight is carried off at the supports to the substructure. During the proof load test, the load on the jacks can be controlled and the superstructure (reinforced concrete slab) is loaded.

Fig. 21: Setup of the load used on viaduct Zijlweg.
