Fatigue behaviour of a welded I-section under a line load in compression

Wardenier, Jaap; de Vries, Peter; Timmerman, Gerrit

Journal of Constructional Steel Research

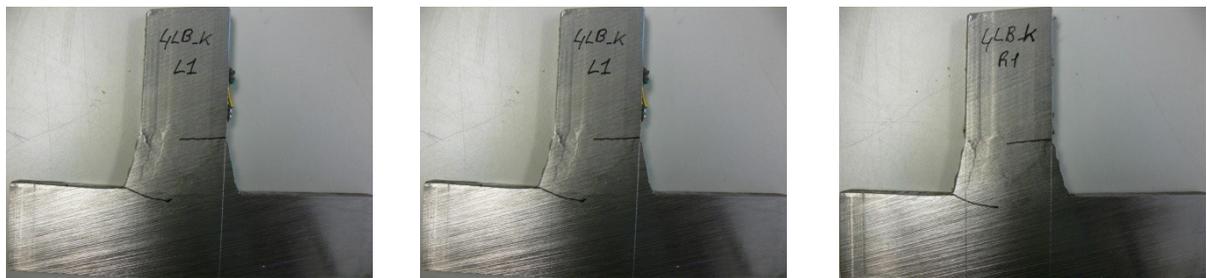
Fig. 13. Cross section of the cracks at the centre of the test specimen 4LB-K
