# Characterization and Hydrological Analysis of the Guarumales Deep-Seated Landslide in the Tropical Ecuadorian Andes

**Abstract:** The high landslide risk potential along the steep hillslopes of the Eastern Andes in Ecuador provides challenges for hazard mitigation, especially in areas with hydropower dams and reservoirs. The objective of this study was to characterize, understand, and quantify the mechanisms driving the motions of the Guarumales landslide. This 1.5 km<sup>2</sup> deep-seated, slow-moving landslide is actively moving and threatening the “Paute Integral” hydroelectric complex. Building on a long time series of measurements of surface displacement, precipitation, and groundwater level fluctuations, we analyzed the role of predisposing conditions and triggering factors on the stability of the landslide. We performed an analysis of the time series of measured groundwater levels and drainage data using transfer functions. The geological interpretation of the landslide was further revised based on twelve new drillings. This demonstrated a locally complex system of colluvium deposits overlying a schist bedrock, reaching up to 100 m. The measured displacement rates were

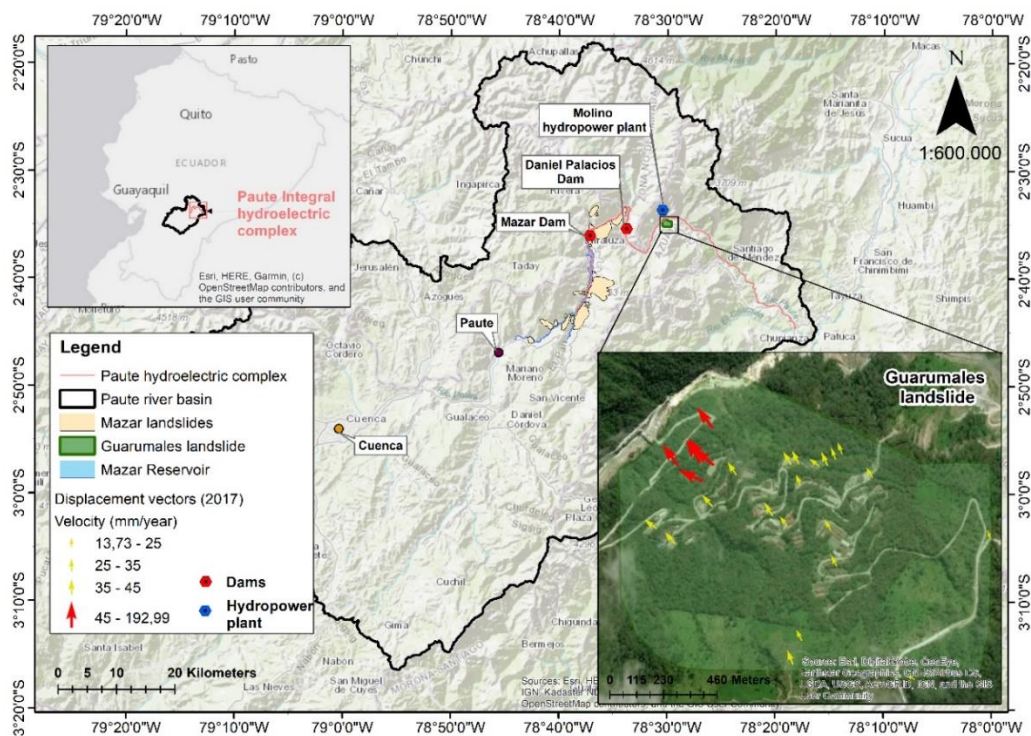
**Figure 1.** Location of the 21 landslides around Mazar and Molino hydropower facilities, including the Guarumales landslide.

The Guarumales landslide endangers one of the most important hydropower plants of Ecuador: the Molino hydropower plant of the Paute Integral hydroelectric complex with an installed capacity of 1100 Mw. The administrative facilities of Molino are located on the Guarumales landslide, where an average of 250 people live. Most of them are employees of CELEC EP (Electrical corporation of Ecuador public company). Instrumentation and essential infrastructure are located on the landslide (Figure 1).

The overall direction of the movement in all 26 points was north-west, with an azimuth that varied from 250 to 330 degrees (see Figure 1). The direction and magnitude of the velocity vectors of all individual observation points along the horizontal plane are presented in Appendix A.3, in Tables A1–A4.

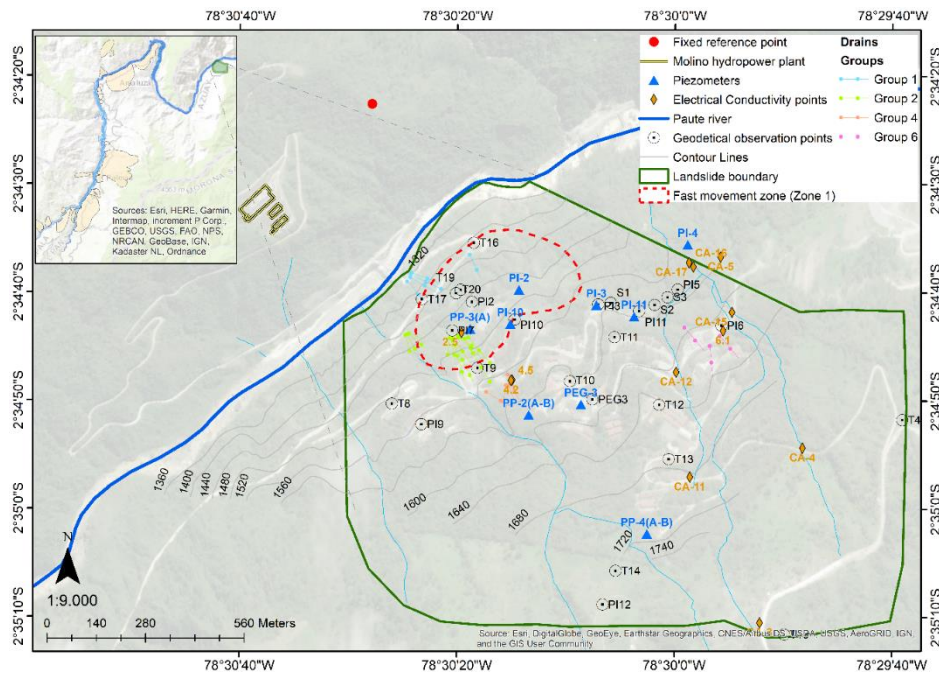
Figure 2. Instruments available in Guarumales and their location.

An overview of the available instrumentation and locations is shown in Figure 2.

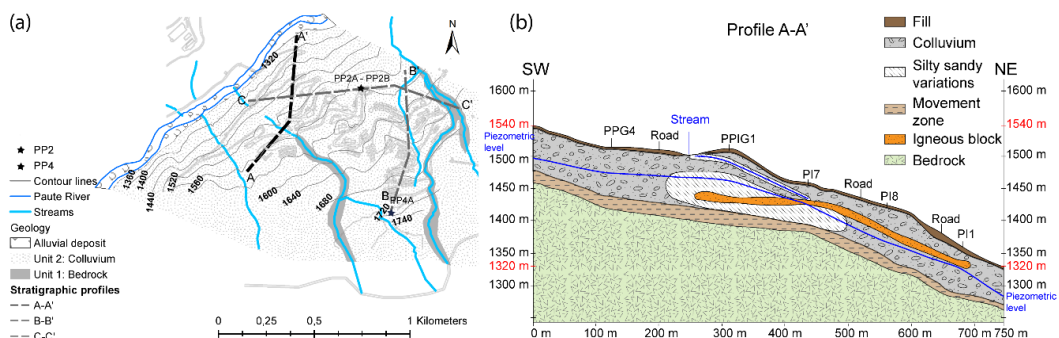
Figure 3. (a) Geological map of the Guarumales landslide, where two litho-stratigraphic units were identified. Unit 1: Bedrock, Unit 2: Colluvium, (b) Profile A-A' indicating the presence of the bedrock, clayey slip surface (that is located ~100 m deep), and a colluvium layer formed by shale blocks and silty sandy lenses. An igneous block was also found through the colluvium layer. Groundwater was present at two levels; one shallow presence that mainly originated in the sandy silt lens and another deeper (30 to 50 m deep) in the colluvium body. Profiles B-B' and C'-C are presented in Figures A3 and A4.

Unit 2—Colluvium: Overlying the slip surface, a thick (20 to 100 m) heterogeneous colluvium layer, consisting mainly of large chloritic, sericitic and graphitic shale clasts in a clayey silt to silty sand matrix. Furthermore, in the close vicinity of the Paute river, unsorted (sub-) rounded alluvial deposits were present (see Figure 3).

Several drilling campaigns were carried out from 2016 to 2018, and these were corroborated by data from before 2016. In addition to a deep, continuous groundwater level, a shallow groundwater level was found during the 2016–2018 drilling campaign in boreholes PP2 and PP4, suggesting that a perched groundwater level existed in a lens of sandy silt matrix, which seemed to link to small surface water streams present on the Guarumales slope (see Figure 3). Within the colluvium layer of profile A-A', a large igneous block was found, possibly associated with the granodioritic body of Amaluza (pluton of the Eocene age) [36]. This unit is present along the Paute river, in the lower part of the basin.

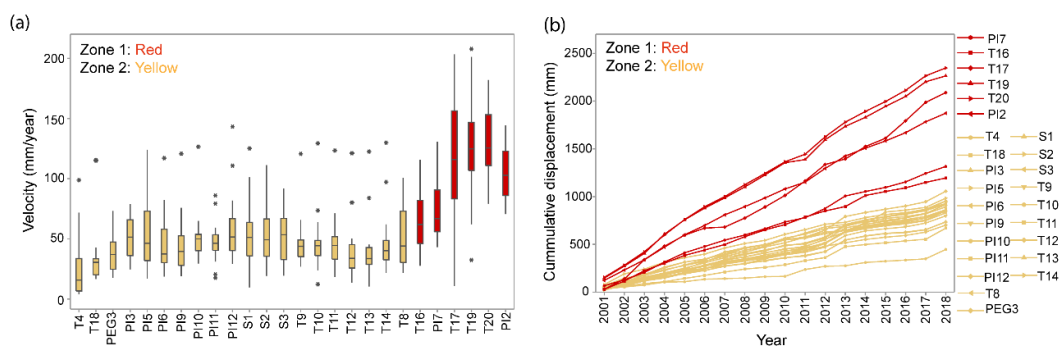
**Figure 4.** The horizontal displacement velocity of 26 geodetical observation points in Guarumales for 18 years, indicating Zone 1 (red, higher velocity) and Zone 2 (yellow, lower velocity). (a) Boxplots, (b) Cumulative horizontal displacement.

Survey campaigns in Guarumales take place once per month, but there are interruptions due to weather conditions resulting in an average of eight measurements per year with a minimum of three measurements per year at the 26 geodetical observation points. There are two zones with distinct movement. Zone 1 (red dashed line in Figure 2) is located in the lower part of the landslide (N-W) and represents the fastest movement with horizontal velocities that can go up to 210 mm/year. Zone 2 (yellow) represents the rest of the slope where the horizontal velocities typically range from 30 to 60 mm/year and up to 150 mm/year (Figure 4a). The cumulative yearly horizontal displacement is plotted in Figure 4b.

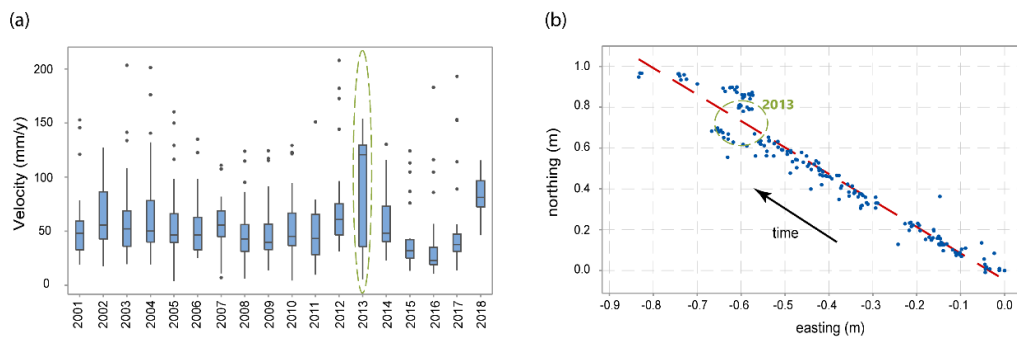
**Figure 5.** (a) Boxplots of the average annual horizontal displacement velocity of 26 geodetical observation points for 18 years. (b) Plan view of the evolution of the horizontal movement from 2001 to 2018, with the respective trendline for observation point PI3.

The annual horizontal velocity of all 26 observation points is presented for each year in Figure 5a. On average, the velocity was around 50 mm/year, which mostly corresponded to the behavior of zone 2. The higher displacement rates (expressed here as outliers) corresponded to observation points in zone 1 with velocities up to 200 mm/year in some years. In 2013, the velocities ranged from 0 to 150 mm/year with no anomalies that corresponded to Zone 1. In Figure 5b, a plan view of the evolution of the horizontal movement over 18 years is shown for P13. It is clear that in 2013, there was a dramatic shift in the displacement; however, the effect vanished after one or two years, as the movement returned to a north-west direction.

The residuals between the observed locations and the trendline (i.e., the azimuth of movement for the horizontal coordinates), as in Figure 5b for P13, were calculated. These results were compared to the average horizontal displacement per year to obtain the normalized residuals. This revealed that the residuals for zones 1 and 2 were  $\sim 1.7$  and  $\sim 3.5$  (up to six) times the average yearly displacement, respectively. To determine a reliable displacement and velocity, it was necessary to average at least 2–3 years of data to overcome the residuals. This can be seen in Appendix A.4, in Figures A5 and A6.

In terms of comparing the displacement to hydro-meteorological factors, we concluded from the data shown in Figure 5b that no seasonal signal in the displacement could be determined due to the coarse time resolution and measurement error, which means that no relation could be established between the rainfall and displacement at this stage.

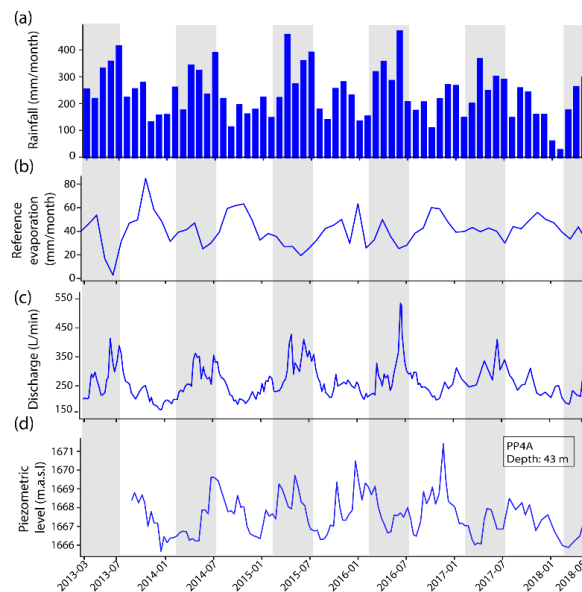
**Figure 6.** Time series of the (a) monthly rainfall, (b) monthly reference evaporation, (c) total discharge from 29 drains, and (d) piezometric level from the piezometer PP4A for the period 2013–2018. The shaded area indicates the rainy season. Time series plots for the 10 remaining piezometers and the individual 29 drains are shown in Appendix A.5, in Figures A7 and A8.

The hydro-meteorological data are summarized in Figure 6. The mean annual rainfall was around 2937 mm per year. The years 2015 and 2013 were the wettest and the driest years with 3144 mm and 2607 mm of rainfall, respectively. The mean monthly rainfall ranged from 237 mm/month to 470 mm/month (Figure 6a). The wet season occurred from March to July. During the dry season, the lowest recorded monthly rainfall was 25 mm/month. The rainfall and discharge from the drains increased during the wet season (Figure 6a,c), while the evaporation increased during the drier season (Figure 6b). A time lag was always observed between the groundwater level rise (here for PP4A, depth: 43 m) and the rainfall (Figure 6d).

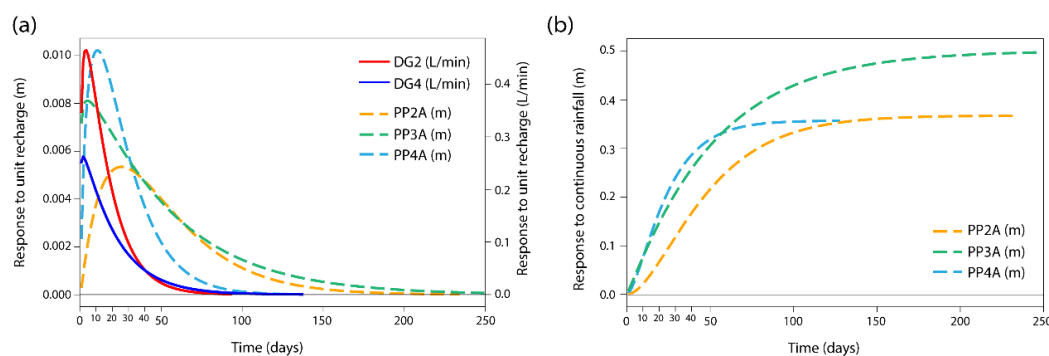
**Figure 7.** The impulse responses (a) for piezometers PP2A, PP3A, and PP4A, and drain groups 2 (DG2) and 4 (DG4); and the step responses (b) for piezometers PP2A, PP3A, and PP4A.

All 11 piezometers were analyzed, and three of them (PP2A, PP3A, and PP4A) showed a Pearson's  $r^2$  higher than 0.65, indicating that measured groundwater levels in these piezometers could be analyzed reasonably well using rainfall as the only stress. The resulting response functions for these three piezometers are shown in Figure 7.

The impulse response represents the response of the groundwater level to an instantaneous recharge event of 1 mm/day (Figure 7a, dashed lines). The response time is defined here as the time when the impulse response reaches a peak, which represents the time lag between the rainfall event and the maximum groundwater response. The optimal value of the response time was estimated together with a 95% confidence interval. The peak response in PP2A was ~0.005 m, and the response time (time lag of the peak) was ~16–31 days. The peak response in PP3A was 0.008 m after ~1–12 days, and the peak response in PP4A was ~0.01 m after ~5–13 days.

The step response represents the level to which the head rises in response to a continuous recharge of 1 mm/day (Figure 7b). The time it takes for the response to reach its plateau is referred to as the memory of the system. Inversely, the memory of the system represents the time it takes for the effect of an impulse of rain to vanish. The optimal value of the memory was estimated together with a 95% confidence interval. In PP2A, the step response leveled off at ~0.35 m, and the memory was ~71–147 days. In PP3A, the step response leveled off at ~0.5 m after ~59–221 days, and in PP4A, the step response leveled off at ~0.35 m after ~41–76 days.

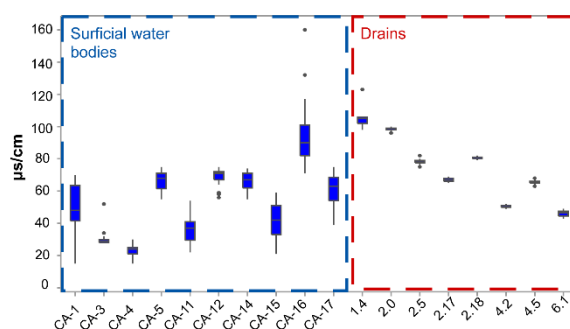
**Figure 8.** The electrical conductivity for 18 observation points in the slope for the period July–December/2018.

The electrical conductivity was tested in 18 locations across the slope and is shown in Figure 8. Values from the samples collected from the surface water bodies and drains were similar, ranging from ~20  $\mu\text{s}/\text{cm}$  to ~90–100  $\mu\text{s}/\text{cm}$  (see Figure 2). These values are typical for rainfall water. The variation of the electrical conductivity values was larger in the surface water bodies than in the drains.

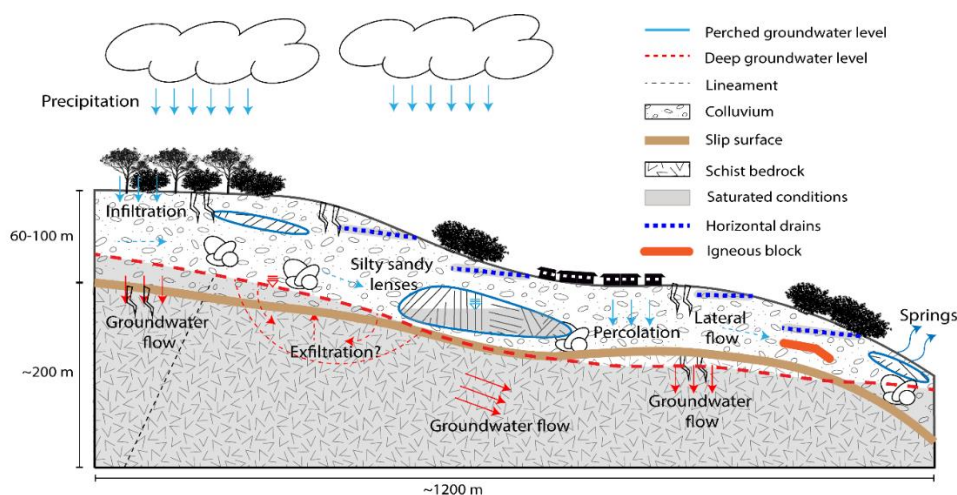
**Figure 9.** Conceptual model of the Guarumales landslide. There is a deep permanent groundwater level that varies around the slip surface, with scattered perched groundwater systems in silty sandy lenses underlaid by low permeable blocks. The Guarumales slope is an unconfined system, which means there is no pressurized water and very limited upward flow of water. There are 29 horizontal drains, which do not reach the deep groundwater systems but drain small perched water bodies in the slope, which are fed by rainfall, as also evidenced by the very low electrical conductivity of the drained water.

Guarumales is a deep-seated landslide in a local complex geological setting. Here, we use the Brönnimann classification system to interpret the hydrogeological characteristics of the slow-moving landslide (see Appendix A.6). Based on all observations, we simplified the landslide in a two-layer slope composed of a relatively permeable and mainly unsaturated colluvium layer and a low permeable, saturated bedrock layer with a 1–3 m thick weak layer acting as slip surface between the colluvium and the bedrock. Furthermore, we observed a delayed but distinct correlation between the rainwater input and groundwater response of the unconfined aquifer in the slope. The heterogeneous nature of the colluvium and bedrock layers, highly fractured and weathered in some locations while intact in others, added complexity, including local perched water tables. Lastly, we found that the drains in the slope did not tap into the deeper groundwater system but drained the perched areas of the otherwise unsaturated top layer. This places the Guarumales slope in hydrogeological class B1 (see Appendix A.6), mainly influenced by local infiltration and percolation processes, free-draining into the Paute river at the toe of the slope, and with limited influence from the deep regional groundwater flow (Figure 9).

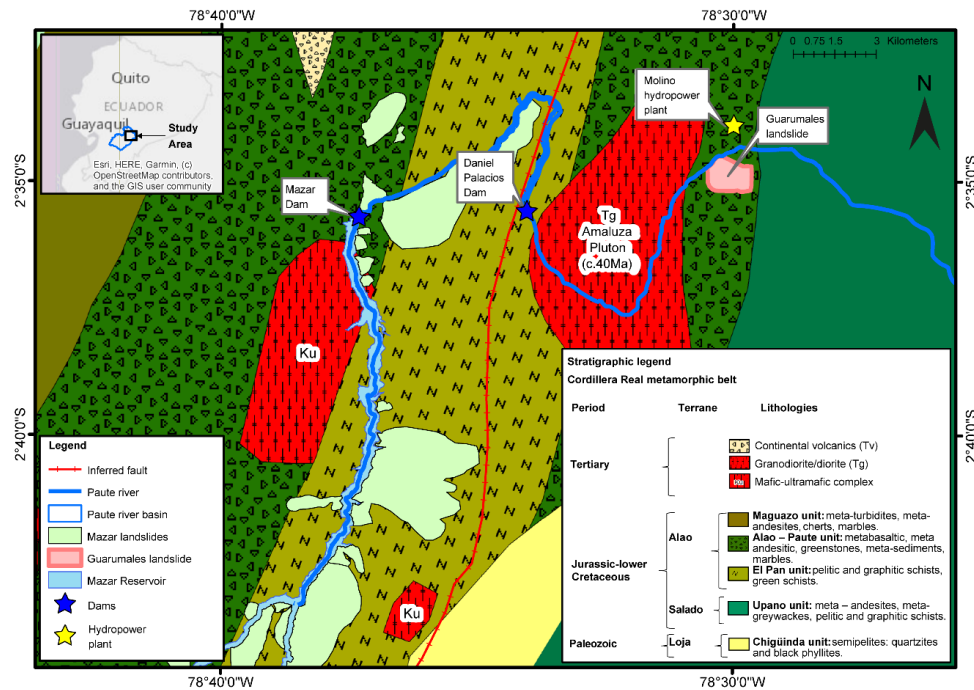
Figure A1. Geological map of the Paute Integral hydroelectric complex.

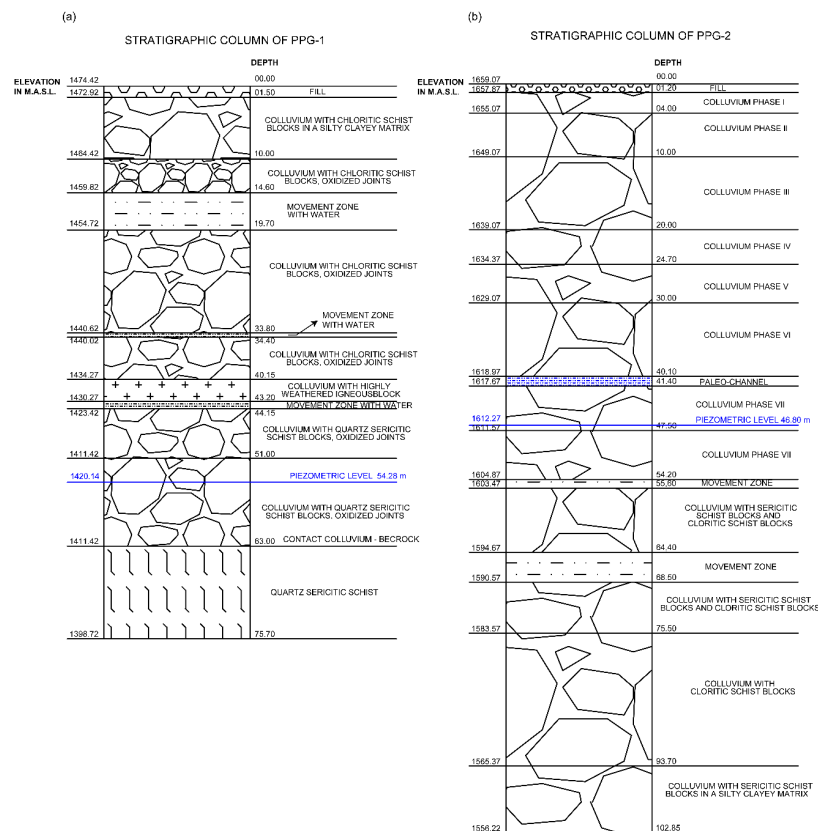
Figure A2. Stratigraphic columns for boreholes PPG-1 (a) and PPG-2 (b).

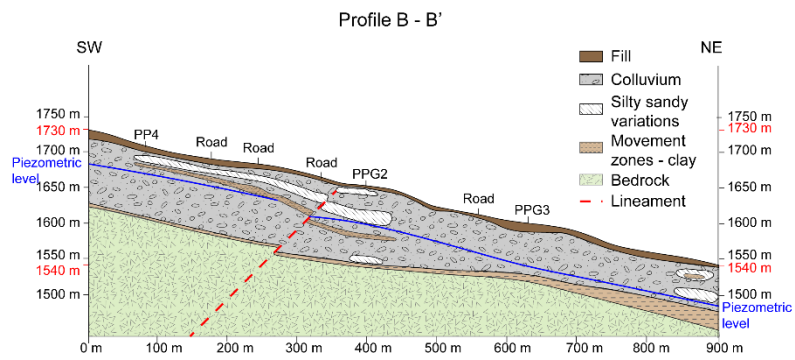
Figure A3. Stratigraphic profile B-B'.

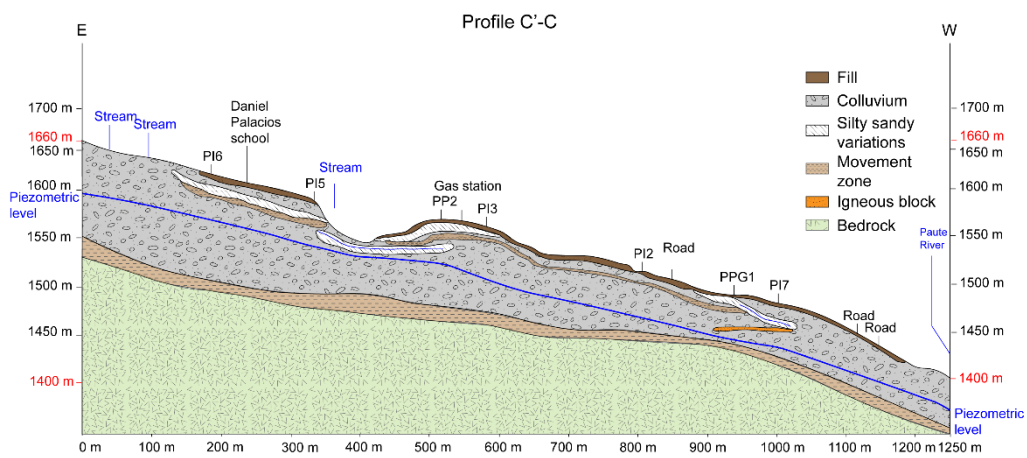
Figure A4. Stratigraphic profile C'-C'.

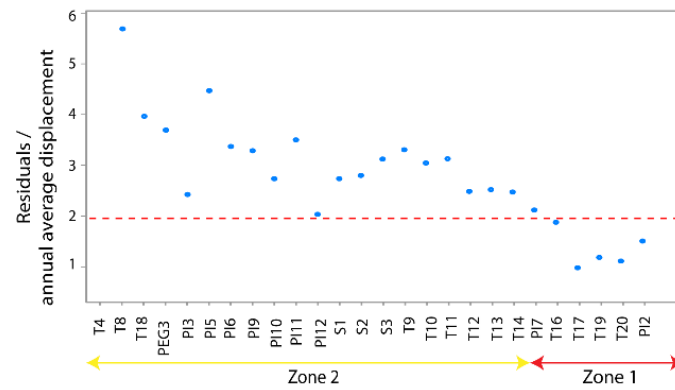
Figure A5. Residuals compared to the horizontal annual average displacement for the 26 geodetical observation points.

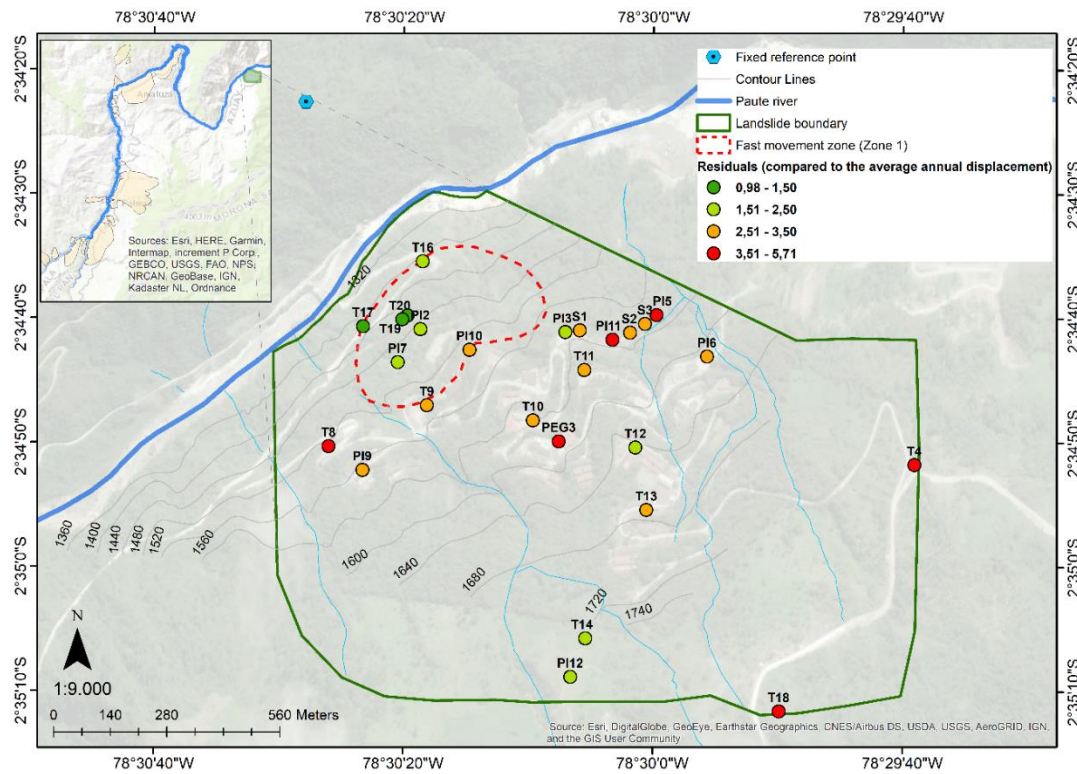
Figure A6. Plan view of the residuals compared to the annual average displacement in Guarumales.

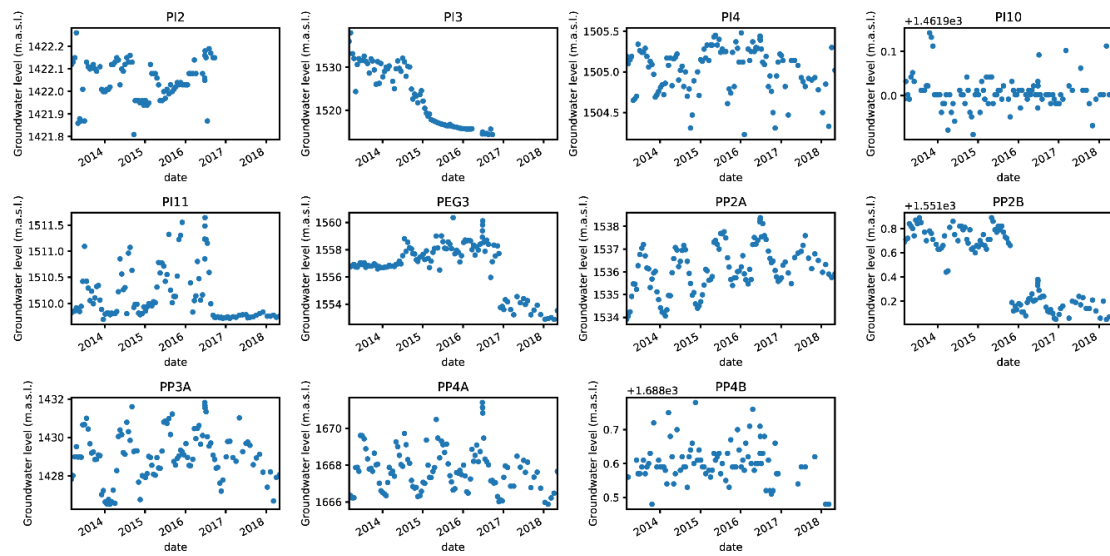
Figure A7. Time series plot of 11 groundwater observation points.

Of the 11 piezometers only 3 had meaningful results in the time series analysis. Out of the 11, 10 showed significant fluctuations; however, those could not be linked via the (simple) time series analysis to meteorological forcing. However, the fluctuations were in the same order of magnitude.

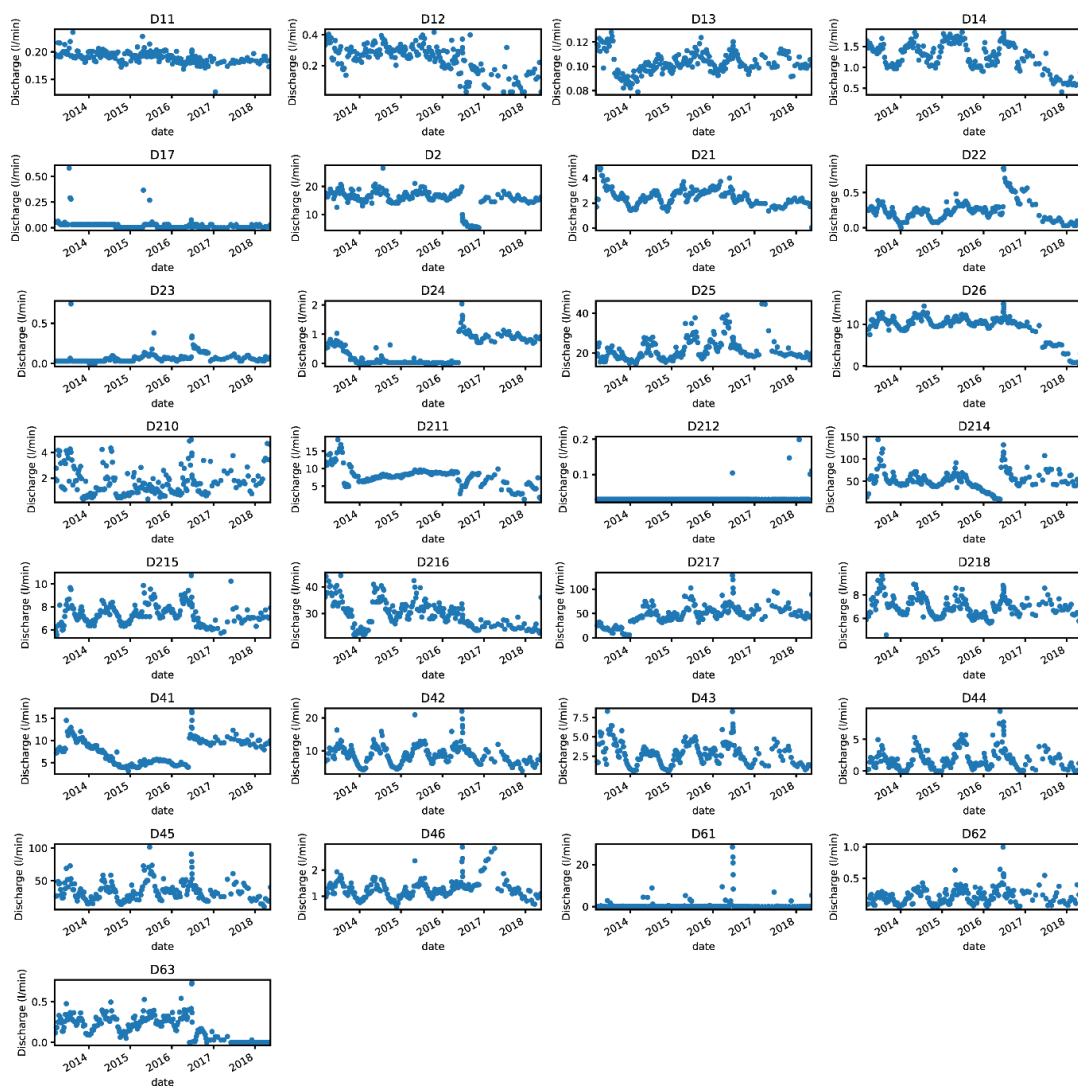
Figure A8. Time series plot of 29 monitored drains.

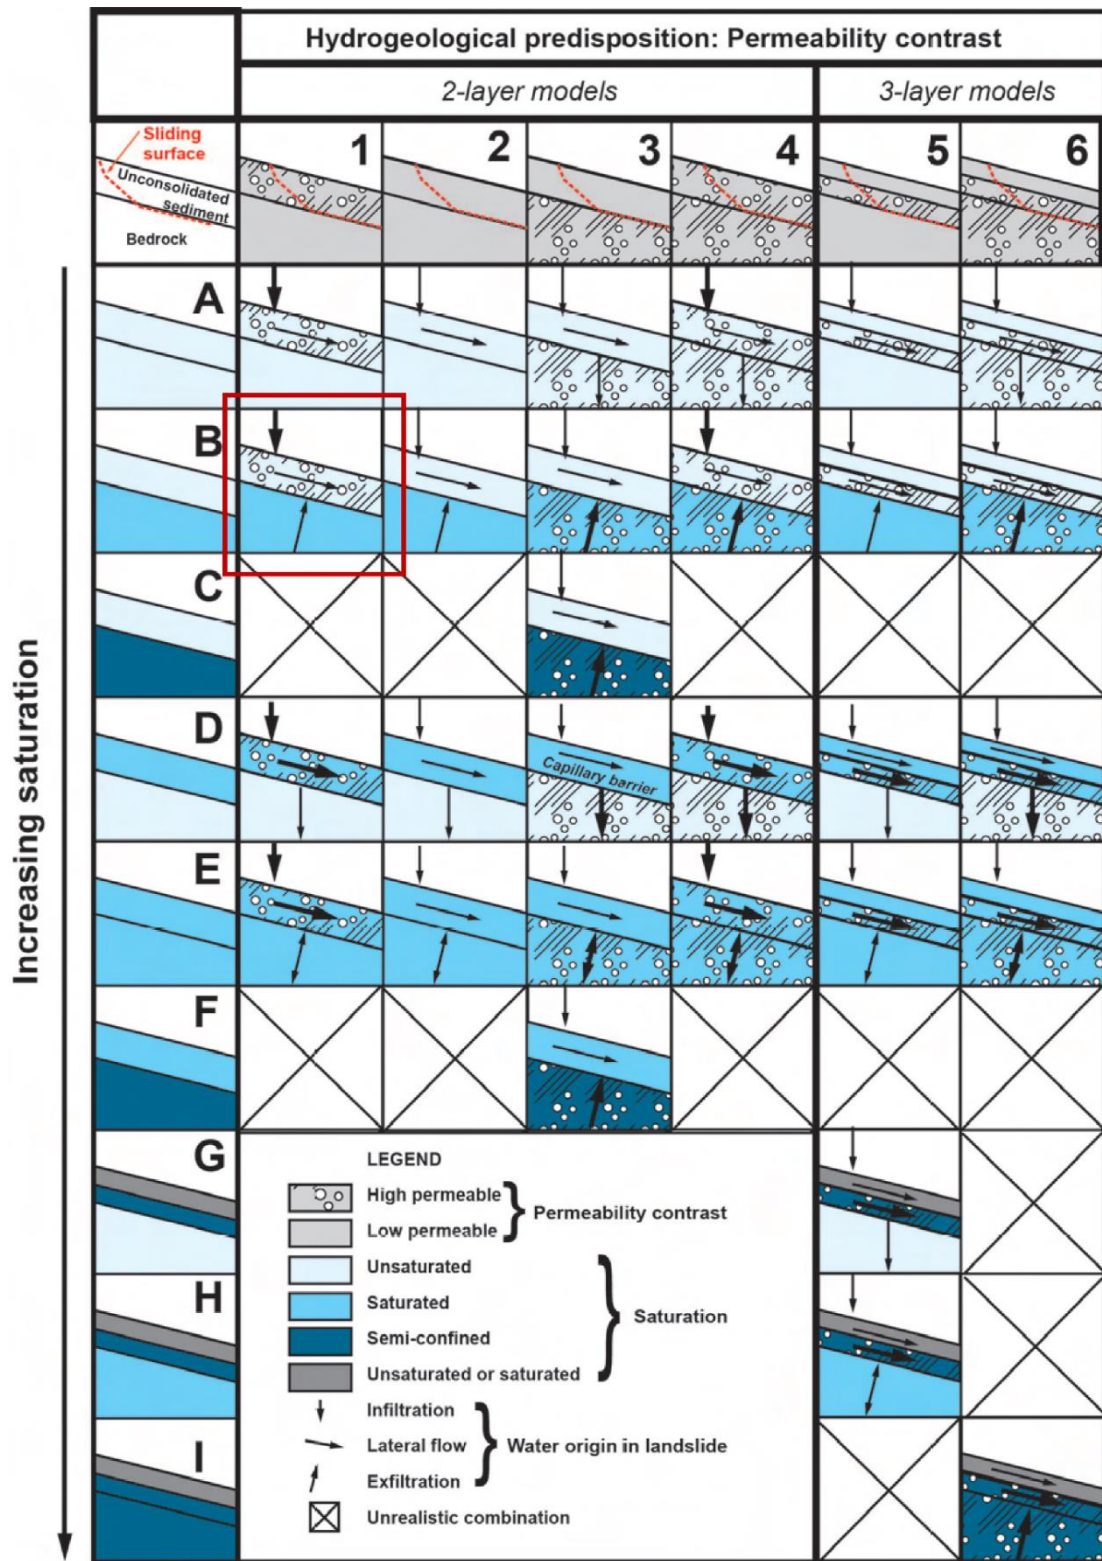
**Figure A9.** Hydrogeological classification for landslides, from Brönnimann [6]. Reproduced with permission from Laurent Tacher, Thesis: Effect of groundwater on landslide triggering; published by EPFL, 2011.

The Brönnimann classification system [6] was used to provide a conceptual assessment of the possible hydrogeological mechanisms influencing mass movement. This system uses the permeability contrast between slope layers (high and low permeable), and the degree of saturation of the layers (unsaturated, saturated, and confined). Figure A9 in Appendix A.6 shows all of the possible combinations of these two parameters. The interpretations that come from analyzing the rainfall, groundwater variations, and drain discharge were linked to the geology and the spatial distribution of the measured surface displacement of the site.
