## Revealing unique inscriptions of a Nazi collaborator in Doodencel 601 of the Oranjehotel

Wempe, Joost; van den Brink, Rick; Mooldijk, Esmée; Feirabend, Nienke; Wiersma, Ruben; Sietsma, Jilt; Dik, Joris

Heritage Science

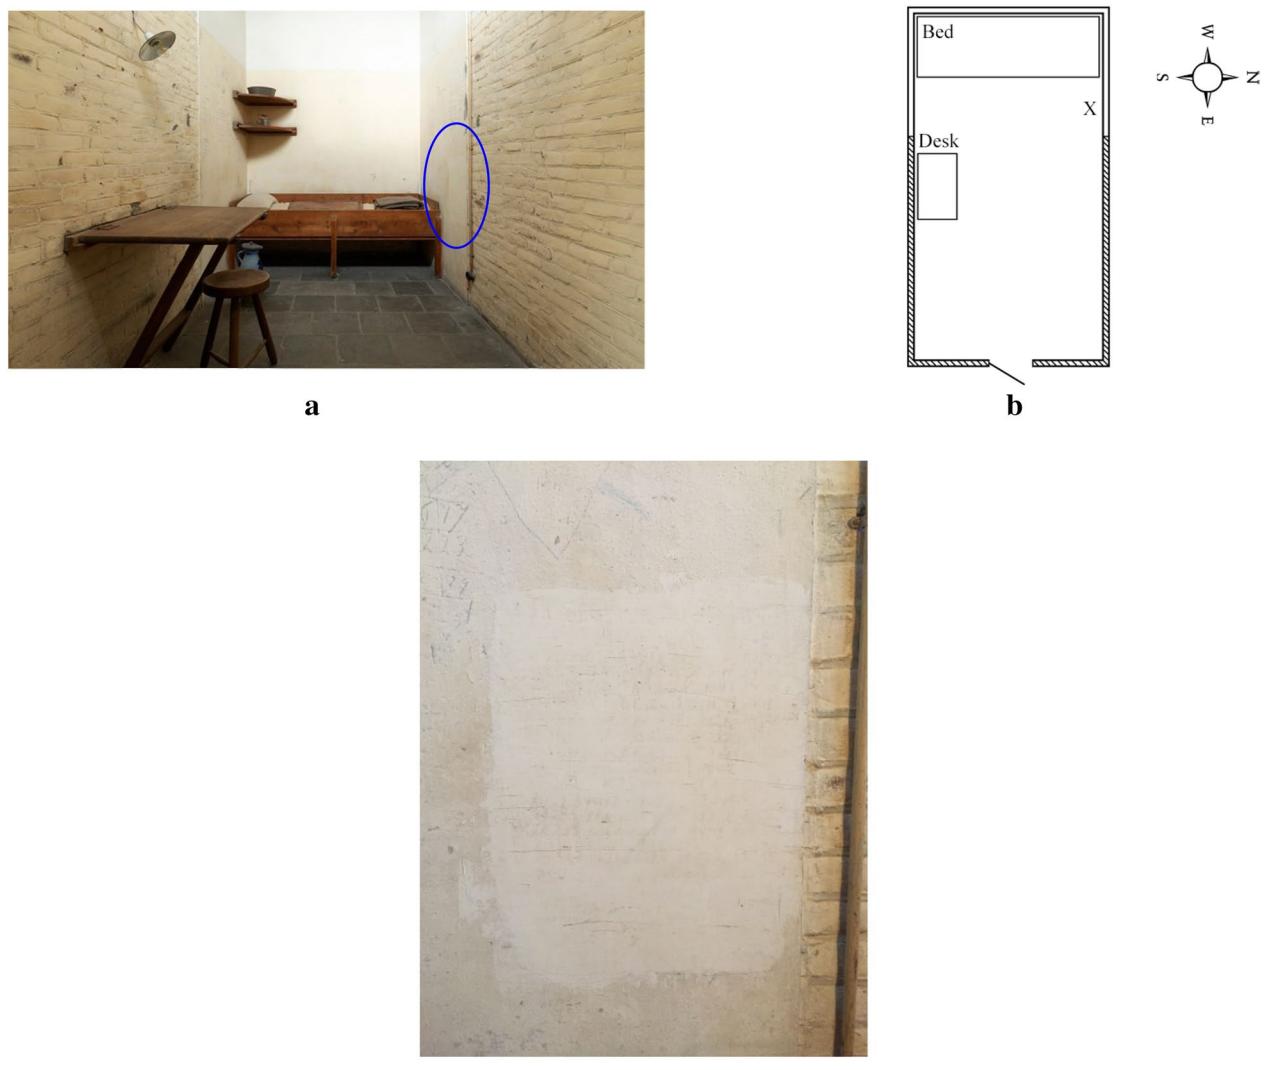
**Fig. 1** **a** Death cell 601 in the present state, preserving the wartime characteristics. The dimensions of the cell are approximately  $3.7 \text{ m} \times 1.9 \text{ m}$ . The post-war plastered section of the northern wall is indicated by the ellipse. **b** Floor plan of cell 601. The walls are built of brick, on the eastern part of the cell the bricks are painted in yellow (dashed) and in the western part of the cell a layer of mortar has been applied on the bricks. The X marks the location of the post-war plaster covering inscriptions in the wall. **c** Close-up of the  $45 \text{ cm} \times 60 \text{ cm}$  post-war plastered section of the northern wall

Visual inspection of cell 601 shows that the walls in the *Oranjehotel* were built using bricks (Fig. 1a). The cell

walls can be divided into two parts: the eastern part and the western part, the lower resp. upper part of Fig. 1b. In the eastern part of the cell the bricks have been painted yellow and in the western part the bricks have been covered with a white painted layer of mortar. The post-war plastered section containing inscriptions is located near the bed in the western part of the northern cell wall, marked by an ellipse in Fig. 1a and an X in Fig. 1b. It is shown in Fig. 1c. Visual inspection of this section makes clear that the plaster has dried into the inscriptions, leaving traces of the inscriptions visible in the plaster's surface topography. The traces are however not sufficiently deep and consistent to identify words or other meaning on visual inspection.

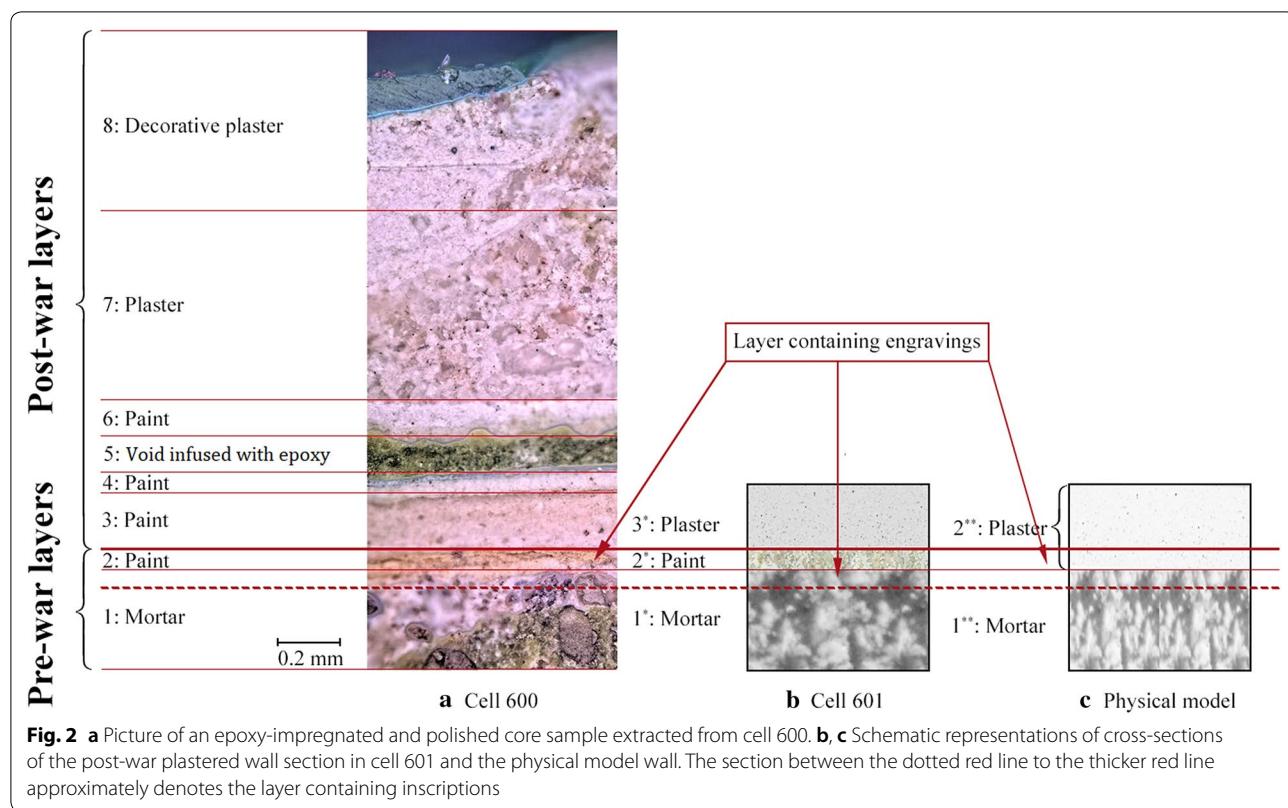
**Fig. 2** **a** Picture of an epoxy-impregnated and polished core sample extracted from cell 600. **b, c** Schematic representations of cross-sections of the post-war plastered wall section in cell 601 and the physical model wall. The section between the dotted red line to the thicker red line approximately denotes the layer containing inscriptions

After extraction, samples of the wall cores were impregnated in epoxy, cut vertically and polished. Figure 2a displays a picture taken with optical microscopy of the epoxy impregnated and polished core sample extracted from cell 600, the cell north of cell 601. In the eight layers visible in Fig. 2a, the layer of yellow paint (layer 2) is identified as the surface layer during the war. Later, paint layers 3 to 6 have been applied. The layer indicated as 5 was actually void before being infused with epoxy during sample preparation. Layers 7 and 8 are plaster layers. Figure 2b schematically shows the expected stratigraphy of the plastered section of the northern wall of cell 601: two layers that are identical or similar to the layers 1 and 2 of cell 600 plus the additional post-war plaster layer.

The analysis of the epoxy-impregnated core sample from cell 600 (Fig. 2a) has shown that the walls of the other cells have been plastered and painted several times since the war, consistent with [3]. The sample further contains a layer that absorbed epoxy during sample preparation (layer 5). Therefore, it can be expected to originally contain air bubbles. If present, this layer, in combination with the new layers of plaster and paint

covering the inscriptions, will be a strongly disturbing factor when analysing wartime inscriptions (layer 2 in Fig. 2a) using infrared thermography. Such studies, as well as more detailed studies of cell 601, can be optimised by using a more accurate procedure for heating and recording within the limitations posed by the monumental status of cell 601.

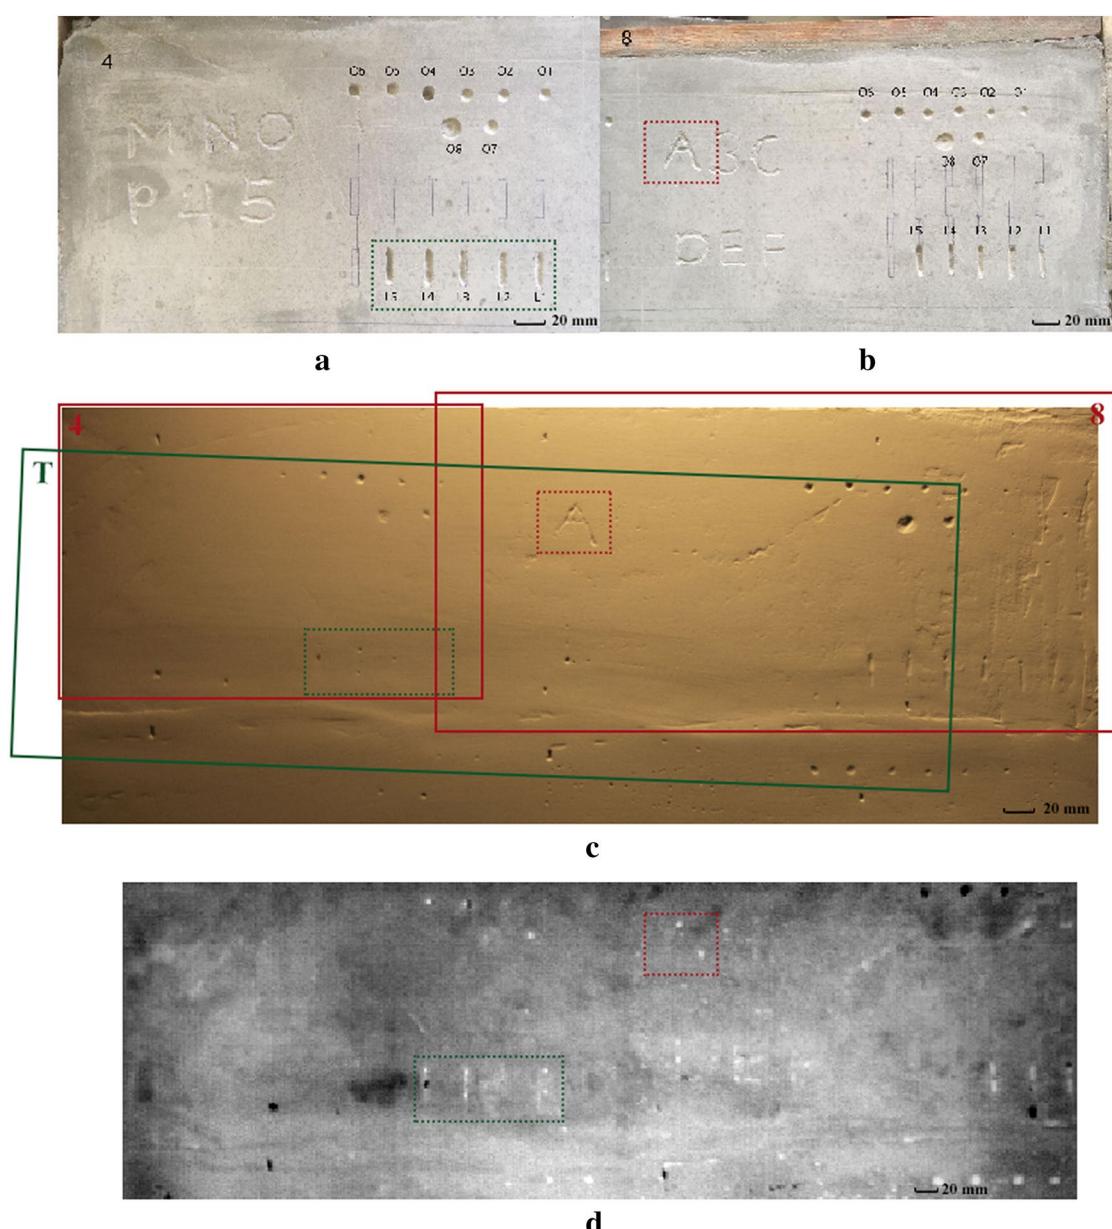
**Fig. 3** **a, b** Sections 4 and 8 of the physical model wall before plastering. **c** Raking-light photograph of the physical model in which the red rectangles labelled 4 and 8 represent the two sections shown in **a** and **b**. The green rectangle labeled T corresponds to the thermograph displayed in **d**. The dotted rectangles mark inscriptions. The inscriptions in the red rectangle are more clearly visualized in raking-light photography, the inscriptions in the green rectangle are more clearly visualized in thermography

This section describes the obtained results of the raking light photography and infrared thermography applied to the physical model wall. A selection of the obtained results is displayed in Fig. 3.

In this figure it is shown that some of the inscriptions are more clearly visible using the raking light method and others are more clearly visible by the application of thermography. One example of each of these cases is given in the figure by the red and green dotted rectangles. The red dotted rectangle contains an inscription of the letter A, see Fig. 3b. This letter can be seen clearly in the raking light photograph of the physical model wall, Fig. 3c, and less so in the thermograph, Fig. 3d. The green dotted rectangle contains five engraved vertical lines, see Fig. 3a. These lines can be seen more clearly in the thermograph than in the raking light photograph.

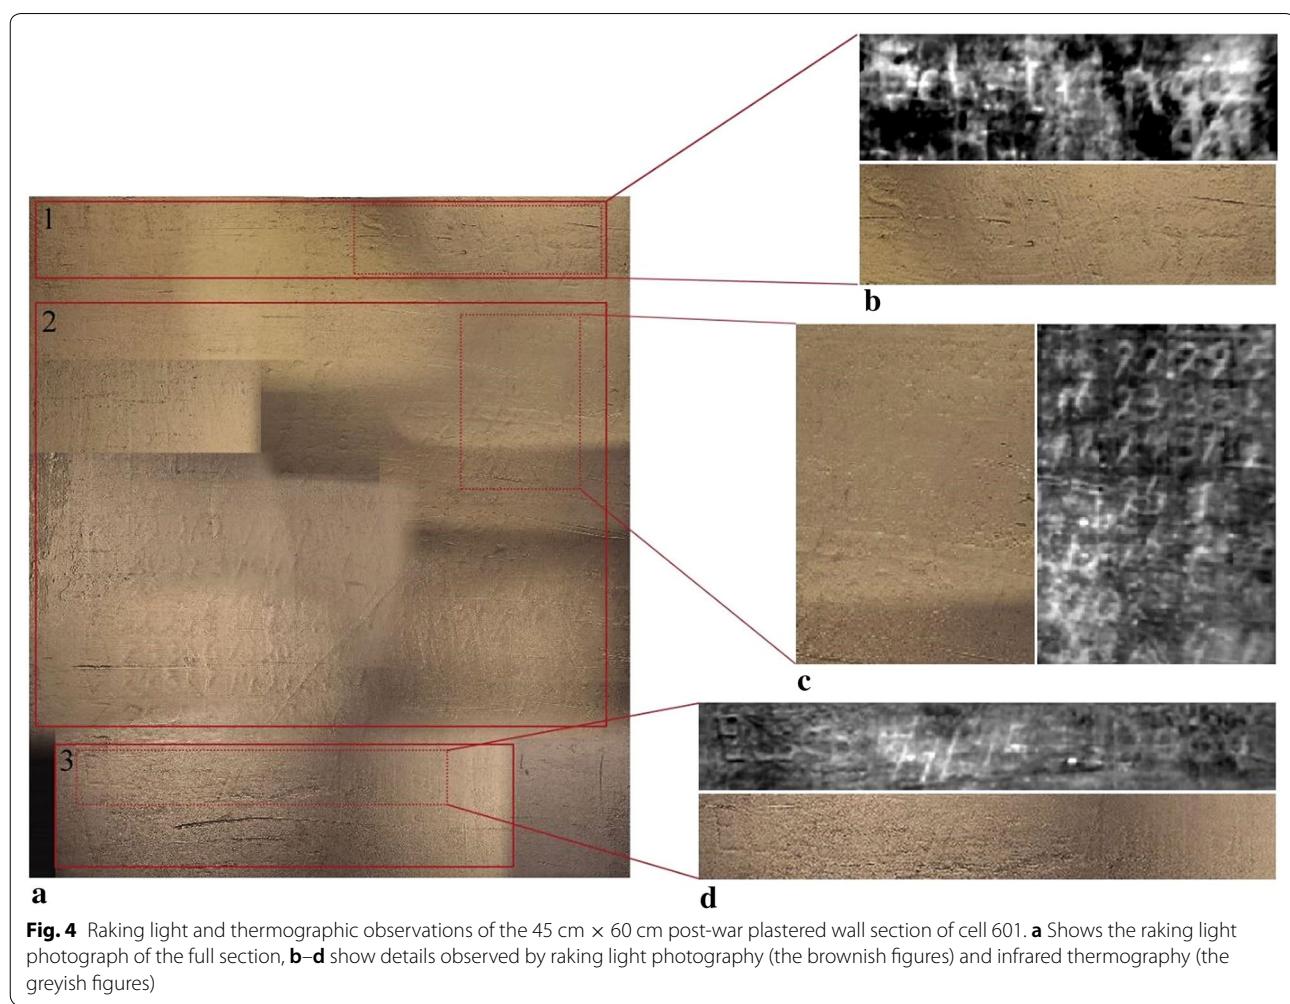
Figure 4 displays results obtained by raking light photography and infrared thermography on the post-war plastered wall section in cell 601. The raking light photograph consists of 24 pictures that were merged into a single picture using Adobe Photoshop CC 2019©. The same software was used to optimise the visibility of the

Three regions of the post-war plastered wall section will be discussed. Region 1 (the upper red rectangle in Fig. 4a) contains words. The raking light and thermography observations on the right-hand part of this region (the dotted rectangle in Fig. 4a) are shown in detail in Fig. 4b. The word "Scheltinga" can be read in this part. The whole region 1 contains the name *De Blocq van Scheltinga*. It is historically known that NSB member Daniël de Blocq van Scheltinga (1903–1962) was imprisoned in the Scheveningen prison right after the war [22].

The raking light and thermography observations on a part of region 2 (the middle red rectangle in Fig. 4a) are shown in detail in Fig. 4c. Region 2 contains an engraved calendar. Analysis of the day numbers and days of the week indicates that the calendar covers the period May 10–November 16, 1945.

Region 3 is indicated by the lower red rectangle in Fig. 4a and the dotted rectangle is shown in detail in Fig. 4d. In this part the word “Eisch” (Dutch for prosecutor’s claim) can be read, followed by an apparent date “..7/’45” and the word “Dood” (Dutch for death). However, a raking light photograph made in the preliminary study described in the Methods section shows the date to be “11/9/’45”, see Fig. 5 [16]. The characteristics of the “9” in this date agree with the “9” of the 29th of July in the calendar (see Fig. 4c). There is also a text inscription below the word *Eisch*, but of this inscription only the two letters “Vo” can be read. Possibly the full word is “Vonnis” (Dutch for verdict). The rest of the line cannot be read.

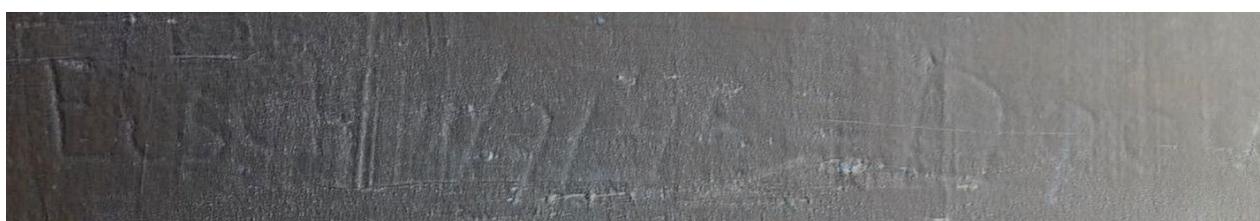
**Fig. 5** Raking light photograph made in a preliminary study of the detail shown in Fig. 4d). [16]

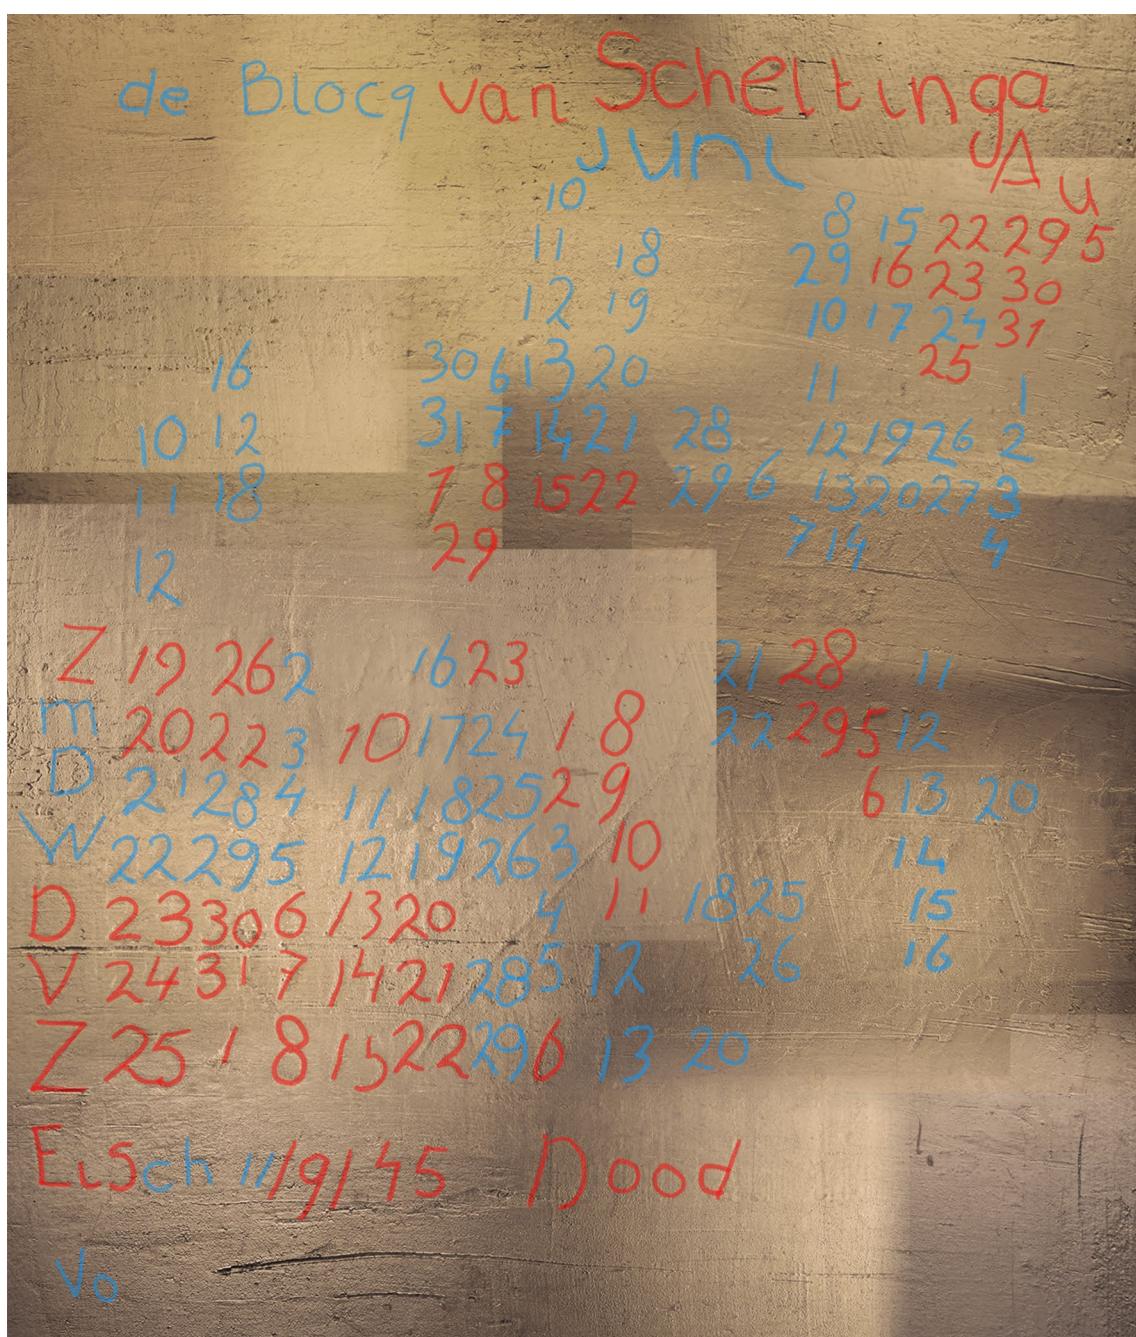
**Fig. 6** Composition of photographs made of the post-war plastered wall section in Doodencel 601. Inscriptions that are revealed by both raking light photography and infrared thermography are shown in red; inscriptions that are detected by infrared thermography only are shown in blue

A complete transcript of the texts that the authors, to the best of their ability, have distinguished in the analysed wall section is given in Fig. 6. Note that the vertical letter sequence Z–M–D–W–D–V–Z indicates the weekdays in Dutch, starting with Sunday.
