**Structural behaviour of a calcium silicate element masonry assemblage
Quasi-static cyclic pushover test**

<i>Project number</i>	C31B67
<i>File reference</i>	C31B67WP5-6
<i>Date</i>	23 November 2017
<i>Corresponding author</i>	Rita Esposito (r.esposito@tudelft.nl)

STRUCTURAL BEHAVIOUR OF A CALCIUM SILICATE ELEMENT MASONRY ASSEMBLAGE: QUASI-STATIC CYCLIC PUSHOVER TEST

INFLUENCE OF THE BEHAVIOUR OF CALCIUM SILICATE BRICK AND ELEMENT MASONRY ON THE LATERAL CAPACITY OF STRUCTURES

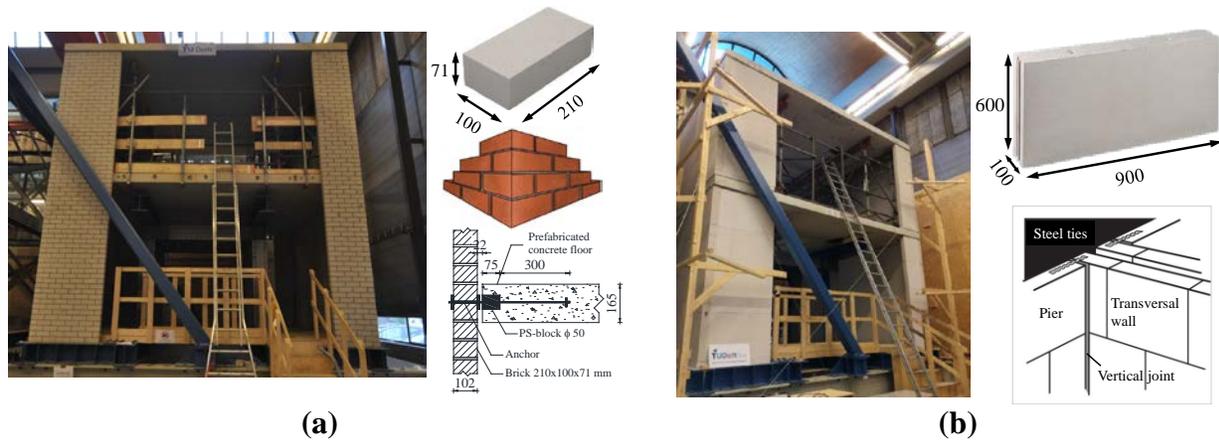
Figure 1: Specimens and main construction details: (a) CS brick masonry assemblage; (b) CS element masonry assemblage.

The CS brick masonry assemblage (Figure 1a) was tested as representative of terraced houses built in 1960-1980 in the northern part of the Netherlands. Small masonry unit having dimensions 210x71x100-mm were used. A running bond pattern was adopted allowing for the interlocking of the bricks at the corners of the transversal walls and the piers. At the first floor level, the floor was connected horizontally to the piers by anchors of 6 mm diameter, cast in the floor and masoned in the piers. The narrow piers were connected by three anchors, while the wide piers by five anchors. These anchors are commonly used as horizontal buckling or wind load support of the pier, and they are not designed to withstand any vertical load. At the second floor level, the floor was laid on both the loadbearing transversal walls and the piers.

The CS element masonry assemblage (Figure 1b) was tested as representative of terraced houses built in 1980-2000 in the northern part of the Netherlands. Large masonry unit having dimensions 897x643x100-mm were used for the facade piers, while unit having dimensions 897x643x120-mm were used for the transversal wall. The masonry was made in stretcher bond. In order to ensure verticality of the wall, a kicker layer made of small masonry unit was adopted at the bottom of the masonry walls both at the ground and first floor. The connection between the façade piers and the transversal wall consisted of a vertical joint; additionally steel ties were placed in the bed joint in correspondence of the vertical joint. Both at the first and second floor level, the floor slabs were laid on both the loadbearing transversal walls and the piers.

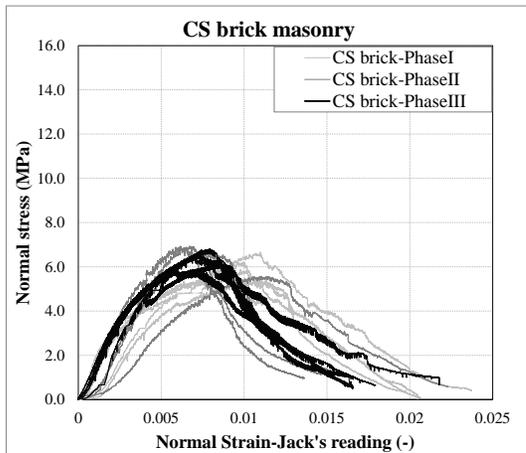
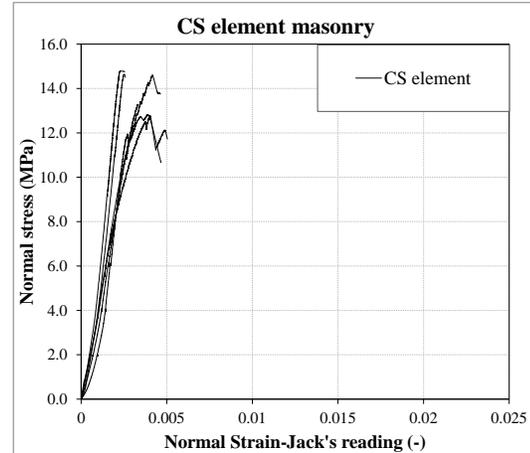
Figure 2: Stress-strain relationship in compression: (a) CS brick masonry; (b) CS element masonry.

The material properties of calcium silicate masonry were selected to represent Dutch masonry used in the construction of terraced house before and after 1980. The compression, bending and shear properties of both masonry specimens were investigated in dedicated experimental campaigns (Esposito et al. 2016, Jafari et al. 2017). The test were mainly performed by following the European standard EN 1052, however a displacement controlled procedure was adopted to obtain an indication of the post-peak behaviour. Table 1 lists the mean material properties for the CS brick and element masonry and their constituents. The CS element masonry showed a higher compressive strength and Young's modulus with respect to the CS brick masonry. In both cases, the pre-peak stage was characterised by linear-elastic followed by a hardening behaviour until the peak. After the maximum stress was reached, a softening behaviour was observed for the calcium silicate brick masonry, while a brittle failure was reported for the element masonry. Both the out-of-plane masonry flexural strength parallel to the bed joint and the initial shear strength resulted higher for the CS element masonry with respect to the CS brick masonry. Consequently the bond between masonry unit and mortar can be considered stronger in the case of CS element masonry.

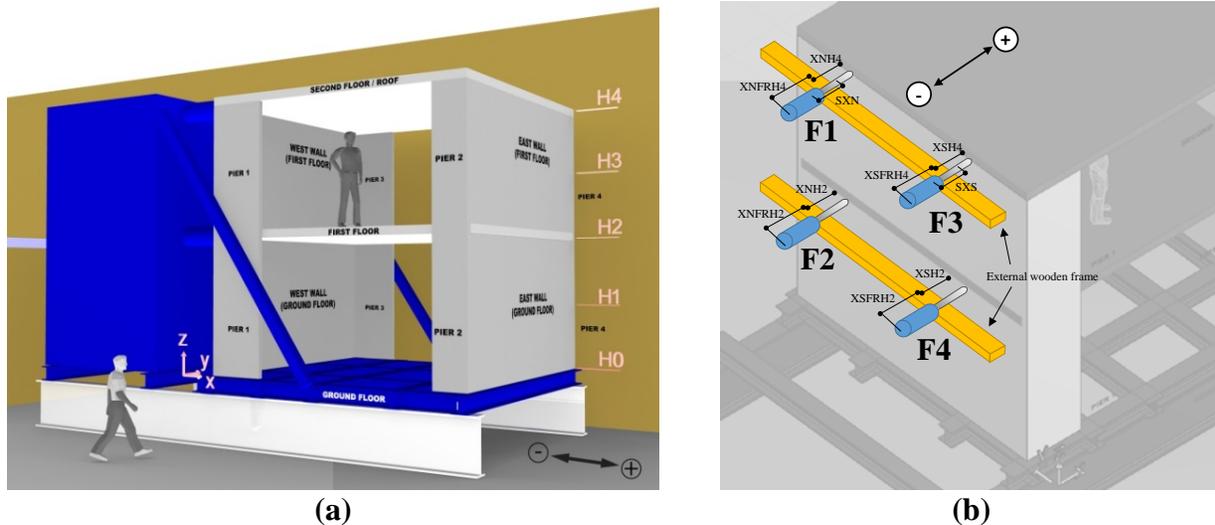
Figure 3: Test set-up

A quasi-static cyclic pushover test was performed on both assembled structures. The masonry structure was loaded by four actuators (Figure 3b), two per each floor, positioned at approximately 1.1 m inwards from the facades. A displacement was imposed at the second floor level, while a ratio 1:1 was maintained between the forces at the two floor levels ($F_1 + F_3 = F_2 + F_4$). To impose a constant ratio between the forces at the two floor levels, the forces in the actuators No. 1 and 3 at the second floor level were mechanically coupled to the forces at the first floor level ($F_1 = F_3$, $F_2 = F_4$).

The deformation of the specimen was measured in absolute sense from a stiff wooden frame, which was connected neither to the steel reaction frame nor to the foundation beams (Figure 3b). The displacements along the X-axis, at the point of application of the loading, have been measured with draw wires with length of 150 mm.

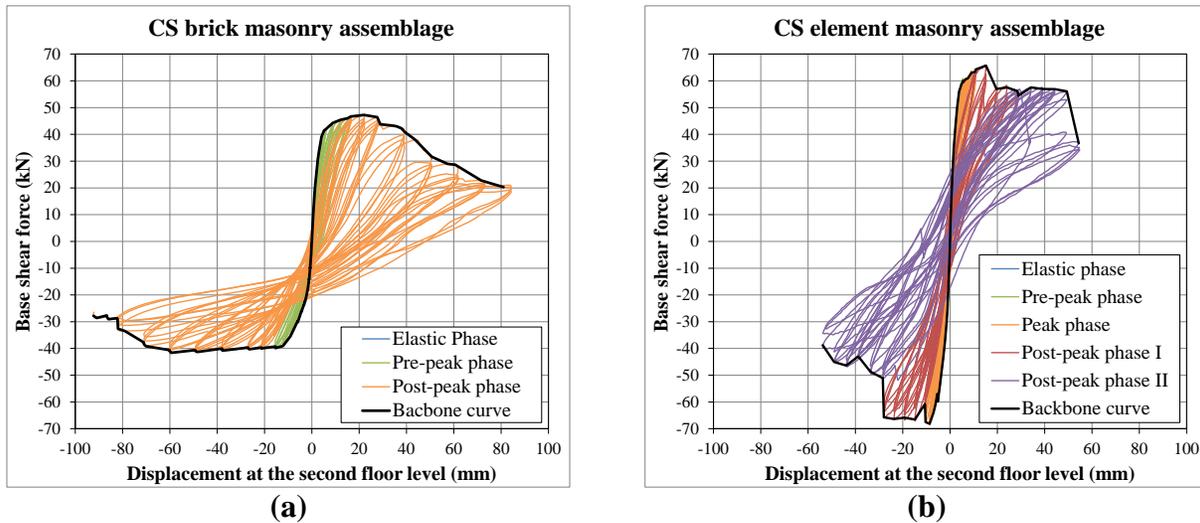
Figure 4: Capacity curve: (a) CS brick masonry; (b) CS element masonry.

Figure 4 shows the response of the CS brick and element masonry assemblages in terms of base shear force versus displacement at the second floor level d_2 . By comparing the two curves, it is possible to note that the CS brick masonry assemblage shows an higher displacement capacity, while the CS element masonry assemblage shows an higher maximum base shear force. In both cases a reduction of 20% in base shear force was achieved during the post-peak phase, but the test was continued until major damage (or even collapse) in the wide piers was observed. For the

CS brick masonry assemblage the 20% reduction in base shear force was obtained at a displacement of $d_2 = +43$ mm and $d_2 = -80$ mm, while for the CS element masonry assemblage it was reached at a displacement of $d_2 = -28$ mm and $d_2 = +50$ mm.

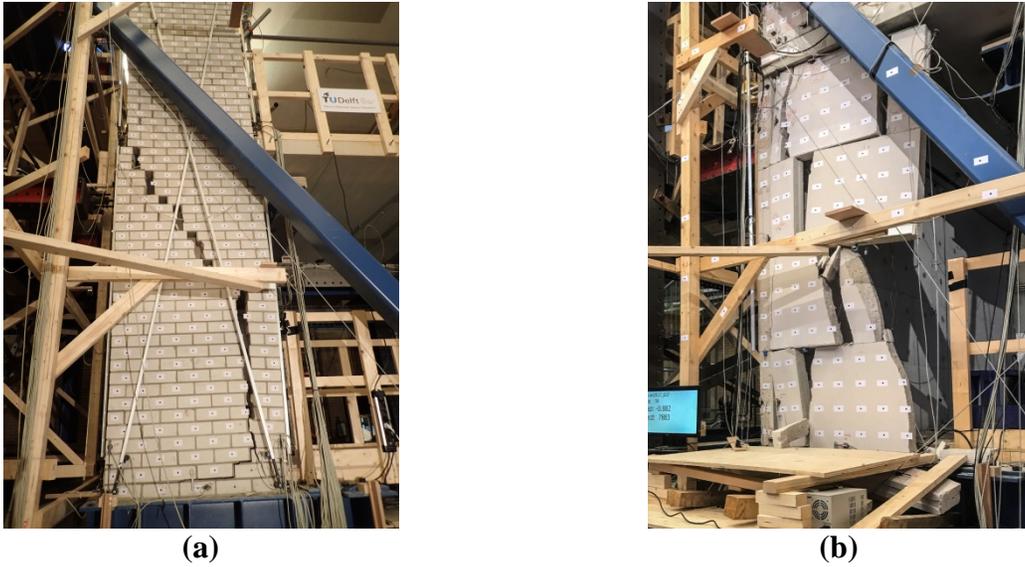
Figure 5: Main damage in the wide piers at the ground floor: (a) CS brick masonry assemblage ($d_2 = 82$ mm); (b) CS element masonry assemblage ($d_2 = 54$ mm).

In both cases, the failure mechanism was mainly governed by the in-plane damage of the facades piers at the ground floor (Figure 5, Figure 6). First, cracks occurred at the joint between the concrete floor and the masonry walls. Subsequently, diagonal/vertical cracks occurred in the wide pier P1 and P3 at the ground floor, while the rest of the structure was only slightly damaged. During the post-peak phase and prior to major damage in the narrow piers, the wide piers were subject also to a reduction in cross section that led to a further reduction in capacity. Both for the brick and element masonry the diagonal/vertical cracking occurred first in the head and bed joints. However, in the case of the CS element masonry assemblage, large out-of-plane deformation up to collapse of the piers occurred; this is caused by the large size of the masonry units.

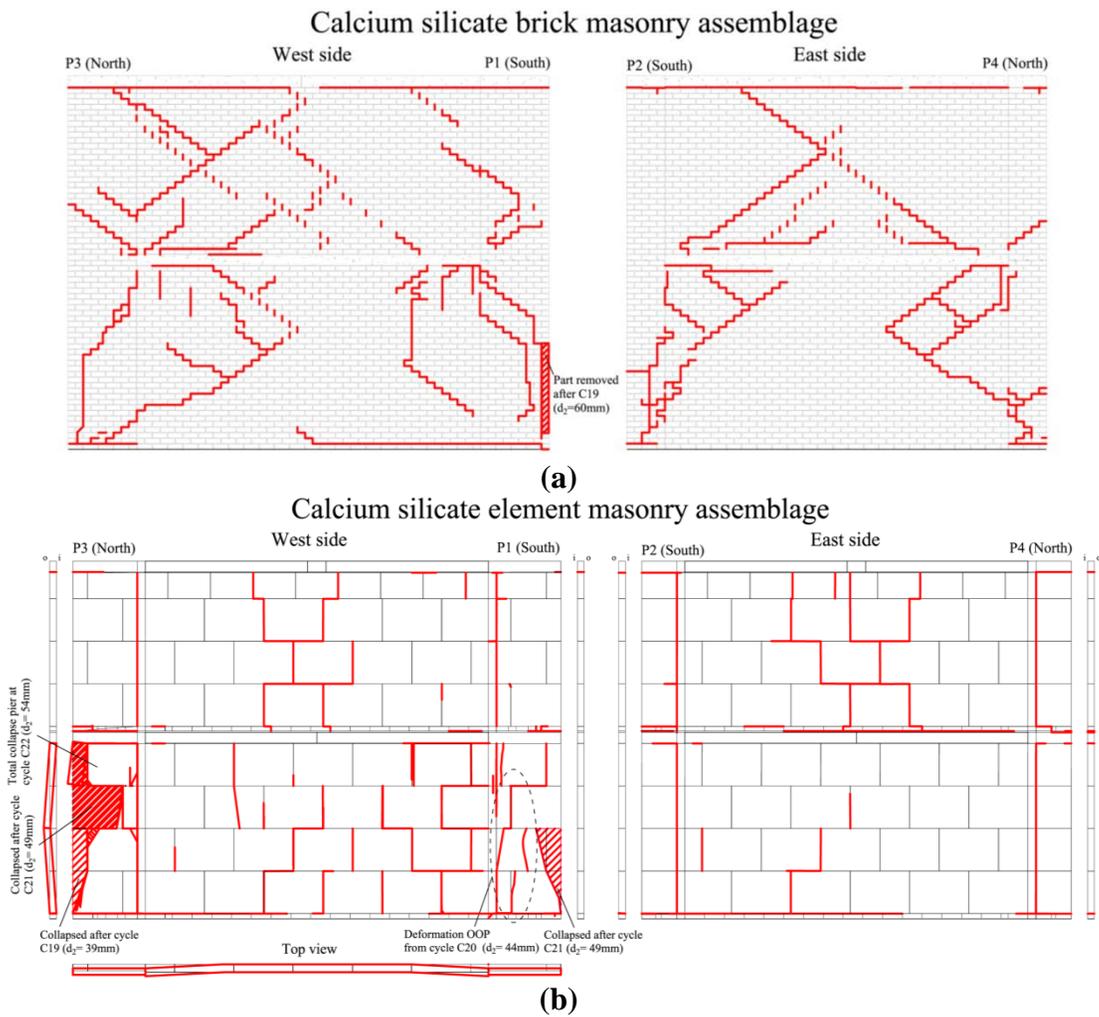
Figure 6: Crack pattern: (a) CS brick masonry; (b) CS element masonry.

By accommodating the in-plane deformation of the piers, the transversal walls deformed out-of-plane showing the effectiveness wall-to-wall connection in both cases. In the case of the CS brick masonry assemblage the running bond allowed a strong connection between the piers and the transversal walls and promoted the flange effect, which is of importance for the base shear capacity (Esposito et al., 2017a). In the case of the CS element masonry assemblage, although cracking occurred in correspondence of the vertical joints at approximately the peak load, the connection was still effective. This was caused by the presence of the steel ties and by the sliding friction mechanism at the vertical joint governed by the high friction coefficient of the CS element masonry. Additionally, the extensive damage of the pier and the detachment of masonry pieces that interlocked within the open cracked promoted local deformation at the end of the transversal wall for a length of approximately 1 m from each wide pier (Figure 6b).

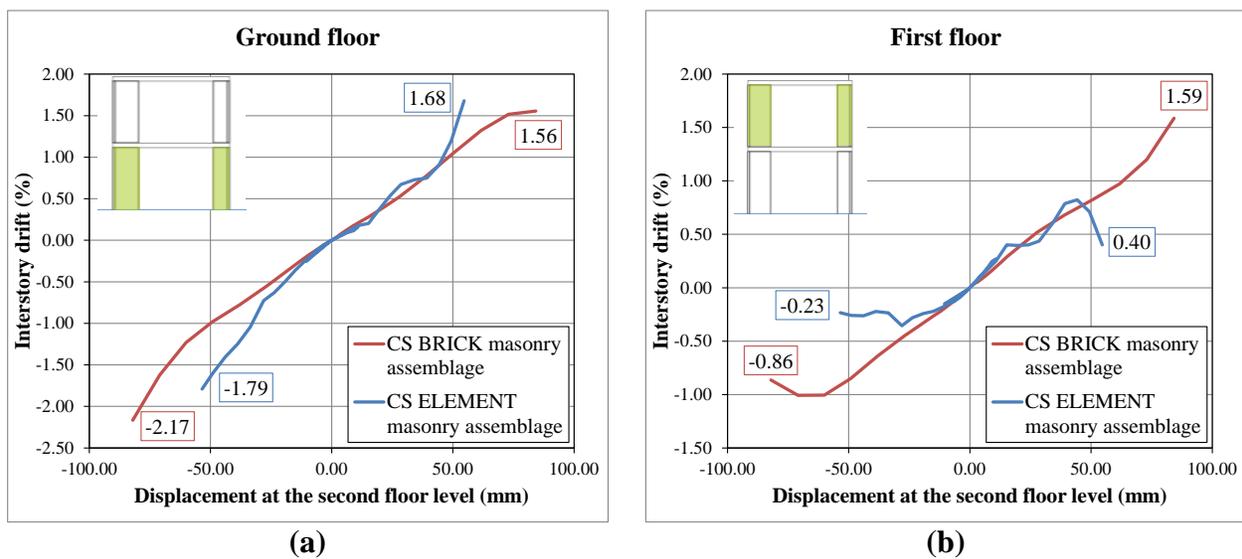
Figure 7: Comparison in terms of interstory drift: (a) Ground floor; (b) First floor.

Figure 7 shows the behaviour of the structure in terms of interstory drifts as a function of the displacement at the second floor level. They are calculated as the ratio between the relative floor displacement and the interstory height, which is 2.7 and 2.6 m for the first and second floor level, respectively. Although the CS brick masonry assemblage reached larger displacement at the second floor level (82 mm in comparison with the 54 mm of the CS element masonry assemblage), the two structures showed a similar interstory drift for the ground floor varying between 1.6% and 2.2%. A substantial different behaviour is observed at the first floor, where at the onset of damage of the wide pier the CS element masonry assemblage showed a nearly constant drift. This difference can be caused by the different load redistribution on the piers at the level of the first floor slab, which is consequence of the different construction detail. In the case of the CS brick masonry assemblage the piers are only horizontally connected to the floor by anchors, while for the CS element masonry assemblage the floor laid on top of the piers. Although in both cases the piers do not bear the floor in the undamaged configuration, for relative large displacement the load transferred by the first floor slab is directly redistributed to the piers in the case of the CS element masonry assemblage, while it is indirectly transferred via the transversal walls in the case of the CS brick masonry assemblage. Consequently, in the former case a concentration of displacement is observed at the ground floor leading to a soft-story mechanism.
