Monitoring Shear Behavior of Prestressed Concrete Bridge Girders Using Acoustic Emission and Digital Image Correlation

Keywords: acoustic emission measurements; crack identification; cracking; digital image correlation; prestressed concrete bridge girders; shear

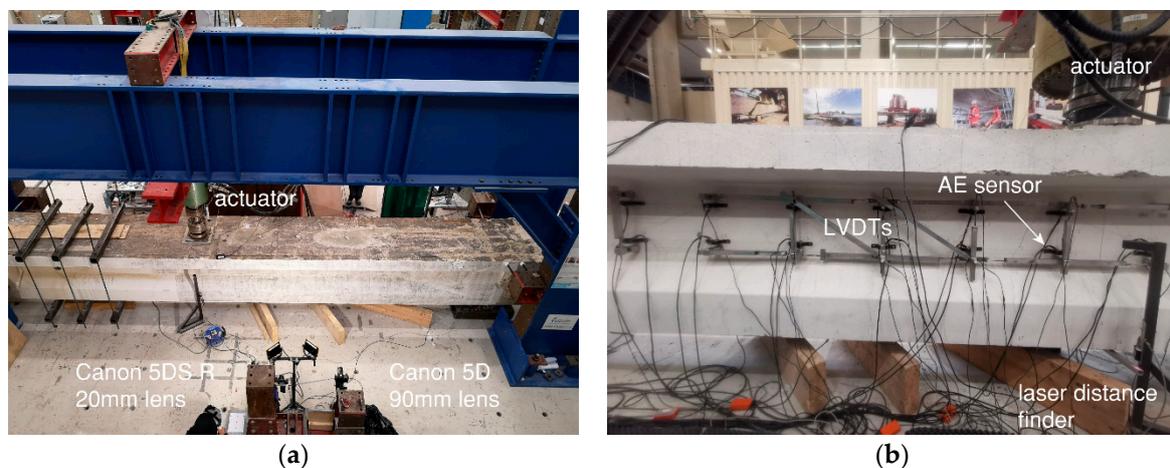
Figure 1a shows an overview of the test setup, including the girder, the steel frame used for applying the loading, one of the supports, and the actuator. The girders were simply supported with a span of 9.6 m. A single concentrated load was applied through a loading plate of 300 mm × 300 mm. The center of the load was at 2903 mm from the center of the support in HPZ01 and HPZ02, and at 4400 mm in HPZ03 and HPZ04. The purpose was to investigate the influence of load position on shear capacity. Detailed analysis can be found in a companion paper [4]. To avoid failure on the unwanted side, slipping of the prestressing strands and a possible spalling failure during the test, vertical prestressing was applied near the other support.

Figure 1. Overview of test setup: (a) At DIC side, and (b) at sensor side.

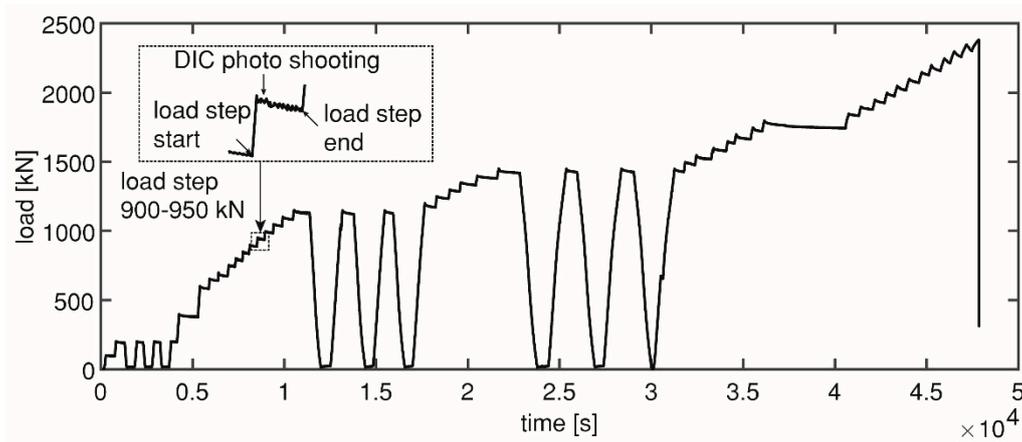
The load was applied in cycles of loading and unloading to predefined load levels, instead of monotonically to failure (Figure 2). For each beam, four load levels were chosen based on the expected structural responses during the test. At the first load level, no cracks occurred. By the second load level, a first flexural crack was expected. By the third load level shear cracks were expected. After the fourth load level, the specimen failed. The first three load levels are composed of three load cycles each. Small load steps of 50 kN were taken when loading to the load level for the first time. With these load cycles, crack opening and closing can be followed.

Figure 2. Loading history of HPZ04.

Local cumulative AE events within each load step was calculated. The start and end point of each load step are marked in Figure 2. In this way, we can track the change of local cumulative AE events with increasing load. As the number of AE events is related to the cracking activities [34], the change of local cumulative AE events was expected to indicate the local crack development.

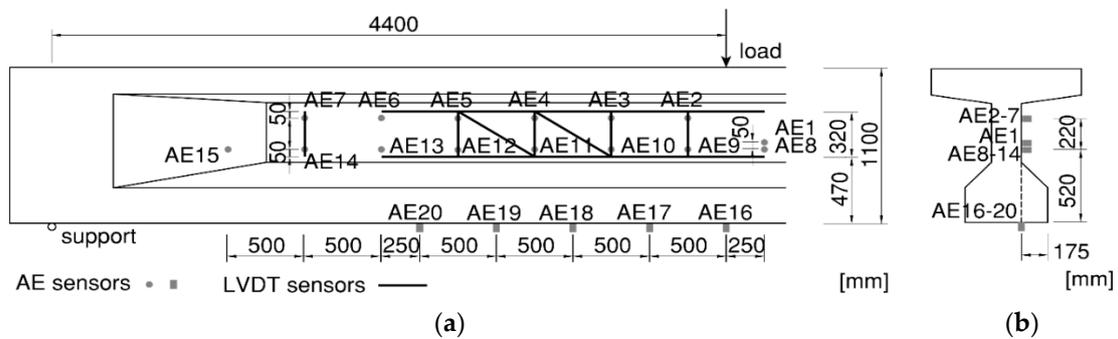
In each experiment, similar sensor layout was used to cover the interesting measuring area. Figure 3 shows the sensor layout as used for HPZ04, including LVDTs and the AE sensors which are discussed in the next section. The other face of the girder was used for the DIC measurements, as also shown in Figure 1a.

Figure 3. Sensor plan for beam HPZ04 showing LVDTs and AE sensors: (a) Side view; (b) cross-section.

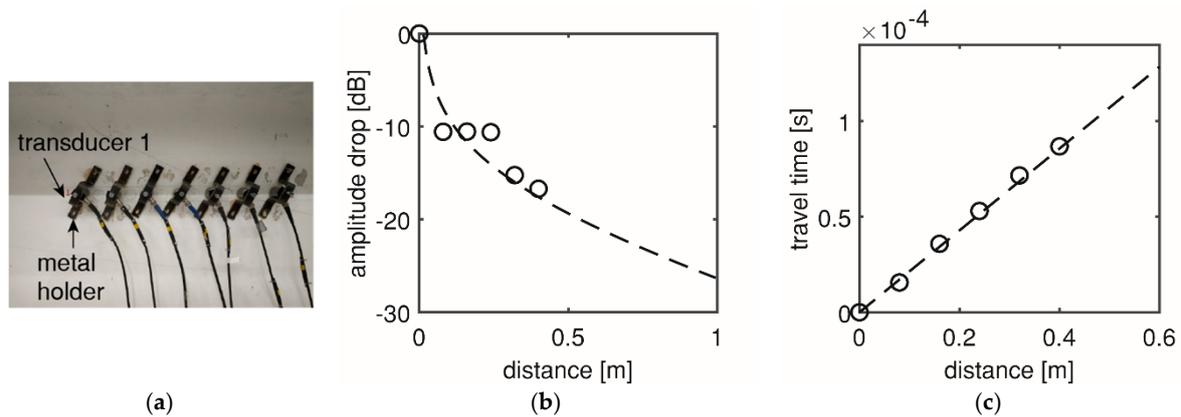
In this paper, AE sensors were installed on the same side as the LVDTs in the web and on the bottom surface. The sensors were resonant type sensors with center frequencies of 60 kHz, i.e., R6I, from MISTRAS Group, Inc. [26]. They were coupled with the concrete surface using electricity compound, and fixed by metal holders, shown in Figure 4a. The sensors on the bottom surface were installed 175 mm inside from the outer edge of the bottom flange, and on the same vertical 2D plane as other sensors in the web (see Figure 3). The area enclosed by AE sensors was referred to as the measuring area, which may vary slightly in the four experiments.

Figure 4. Baseline measurement in HPZ03: (a) Setup, (b) amplitude drop, and (c) wave speed.

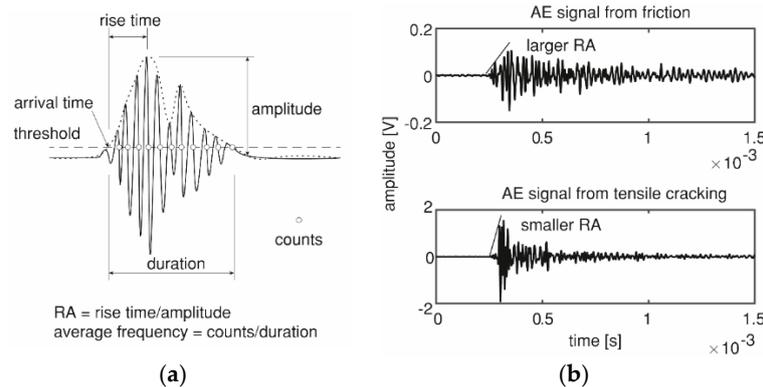
Figure 5. (a) Illustration of AE parameters and (b) AE signals from friction and tensile cracking. Based on the recorded signal arrival times, grid search method was used to estimate the source location [33]. The grid point, of which the calculated arrival times at the sensors were best matched with the recorded arrival times, was determined as the source location [7]. In this paper, the measuring area was discretized into a grid with size 5×5 mm. The mathematical formulation used in source localization can be found in our previous paper [6].

Based on the features of the received signals, one can classify the source types into tensile cracking and friction [8]. Four parameters derived from the signal are relevant: rise time, amplitude, counts, and duration, as defined in Figure 5a. Based on these four parameters, two widely-applied features in source classification are RA value, which is the ratio of rise time and amplitude, and average frequency,

which is the ratio of counts and duration [8]. Generally, signals from tensile cracking have a larger average frequency and a smaller RA value than those from friction [9,10]. These features were observed from two typical signals in our tests (Figure 5b). The counts are not marked in the typical signals because of their large number.

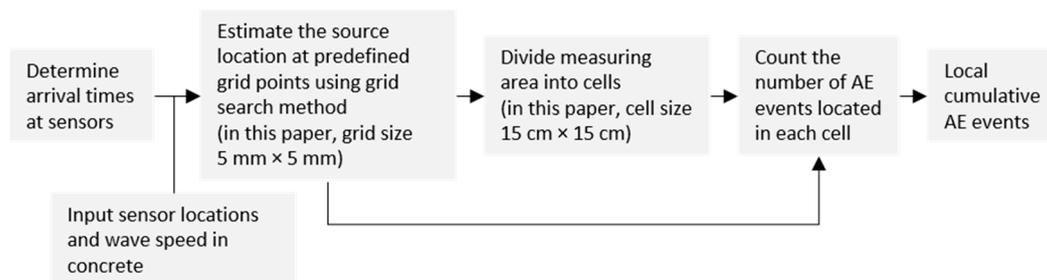
To quantify the spatial distribution of the located AE events, we divided the measuring area into cells, and counted the number of AE events located in each cell, which was referred to as local cumulative AE events. This approach has been described in detail in [29]. The cell dimension is limited by the source localization error, and was taken as 15×15 cm in this paper. The approach of calculating the local cumulative AE events is illustrated in Figure 6.

Figure 6. Approach of calculating local cumulative AE events.

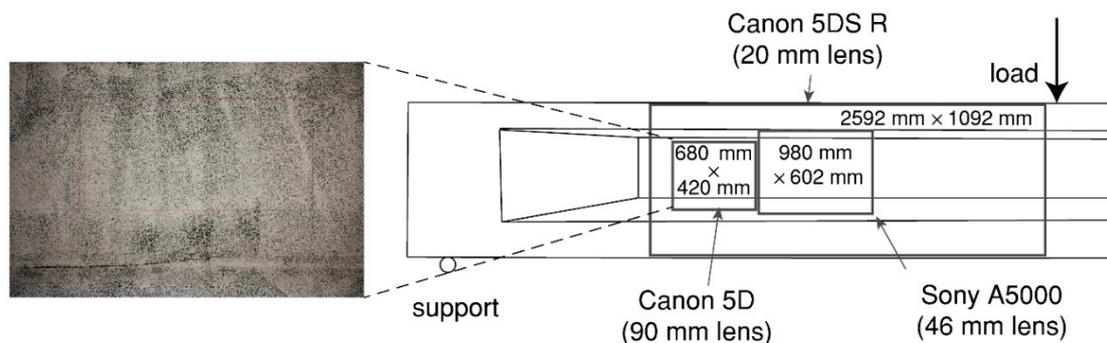
At each load step, photos were taken of the DIC side. Figure 2 shows an example of one load step. For the four girders, a Canon 5DS R camera with 50.6 Megapixels resolution and a wide-angle lens (20 mm F1.4 fixed focus lens) were used on one side of the girder to capture the deformation in the web of the shear span. For HPZ02, HPZ03, and HPZ04, two extra cameras were used to capture the development of shear cracks in the web: a Canon 5D with 21 Megapixels with a macro lens (90 mm F/2.8 fixed focus lens) and a Sony A5000 (16–50 mm zoom lens at focal length of 46 mm) with 19.8 Megapixels. The camera-specimen distance for the Canon 5DS R was fixed to cover an area of 2590×1092 mm with a resulting pixel size equal to 0.31 mm. The Sony A5000 covered an area in the web equal to 980×602 mm with a pixel size of 0.19 mm. The measuring area of the Canon 5D was of 680×420 mm and the resulting pixel size was 0.13 mm. A scheme of the DIC setup with the areas of interest is shown in Figure 7.

Figure 7. DIC setup for beam HZP04 showing the random pattern, and the position of the 20 mm wide angle lens, the 90 mm lens and the SONY A5000 camera.

In these experiments, a random speckle pattern was applied by a paint roller. The size of the speckles varied from 1 to 2 mm. DIC uses the random patterns to track and match subsets between two digital images [35]. Two LED (light-emitting diode) lights were used to provide constant illumination during the tests.

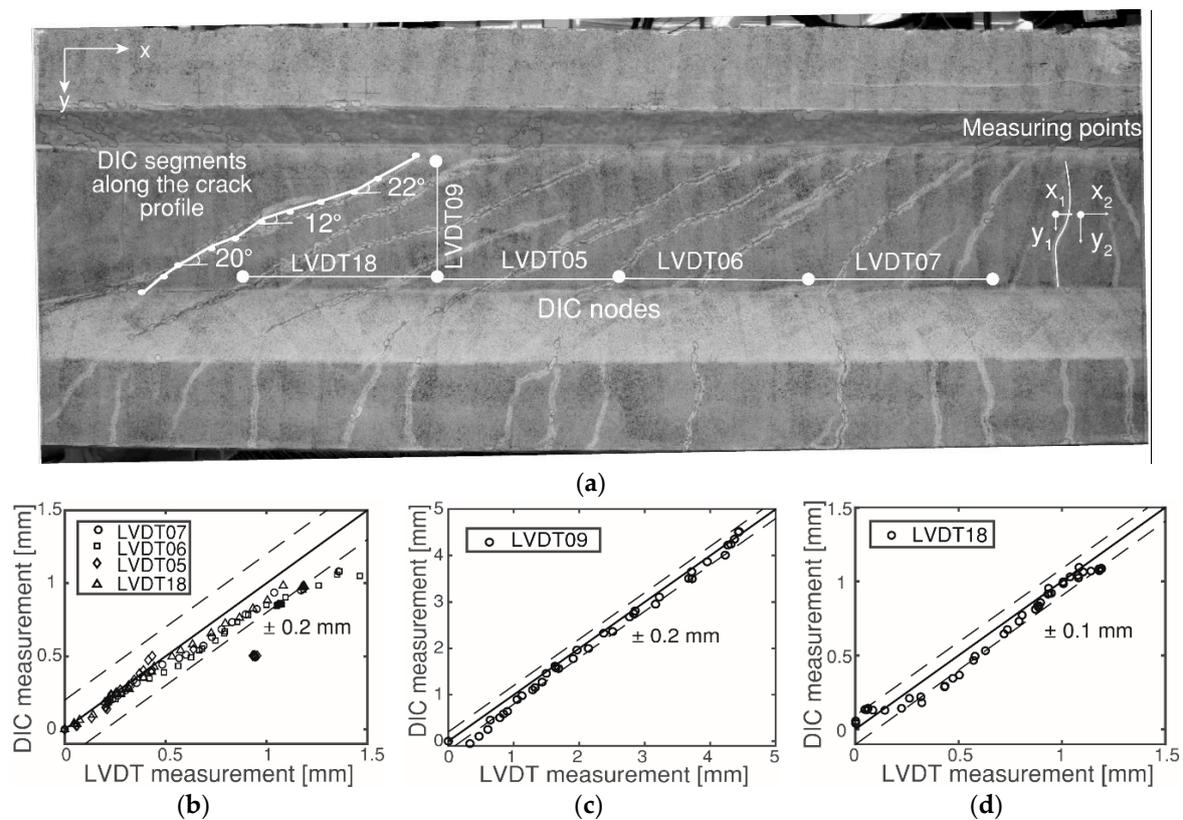
First, the accuracy of the displacement measurement from the DIC analysis was evaluated with the LVDT readings. The wide-angle lens distortion was corrected following the procedure described in [37]. The locations of the mounting nodes of LVDT 5, LVDT 6, LVDT 7, LVDT 9 and LVDT18 were determined on the DIC side. Figure 8a shows the location of the nodes on HPZ04. At these locations, the relative displacement differences in the horizontal or vertical direction of the nodes were compared with the measurements of the LVDTs. The comparisons between the DIC and LVDT measurements are given in Figure 8b,d. This figure shows that the difference between the two methods is within 0.2 mm and 0.1 mm depending on the resolution of the camera and the lens. Considering that the crack pattern and the displacement field were not completely equal for both sides of the specimen, the difference was acceptable. Similar results were found for the remaining girders in the experimental program. In general, the accuracy of DIC is dependent on the quality of the pattern, the subset size, the resolution of the camera and the lens [38,39].

Figure 8. Calibration of DIC with LVDT in HPZ04: (a) location of DIC nodes and LVDTs 05–07, LVDT09, and LVDT18, together with the segmental division in one crack; (b) LVDTs 05–07 and LVDT18 measurements and DIC with Canon 5DS R (20 mm lens); (c) LVDT09 measurement and DIC with Sony A5000; and (d) LVDT18 measurement and DIC with Canon 5D (90 mm lens).

The cracks obtained from the strain distribution were manually approximated to ten linear segments, from which the crack angles were calculated as shown in Figure 8a. The simplified crack pattern and crack angle were used for further analysis.

For each crack, two measuring points on both sides of the crack profile were determined. The displacement difference in the x -direction was defined as W (crack opening in the longitudinal direction), and the displacement difference in the y -direction was defined as Δ (crack opening in the transverse direction). An example of the measuring points is given in Figure 8a as x_i and y_i .

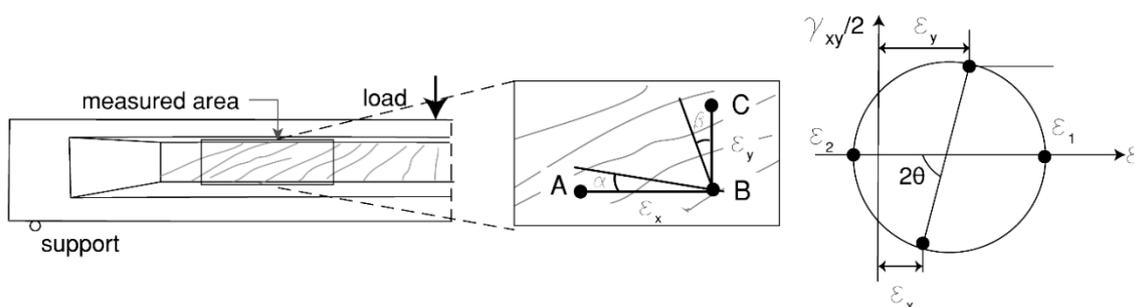
Figure 9. Scheme of measured area for HPZ04 and Mohr's circle for average strains.

An algorithm was developed to select the area of interest and to calculate the average strains (ε_x , ε_y , and γ_{xy}) from the displacement measurements of the DIC results. The normal strain in the y -direction (ε_y) was calculated from the average displacements along the vertical line \overline{BC} removing the outliers. For the normal strain in the x -direction (ε_x), a linear strain distribution was assumed along the height direction with the strain at the top side of the web being zero. When AB is located at the bottom of the web, the assumed distribution result in $\varepsilon_x = \varepsilon_{x\overline{AB}}/2$ with $\varepsilon_{x\overline{AB}}$ as the average strains along the horizontal line \overline{AB} located at the bottom of the web. The shear strain (γ_{xy}) was computed as the change of the angle between the lines \overline{AB} and \overline{BC} , thus $\gamma_{xy} = \alpha + \beta$, with α and β as shown in Figure 9.

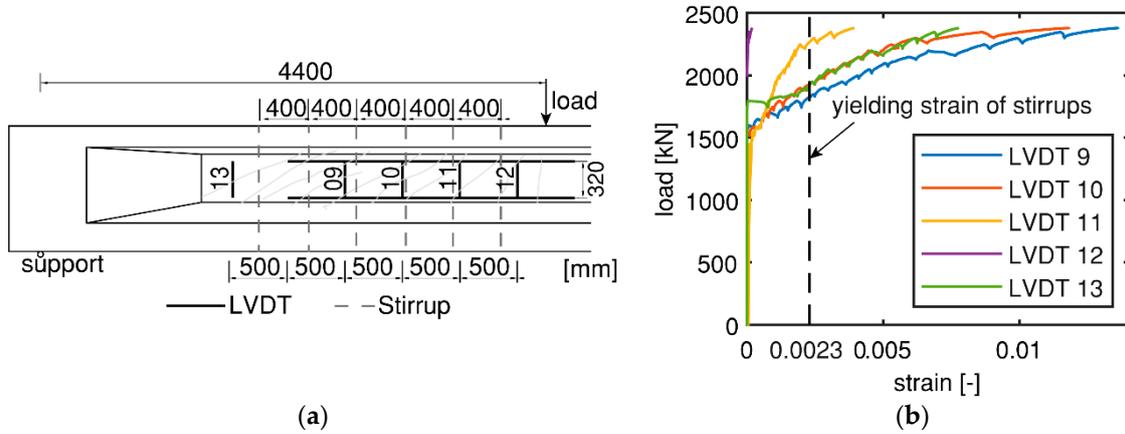
Vertical web deformations measured by the LVDTs can help identify yielding of the stirrups. For example, Figure 10a shows the position of the stirrups and the vertical LVDTs in HPZ04. The results from the LVDTs are given in Figure 10b in which the yielding strain of the reinforcement (0.0023) is indicated with a dashed line. We can observe that strains at LVDTs 9–11 and 13 exceeded the yielding strain with increasing loading, but not for LVDT12. This could be because that LVDT12 was not in the shear cracking zone. An initial conclusion was that the stirrup next to LVDT12 was not yielded,

while the other five stirrups near LVDTs 9–11 and 13 possibly yielded. However, the information from LVDTs was not sufficient to determine the number of stirrups that yielded. Further study on the angle of compression field is needed which is discussed in Section 3.2.3.

Figure 10. Measurement of yielding stirrups from LVDTs for HPZ04: (a) Position of the stirrups and LVDTs; and (b) Vertical deformation results of LVDTs.

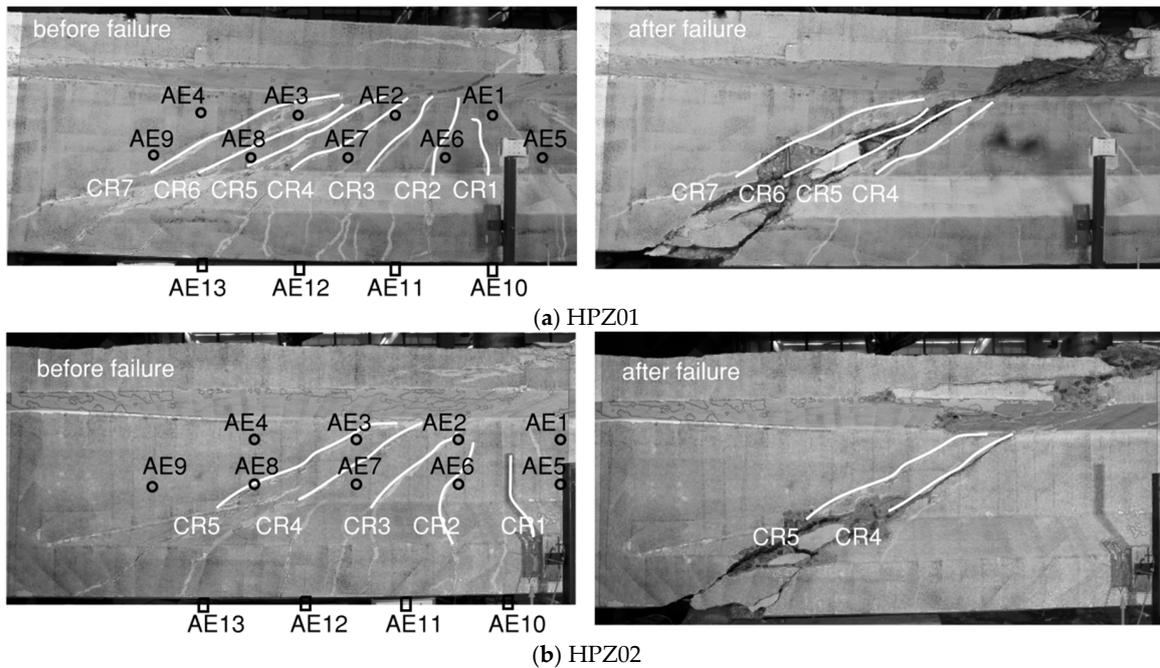
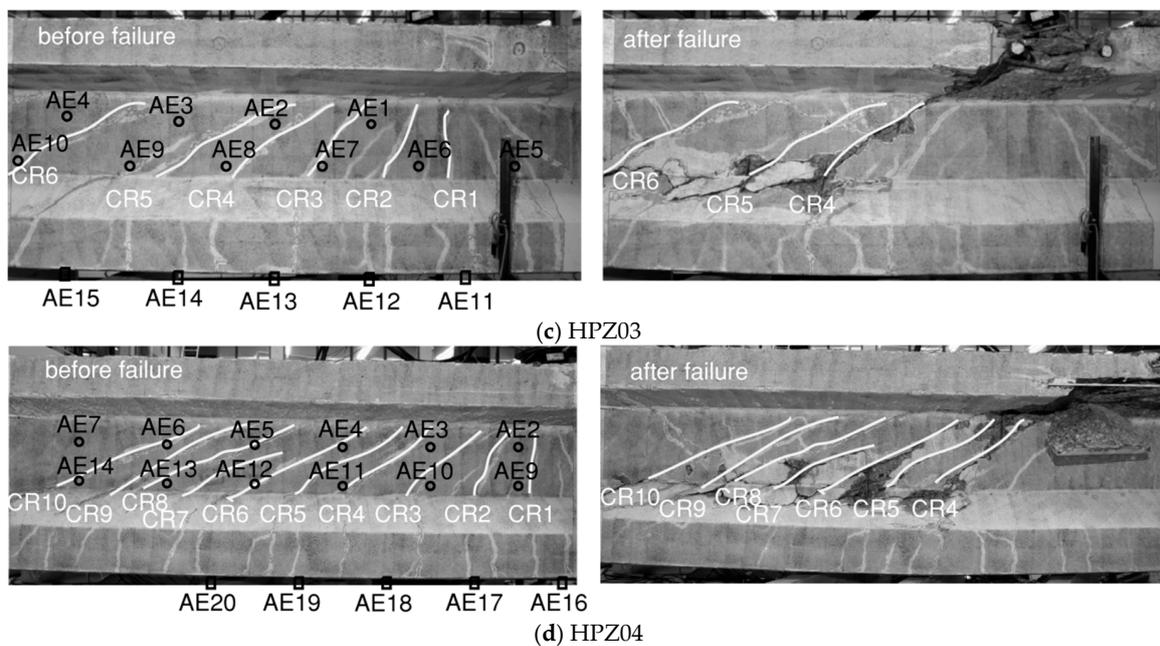
Figure 11 shows the DIC visualization of the cracks with numbering from smaller to larger according to their opening sequence. First, flexural cracks developed (e.g., CR1 in HPZ01), then flexure-shear cracks (e.g., CR3 in HPZ01), then shear-tension cracks (e.g., CR7 in HPZ01), and finally the failure of the specimen occurred (shown on the right-hand side in Figure 11).

Figure 11. Crack patterns in the four girders from DIC results before and after failure, with the locations of AE sensors: (a) HPZ01, (b) HPZ02, (c) HPZ03, (d) HPZ04.

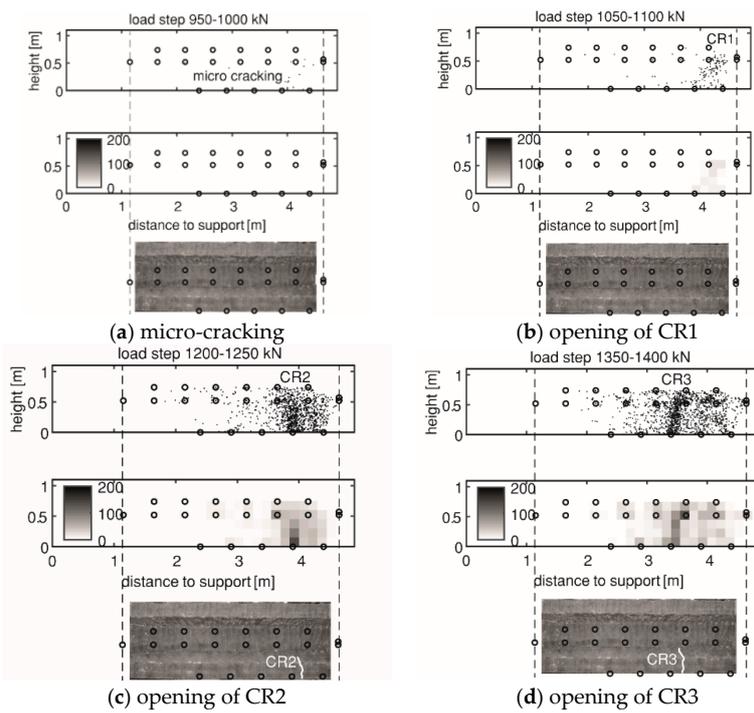
Figures 12 and 13 indicate the gradually opening of flexural cracks and shear cracks in HPZ04 in the measuring area of AE and DIC. For each load step, three types of plots are included: the first one is the estimated location of AE events that occurred in this load step, the second one shows the local cumulative AE events, and the third one is the incremental crack opening from DIC. The interval of each load step is 50 kN.

Figure 12. Opening of flexural cracks in HPZ04: (a) Microcracking; (b) CR1; (c) CR2; and (d) CR3. At each subfigure, from top to bottom: the first plot is the estimated location of AE events, the second plot shows the local cumulative AE events, and the third plot shows the incremental crack opening from DIC. The DIC results are edited to help the reader identify the important cracks.

When microcracking and the first crack CR1 were detected by AE, DIC did not show a clear crack pattern. For the other cracks like CR2 and CR3, DIC can detect the cracking at the same load step as AE. The main reason was that small crack widths can be masked by the noise in the DIC measurements. The difference in crack width was also reflected by the local cumulative AE events, as in CR1 the value was less than 50, while in CR2 the value was over 100. This meant the opening of CR2 was wider with more released energy. The drawback of AE was a lower resolution compared to DIC due to the source localization error.

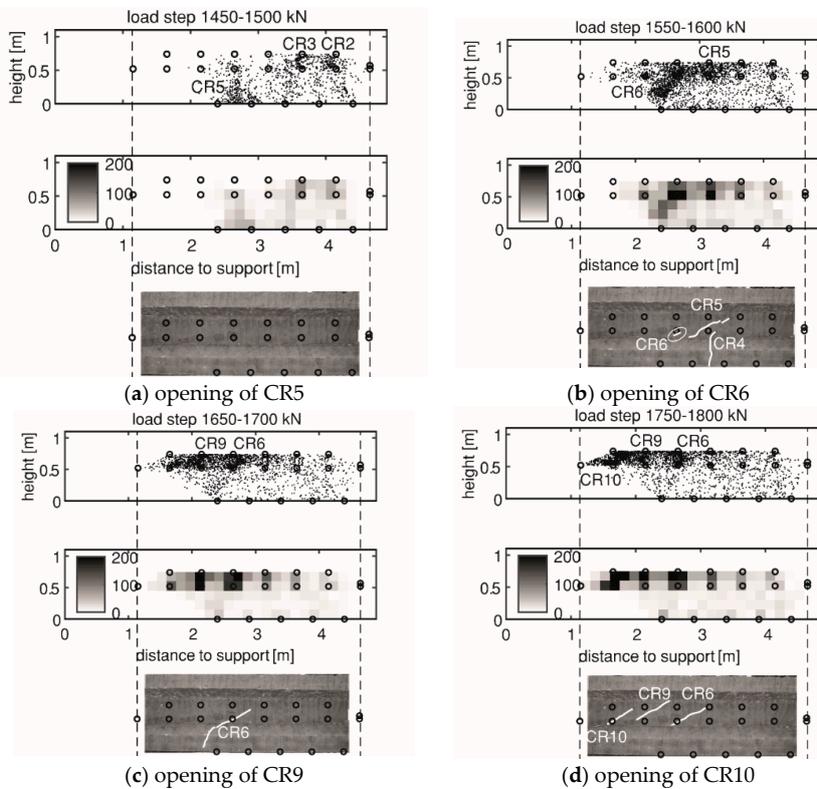
Figure 13. Opening of shear cracks in HPZ04: (a) CR5; (b) CR6; (c) CR9; and (d) CR10. At each subfigure, from top to bottom: the first plot is the estimated location of AE events, the second plot shows the local cumulative AE events, and the third plot shows the incremental crack opening from DIC. The DIC results are edited to help the reader identify the important cracks.

At a later stage, when more cracks opened, AE again detected cracks earlier than DIC. DIC was not able to detect the opening of CR5, further crack tip opening of CR2 and CR3 at 1450–1500 kN, when AE detected these activities (Figure 13a). AE can also detect opening of CR6 and CR9 earlier than DIC as can be seen in Figure 13b,c, respectively. However, AE was not sufficient to distinguish the actual crack pattern. More cracks between source and receiver delayed the wave arrival time and increased the source localization error, leading to unclear crack detection from AE at a later stage in the experiment.

Figure 14 shows the AE crack classification results. Two parameters, the RA value and average frequency, are plotted for AE events occurring in an earlier load step (1050–1100 kN) and later load step (1750–1800 kN). The former load step was when the first flexural crack CR1 was detected (see Figure 12b), and the latter was when the last shear crack CR10 was detected (see Figure 13d).

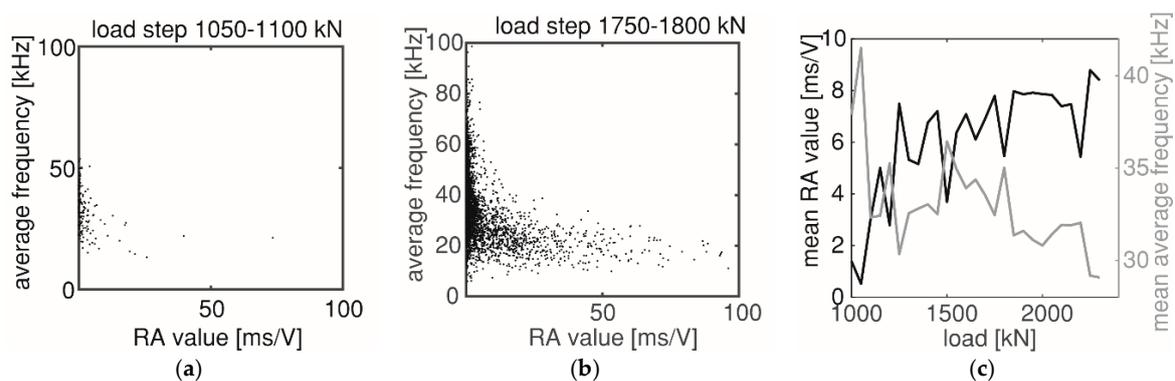
Figure 14. (a,b): Average frequency and RA value of each AE event at load steps 1050–1100 kN and 1750–1800 kN, respectively, and (c): Changing of mean average frequency and mean RA value with loading.

Comparing Figure 14a,b, more AE events tended to have lower average frequency and higher RA value in the later load step of 1750–1800 kN. This observation means that more friction events happened in the later load step when the shear crack CR10 opened. This result agreed with the expectation that friction between crack surfaces occurred more in a structural member with more shear cracks than flexural cracks. Figure 14c compares the change of mean RA value and mean average frequency obtained in each load step with the applied load level, showing the trend of decreasing average frequency and increasing RA value when the load increased.

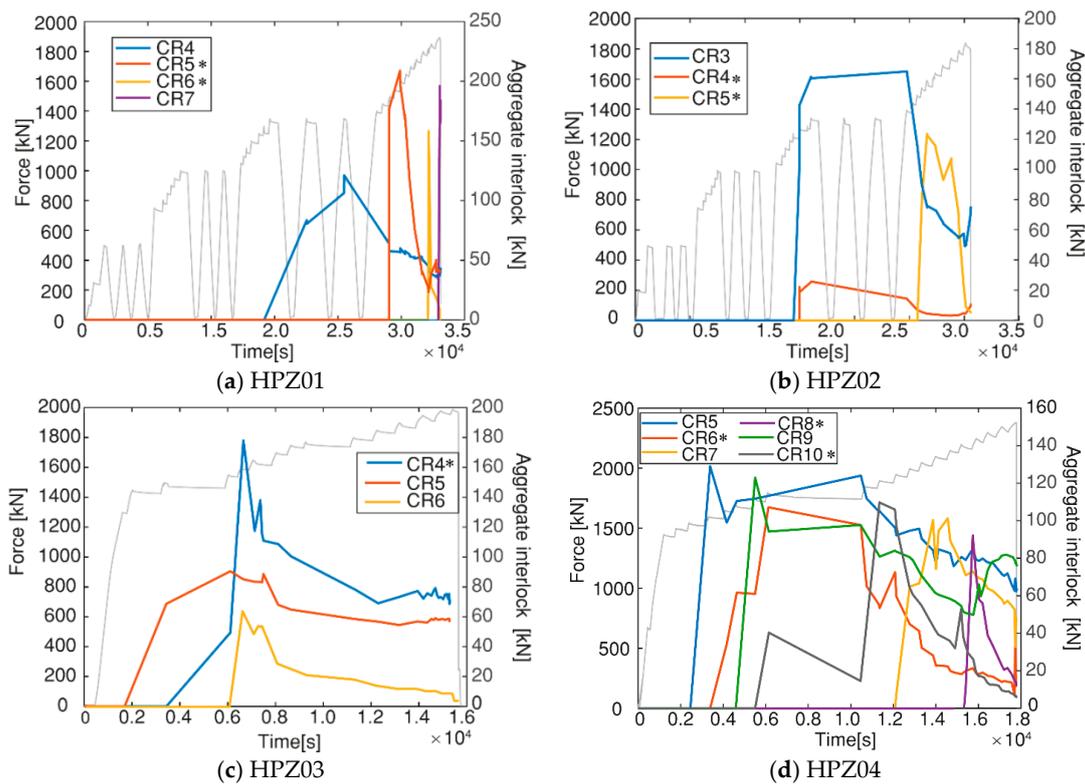
The aggregate interlock distribution was computed for all the experiments using the detailed results of crack kinematics and the crack profiles as introduced in Section 2.3.2. The results of aggregate interlock are given in Figure 15. For comparison, the loading scheme was also plotted in the same figure. The results for HPZ03 and HPZ04 considered only the last part of the loading scheme since flexure-shear and shear-tension cracks developed at this stage.

Figure 15. Aggregate interlock contribution during loading analyzed over time for all the experiments: (a) HPZ01; (b) HPZ02; (c) HPZ03; and (d) HPZ04. * indicates the critical shear cracks.

The general tendency shown in Figure 14 is that the aggregate interlock contribution was higher when the crack opening was smaller since larger contact areas were expected. The shear forces that were transferred through aggregate interlock of the cracks reduces with the increase of the applied load. The loss of aggregate interlock corresponded to an increase of the crack opening. For HPZ01, CR5 and CR6 merged into the critical shear crack which finally led to failure (see Figure 11a). A similar observation was found for HPZ02: CR4 and a secondary crack merged into the critical shear crack as shown in Figure 11b. Regarding HPZ03, the aggregate interlock could not be computed for the last load step due to a technical problem with the camera. However, the tendency indicates that there was a decrease of the contribution for CR4, CR5, and CR6. Figure 15d shows the results of the contribution of aggregate interlock for HPZ04. CR8, and CR10 present a decrease of aggregate interlock after the opening and development of CR8 at the load of 2145 kN. The shear stresses that were transferred through aggregate interlock in these cracks were almost zero at the moment before failure. CR9 presented an increase of aggregate interlock due to the compression of the cracked surface as a result of opening of the adjacent cracks. From these observations, we can conclude that aggregate interlock was not the governing shear-transfer mechanism. It became ineffective as the cracks widened and slid. The shear was transferred through the other actions, such as the stirrups and the direct strut from the load to the support.

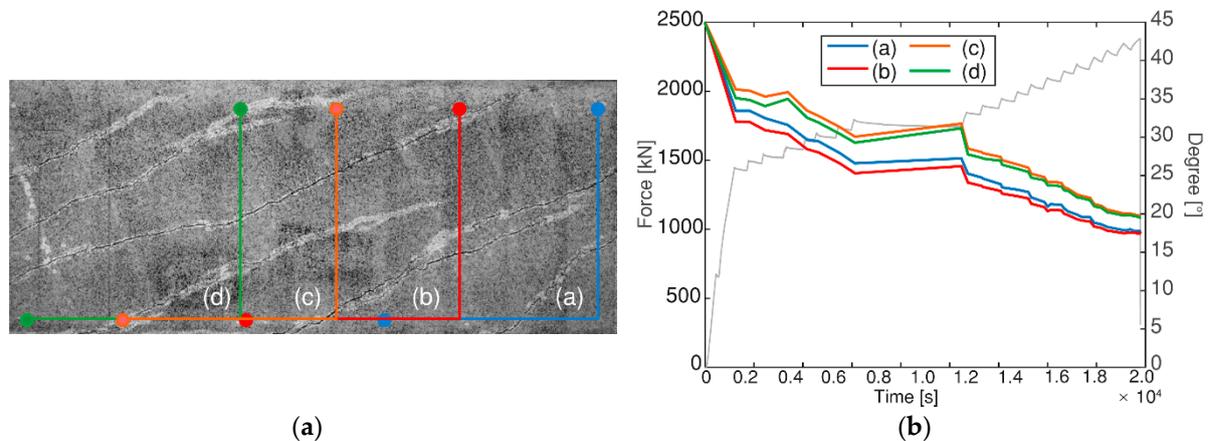
The angle of the compression field θ was calculated from the strain measurements as a function of the load. Figure 16a shows the four areas that were analyzed with the DIC algorithm and Figure 16b presents the resulting angle as a function of time and the applied load for HPZ04. The general tendency was that before cracking the principal strain direction was approximately 45° . Then, after the development of the first inclined crack, the stiffness changes and the principal strain direction rotated to a lower angle. The angle tended to increase slightly when the load was held for a considerable

amount of time as a result of the sustained loading. The results of the angle of the principal strain direction indicated that there was continuous rotation until failure, thus confirming that the angle of the compressive strut can be variable, as stated in the VATM.

Figure 16. (a) Evaluated areas for HPZ04, and (b) Rotation of the principal strain direction during loading for HPZ04.

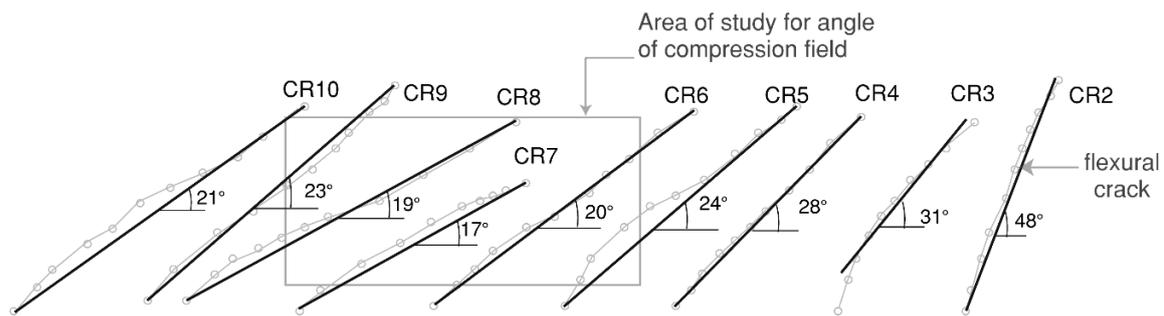
The measurement of DIC also supports the assumption that the actual angle of the compression field at failure is lower than the lower limit specified by NEN-EN 1992-1-1:2005 at 21.8° . With the measured angle of the compression field, we estimated the number of activated stirrups according to Equation (3). For HPZ04, we found five activated stirrups, with angle of compression of 18.5° , height of lever arm of 731.5 mm, and stirrup spacing of 400 mm. This result was also supported by the vertical web deformations measured by LVDTs (Figure 10 in Section 3.1). Following the same procedure, the estimated number of activated stirrups in HPZ01-03 was also five.

Figure 17. Crack pattern and crack angle from DIC results of HPZ04.
