Inspection and Assessment of Corrosion in Pretensioned Concrete Bridge Girders Exposed to Coastal Climate

To investigate the applicability and accuracy of the above measurement methods for corrosion detection in pretensioned bridge girders, we carried out a study based on experimental data collected during field investigations of Dalselv Bridge, a 33-year-old girder bridge exposed to the Norwegian coastal climate.

Dalselv Bridge is a 40 m long, two-span bridge consisting of nine simply-supported standardized I-shaped precast pretensioned (NIB) girders in each span; see Figure 1. The bridge was built in 1985 in the inner coastal climate (fjord area) of the northern part of Norway. The superstructure is close to sea level (approximately 2.3–2.9 m measured at high and low tide), which implies high chloride loads on the bridge superstructure. According to data from the Norwegian Meteorological Institute collected in the years 2011–2019, the prevailing winds come from the sea side, from the south-west; see Figure 1a. The average temperature and relative humidity are $4.6 \text{ }^\circ\text{C}$ and 77%, respectively.

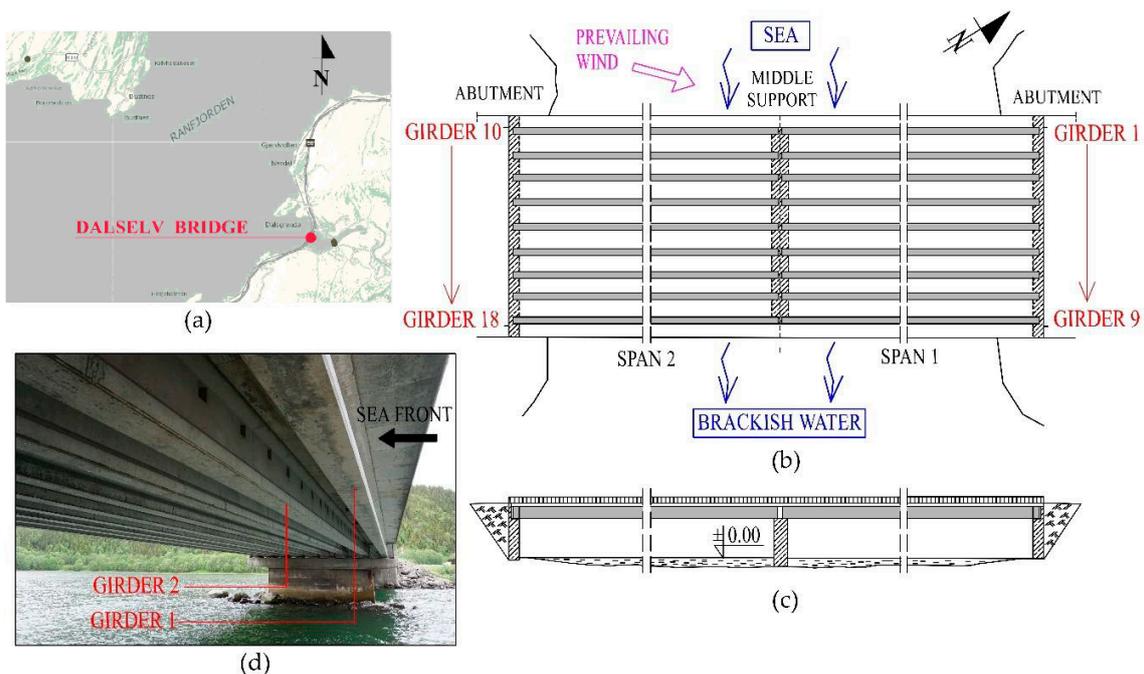
Figure 1. Dalselv Bridge: (a) bridge location; (b) bottom view; (c) side view; (d) photo taken underneath the bridge, facing south.

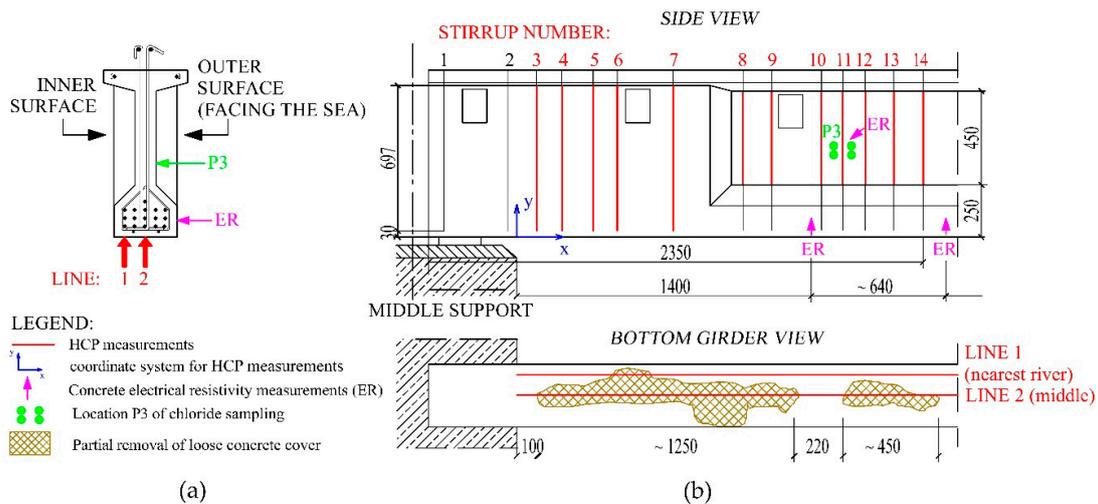
Figure 2. Location of half-cell potential (HCP) and electrical resistivity (ER) measurements in Girder 2: (a) measurements in the girder’s bottom flange; (b) measurements (mm) in the web above the stirrups, and removal of loose parts of concrete cover.

To locate areas with high corrosion probability in Girder 2, HCP mapping was performed along the whole span length of the bottom surface of the girder, see Figure 2a. The measurements followed two lines to detect possible variations in corrosion probability between the strands. Moreover, to assess the condition of the vertical reinforcement in the shear zone near the middle support, the HCP was measured above the stirrups (numbered 3–14 in Figure 2b) on the inner and outer vertical surfaces of the girder.

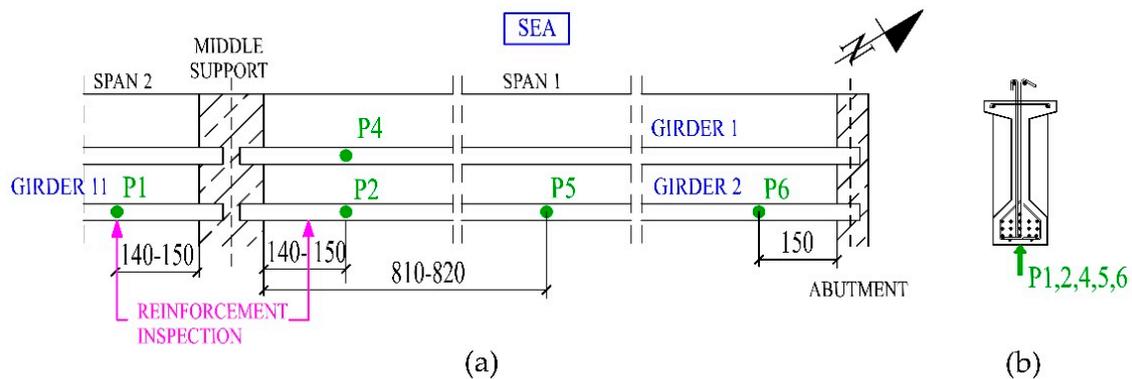
Figure 3. Locations P1, P2, P4, P5, and P6 for chloride sampling (distances in cm): (a) girder layout; (b) girder cross section.

Chloride concentrations in Girder 2 were measured at four locations, three of which were in the girder’s bottom flange: P2 close to the middle support, P6 close to the abutment, and P5 in the middle of the span; see Figure 3. The fourth sampling point, P3, was located in the girder web; see Figure 2b. Additional chloride measurements were taken from the bottom flange of Girder 1 (P4) and Girder 11 (P1) at the same distance from the middle support as P2; see Figure 3a.

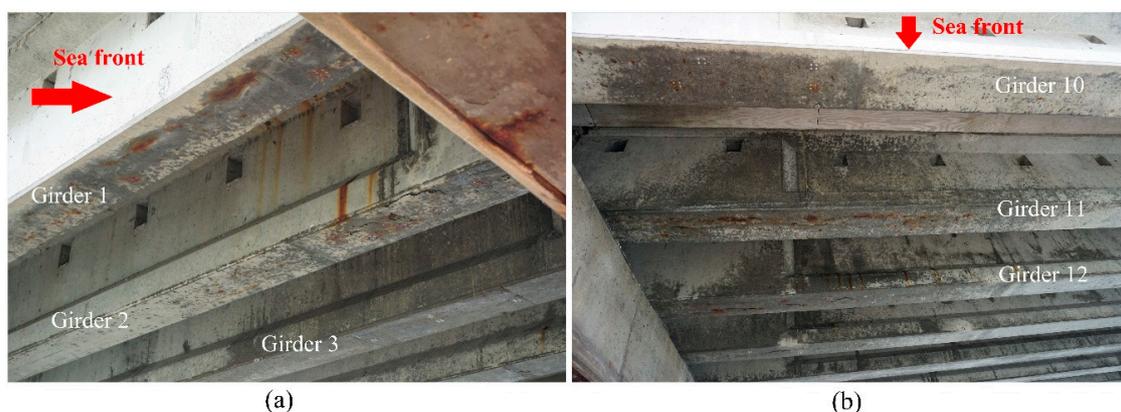
Corrosion was found in the pretensioned NIB girders of Dalselv Bridge, in and near the support zones. The most severe corrosion damage was found close to the middle support, in the second and third girders facing the sea (Girders 2, 11, 12), and in the bottom flanges of the outermost girders facing the sea (Girders 1, 10); see Figure 4. Less severe corrosion cracking was detected in the bottom flanges of girders close to the abutments. Girders 1 and 2 also had severe cracking with visibly corroding strands in the top flange next to the middle support.

Figure 4. Corrosion-induced damage and humid areas in NIB girders: (a) in the first bridge span (1st to 3rd girders facing the sea) next to the middle support; (b) in the second bridge span (1st to 3rd girders facing the sea) next to the middle support.

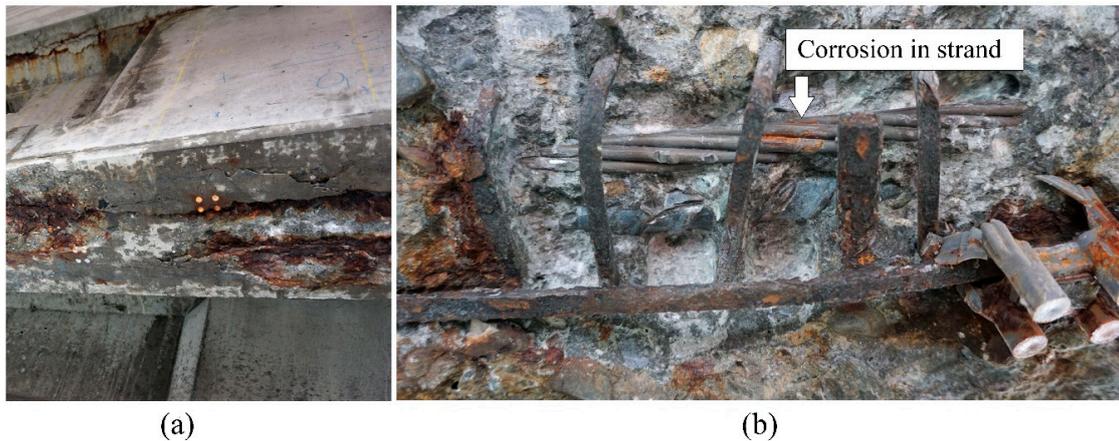
The removal of the concrete cover in the bottom flange of Girder 2 revealed severe corrosion of mounting bars; see Figure 5a. Similar damage was found in the exposed mounting bars in Girder 11. Inspection of chloride sampling location P1 (in Girder 11) also revealed corrosion in stirrups and one strand; see Figure 5b. In the $\phi 6$ stirrups, the severest corrosion had accumulated in and near their bends, with a loss of diameter measured at about 50%. The horizontal part of the $\phi 12$ stirrup shows fairly moderate corrosion.

Figure 5. Reinforcement corrosion: (a) next to chloride sampling location P2 in Girder 2; (b) next to chloride sampling location P1 in Girder 11.

Surprisingly, only small corrosion spots were found on the strand itself (see Figure 5), which suggests that corrosion started recently or that the corrosion rate is low. It should be noted that only a short length of strand was exposed and more corrosion spots could probably be found outside this area.

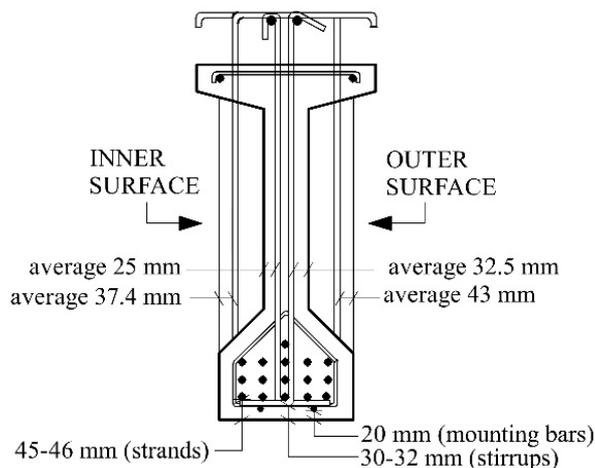
Measurement of the concrete cover up to the stirrups in Girder 2 revealed 5.5–7.5 mm more cover on the outer than the inner surface of the web, see Figure 6. This means that the mold must have moved before casting. During inspection, we also detected two visible mounting bars supporting stirrups in the girder’s bottom flange, with plastic reinforcement chairs supporting the bars.

Figure 6. Concrete cover thickness measured in Girder 2.

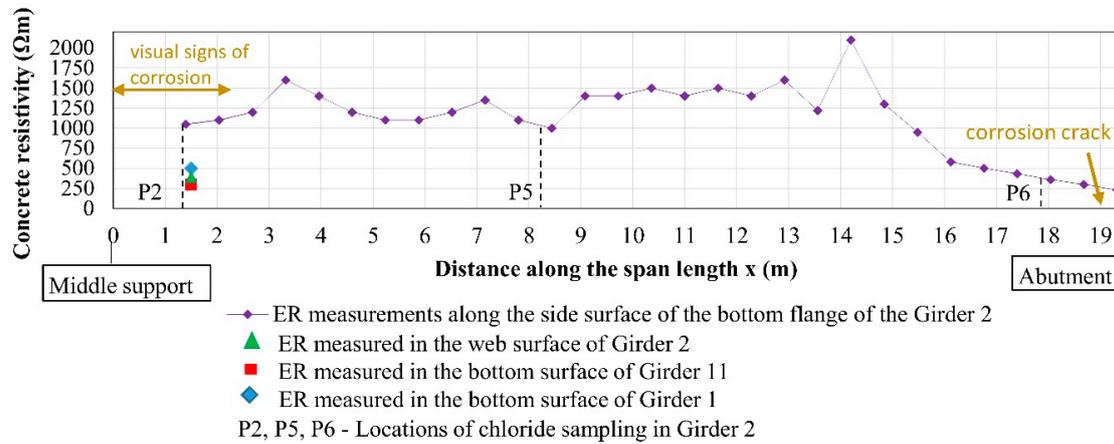
The ER readings scatter significantly along the girder span from 230 Ωm to more than 1000 Ωm; see Figure 7. Overall, the ER measurements were rather high, which can indicate a good concrete quality (low w/c) with low concrete porosity.

Figure 7. Concrete resistivity measured along the side surface of the bottom flange of Girder 2, in the web of Girder 2, and in the bottom surface of Girders 1 and 11 (about 1.5 m from the middle support).

For most of the span, the ER was greater than 1000 Ωm, which suggests dry concrete [23]. The ER readings decreased in the last approximately 4.5 meters to the abutment, which suggests a gradual change in moisture conditions; see Figure 7. Although wet areas observed during visual inspection suggested ER would also decrease near the middle support, high ER readings were recorded (more than 1000 Ωm). For comparison, the ER measurements in wet areas of Girders 1 and 11 close to the middle support were considerably lower (500 and 320 Ωm, respectively) than those in Girder 2; see Figure 7. In addition, the ER of 380 Ωm measured in the web of Girder 2 indicates high moisture next to the middle support. The high ER in the bottom flange of Girder 2 near the middle support may be due to delamination of the concrete cover caused by corrosion, the signs of which were visible over a distance of about 2.1 m from the middle support; see Figure 4a. Wind conditions and the location of the measurements on the side of the girder flange could also have had an impact.

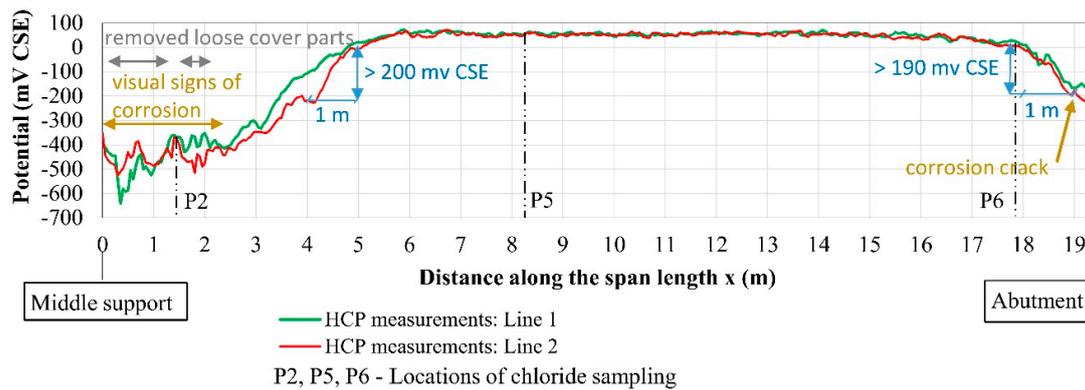
The HCP mapping along the bottom flange of Girder 2 is shown in Figure 8. Lines 1 and 2 both showed positive and stable HCP values (0 to 72 mV CSE) in the middle part of the span between 5 and 18 m from the middle support. Near the girder supports, HCP measurements decreased to their most negative values. The potential gradients near both supports were greater than 190 mV CSE/m, while no potential drops occurred in the middle of the span; see Figure 8. This indicates a higher probability of corrosion in reinforcement near the supports and a low probability of corrosion in the main part of the span.

Figure 8. Distribution of half-cell potentials along the bottom surface of Girder 2.

The local scatter in HCP readings from 0.1 to 1.3 m and from 1.6 to 2.1 m from the middle support is probably due to partially removed loose concrete cover; see Figure 8. Outside the area of removed cover, the HCP readings in Line 2 are slightly lower than in Line 1; see Figure 8. Otherwise, the potential gradients in both lines show the same trend. In this case, therefore, it was not possible to detect variation in corrosion probability between closely spaced (about 50 mm) and electrically connected strands. This can be explained by either active corrosion in both strands or polarization of neighboring strands by a locally active corrosion area. The area polarized depends, amongst other things, on the ER. As the ER decreases, the area polarized increases.

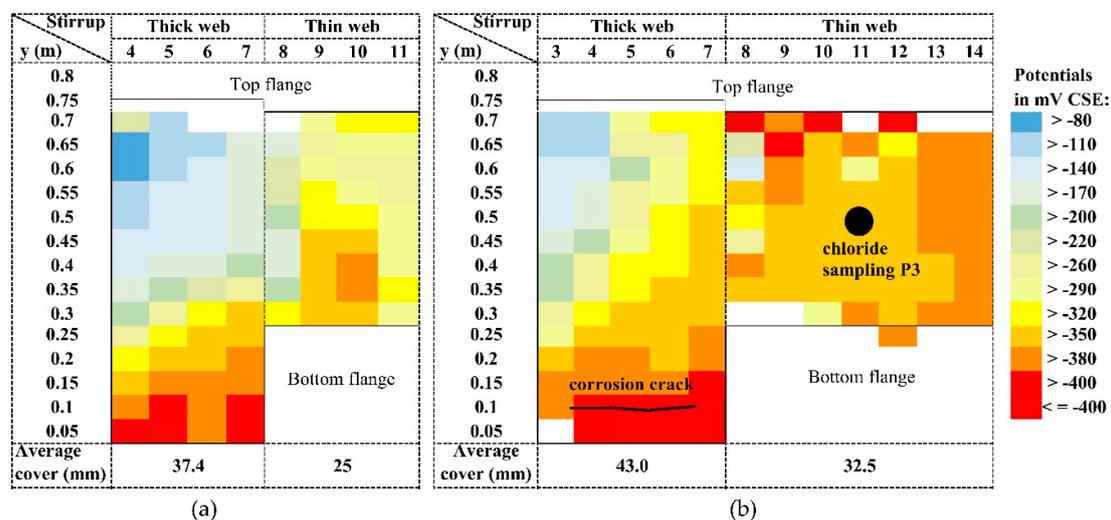
The potentials measured above the stirrups near the middle support (numbered 3–14 in Figure 2b) are shown in Figure 9. The highest HCP values were measured in the upper corner of the girder end cross section, referred to here as the thick web. The potential distribution follows the moisture pattern observed in inner NIB girders close to the middle support (see Figure 4) and confirms the influence of moisture on HCP measurements.

Figure 9. HCP measured above the stirrups in Girder 2: (a) inner surface; (b) outer surface (facing the sea) cf. Figures 2 and 6.

The most negative potentials (less than -380 mV) were found for parts of the stirrups at the bottom of the thick web. These locations correspond to the areas with visible corrosion damage shown in Figure 4a. The HCP readings above the stirrups show more negative values for the outer web surface (facing the sea) than for the inner surface. Despite its thicker cover (by 5.5–7.5 mm), the outer surface facing the sea is more likely to corrode than the inner surface.

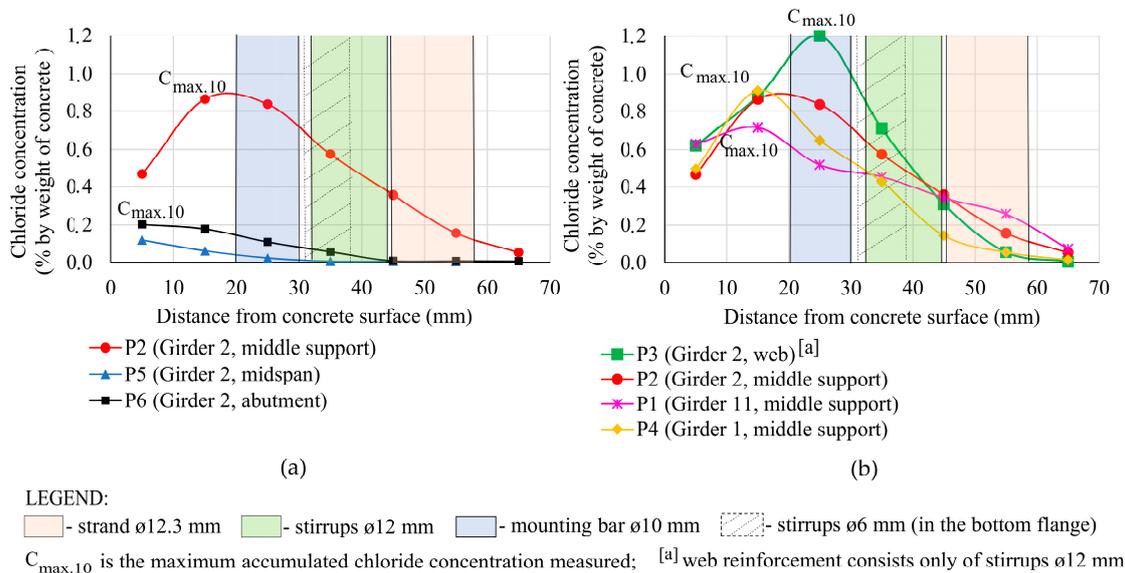
The chloride profiles obtained for all of the sampling locations are presented in Figure 10. The chloride sampling locations on the bottom flanges of Girders 1, 2, and 11 (P1, P2, P4, P5, and P6) are given in Figure 3, and the chloride sampling in the web of Girder 2 near the middle support (P3) is given in Figure 2.

Figure 10. Chloride profiles obtained in Girders 1, 2, and 11: (a) along the bottom flange in Girder 2; (b) near the middle support in Girders 1, 2 and 11.

As shown in Figure 10a for the bottom flange of Girder 2, the highest chloride content at the level of the reinforcement was found near the middle support (P2). The chloride content in unsaturated concrete is strongly affected by the accumulation of surface chlorides [55]. The maximum accumulated chloride concentration, based on measurements at 10 mm concrete depth intervals (denoted $C_{max.10}$), was more than seven times higher near the middle support and almost two times higher near the abutment than in the midspan. This resulted in deeper chloride penetrations in the support zones of Girder 2.

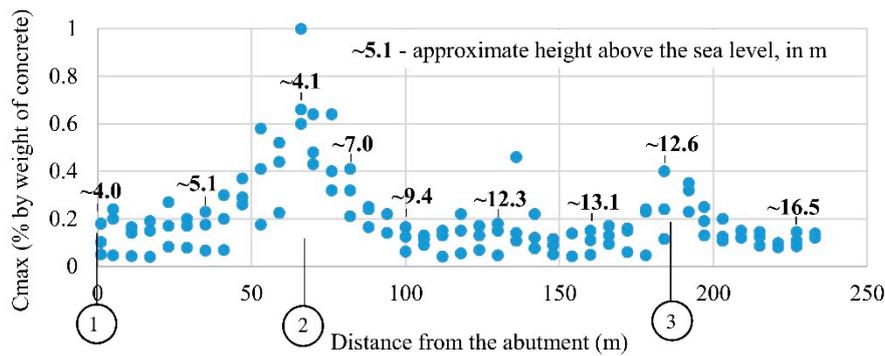
Higher maximum accumulated chloride concentrations close to supports were also observed in the box-girder Gimsøystraumen Bridge in Norway after 11 years of exposure to coastal climate [59]. Figure 11 shows that the $C_{max.10}$ next to the abutment (axis 1) was lower than that around the middle support (axis 2). The moisture content measured also varied along the box girder, with the highest values next to supports and lowest in the midspans [59], which confirms the findings in this study.

Figure 11. Chloride concentrations C_{max} in Gimsøystraumen Bridge measured in a 10 mm thick concrete layer after 11 years of exposure to Norwegian coastal climate [59].

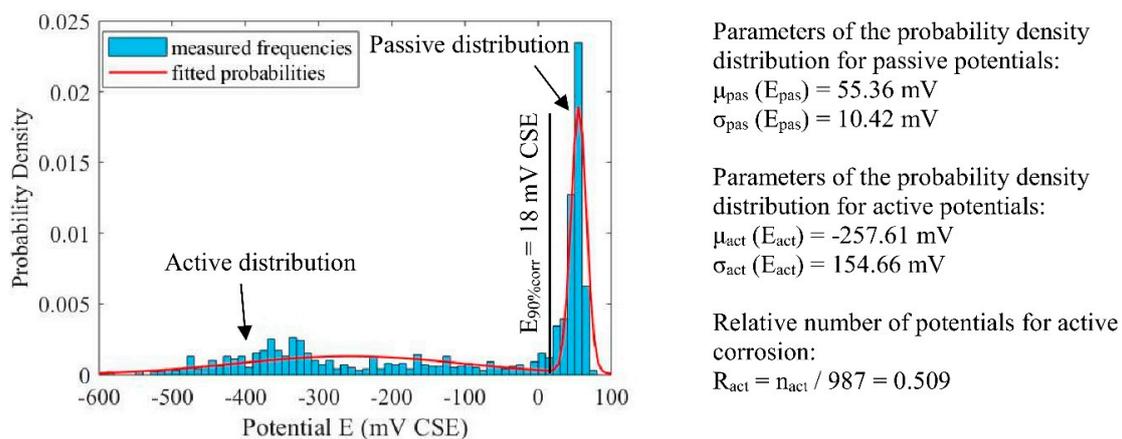
First, we assumed that Girder 2 is a homogenous structure with comparable exposure to chlorides and moisture. All 987 measured potentials were therefore considered in the statistical analysis. Results of regression analysis are presented in Figure 12.

Figure 12. Frequency density distribution of measured and fitted potentials assuming homogenous environmental exposure in Girder 2. Parameters of the potential distributions.

A 90% probability of corrosion was found for a potential of 18 mV CSE, as indicated in Figure 12, while a corrosion probability close to 100% was calculated for potentials below 10 mV CSE. We found these values unrealistically high compared to commonly reported thresholds [40,46]. Moreover, no steep

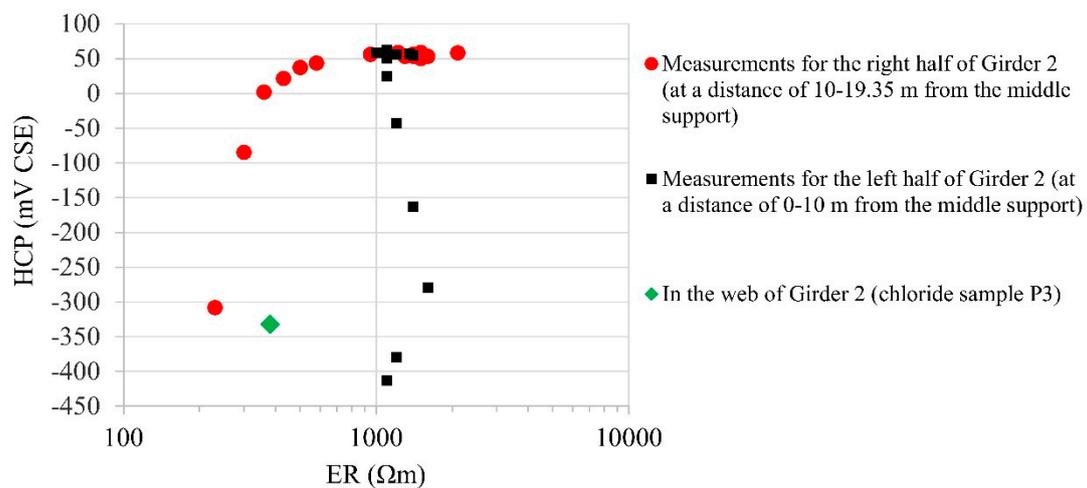
As shown in Figure 13, we found a strong correlation between HCP and ER measurements for the right half of Girder 2. The potential decreases when the ER is below approximately 580–950 Ωm. These values are close to the ER thresholds of 500 and 1000 Ωm, above which the corrosion probability is low and negligible, respectively [23]. However, they are higher than the ER of 350–530 Ωm found by Pailes [46], which may be because NIB girders require a higher quality concrete than bridge decks. For the left half of Girder 2, no clear relationship was found between HCP and ER, see Figure 13. Despite a high ER, decreasing HC potentials with decreasing distance to the middle support showed the same trend as in the right half near the abutment; see Figure 8. We therefore concluded that HCP measurements were more reliable for corrosion assessment than ER results, which should always be verified with visual inspection.

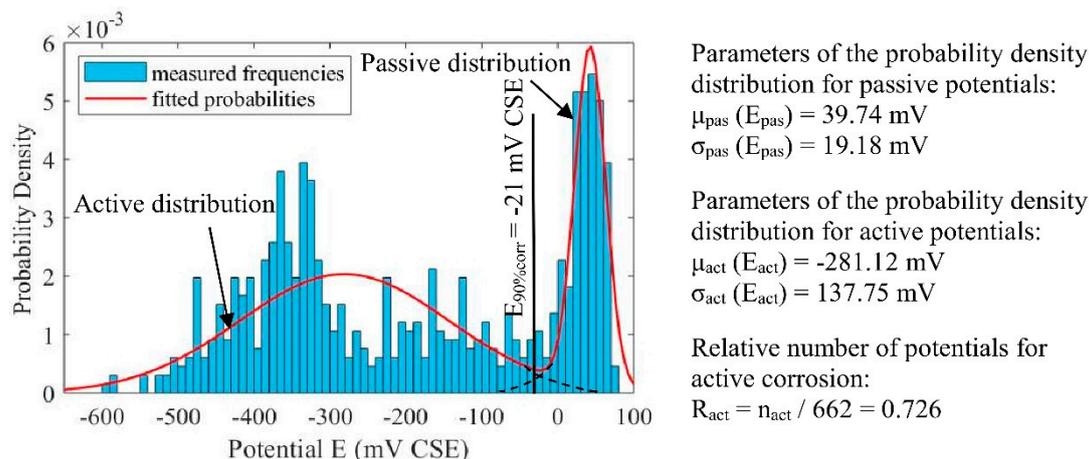
Figure 14. Frequency density distribution of measured and fitted potentials assuming similar moisture conditions near supports. Parameters of the potential distributions.

An additional analysis was performed for the region of increased moisture limited to the distance of 3.3 m from the abutment (ER lower than 580 Ωm) and 6 m from the middle support. In this case, the corrosion probability of 90% was calculated for a potential of −26 mV CSE. The calculated values of −21 to −26 mV CSE are higher than the potentials of −670 to −360 mV CSE measured in corroding areas, but slightly lower than the threshold of 18 mV CSE found from analysis of all of the data collected. The estimated corrosion probability can therefore be considered a conservative indicator of corrosion, and HCP measurements could be limited to areas with high levels of moisture in concrete. In contrast, statistical analyses that disregard varying exposure conditions in some cases may lead to overestimation of the area with high corrosion probability, and therefore additional but unnecessary repairs.

To analyze the correlation between NDT and DT results, the corrosion probabilities calculated for HCP based on statistical distributions in Figure 14 were compared with the probabilities calculated for chloride concentrations based on the Markeset model. The results are shown in Figure 17.

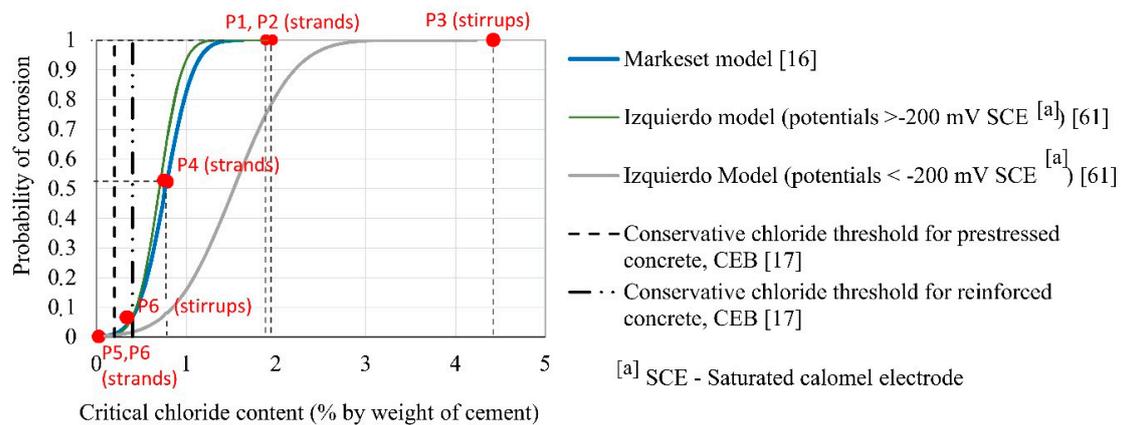
Using this model, we found that the corrosion probability was close to 100% for strands and stirrups close to middle support in the inner girders (P1–P3), whereas strands in the midspan (P5) and abutment vicinity (P6) had a negligible corrosion probability of less than 1%; see Figure 15.

Figure 15. Probability of reinforcement corrosion calculated based on the Marqueset statistical model.

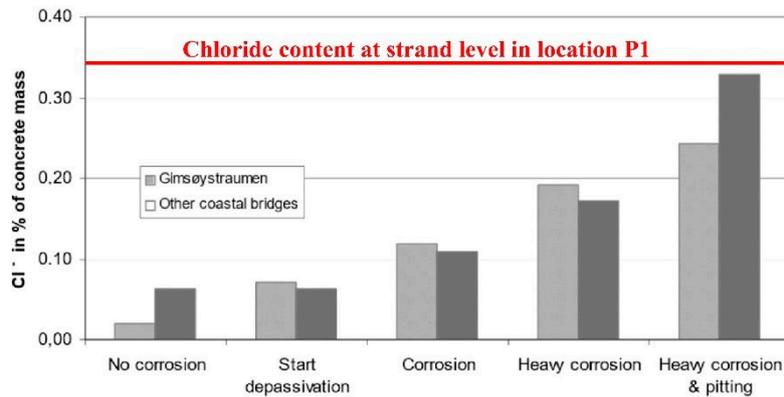
In this study, exposing the reinforcement in location P1 (Figure 5b) confirmed the indicated 100% corrosion probability of the strands. However, for chloride concentrations of 0.344% by weight of concrete (1.81% by weight of cement) only small pitting was detected, whereas heavier corrosion would have been expected based on corrosion bridge studies [62]; see Figure 16. Moreover, for the high chloride content at the level of both strands and stirrups in location P1 (Table 3), stirrups exhibit more severe and uniform corrosion; see Figure 5b. This means that relying on chloride concentrations alone may give unreliable information about not only the probability, but also the severity of corrosion in NIB girder strands.

Figure 16. Relationships between corrosion severity and chloride content from more than 300 registrations on various coastal bridges in Norway [62]. Red line—chlorides at the strand level in location P1.

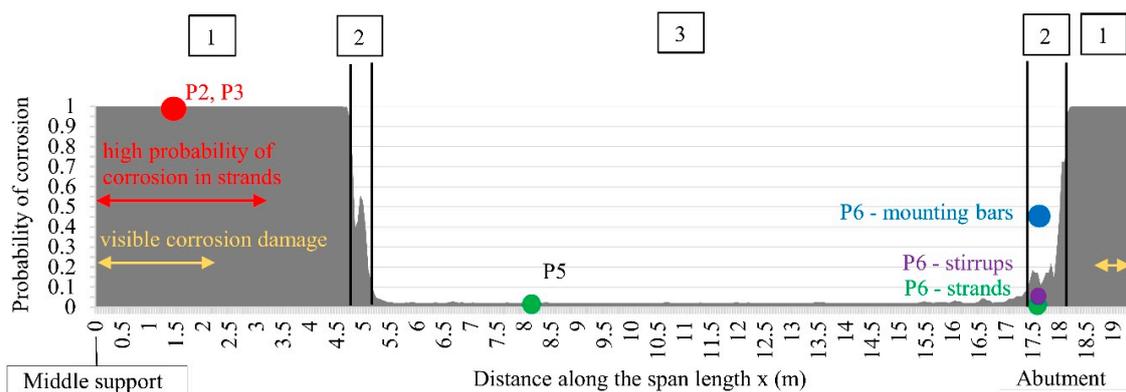
Figure 17. Comparison of calculated corrosion probability along Girder 2: grey area—corrosion probability based on HCP collected from support zones; dots—corrosion probability based on chloride concentrations; nos. 1, 2, 3—zones with high (>90%), uncertain, and low (<10%) corrosion probability, respectively.

The corrosion probabilities obtained from both kinds of test on Girder 2 are consistent for all reinforcements in locations P2, P3, and P5, which increases the reliability of assessment in the zones with the highest and lowest corrosion probabilities. Moreover, the zones with a corrosion probability greater

Nevertheless, a negligible corrosion probability was detected in location P5, where chloride content at the level of mounting bars was 0.04% by weight of concrete (0.20% by weight of cement). This means that the CEB [17] chloride threshold for prestressed structures was too conservative for the NIB girder in this study. In location P1, corrosion spots were found in the strands with a chloride content of 0.344% by weight of concrete, so corrosion in strands with a higher chloride level in location P2 is also to be expected; see Figure 18. Removal of cover in locations with severe damage allowed us to estimate the chloride threshold for initiation of strand corrosion. This was approximated at between 0.14 and 0.34% by weight of concrete; see Figure 18. Since strands probably corrode with potentials lower than the -370 mV CSE found in location P2, the area with a high probability of strand corrosion extends about 3.2 m from the middle support; see Figure 17.

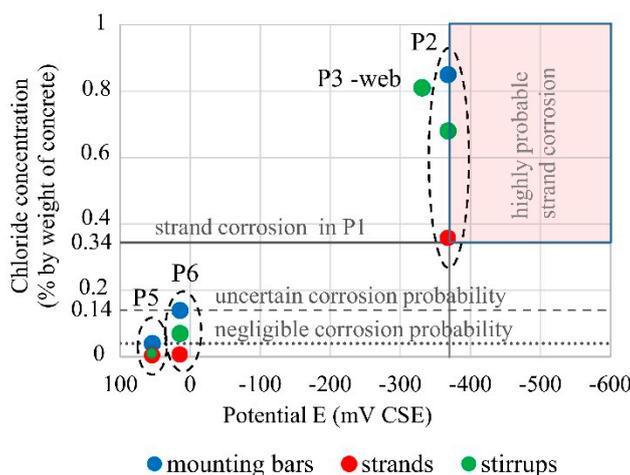
Figure 18. HCP and chloride concentrations for sampling locations in Girder 2. The chloride concentration at the level of the corroding strand in location P1 (in Girder 11) is included for comparison.

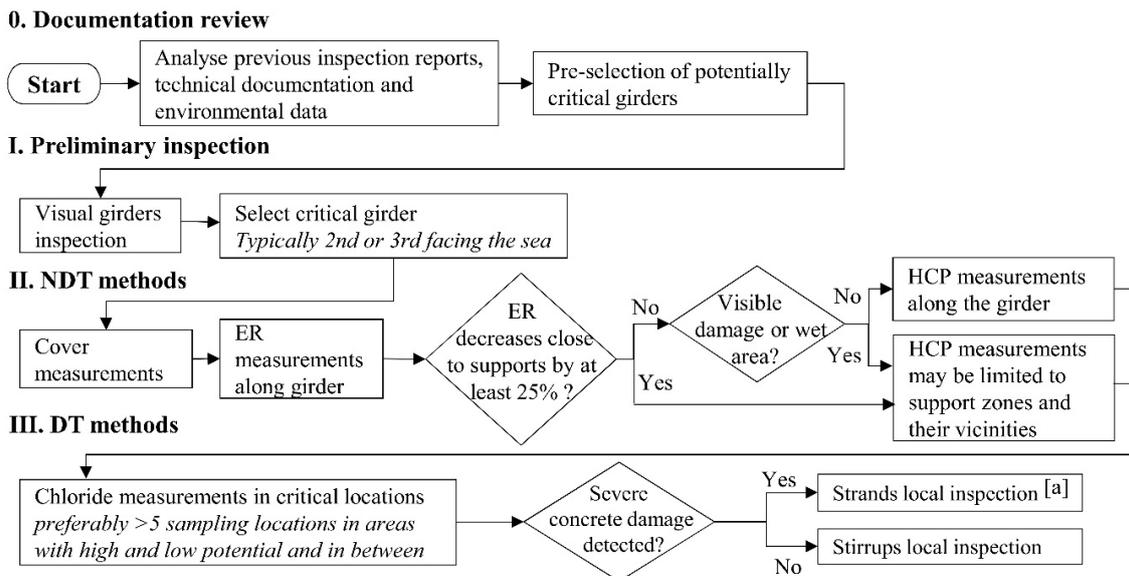
The critical girder(s) for detailed inspection should be based on a visual inspection of all of the bridge girders; see Figure 19. Considering findings in both our previous research [2] and this study, the 2nd and/or 3rd girder facing the sea are typically those with the highest probability of reinforcement corrosion damage due to chloride exposure.

[a] Strand local inspection has to be carried out with extreme caution, so as not to mechanically damage the strands. The inspection area has to be limited to minimum (max. 50 mm), preferably selected where concrete cover is already loose.

Figure 19. Procedure for detailed inspection of pretensioned bridge girders in a marine environment.

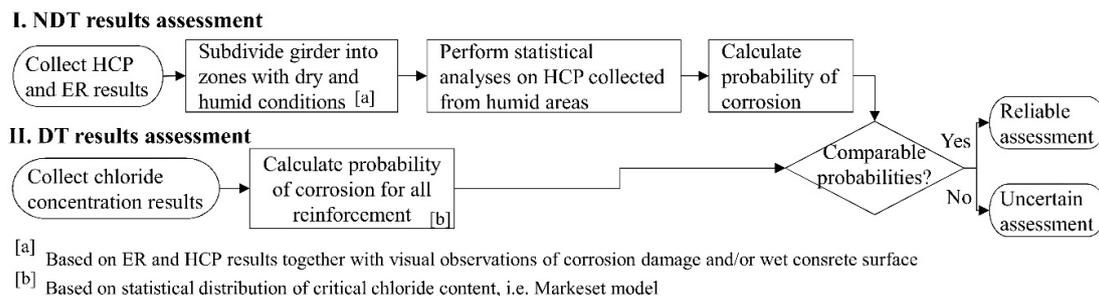
The assessment of the data collected is described in Figure 20. The statistical analysis of HCP should be performed following the procedure developed by Gulikers and Elsener [42] on data collected from areas where an increase in moisture is detected, e.g., support zones and their vicinities. Corrosion probabilities from measured chloride concentrations should be evaluated based on the statistical model for critical chloride distribution for similar structures and environmental conditions as proposed by Marqueset [16]. The estimated corrosion probabilities from both chloride concentrations and HCP collected from areas with similar moisture conditions are then compared. Corrosion probability assessment can be considered reliable when both methods point to the same conclusions and coincide with the visual damage where present. The results can also be supported with reinforcement inspection results.

Figure 20. Procedure for assessment of pretensioned bridge girders in a marine environment.
