Effect of Unit-Cell Size on the Barely Visible Impact Damage in Woven Composites

Applied Sciences

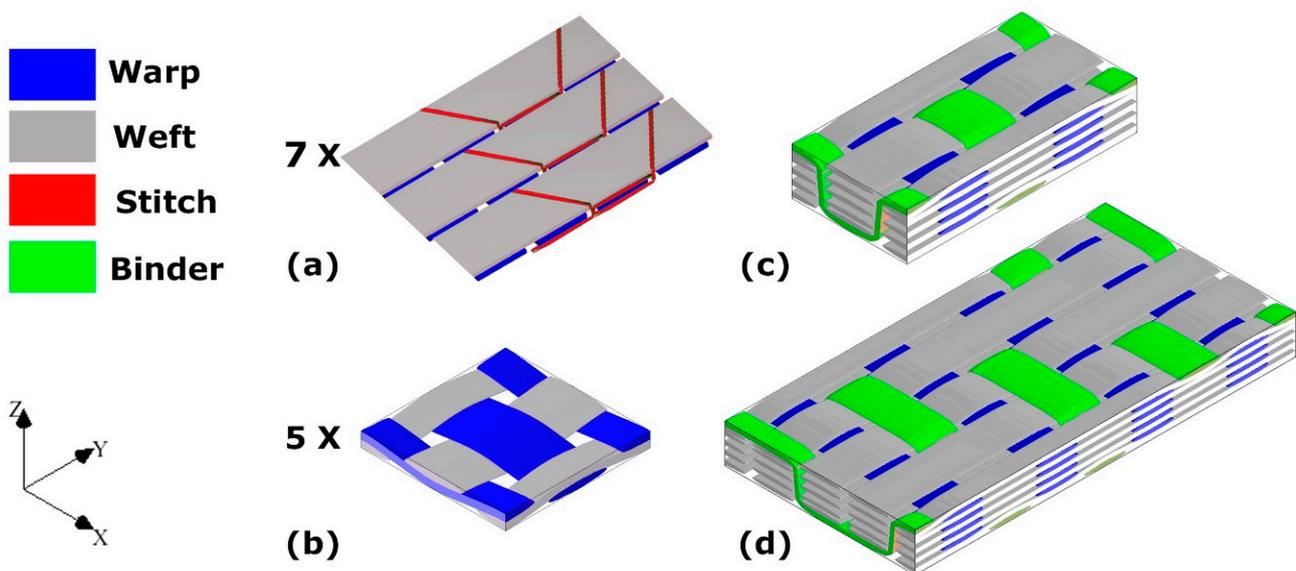
Figure 1. Schematic of the different types of investigated composites: (a) noncrimp fabric (NCF), (b) 2D plain (2D-PW), (c) twill (orthogonal) and (d) ORT-TW (twill) (the warp yarns highlighted in blue, the weft yarns in grey, the through thickness z-binding yarns in green, and the stitch “polyester” yarns for the noncrimp fabric (NCF) in red).

EAT-3D Composites Module, a newly developed weave-design program for technical weaving and complex composite structures, was used to design all the weaving architectures in this study. These architectures are referred to as: 2D plain (2D-PW), 3D plain orthogonal (ORT-PW) and twill (ORT-TW) weaves, each of which consists of 5 warp and 5 weft layers, including z-binding warp yarns. Figure 1 schematically summarises the unit-cells of the four different fabrics used in this study. The main difference between the two 3D orthogonal weaves is the z-binding yarn's path, which translates into different unit-cell sizes. In the case of the ORT-TW (Figure 1d), the binding frequency, through the thickness, is half the binding frequency of the ORT-PW (Figure 1c). This unit-cell size variation is one of the main design parameters of this study as its effect on the impact resistance is detailed in Section 4.2.

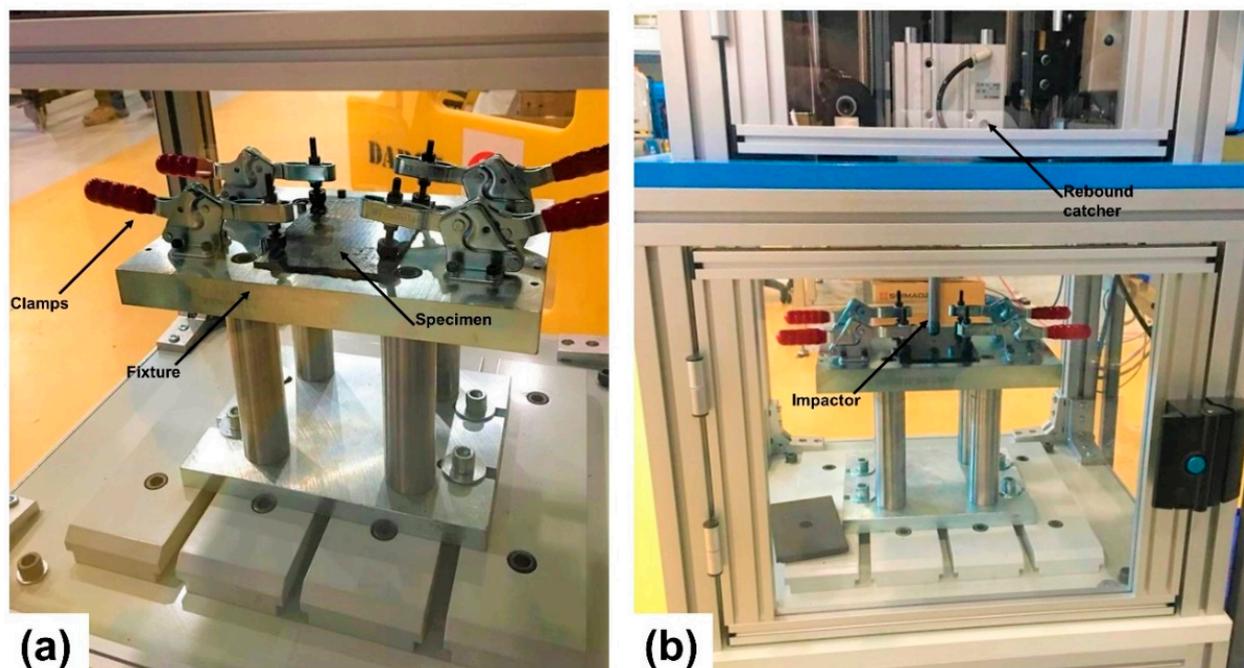
Figure 2. Testing setup (a) before and (b) after impact.

Using a drop-weight impact tester (IMIC-15) from Imatek Ltd. UK, impact testing for all specimens, 3 repeats per architecture, was carried out as per the ASTM D7136 [27] standard. The SI Units version of the standard was used. The clamping fixture of the specimens, according to the ASTM standard, should have a cut-out with an area of 125×75 mm². All specimens were secured with four clamps to ensure they were fully restrained during the impact test (see Figure 2). A 16 mm diameter hemispherical impactor with a mass of approximately 6.7 kg was used to impact all the specimens in the centre. To avoid puncture of the specimens due to impact, initial trials were conducted with 15 , 18 , 20 and 25 J. The 15 J energy level was then chosen as the weakest architecture. “NCF” could not survive the higher energy levels. The force, velocity and displacement as a function of time were recorded during the testing. In addition, the drop-weight tower was equipped with a rebound catcher to ensure that the striker would only hit the specimen once and no damage accumulation due to multiple repeated impacts would occur.

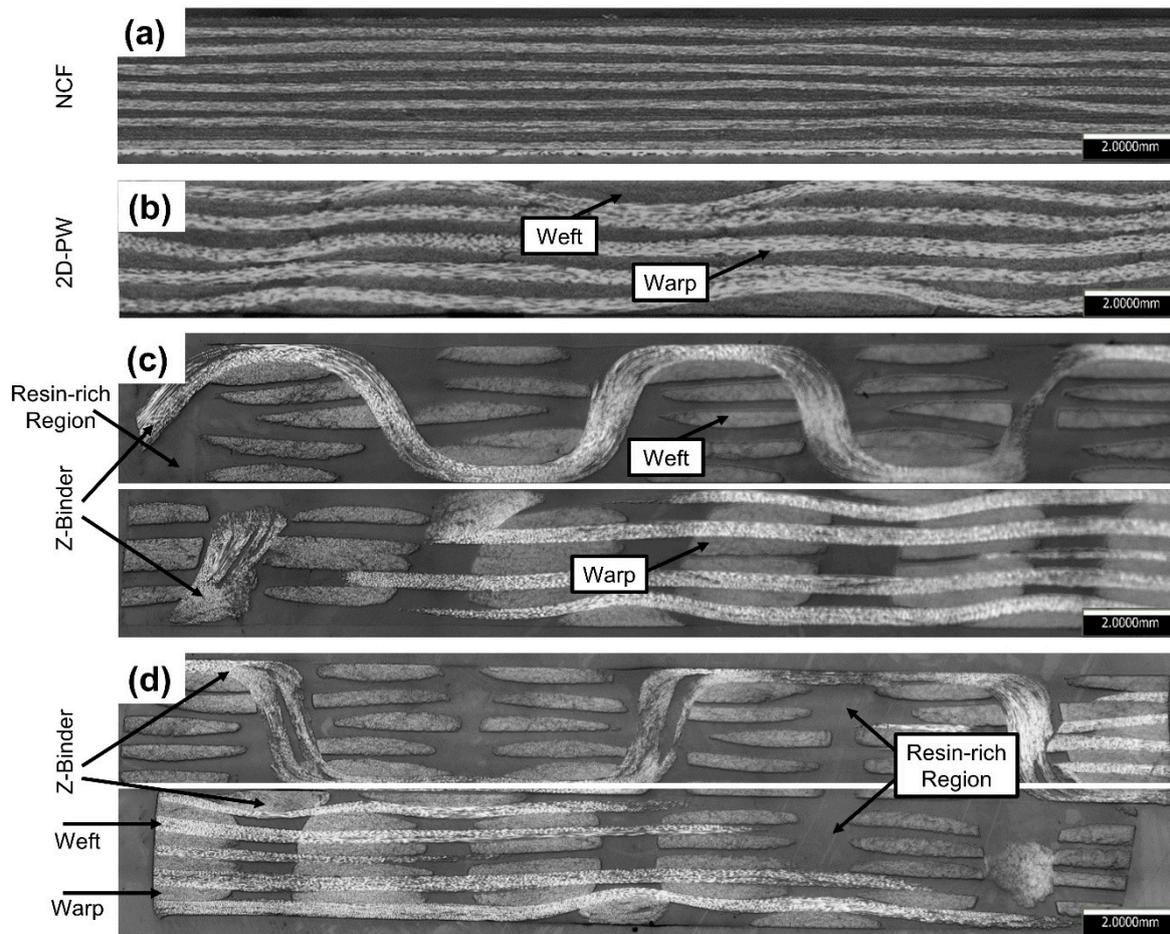
Figure 3. Optical micrographs of composites cross-sections: (a) NCF, (b) 2D-PW, (c) ORT-PW and (d) ORT-TW. For ORT-PW and ORT-TW architectures, two micrographs were captured: along the warp (top image) and along the weft (bottom image).

Images of the optical cross-sections were obtained for all architectures, namely: NCF, 2D-PW, ORT-PW and ORT-TW (see Figure 3). In the case of NCF (Figure 3a) and 2D-PW (Figure 3b), one cross-sectional image is shown for each along the warp direction. However, for the ORT-PW and ORT-TW, in order to fully inspect the microstructure of these complex architectures, micrographs are taken along both the warp and weft directions. All the optical cross-sectional images show no trace of voids in the microstructure, confirming the quality of the infusion process. The NCF specimen is characterised by straight yarns with minimal crimp as opposed to the 2D-PW and the 3D woven architectures. Moreover, as expected, due to the infusion process and compaction of the 3D preforms, some geometrical distortions of the cured laminates can be observed. This is even more significant in ORT-PW when it comes to the weft yarns being staggered (see Figure 3a). It is also observed in the nonuniform thickness of the z-binding yarns in the ORT-TW case (see Figure 3b), especially at the interlacement locations with the weft yarns. Clearly, the optical images confirm that all the manufactured specimens are void-free. However, the existence of the z-binding yarns resulted in relatively large resin-rich regions in the cured laminates, which is one of the well-known drawbacks of 3D woven composites. In addition, it is clear that in the case of ORT-PW architecture, the frequency and undulation of z-binding is higher than that of ORT-TW confirming that the ORT-TW is less crimped.

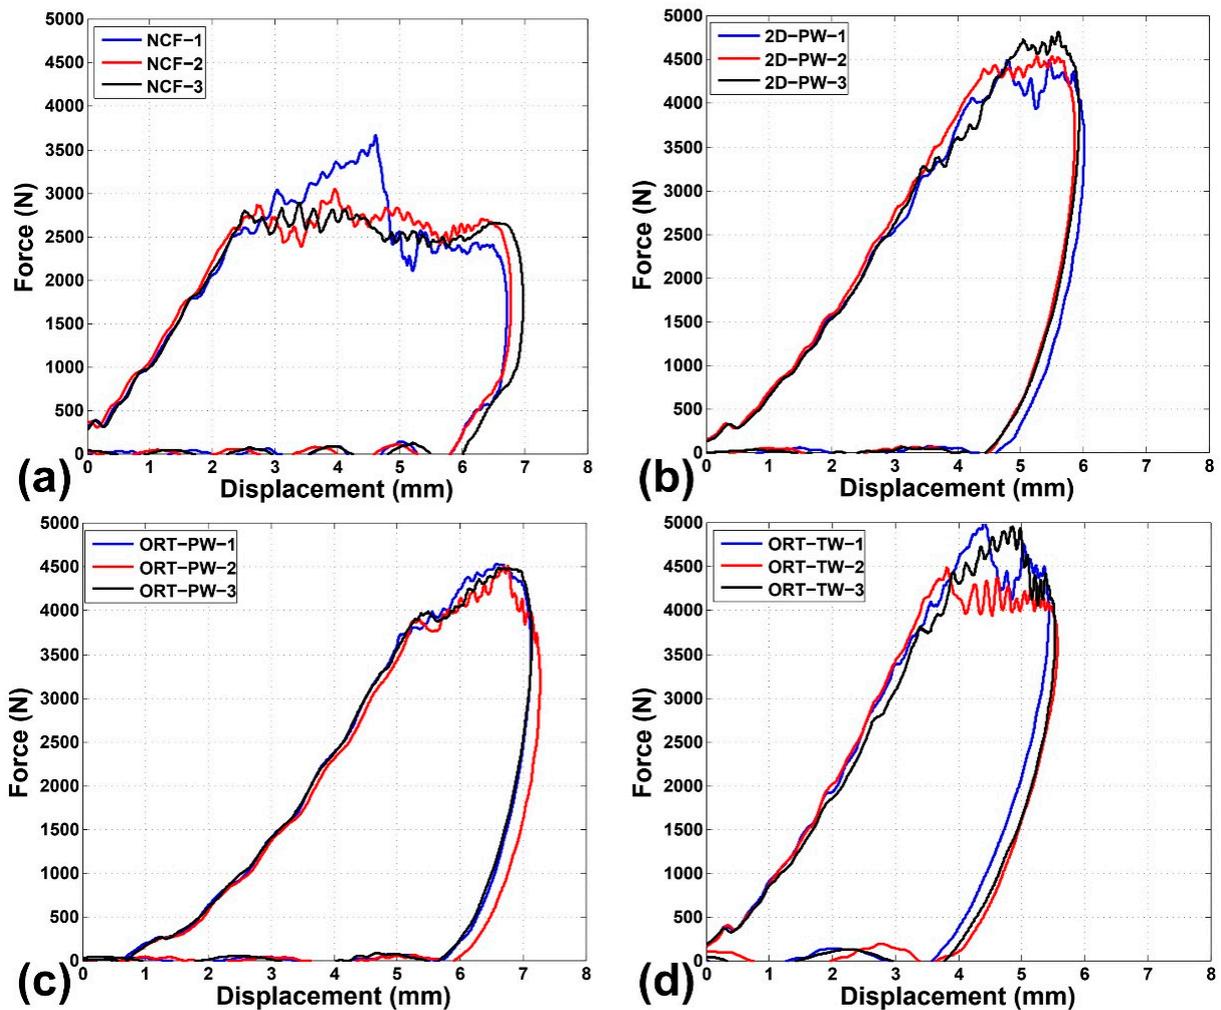
Figure 4. Impact force–displacement curves for the impacted specimens: (a) NCF, (b) 2D-PW, (c) ORT-PW and (d) ORT-TW.

The impact force–displacement curves of the four impacted architectures are depicted in Figure 4. The displacement was calculated by numerically integrating the acceleration (the impact force divided by the mass of the impactor) as a function of time. The reproducibility of the test results and the repeatability of the impact response are confirmed by the small experimental scatter in all cases. In an impact test, the force increases linearly as a function of the displacement/time up to a maximum value when the impactor velocity changes direction. This can be accompanied by damage occurrence in the specimen, in the form of a sudden drop in the force. Afterwards, the force gradually decreases to zero and the impactor returns back to zero displacement. The stiffness of the specimen can be calculated as the slope of the initial linear segment of the force–displacement curve. A clear difference is noticed among the architectures in the sense that the NCF specimens experience the least maximum force of approximately 2500 N while all the other remaining architectures (2D-PW, ORT-PW and ORT-TW) have almost the same range of maximum force ~4500 N. However, the calculated stiffness of all the architectures is comparable (NCF: 954 ± 50 , 2D-PW: 966 ± 29 , ORT-PW: 963 ± 14 and ORT-TW: 1075 ± 70 N/mm). This suggests that the crimp and undulation in the 2D and 3D woven architectures have a negligible effect on the stiffness of the impacted specimens.

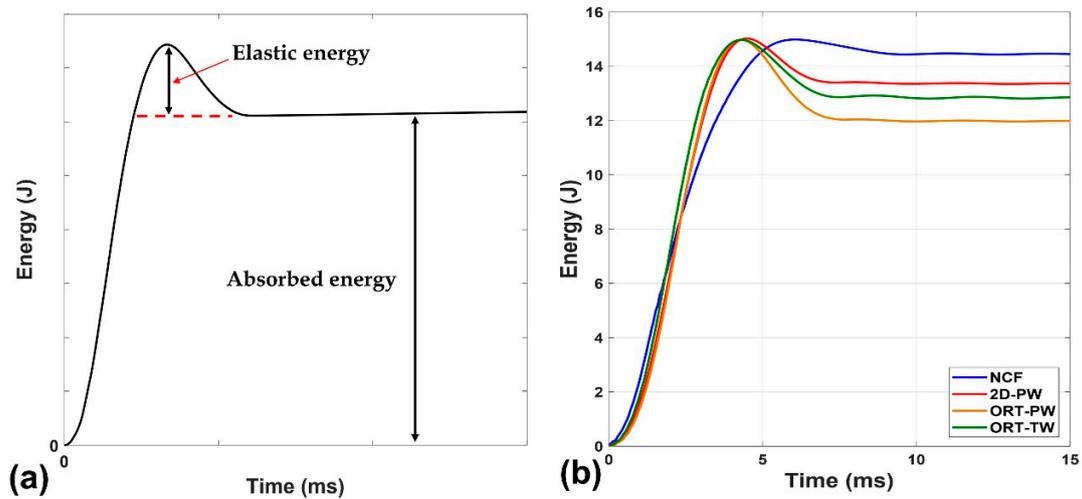
Figure 5. Energy versus time: (a) schematic explaining the elastic and absorbed component and (b) representative sample for each architecture.

In an impact test, the majority of the energy is absorbed by the impacted specimen in the form of permanent induced damage while the remaining part of the energy is stored in the form of elastic energy due to the specimen deformation. As a function of time, the energy can be calculated by numerically integrating the area below the impact force–displacement curve. Figure 5a depicts a representative energy vs. time impact curve [29]. This curve clearly differentiates the elastic component of the energy from the absorbed energy component by the asymptotic dashed line shown (see Figure 5a). The higher the absorbed energy, the larger the damage induced in the specimen due to impact. When applying this principle on the comparison among the four tested architectures in this study (see Figure 5b), it is found that the NCF architecture absorbs the highest energy followed by the 2D-PW, then ORT-TW and finally the ORT-PW. This suggests that the induced damage size should be expected to follow the same pattern. This can be supported by the ultrasonic C-scanning results as well as the damage quantification using the X-ray CT data.

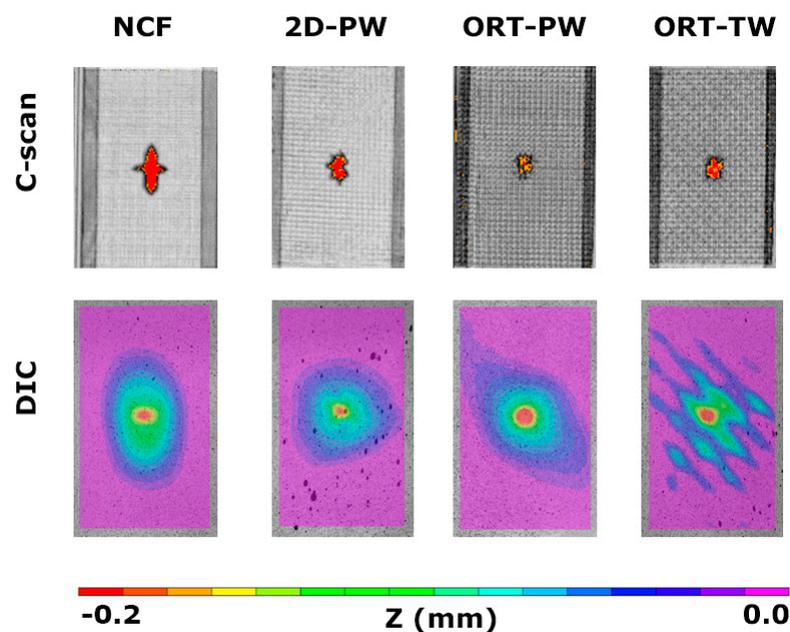
Figure 6. C-scanning and digital image correlation (DIC) results for the impacted specimens.

After all the specimens were impacted, the ultrasonic C-scanning was used to have a better idea of the level of the internal induced damage. A representative C-scan of each architecture is shown in Figure 6. Just by visual inspection, it was difficult to spot the difference among all the different architectures as the impact was a BVID; however, thanks to the C-scans, a clear distinction can be made. Before even calculating the size of the damaged area, it is obvious that the shape of the induced damage is dependent on the architecture. For the NCF case, which has the minimum waviness among all the tested architectures, the shape of the damage induced is characterised by a cross ($0^\circ/90^\circ$) shape. This can be attributed to the fact that, due to impact loading, splitting occurs in the 0° plies, which have longer floats as opposed to the 90° counterparts [29]. Moving on to the 2D-PW case, this cross shape almost disappears with a relatively smaller damage region, but still, it is larger compared to the 3D woven architectures. For both ORT-TW and ORT-PW, the damage size is smaller but still, the ORT-PW demonstrates the smallest induced damage region.

Impact damage resistance is generally evaluated in light of the size of induced damage and the energy absorption. The comparison among all the architectures using these two parameters should help in understanding the effect of the fabric/composite architecture. Therefore, the size of the induced damage was calculated using MATLAB image segmenting tool for all the architectures using the C-scan images. Table 1 summarises the percentage of the damaged area normalised by the total area of the specimen. It is clear that the NCF architecture experienced the largest damage due to impact followed by the 2D-PW. When it comes to the 3D woven architectures, although both architectures experienced less damage as opposed to the NCF, a significant difference is observed between the ORT-PW and the ORT-TW specimens. The induced damage in the case of ORT-TW is almost 1.5 times the damage in the case of the ORT-PW, which clearly highlights the effect of the z-binding yarns frequency or in other words, the unit-cell size of the weave on the impact resistance of the woven composites. This is very much in line with observations, previously reported in [30–35], explaining the role of the z-binding yarns in resisting delamination propagation in 3D woven composites for different loading conditions. The z-binding yarns' path effect is further discussed in this study using the X-ray CT ortho-slices. When it comes to energy absorption, the results confirm the findings obtained from the C-scan images. The NCF architecture which experienced the largest damage absorbed approximately 1 and 2 more Joules compared to the 2D-PW counterpart and the two 3D woven architectures, respectively. In the case of the 3D woven architectures, despite the comparable energy absorption of both the ORT-PW and ORT-TW, the damage is less severe in the former.

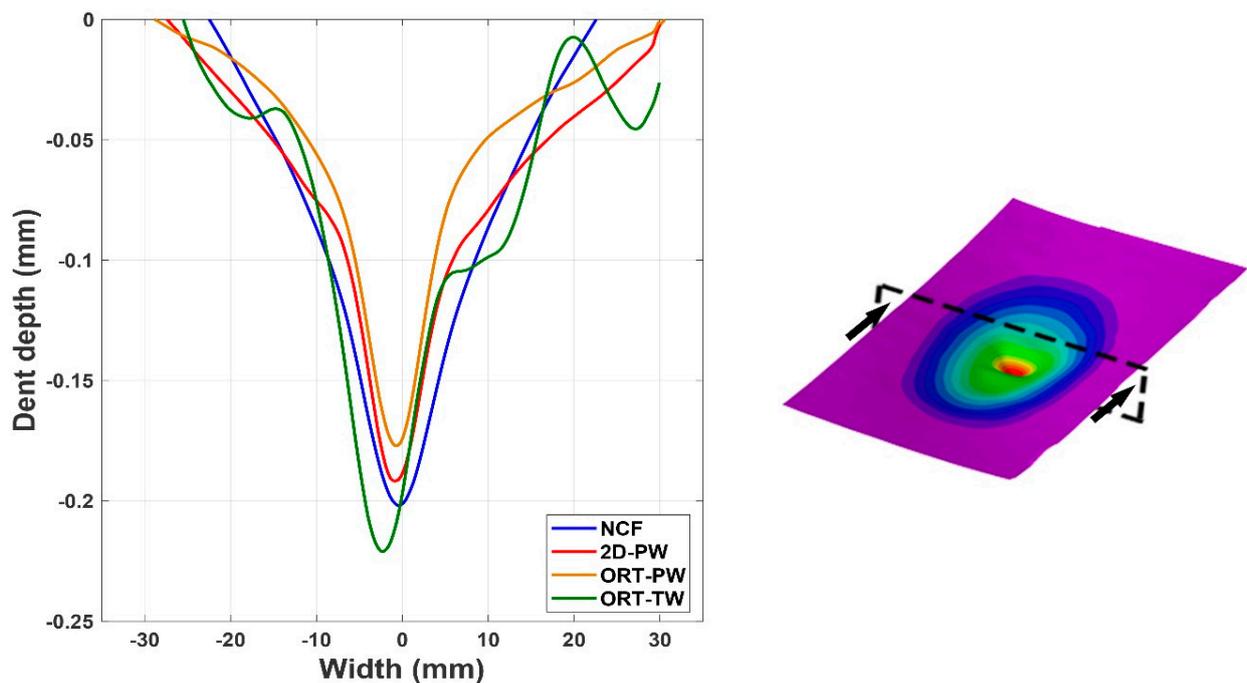
Figure 7. Dent depth comparison for representative cases of all the tested specimens along the cutting plane shown.

The C-scan image analysis is useful in providing planer information about the induced damage, but it does not provide any information regarding the thickness or the out-of-plane direction. Therefore, using the dent depth calculations by incorporating the 3D DIC analysis complements the understanding of the phenomena. The comparison of the dent depth, denoted by the z-coordinate, measured by the 3D DIC is detailed in Figure 7. It is

again clear that the affected area, because of the low-velocity impact, is larger compared to the other architectures. By plotting a line across the width of a representative specimen from each architecture (see Figure 7), the level of plastic deformation, in the form of the dent depth, can be analysed. Regardless of the specimen architecture, it seems like the dent depth due to the impact is very comparable, with a value of ~ 0.2 mm. However, again it is noticed that the architecture with the shallowest dent is the ORT-PW, followed by the 2D-PW and then the NCF. The dent depth of the ORT-TW seems to be the deepest but this might be just due to the damage being very localised at maybe the z-binding yarn location. Later in the X-ray CT analysis it will be shown that specifically for this architecture, the yarns' breakage was observed.

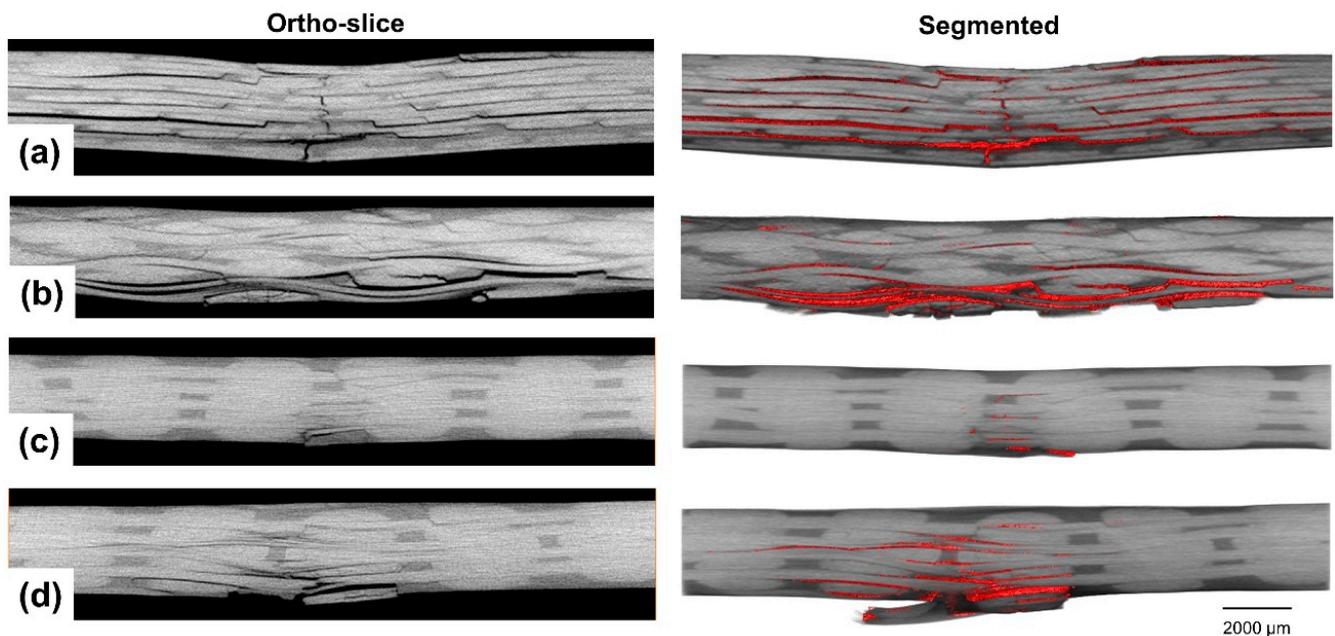
Figure 8. Ortho-slices and segmented damage highlighted in red in locations where there are no binding yarns (the top is the front side of the impact and the bottom is the backside) for: (a) NCF, (b) 2D-PW, (c) ORT-PW and (d) ORT-TW.

In locations where no z-binding yarns exist (see Figure 8), The dominant damage mechanisms represent the typical damage mechanisms due to low-velocity impact [37]: matrix cracking (due to shear and bending stresses), delamination (because of the large out-of-plane deformation and interlaminar shear) and localised fibres/yarns breakage (directly beneath the impactor at the front side and tensile failure at the backside due to bending). The severity of each damage mechanism differs from one architecture to the other. In the case of the NCF specimen (see Figure 8a), interlaminar delamination between all the adjacent plies, extending from the impact location, is very obvious as well as surface plies splitting. This is also accompanied by extensive matrix cracking and fibre/yarn breakage especially at the backside of the specimen, away from the impact location in the thickness direction. The interlaminar delamination, however, in the case of the woven architectures (2D-PW, ORT-PW and ORT-TW), is guided by the waviness of each architecture. The severity of the damage beneath the impact location at the front side is very minimal compared to the damage experienced at the backside. Tensile matrix cracking and fibre/yarn breakage are dominant especially in the 2D-PW (Figure 8b) and ORT-TW (Figure 8d) specimens. Moreover, this type of damage is much localised in the ORT-TW case, which could explain the reason why the dent depth previously measured in Section 4.2.2 using the DIC was found to be the largest. By visual inspection of the damage size among all the architectures in these locations, it is clear that the ORT-PW (Figure 8c) experiences the least damage, but this should be also confirmed in other planes as well as the 3D reconstructed volume as discussed later.

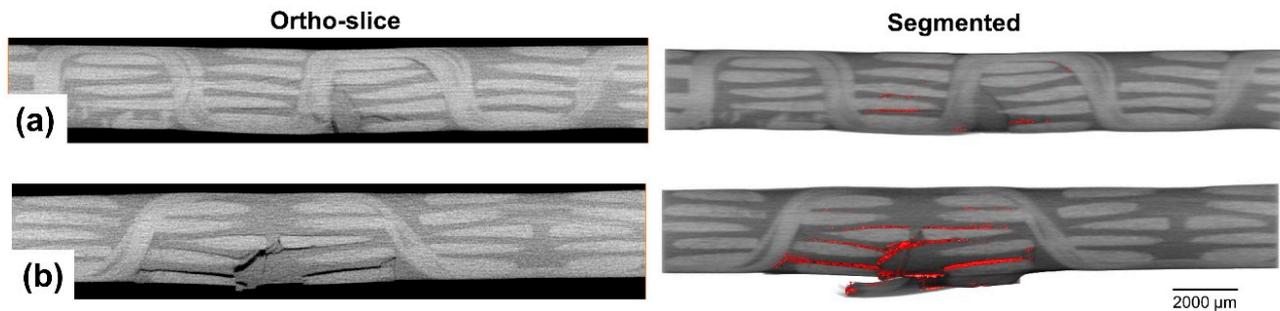
Figure 9. Ortho-slices and segmented damage highlighted in red in locations where there exist binding yarns in the 3D woven composites (the top is the front side of the impact and the bottom is the backside) for: (a) ORT-PW and (b) ORT-TW.

Moving on to locations where z-binding yarns exist (see Figure 9), a comparison can be made between the two 3D woven architectures, the ORT-PW and ORT-TW. Although the aforementioned dominant damage mechanisms (matrix cracking, delamination and fibre/yarn failure) are still the same, it is very obvious that the size of them is much smaller in the planes where the z-binding yarns exist. Again, most of the damage occurs at the backside, which is typical for low-velocity impact damage. Nevertheless, the unit-cell size effect is very significant. In the case of the ORT-PW (Figure 9a), the frequency of the z-binding yarns is double the frequency of the ORT-TW (Figure 9b) counterpart. In other

words, the unit-cell size of the ORT-PW is half of the ORT-TW. This enables the ORT-PW architecture to resist the induced impact damage more than the ORT-TW. In both cases, the z-binding yarns act as crack/delamination stoppers, hence delamination or matrix cracking grows as long as it is not arrested by any z-binding yarn. This results in longer delamination and larger damage size in the case of the ORT-TW as opposed to the ORT-PW architecture.

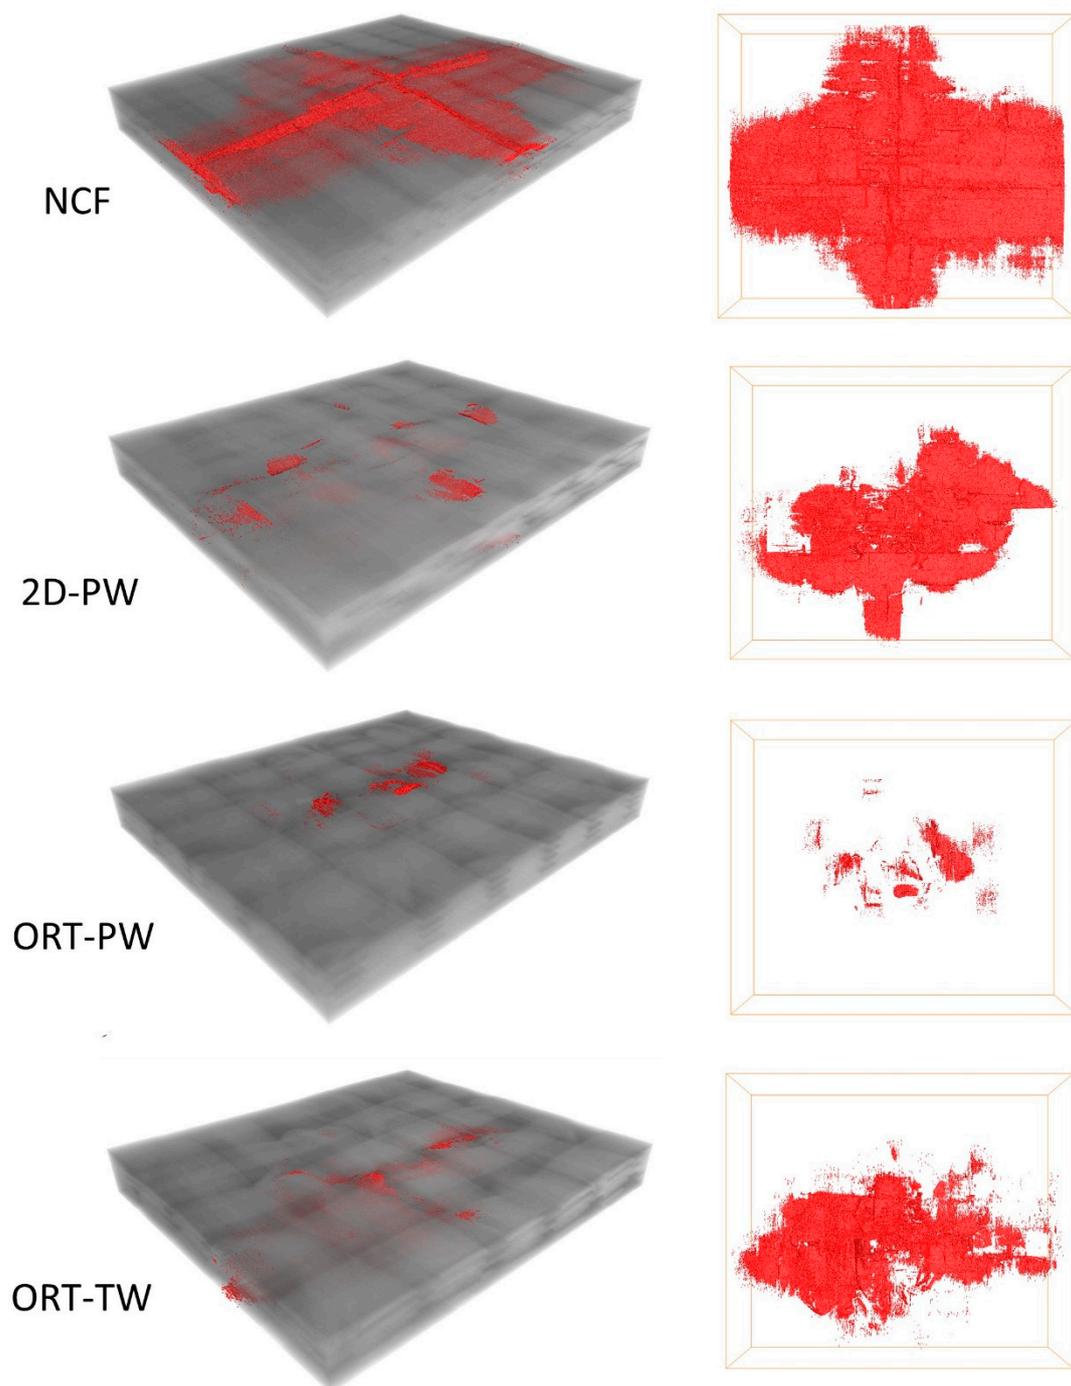
Figure 10. 3D X-ray CT reconstructed volume with the segmentation of damage due to impact highlighted in red (left) and 2D top view (right).

So far the discussion and comparison have been made only based on 2D planar data. To confirm the findings in 3D space, volume reconstruction and segmentation are inevitable. Here, the 3D morphology and distribution of interyarn impact damage are of interest and simple automatic thresholding could not fit this purpose. Thus, a routine was developed to segment interyarn damage (mostly in-plane but may deviate when z-binding yarns exist) in a reliable and repeatable way across different structures. The full composite volume was firstly segmented out to define the region-of-interest for further image processing. This was followed by applying the top-hat segmentation tool to the composite volume. Line kernels sized 40 lying in-plane were used as seeds to extract black features (in this case, the impact image) and the masking range of 48–255 was selected. The selected damage volume was then denoised by removing all isolated islands smaller than 5 voxels in 3D to provide the final segmented interyarn damage volume for all types of architectures as shown in Figure 10.

The damage volume fraction (see Table 2) was calculated by dividing the volume of the segmented impact damage by the analysed image volume (width ~ 19 mm \times height ~ 22 mm \times thickness) of the composite panel before impact. It is clear from the comparison that the same trend observed from the C-scan results is prevailing. The NCF architecture experiences the maximum damage due to the single impact followed by the 2D-PW. Both 3D woven architectures experience less damage with the ORT-PW having the least damage volume fraction. This demonstrates first the effect of the z-binding yarns in resisting the induced damage due to out-of-plane loading compared to laminated and 2D woven composites. Second, the frequency of the z-binding yarns through the thickness also has a noticeable effect on the damage resistance. The higher the z-binding yarns' density, as in the ORT-PW case, directly translates into less damage volume fraction compared to the ORT-TW.
