State of Conservation of Concrete Heritage Buildings: A European Screening

Gabriel Pardo Redondo ^{1,*}, Giovanna Franco ², Antroula Georgiou ³, Ioannis Ioannou ³, Barbara Lubelli ¹, Stefano F. Musso ², Silvia Naldini ¹, Cristiana Nunes ⁴ and Rita Vecchiattini ²

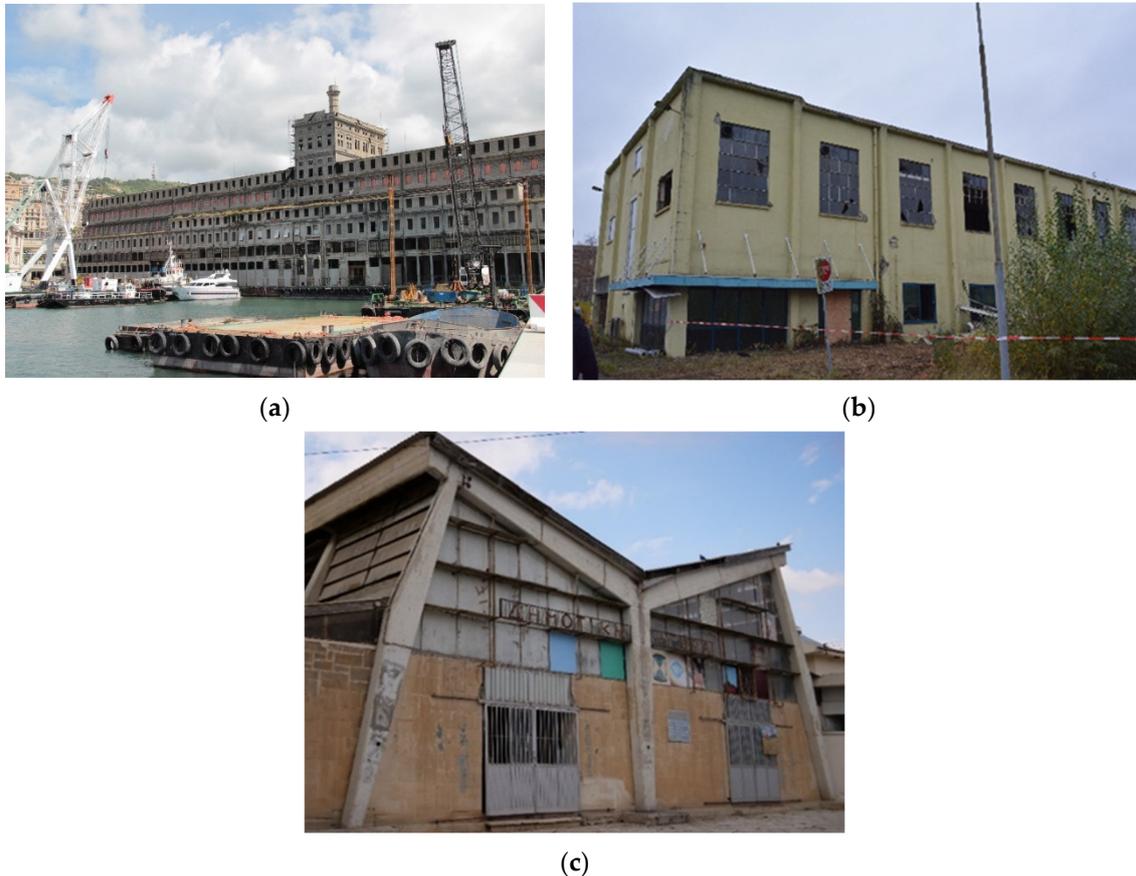
Figure 1. Historic concrete buildings. (a) Hennebique Silos in Genova (1901–1906). Source: Authors 6; (b) Calve Building (1908) in Delft, the Netherlands. Demolished in 2019. Source: Author 1; (c) Athienou Municipal Market (1951–1955) in Cyprus. Source: Authors 3 and 4.

Reinforced concrete (RC) started to be used in Europe in the late 19th and early 20th centuries. The new material was eagerly adopted in some countries to construct new buildings; whereas in others, concrete boomed in a later period. In Genova, Italy, for instance, the Hennebique silos (1901–1906) (Figure 1a) exhibited an early mastery in the use of concrete systems in a large-scale building with a system patented nine years before [1]. Whereas, in the same period, in the Netherlands, RC buildings tended to be of less entity and complexity like the Calve building in Delft (1908) (Figure 1b) as concrete had not yet found its niche in the country.

Cyprus, for instance, started late in the tenacious use of concrete. When the island was a British colony (1922–1960), RC was introduced to modernize the Cypriot landscape (Pyla and Phokaides, 2009). However, it was not until the decade of the 1960s, with the island's independency from the British Empire, when the concrete 'boom' started with the construction of many private and public buildings (Figure 1c).

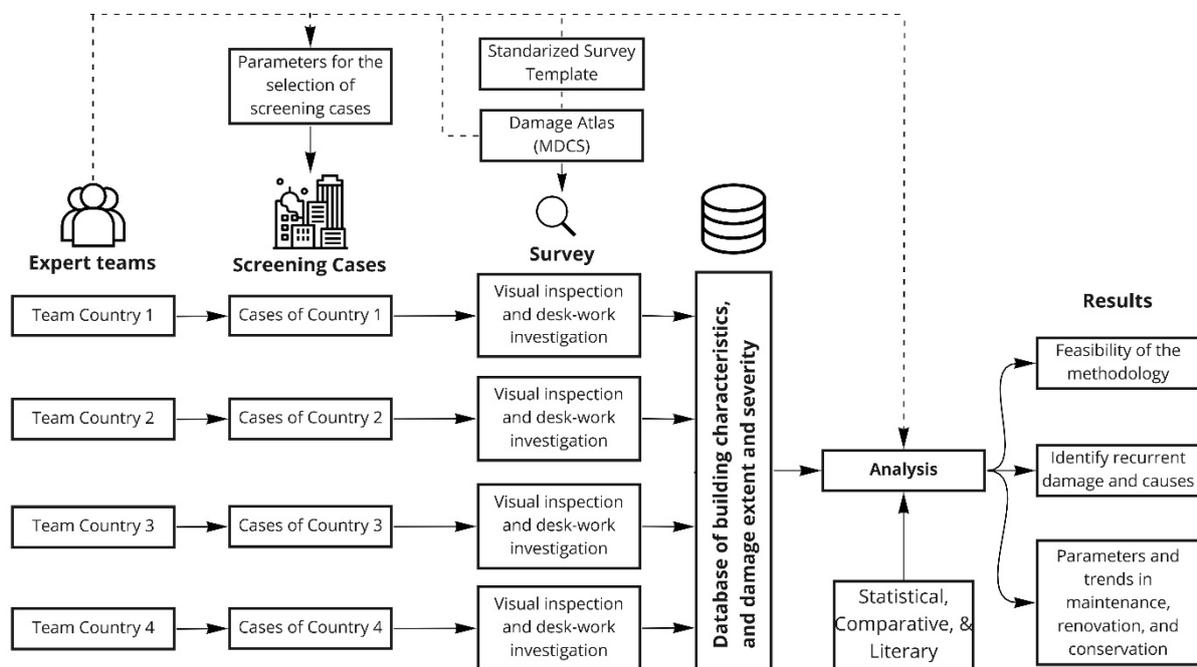
A scheme of the methodology can be found in Figure 2. The survey for each building was carried out by a designated team in each country. Each team was specialized in damage assessment, conservation, and concrete degradation. Starting from the visible damage, each team recorded the most common damage types and evaluated the possible cause(s) of each damage. For this task, the Damage Atlas of the online tool MDCS was used [9], which defines illustrative examples and explains the characteristics and plausible causes of the different damage types.

Figure 2. Flow chart of the proposed methodology.

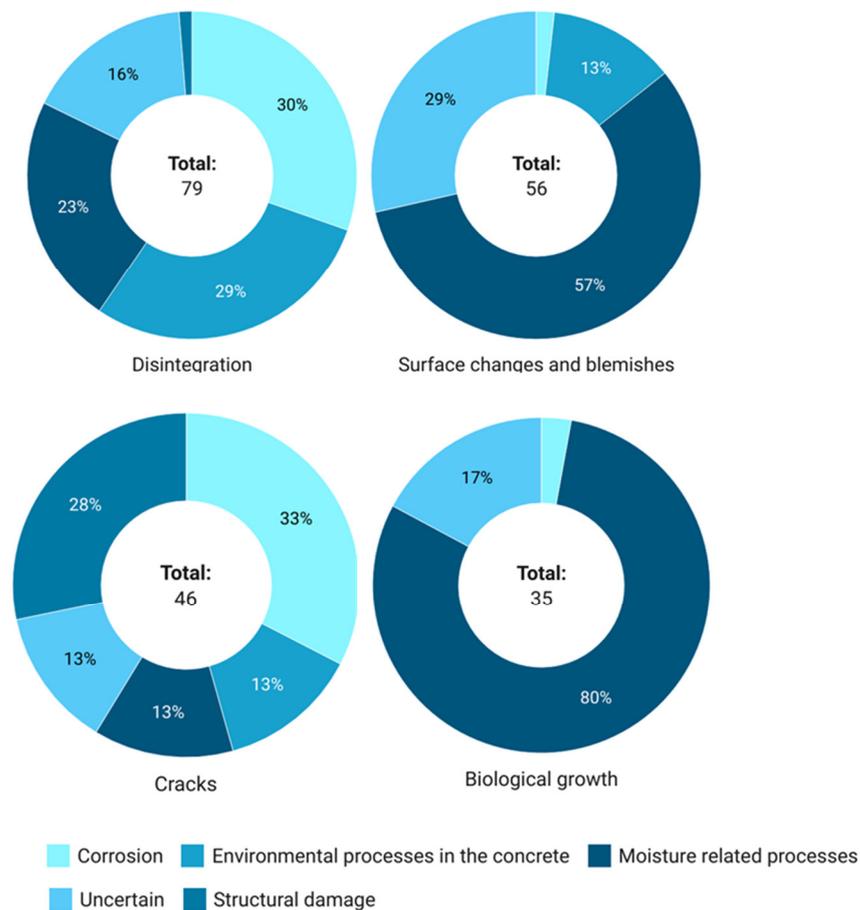
The correlation between the damage and the potential cause/s is summarized in Figure 5. The most relevant results were that Cracks were predominantly related to corrosion and structural damage, and Disintegration was primarily linked to corrosion, moisture, and environmental processes. The rest of the correlations did not provide significant findings.

Figure 5. Hypothetical causes of damage per type of damage group.

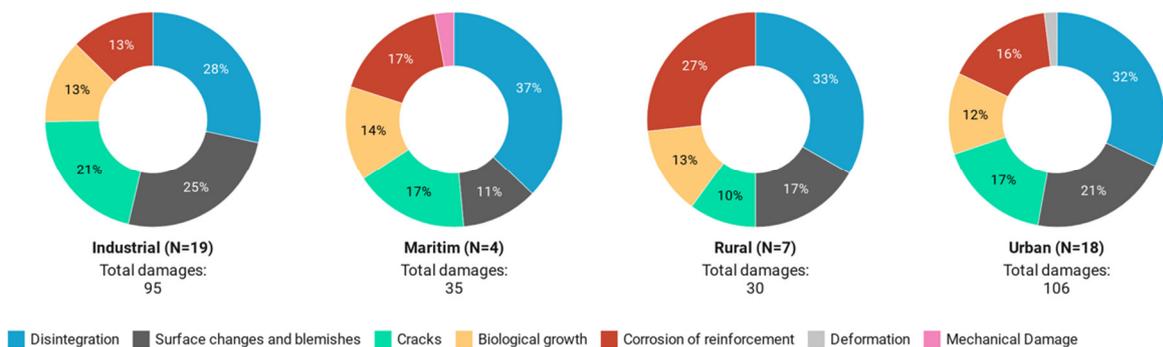
The environment is believed to be one of the leading causes of concrete degradation [15]. This non-physical characteristic was also studied by comparing different environments. Buildings in urban areas showed more extent and severity of damage than buildings in industrial areas (refer to Table 3). The highest severity of damage was found in buildings in maritime areas, although the number of buildings was limited to only three. A relation was also expected between specific types of damage, depending on the environment. However, the relative distribution of the types of damage was similar across all environments studied (refer to Figure 6). Disintegration was the most common damage, followed by surface changes and blemishes in most environments. Corrosion, cracks, and biological growth appeared in lesser numbers.

Figure 6. Types of damage per environment.

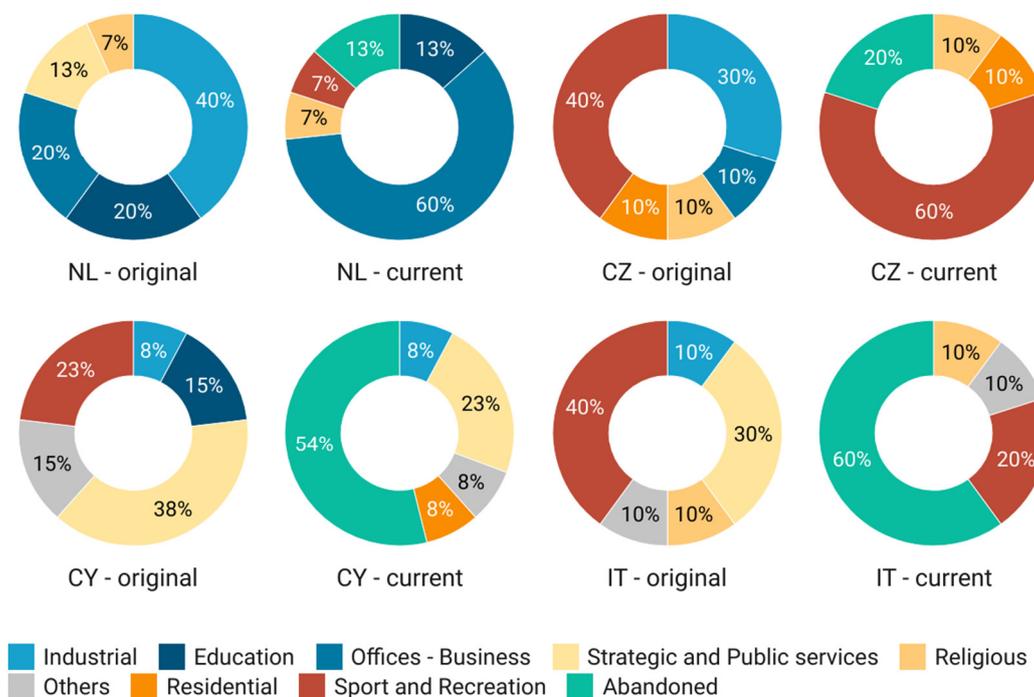
Whether the building had changed its original use or not did not have a noticeable impact on the state of its conservation. Most of the industrial buildings had been converted or abandoned. Educational and Sport and Recreational buildings have been abandoned in Cyprus (CY). In Genova (IT), the only buildings that did not fall into abandonment were religious and “others” (Figure 7).

Figure 7. Change of building use per country.

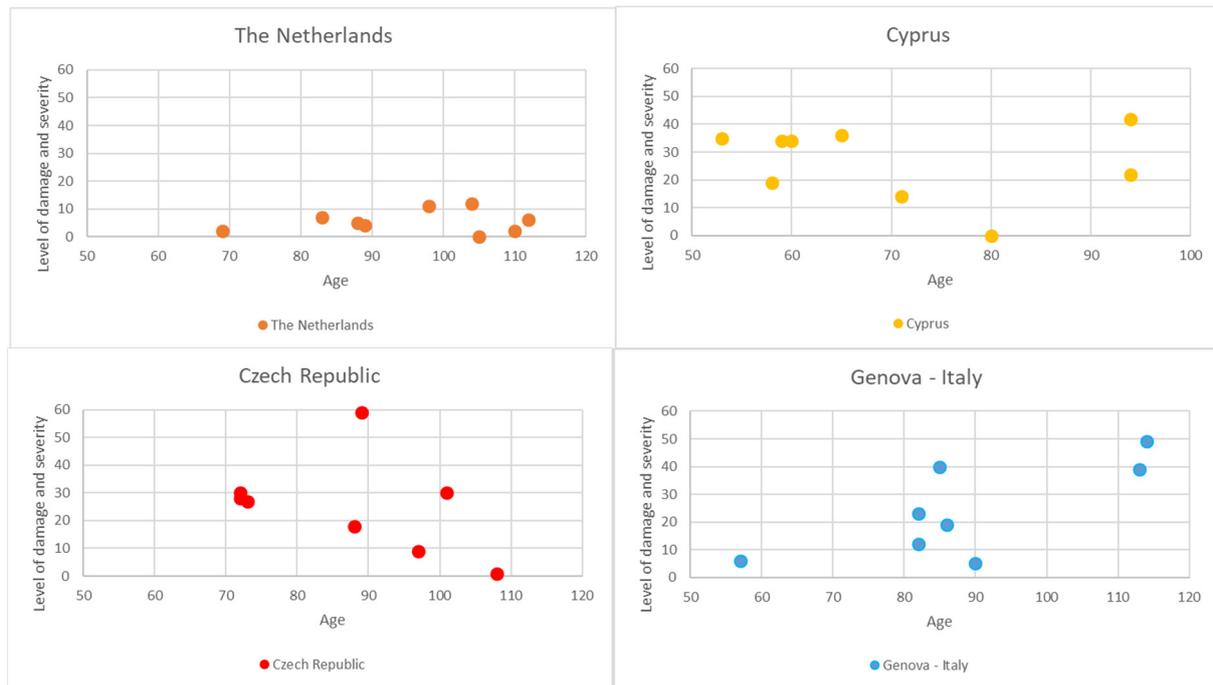
By comparing the state of conservation of non-restored buildings, a trend in building maintenance could be observed among countries. In Figure 8, the non-restored buildings of each country are displayed in terms of Age (X axis) and Level of damage extent and severity (Y axis). The large scatter of the results does not allow for precise conclusions, but some trends can be extracted. Buildings in the Netherlands showed a better state of conservation, having the lowest level of damage across all ages. Cyprus had, on average, higher damage—even in younger buildings. The Czech Republic had scattered results but there seems to be a tendency for a better state of conservation of older buildings. On the contrary, Genova had an opposite trend, where the younger buildings were in a better state than older buildings.

Figure 8. Age (X axis) and Level of damage (Y axis) of the non-restored buildings in each country.

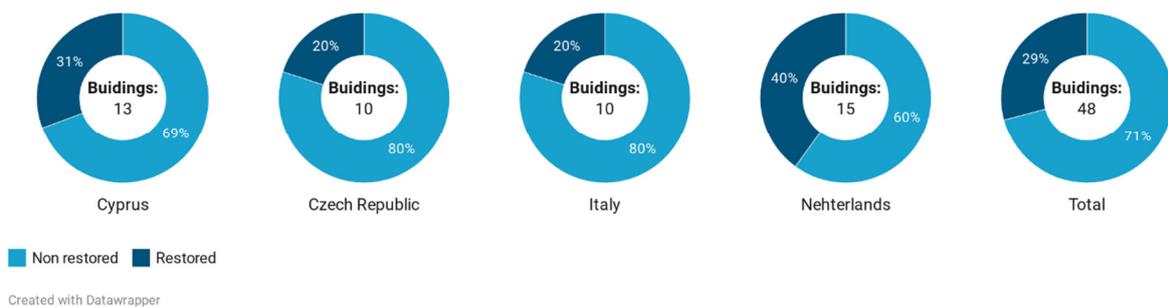
Non-restored buildings accounted for 71% of the buildings studied, showing a similar percentage (from 60 to 80%) in all countries (Figure 9). As expected, restored buildings showed a lower level of damage severity than non-restored buildings.

Figure 9. Restored and non-restored buildings per country.

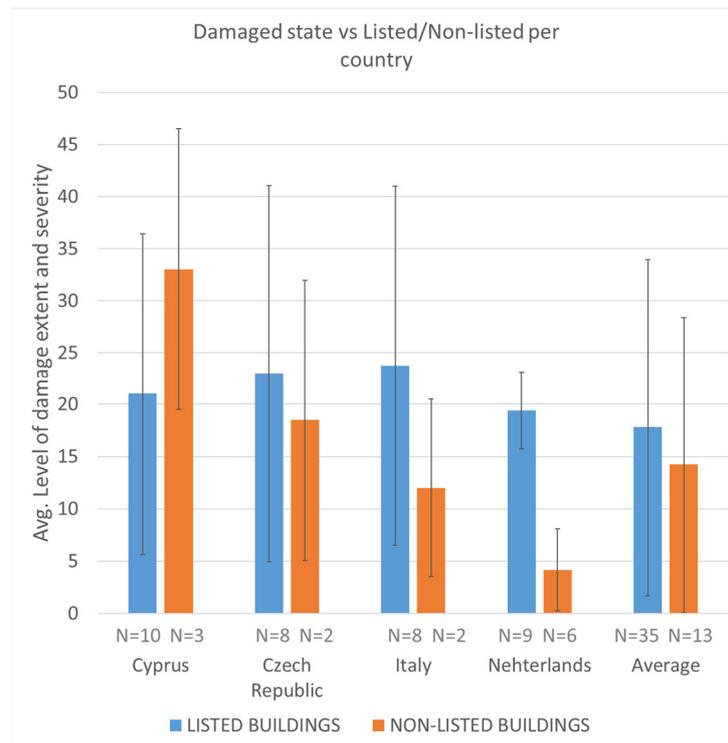
On average, 73% of all buildings had some type of monumental protection. The protection could be local, provincial, or national. Interestingly, the level of damage severity was higher in listed buildings, compared to non-listed, in all countries except Cyprus (Figure 10).

Figure 10. Level of damage severity vs. Building protection per country.

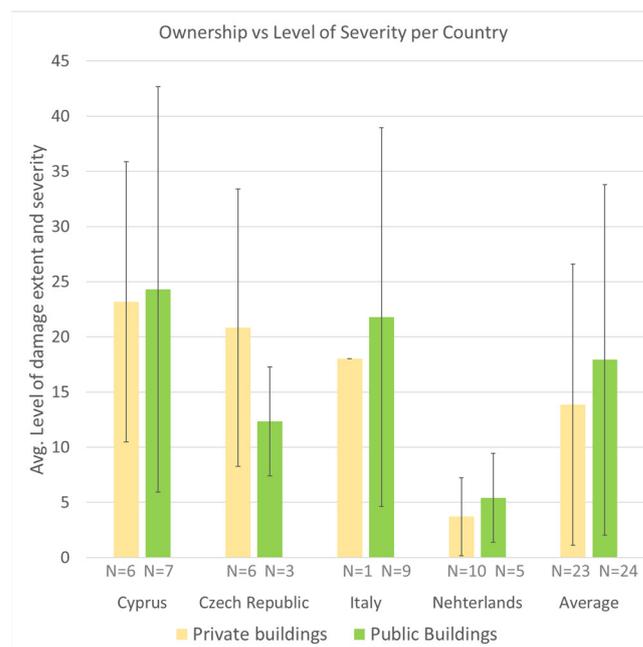
Generally, there is an even number of private and public buildings in the sample, although there are significant differences in their state of conservation among countries. Considering all the buildings, restored and non-restored, the Netherlands and Czech Republic have similar ratios, 67–33% and 60–40% ratios of private–public buildings, respectively. On the contrary, the buildings in Genova were predominantly public ones (90%). Cyprus had an even ratio, 46–54% of private to public buildings. There is not a clear indication between the level of damage and the ownership; although, private buildings tend to be in a better condition than public ones (Figure 11).

Figure 11. Level of damage severity vs. type of ownership per country.
